MINERALS PROGRAM INSPECTION REPORT

MINE NAME: The Broyles Pit	MINE/PROSPECTING ID#: M-2004-028	MINERAL: Gravel	COUNTY: Las Animas
INSPECTION TYPE: Monitoring	WEATHER: Clear	INSP. DATE: March 26, 2025	INSP. TIME: 08:31
OPERATOR: Michele M and Frederick V Eichler IV	OPERATOR REPRESENTATIVE: Seth Crummer	TYPE OF OPERATION: 112c - Construction Regular Operation

The Broyles Pit was inspected by Amber Gibson with the Division of Reclamation, Mining and Safety (Division/DRMS). The inspection was completed as part of the Division's routine monitoring inspection program. The site was previously inspected by the Division on November 3, 2020 as a routine monitoring inspection. Seth Crummer (representing the Operator/Permittee), accompanied me during the inspection. The sky was clear, and the weather was warm.

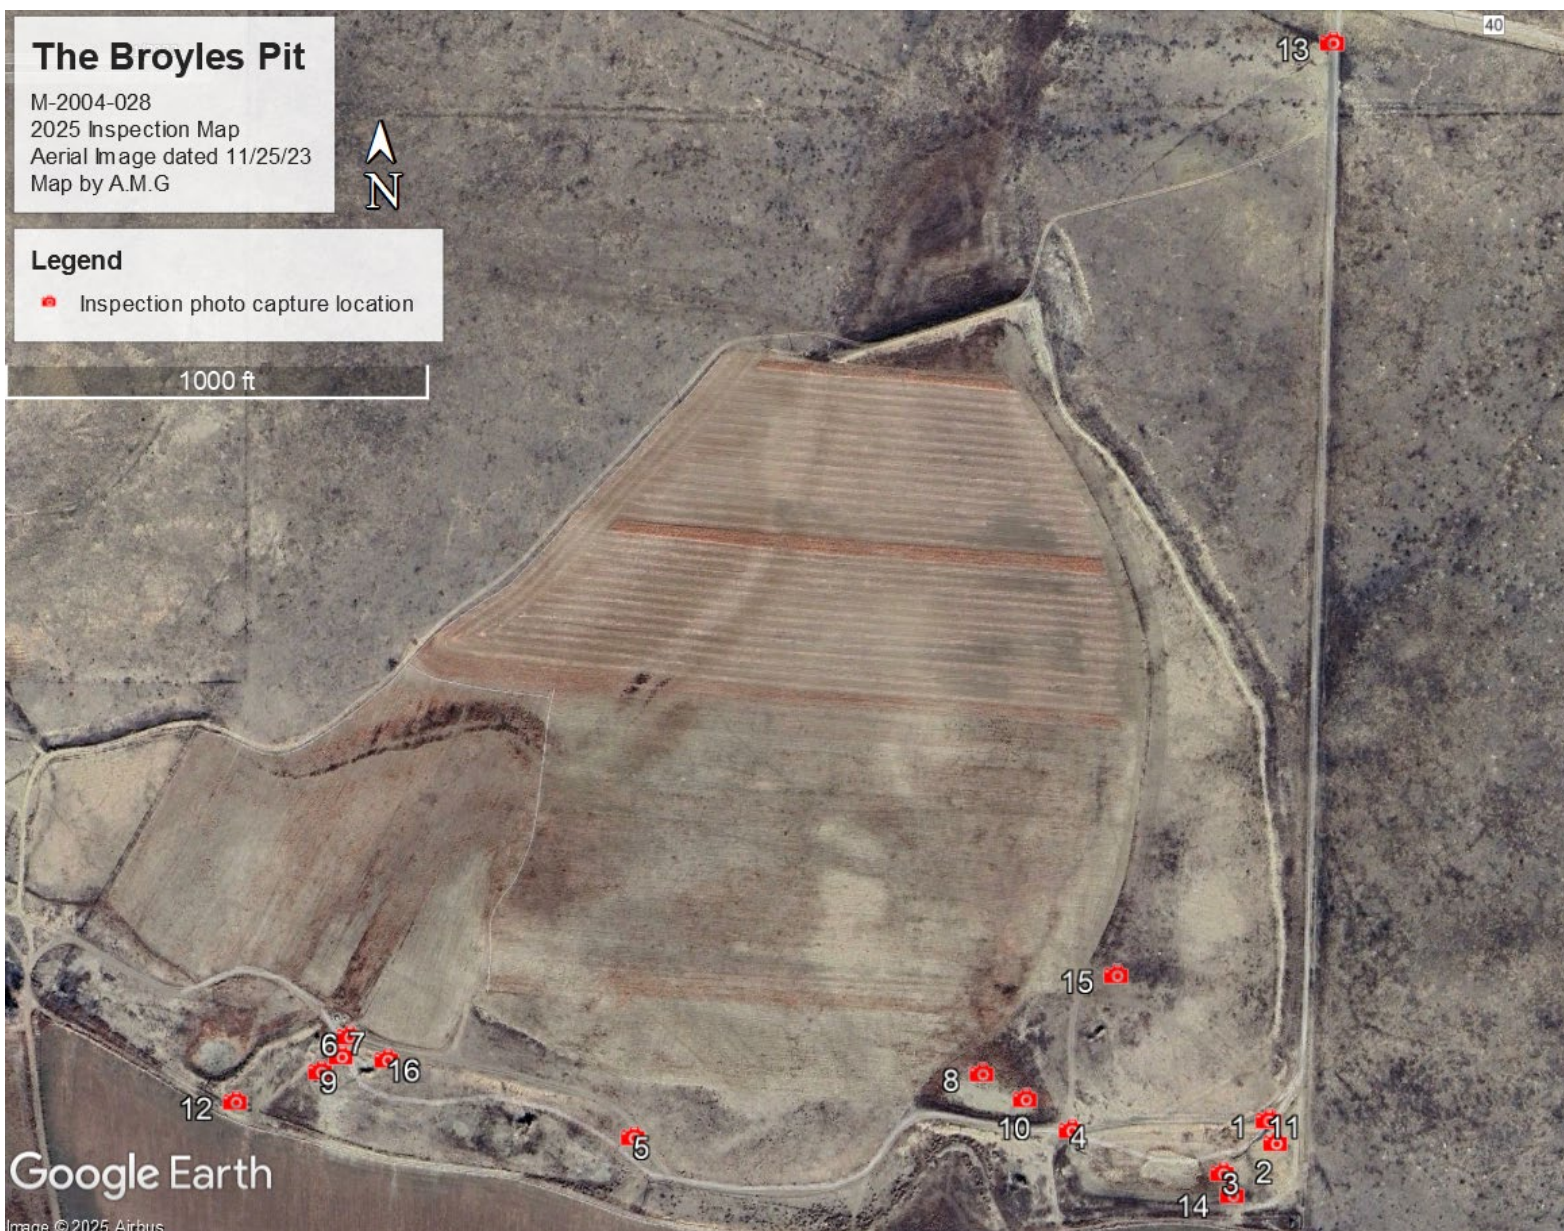
There appears to be some topsoil piled in the West Pit (Photo 16). The Operator shall use this material to topsoil the highwall in the West Pit once it has been backfilled and graded.

Photo 16: Looking southwest at some topsoil material in the West Pit.
