PITCH RECLAMATION PROJECT COLORADO MINED LAND RECLAMATION BOARD 2024 ANNUAL RECLAMATION REPORT

RECLAMATION PERMIT NUMBER M-1977-004

April 2025

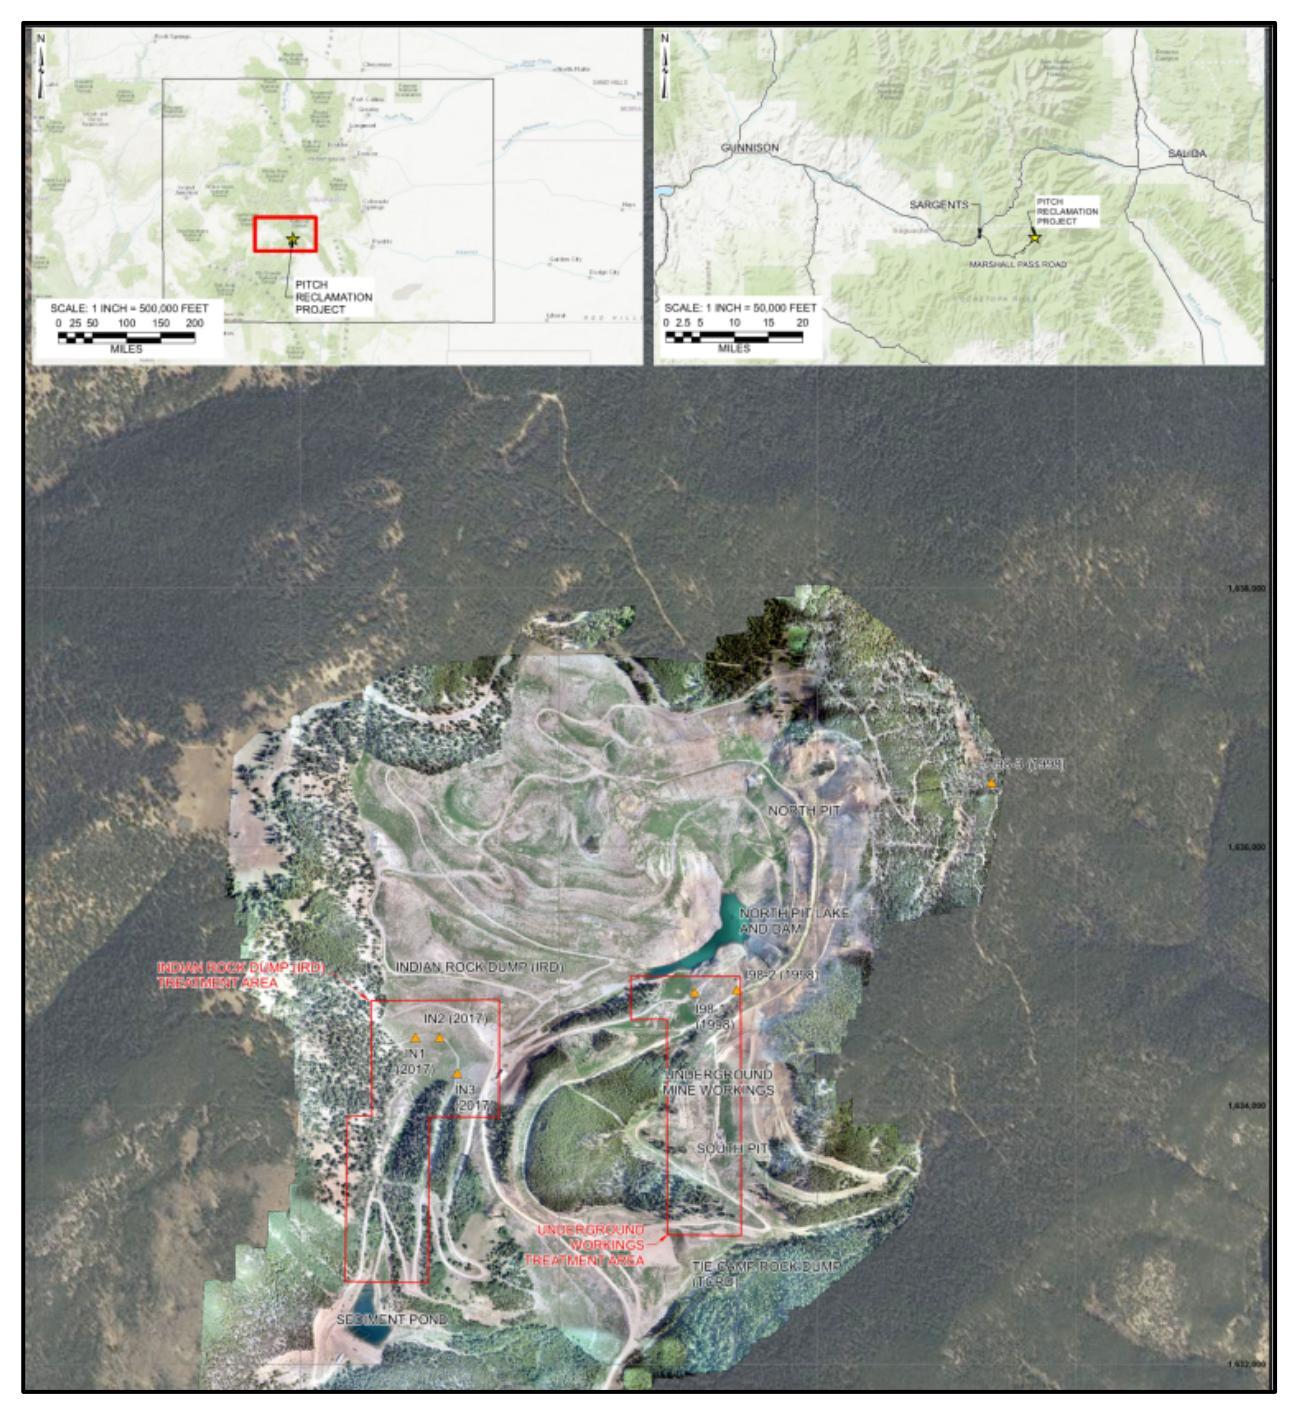
Figure 1-1: Site Location and Location of Inclinometers

Inclinometer and survey monument locations are shown on Figure 1-1.

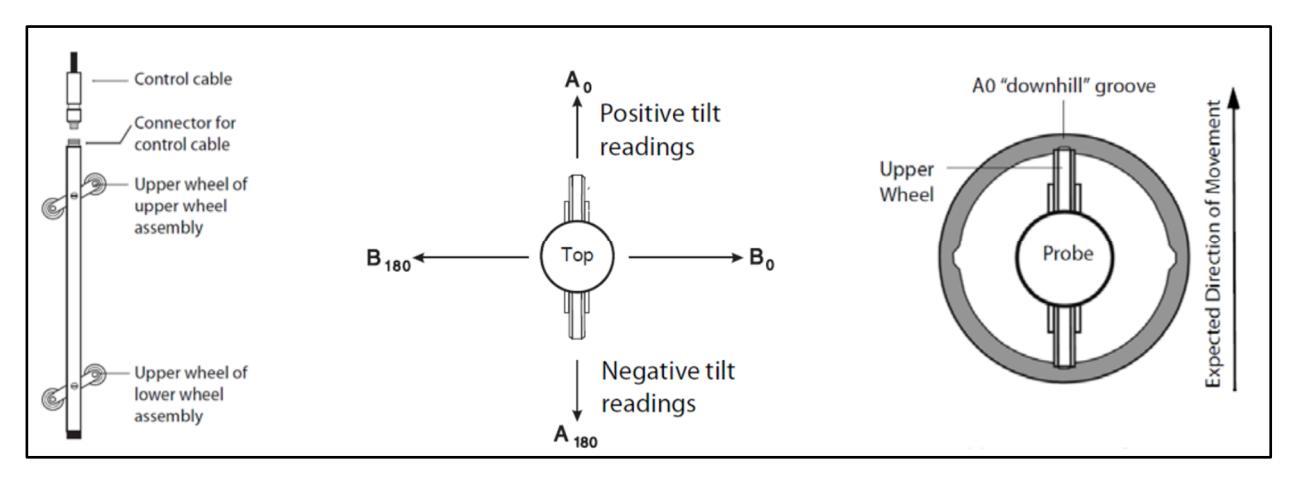
Figure 2-1: Inclinometer Probe and Casing Directions

The inclinometer casings at site were installed in a near-vertical borehole. The inclinometer probe used was provided by HMC and employs two force-balanced servo-accelerometers to measure tilt in two planes of the inclinometer wheels ("A" axis) and perpendicular to the wheels ("B" axis) (Slope Indicator, 2011). The drawings in Figure 2-1 show the probe from the side, top, and in the casing.
