### MINERALS PROGRAM INSPECTION REPORT PHONE: (303) 866-3567

MINE NAME:	MINE/PROSPECTING ID#:	MINERAL:	COUNTY:
Kirtright Pit	M-1986-123	Sand and gravel	Larimer
<b>INSPECTION TYPE:</b> Preoperation Inspection	WEATHER: Clear	INSP. DATE: April 21, 2025	INSP. TIME: 09:00
<b>OPERATOR:</b>	<b>OPERATOR REPRESENTATIVE:</b>	<b>TYPE OF OPERATION:</b>	
Coulson Excavating Company, Inc.	Ken Coulson, Peter Wayland	112c - Construction Regular Operation	
<b>REASON FOR INSPECTION:</b>	BOND CALCULATION TYPE:	BOND AMOUNT:	
Preoperation Inspection	None	\$58,400.00	
DATE OF COMPLAINT:	POST INSP. CONTACTS:	JOINT INSP. AGE	NCY:
NA	None	None	
INSPECTOR(S): Patrick Lennberg Joel Renfro	INSPECTOR'S SIGNATURE:	SIGNATURE DAT May 5, 2025	Е:

This was a pre-operation inspection of the Kirtright Pit (M1986-123) conducted by Patrick Lennberg and Joel Renfro of the Division of Reclamation, Mining, and Safety (Division/DRMS). The inspection was completed in response to a Board Ordered Amendment Application (AM-1), received by the Division on February 27, 2024. The application was deemed complete for the purpose of filing on June 14, 2024. The site was previously inspected by the Division on June 27, 2023, in respo

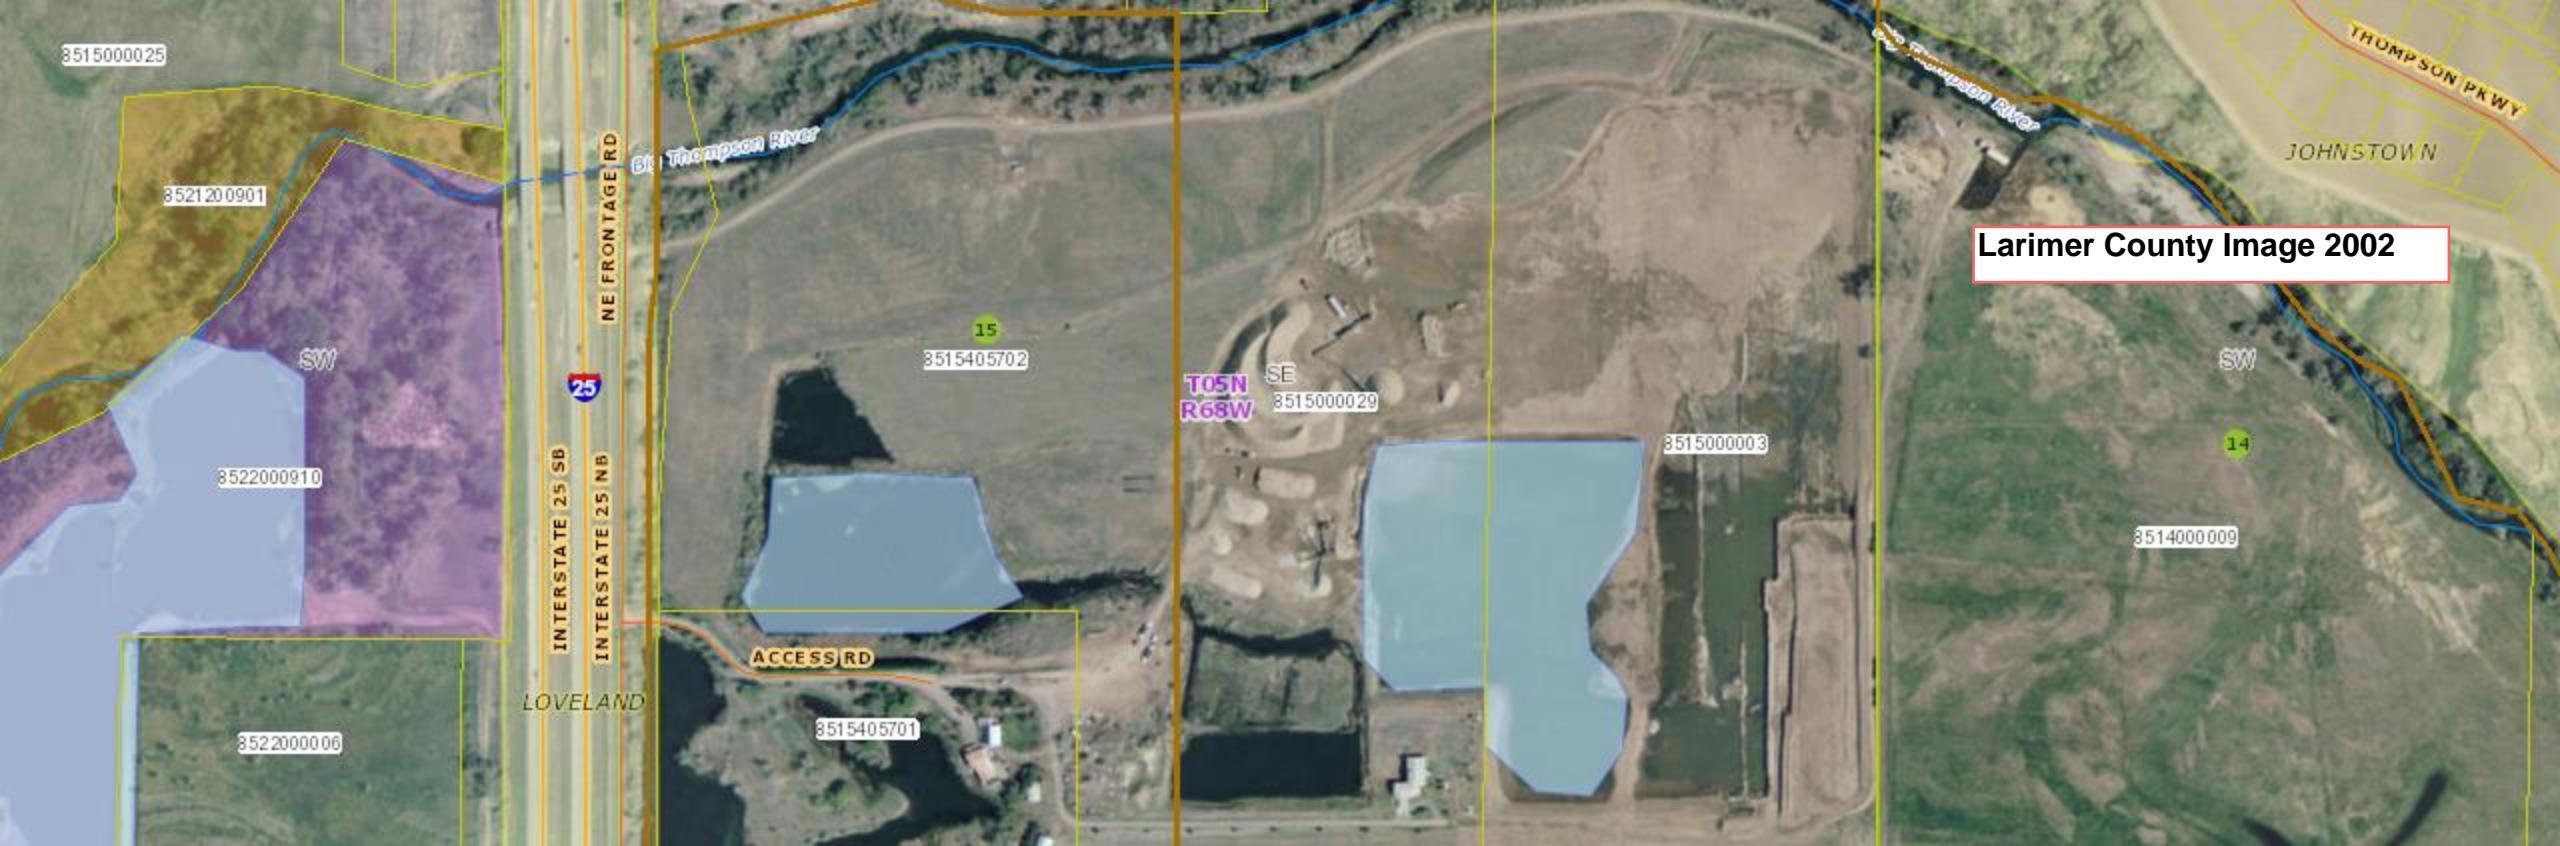
Aerial Image 2004

During the inspection the Division noted there are three isolated piles of gravel material in the area north of the currently approved and proposed permit boundary. Two of the piles (Pile 1 and 2) are on the easternmost property owned by Randy Kirtright and the other (Pile 3) is on the O'Brien property. Two of the piles (Pile 1 and 3) are north of the proposed/current permit boundary. The other (Pile 2) appears to be on the proposed/current permit boundary. A review of historic aerial imagery, using Google Earth and the Larimer County Assessor's website, shows that these piles were generated during mining operations at the Kirtright Pit that occurred outside the approved permit boundary. Please see Attachment 1. The Operator will have to include these piles and areas affected by mining into the revised permit boundary. After this inspection the Division issued Adequacy Review #3 addressing this concern and others.
