Re: M-1977-573 - West Pueblo Pit – TR07 Request Letter

The Arkansas Groundwater and Reservoir Association (“AGRA”), permit holder of active permit M-1977-573 (the Permit), would like to submit this letter to you requesting from the Division of Reclamation, Mining, and Safety (DRMS) a Technical Revision (TR) to the existing mine reclamation plan currently approved for the Permit and the West Pueblo Pit (Pit).

UPDATED RECLAMATION PLAN MAP FOR M1977-573 - TR07

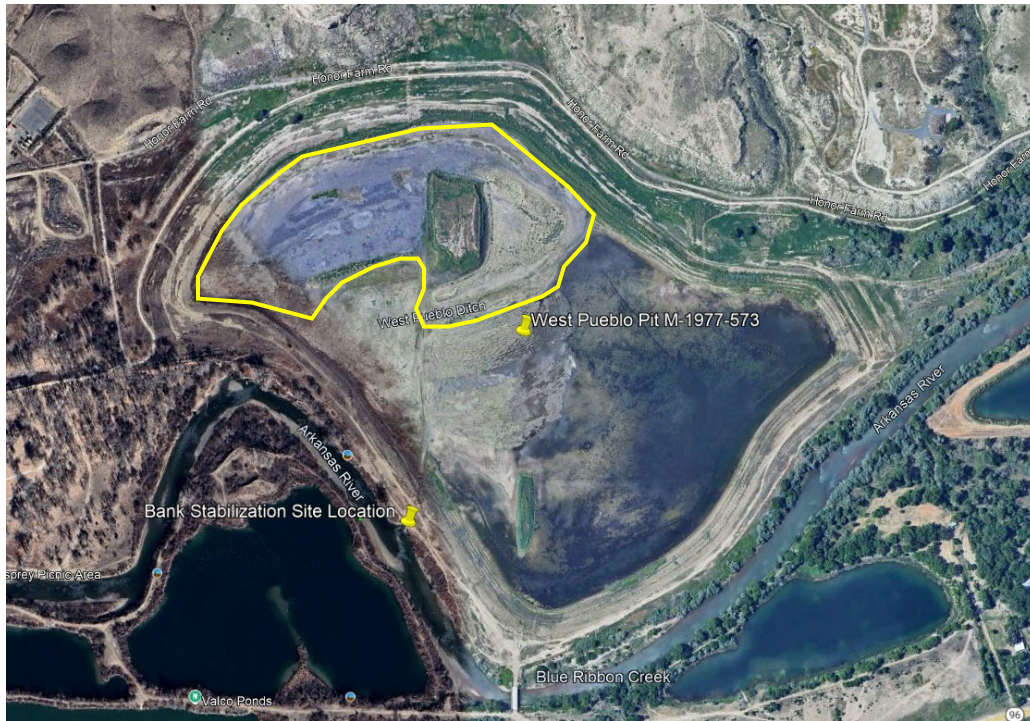
There is also a significant unquantified amount of limestone boulders that may also be from SDS related excavations, although this is uncertain. This deposit is located just south of the fills. No classification of this rock has been performed but a visual inspection has been performed, and the rock appears to range in gradation from large boulders to small cobbles, with most rocks being angular in shape. Approximately 600 CY of this rock was recently used as riprap for emergency repairs along the Arkansas River at the west side of parcel boundary. These repairs will be discussed in more detail in the section below.
