**MINERALS PROGRAM INSPECTION REPORT**  
**PHONE: (303) 866-3567**

| <b>MINE NAME:</b><br>Becker Pit | <b>MINE/PROSPECTING ID#:</b><br>M-2020-022 | <b>MINERAL:</b><br>Sand, gravel and borrow material for construction | <b>COUNTY:</b><br>Huerfano |
| <b>INSPECTION TYPE:</b><br>Monitoring | <b>WEATHER:</b><br>Cloudy | <b>INSP. DATE:</b><br>April 25, 2025 | <b>INSP. TIME:</b><br>12:00 |

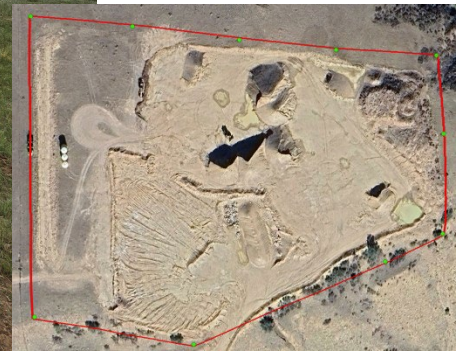
The mining plans states that "prior to mining a section of the surface it will be stripped of topsoil and placed around the mine setback or on the mine floor for used in reclamation. As mining progresses the stripped material may be placed directly on the seedbed, if it will not be re-disturbed." The 2024 annual report map indicates that topsoil is located within the mining setback along the west side of the pit, and at the edge of the disturbed area on the east side of the pit (see Figure 1). During the inspection, the Operator was asked if the material on the east side was topsoil to which they stated no, and that the topsoil was located on the west side in the stabilized configuration (Photo 11), and an additional newer pile is located east of that (Photo 10).

**Photo 10:** New topsoil pile east of the stabilized pile. The Operator shall ensure this pile is stabilized and seeded if not used for reclamation within one growing season.

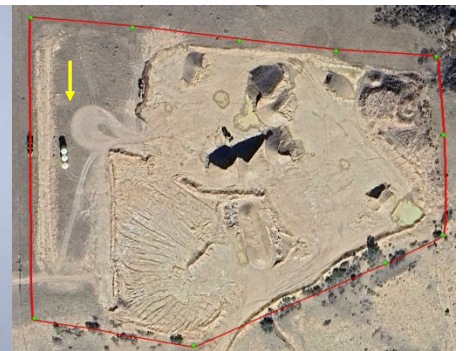
**Photo 11:** Looking north at the stabilized topsoil stockpile located within the mining setback on the west side of the permit area.
