MINERALS PROGRAM INSPECTION REPORT

MINE NAME: Castillo Pit	MINE/PROSPECTING ID#: M-2000-053	MINERAL: Gravel	COUNTY: Las Animas
INSPECTION TYPE: Monitoring	WEATHER: Clear	INSP. DATE: April 24, 2025	INSP. TIME: 10:14
OPERATOR: Las Animas County	OPERATOR REPRESENTATIVE: Keith Woodring	TYPE OF OPERATION: 112c - Construction Regular Operation

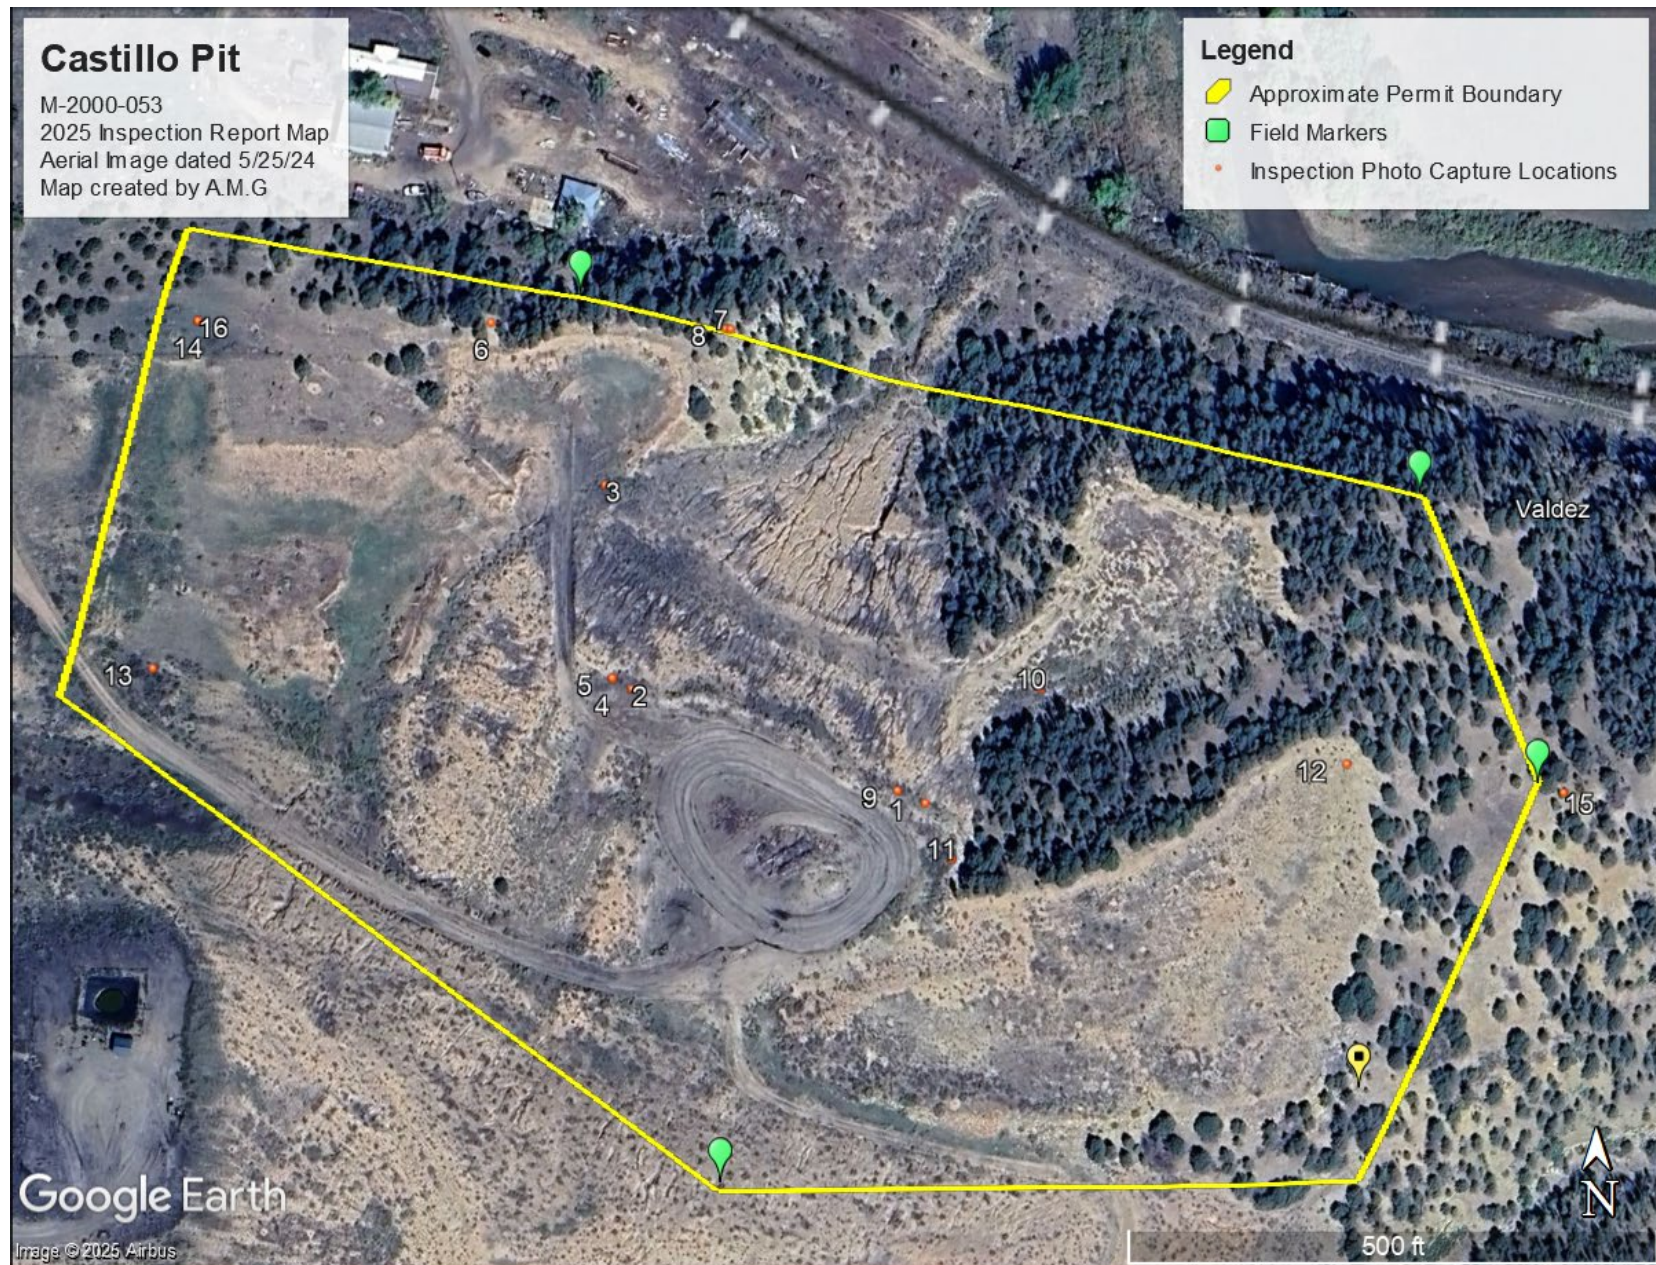
Map 1: Inspection Report Map for the 2025 inspection created using Google Earth Pro. The yellow marker in the southeast side indicates where a fence goes through the permit area. The numbers next to the inspection photos correspond with the photos within this report.
