C-1981-035 King June 2025 OSMRE Oversight Partial Inspection Report

| Permit Number: C-1981-035 Mine Name: King Coal Mine Operator: GCC Energy, LLC Operator Address: Mr Jordan McCourt 6473 County Road 120 Hesperus, CO 81326 | County: La Plata Operation Type: Underground Permit Status: Active Ownership: Private |

| Inspection Start Date: June 3, 2025 Inspection Start Time: 08:26 Inspection End Date: June 3, 2025 Inspection End Time: 11:40 | Inspection Type: Coal Partial Inspection Inspection Reason: OSM Oversight Inspection Weather: Clear |

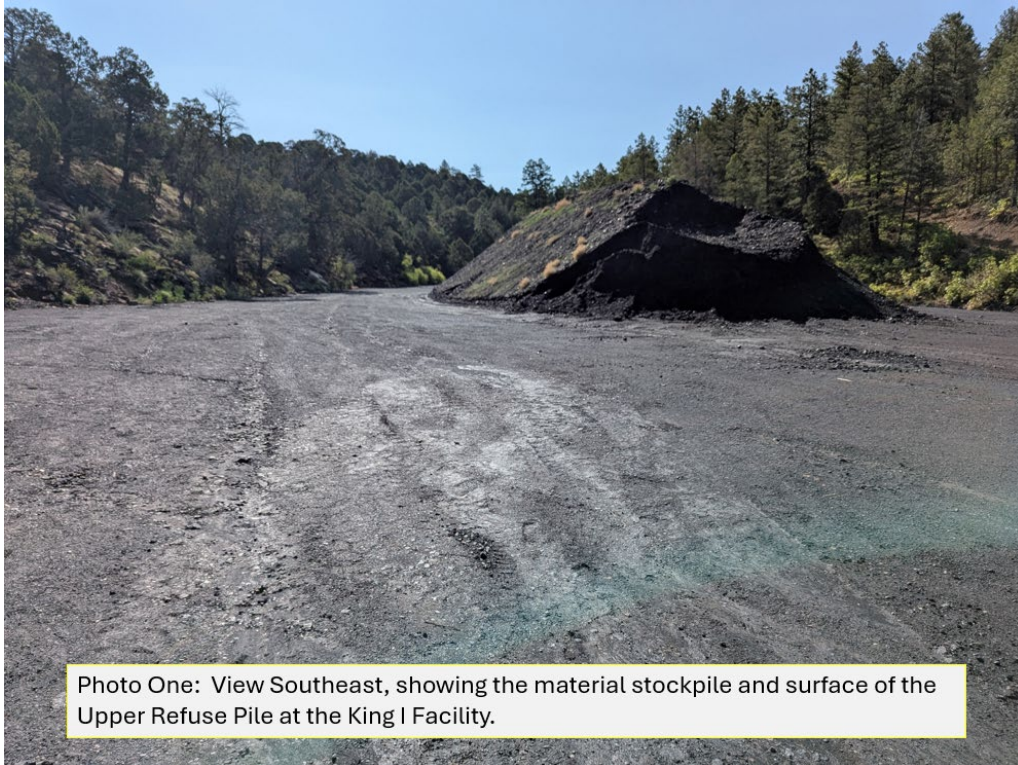
During this inspection both the Upper and Lower Refuse Piles, (URP and LRP respectively) at the King I Facility were observed. The condition of the URP remains unchanged from the Division's previous inspections. The surface of the pile is well compacted with no evidence of settling, slumping or erosion having been noted. The stockpile of material at the East end of the refuse pile shows no signs of recent placement, nor signs of erosion or sediment transport. The stockpile and an example of the surface of the pile can be seen in Photo One. The outcrops of the pile at the West end have been recently compacted and are in good condition as seen in Photo Two. All observed condition of the Upper Refuse Pile appear to be consistent with the design specifications.
