MINERALS PROGRAM INSPECTION REPORT
PHONE: (303) 866-3567

MINE NAME: McKenna Limestone Quarry	MINE/PROSPECTING ID#: M-2000-039	MINERAL: Limestone (general)	COUNTY: Huerfano
INSPECTION TYPE: Surety-Related Inspection	WEATHER: Clear	INSP. DATE: May 20, 2025	INSP. TIME: 12:52
OPERATOR: Delhur Industries, Inc.	OPERATOR REPRESENTATIVE: None	TYPE OF OPERATION: 110c - Construction Limited Impact

REASON FOR INSPECTION: Surety Related	BOND CALCULATION TYPE: Complete Bond	BOND AMOUNT: \$17,100.00
DATE OF COMPLAINT: NA	POST INSP. CONTACTS: None	JOINT INSP. AGENCY: None
INSPECTOR(S): Amber M. Gibson	INSPECTOR'S SIGNATURE:

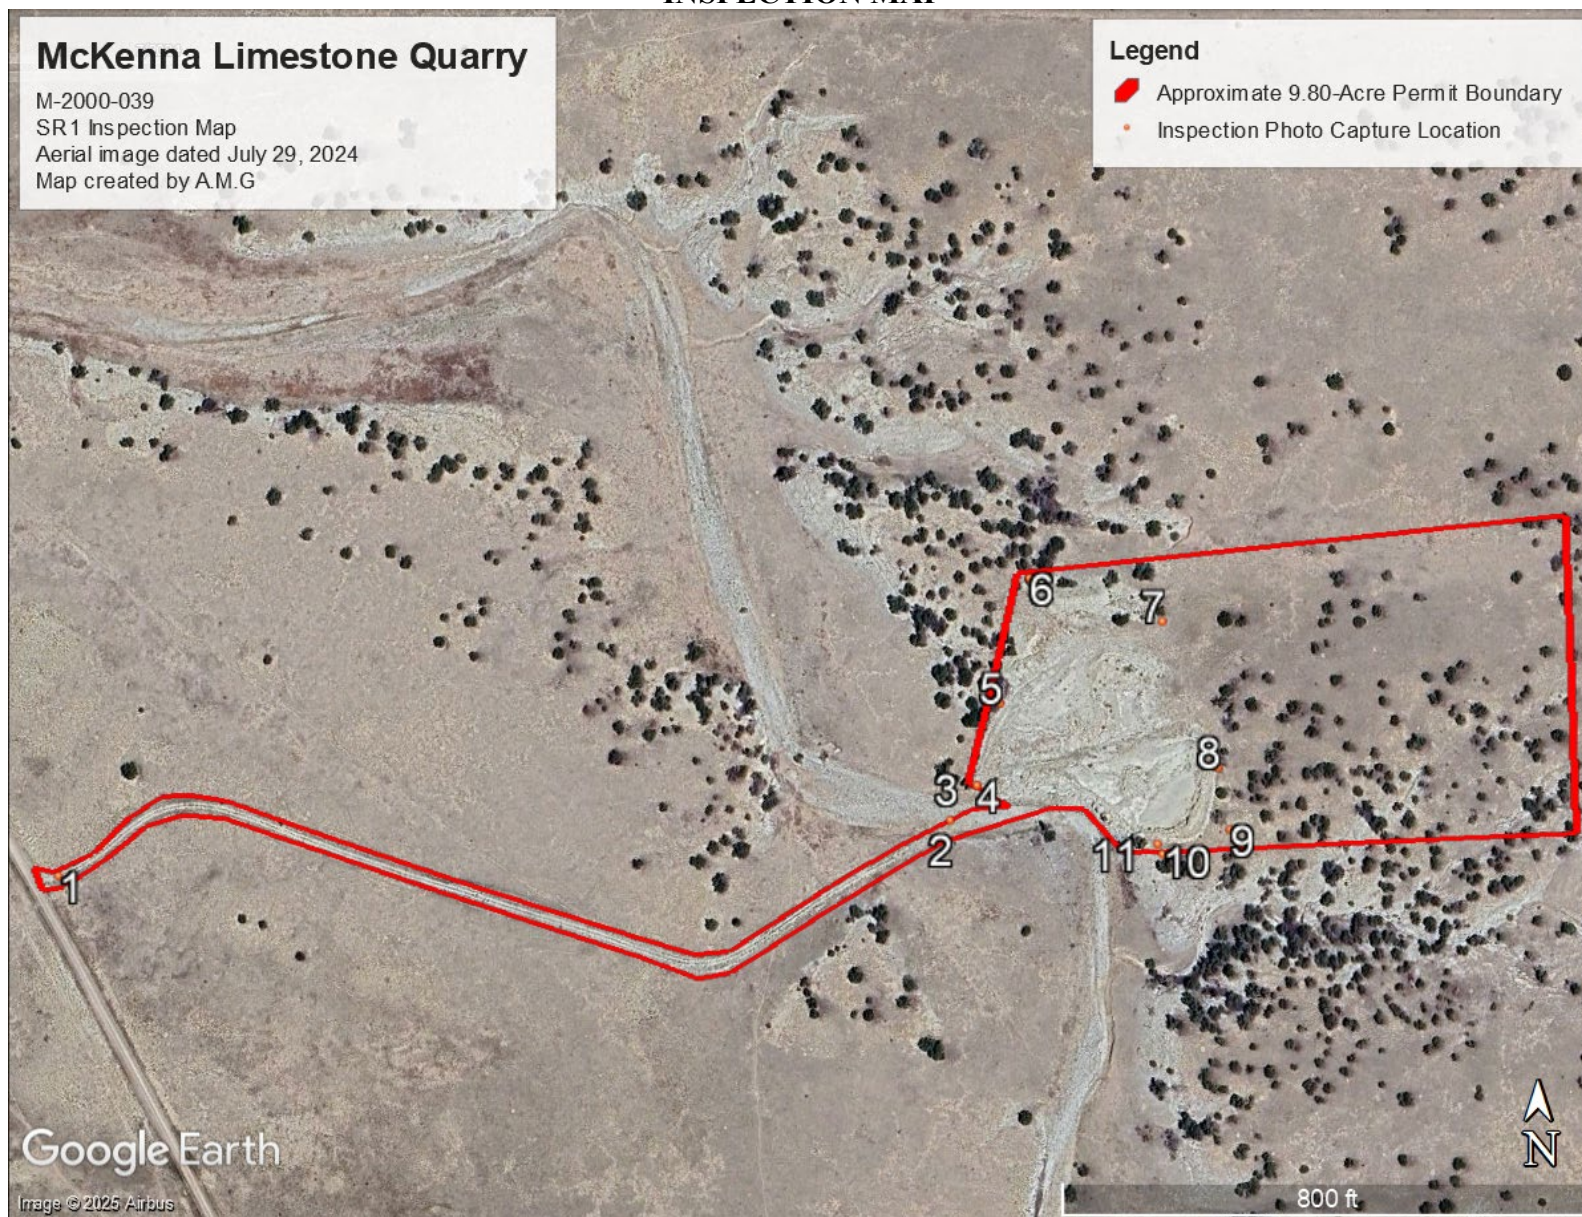
Map 1: Inspection Map generated using Google Earth Pro for the SR1 inspection. The aerial imagery was taken prior to the recent reclamation activities. The inspection photo icons on the map indicate the locations where the corresponding numbered inspection photos on the following pages were taken.
