**MINERALS PROGRAM INSPECTION REPORT**  
**PHONE: (303) 866-3567**

<b>MINE NAME:</b> Cresson Project	<b>MINE/PROSPECTING ID#:</b> M-1980-244	<b>MINERAL:</b> Gold and silver	<b>COUNTY:</b> Teller
<b>INSPECTION TYPE:</b> Monitoring	<b>WEATHER:</b> Windy	<b>INSP. DATE:</b> May 19, 2025	<b>INSP. TIME:</b> 09:00
<b>OPERATOR:</b> Cripple Creek & Victor Gold Mining Co.	<b>OPERATOR REPRESENTATIVE:</b> Brian Doering, Paulina Barrella	<b>TYPE OF OPERATION:</b> 112d-3 - Designated Mining Operation	
<b>REASON FOR INSPECTION:</b> Normal I&E Program	<b>BOND CALCULATION TYPE:</b> None	<b>BOND AMOUNT:</b> \$319,158,980.00	
<b>DATE OF COMPLAINT:</b> NA	<b>POST INSP. CONTACTS:</b> None	<b>JOINT INSP. AGENCY:</b> None	
<b>INSPECTOR(S):</b> Patrick Lennberg	<b>INSPECTOR'S SIGNATURE:</b>

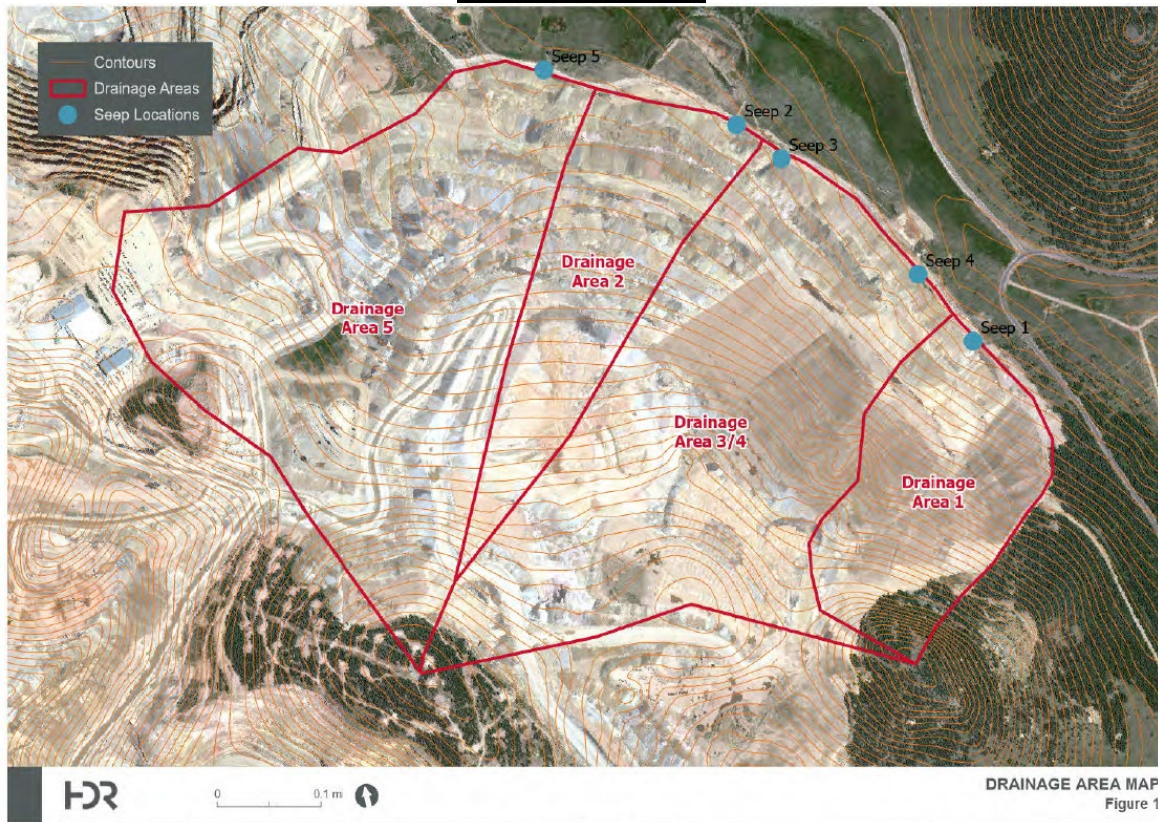
The Division inspected the Grassy Valley Seep collection improvements and basin construction. The Division observed that the basins had been constructed but not yet lined with the geomembrane liner. Lining of the basins and ditches was not scheduled to begin until the beginning of June and work was being done to ensure the subgrade was at the correct elevations. In the Seep 1 collection area, the most southern basin, the collection ditch had been shortened by ~75 feet due to safety concerns for excavation equipment. However, the ditch still extends beyond where the seep area is actively expressing or where there are signs of seepage.

**Image 1:** Seep and basin location map, figure 1 from TR-144
