Division of Reclamation,
Mining and Safety

PERMIT INFORMATION

Permit Number: C-1996-084 Mine Name: Lorencito Canyon Mine Operator: New Elk Coal Company, LLC Operator Address: 12250 Highway 12 Weston, CO 81091	County: Las Animas Operation Type: Surface Permit Status: Suspended Ownership: Private
	Operator Representative Present: None
Operator Representative Signature: (Field Issuance Only)

INSPECTION INFORMATION

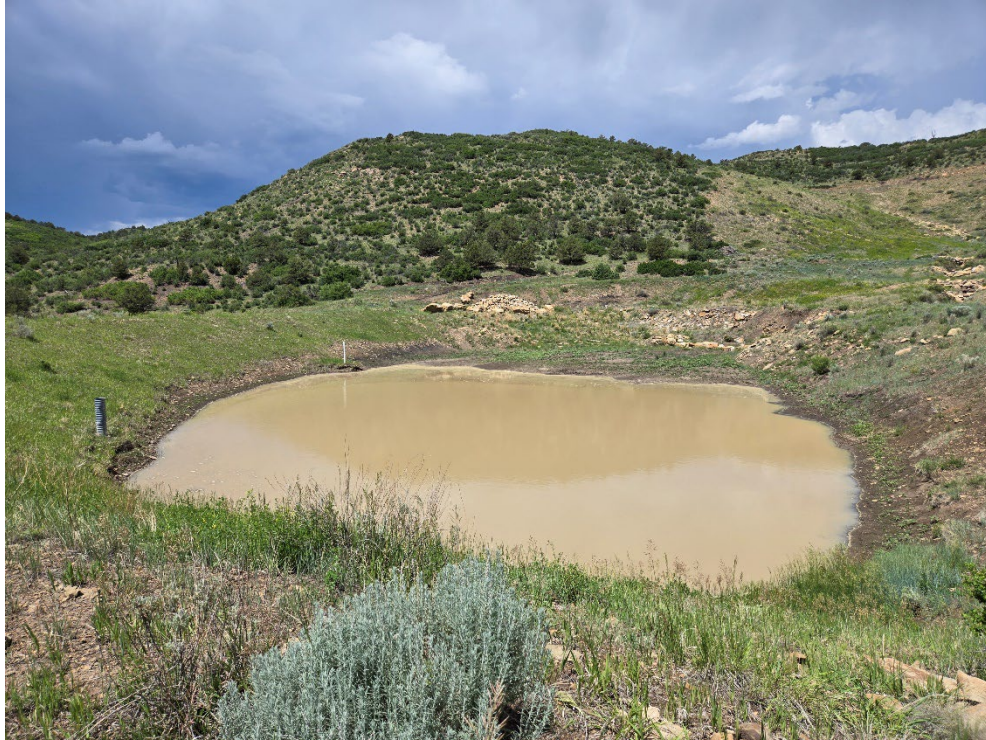
Photo 14: Pond 006a

- Pond 005:
 - Pond 005 contained a small amount of water at the time of the inspection (Photo 12).
 - The flume contained water and was discharging from a leak on the bottom (Photo 13).
 - The primary and emergency spillways appeared to be clear and functional.
- Pond 006a:
 - The pond held water at the time of the inspection (Photo 14).
 - The pond embankment appeared to be stable and vegetated. **See outstanding maintenance Item # 1.**
 - The primary and emergency spillways appeared clear and functional.
