## **Inspection Yoast Bond Release SL9**

## **PERMIT INFORMATION**

Permit Number: C-1994-082 County: Routt

Mine Name: Yoast Mine Operation Type: Surface

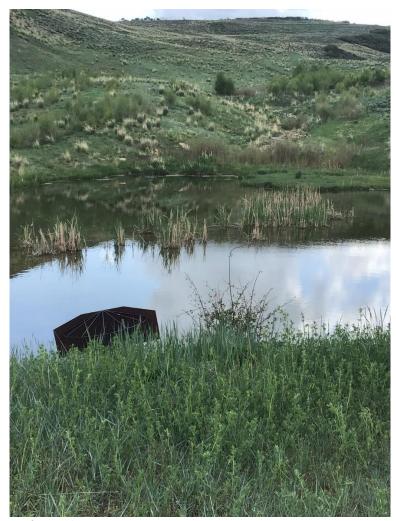
- DrainageYPM13, (parcel 88) above pond 11A was inspected and found to be in good repair, functioning adequately with well vegetated banks. Exposed landscape fabric was noted in a couple of areas.

Photo 9: Pond 11A and lower YPM13 drainage
