**MINERALS PROGRAM INSPECTION REPORT**  
**PHONE: (303) 866-3567**

<b>MINE NAME:</b> Orlando Pit	<b>MINE/PROSPECTING ID#:</b> M-2001-106	<b>MINERAL:</b> Sand and gravel	<b>COUNTY:</b> Huerfano
<b>INSPECTION TYPE:</b> Monitoring	<b>WEATHER:</b> Cloudy	<b>INSP. DATE:</b> June 11, 2025	<b>INSP. TIME:</b> 12:03
<b>OPERATOR:</b> Huerfano County	<b>OPERATOR REPRESENTATIVE:</b> Dustin Hribar	<b>TYPE OF OPERATION:</b> 112c - Construction Regular Operation	
<b>REASON FOR INSPECTION:</b> Normal I&E Program	<b>BOND CALCULATION TYPE:</b> None	<b>BOND AMOUNT:</b> \$0.00	
<b>DATE OF COMPLAINT:</b> NA	<b>POST INSP. CONTACTS:</b> None	<b>JOINT INSP. AGENCY:</b> None	
<b>INSPECTOR(S):</b> Amber M. Gibson	<b>INSPECTOR'S SIGNATURE:</b>

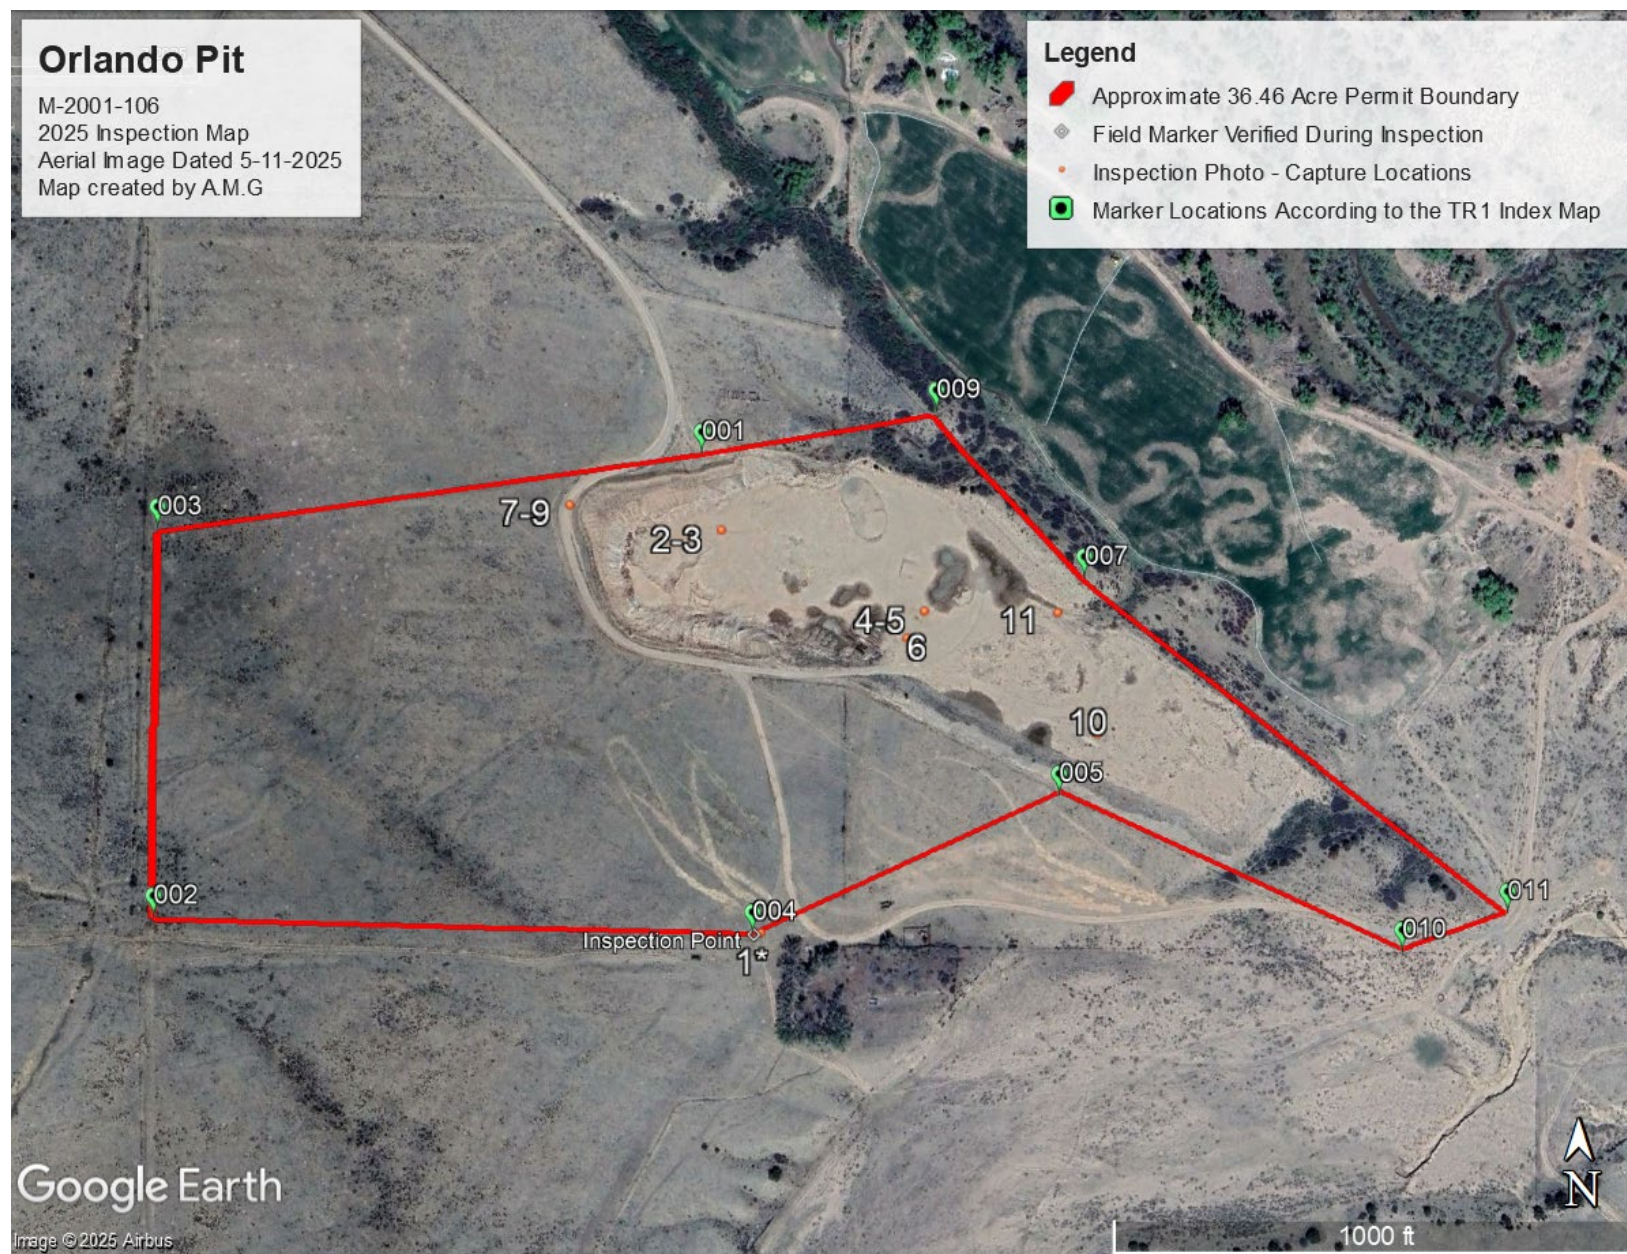
**Map 1:** 2025 Inspection Report Map generated using Google Earth Pro. The numbers beside the inspection photo capture locations correspond with the inspection photo captions within this report. \*The photo location for Photo 1 indicated on the map is for the **right** side photo 1. The left photo's location (mine sign) is indicated by a blue star on Map 2.

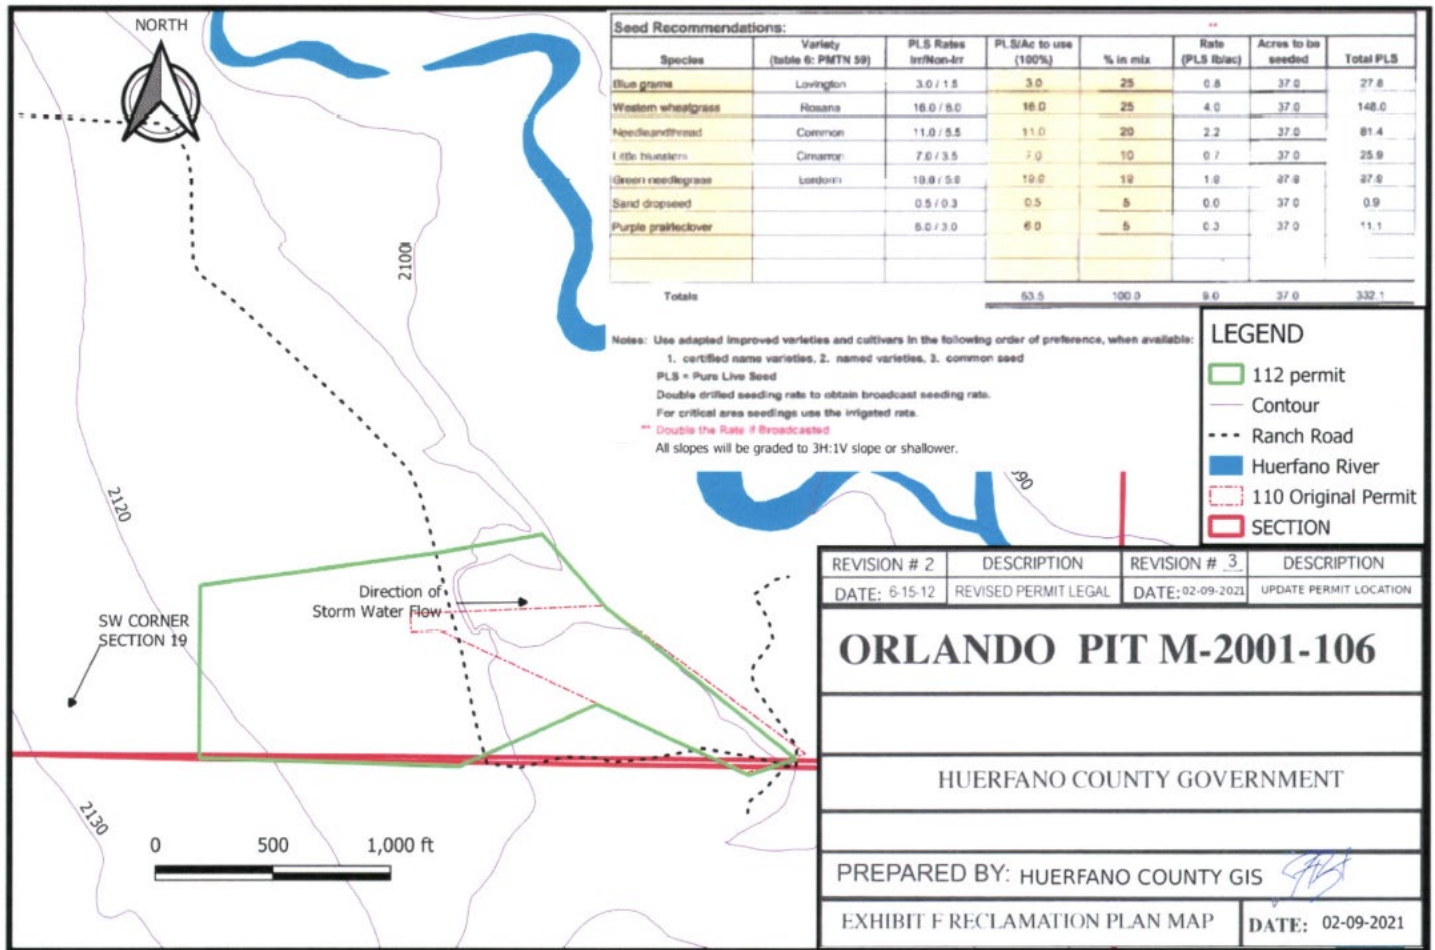
The entrance to the site is usually accessed by taking County Road 543, off of Highway 69 (see Map 2). During the inspection, the access to County Road 543 was detoured, and was accessed via County Road 560 instead. The site shares an access road with another permitted operation (M-1985-008). During the Inspection, the Operator stated that they move the access road (a.k.a haul road or ranch road) around new disturbance, so that the Landowner on the south side of the permit boundary maintains access to their house. Upon post inspection review, it appears that the diverted road has been diverted outside of the permit boundary on the north side (see Figure 1). It is unclear whether the diversion to the road occurred when the CN1 boundary still encompassed that area (from 2012 to 2021), or after the permit boundary was adjusted following a correction survey through TR1 (2021-current). The aerial imagery available jumps from 2020 to 2025 and is unable to be used to determine exactly when the now offsite disturbance occurred. Additionally, the currently approved reclamation plan states that the access road will remain after reclamation, per request of the Landowner. The current reclamation plan map depicts that the road will remain in/or be put back to its original orientation.

**Figure 1:** The green boundary indicates the permit boundary as described in the 2012 CN1 revision. The red boundary indicates the permit boundary as described in the TR1 revision, and represents the currently approved boundary. The yellow arrows point to disturbance located out of the currently approved boundary, resulting from diverting the access road. The access road running north-south has been diverted, and the path seen in the image is from Google Earth's 'roads' layer. The orientation of the access road prior

to the diversion corresponds to what is seen in the Google Earth 'roads' layer. The orientation of the access road depicted on the approved Reclamation Plan Map also corresponds with this orientation (see the currently approved Reclamation Plan Map below).

Note\*- No additional disturbance to the access road outside of the permit boundary will be accepted. If additional disturbance is found to be located outside of the permit boundary at the next inspection, the Division may cite a possible violation, resulting in enforcement actions. If the Operator intends to divert the road above and outside of the permitted boundary, an amendment to the application would be required prior to additional disturbance.
