MINERALS PROGRAM INSPECTION REPORT
PHONE: (303) 866-3567

MINE NAME: Hobo 2	MINE/PROSPECTING ID#: M-2017-044	MINERAL: Gemstones	COUNTY: San Juan
INSPECTION TYPE: Monitoring	WEATHER: Clear	INSP. DATE: June 30, 2025	INSP. TIME: 09:38
OPERATOR: McFarland Enterprises, Inc.	OPERATOR REPRESENTATIVE: None	TYPE OF OPERATION: 110(1) - Hard Rock Limited Impact	
REASON FOR INSPECTION: Normal I&E Program	BOND CALCULATION TYPE: Complete Bond	BOND AMOUNT: \$12,960.00	
DATE OF COMPLAINT: NA	POST INSP. CONTACTS: None	JOINT INSP. AGENCY: None	
INSPECTOR(S): Lucas West	INSPECTOR'S SIGNATURE:

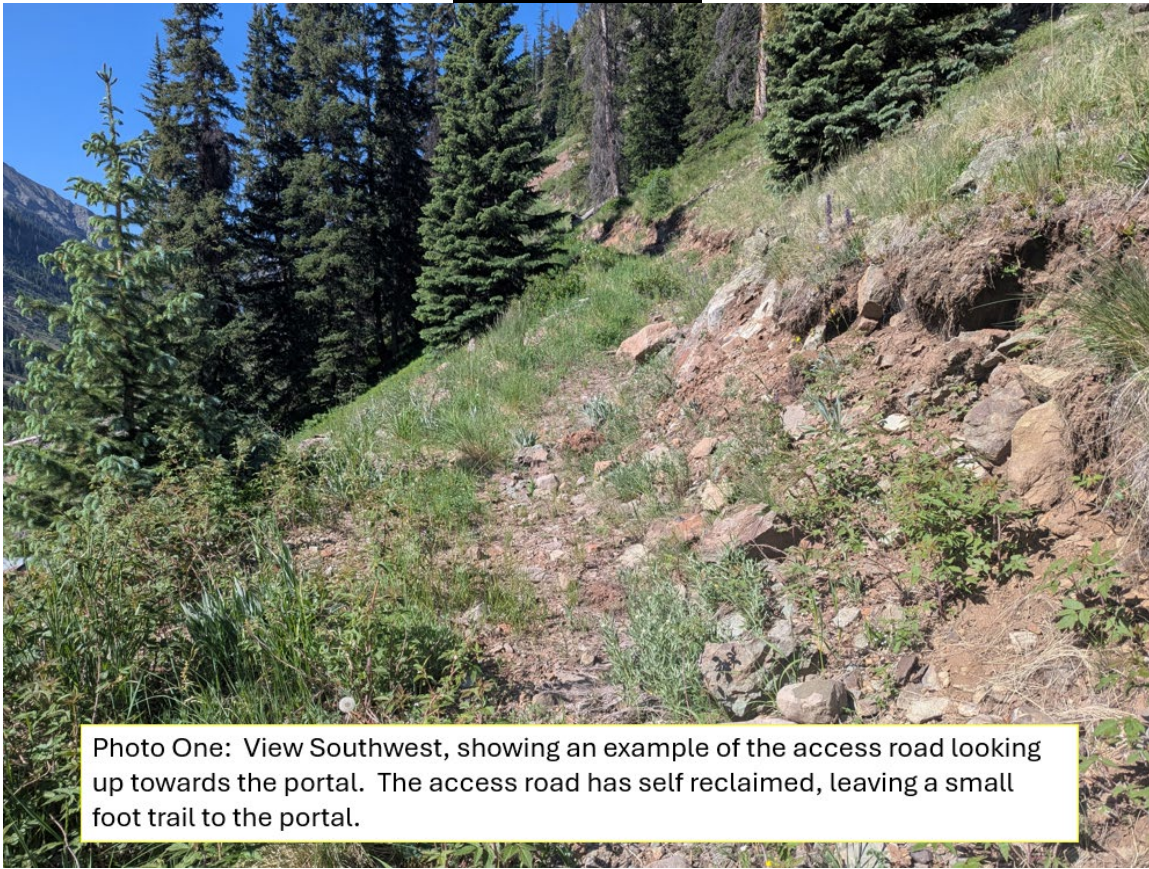
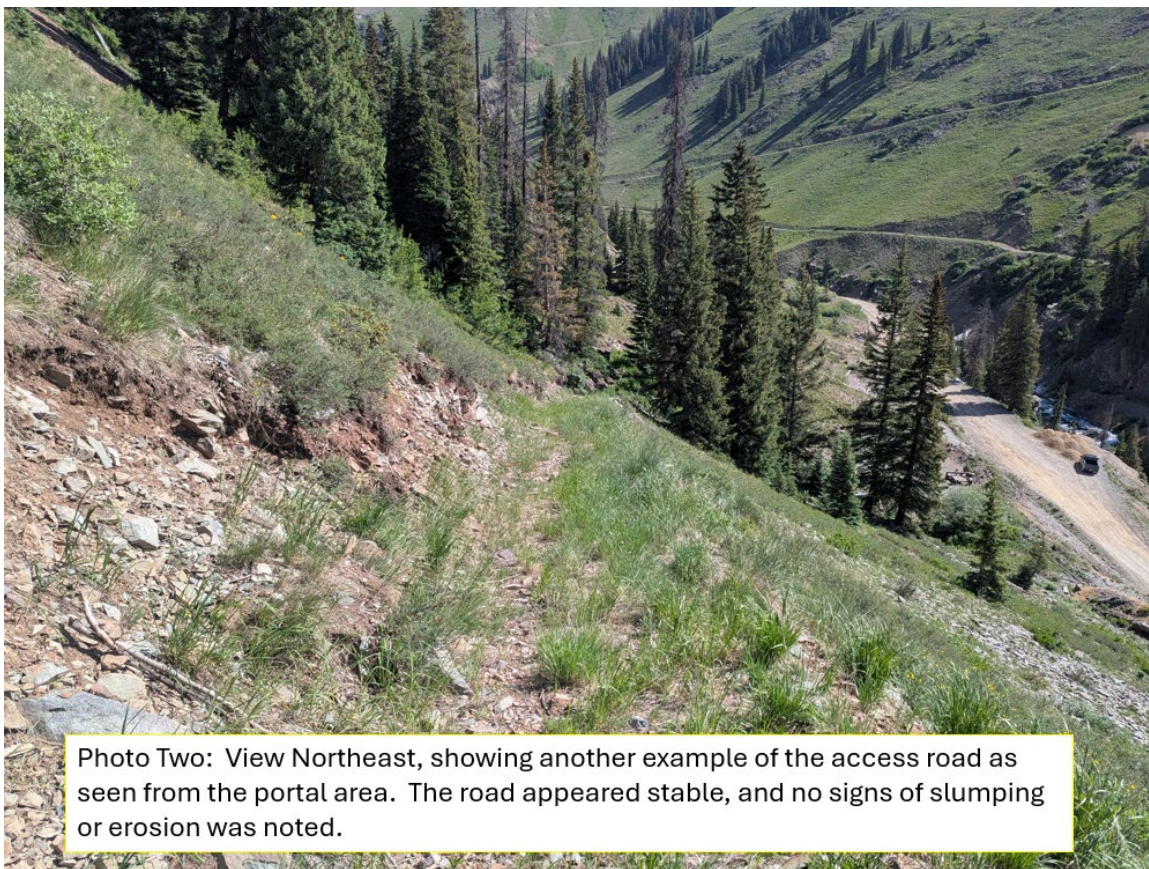
The .71 acres of the site is made up of the access road, portal pad and portal areas. The access road was observed to be in good condition and appeared stable at the time of the inspection. No evidence of erosion or slumping of the cut banks was noted. The entire length of the access road has revegetated itself with volunteer species and shows no evidence of recent travel. The access road can be seen in Photos One and Two. At the top of the access road lies the portal and portal pad. The portal pad, made up of waste rock and other local materials, was found to be in good condition and appeared stable. No evidence of settling or slumping was noted. The outsoles of the pad appeared to be stable at the time, and no significant erosion or rilling was noted down the slope. Photos Three and Four show the portal pad and an example of the out slope.
