Huddleston-Berry
Engineering & Testing, LLC

July 8, 2025
Project#01349-0001

Subject: Summary of Instrumentation Monitoring
2nd Quarter 2025
Bowie Coal Waste Disposal Area No. 2
Paonia, Colorado

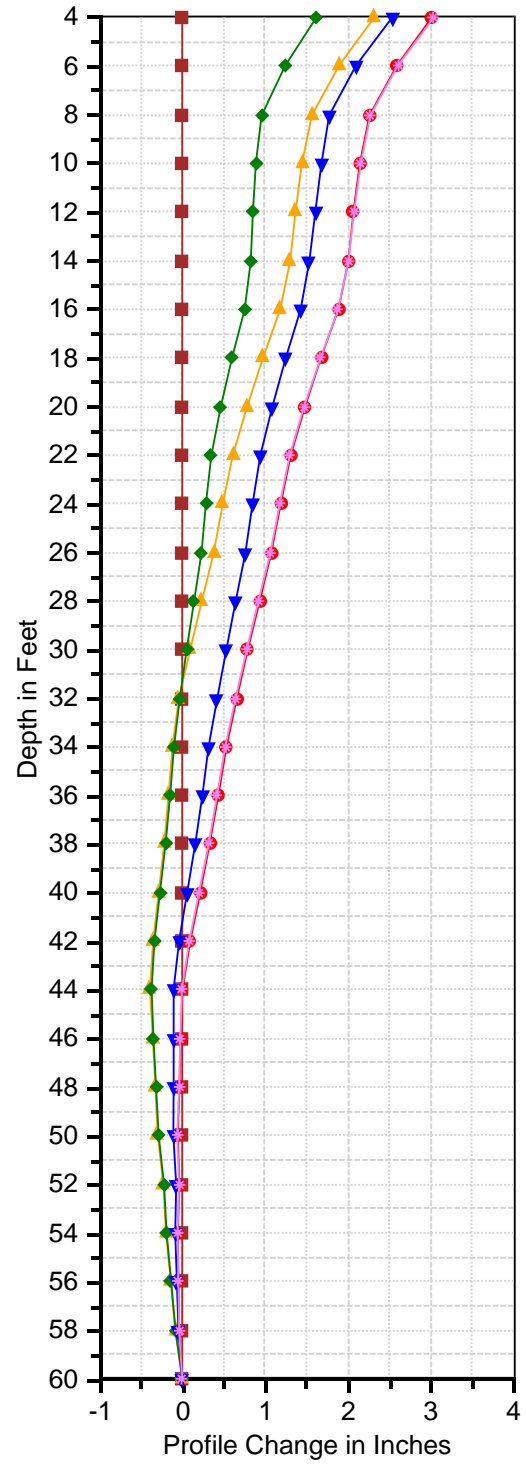
BOWIE BG05_5 B

As described in previous reports, historic displacements indicated on the plots for the approximate upper 14-16 feet of the inclinometers since installation in 2005 are due to placement of cover soil on the face of the waste pile during revegetation/regrading operations in late 2006 and early 2007. This man-caused displacement is documented in a report by Buckhorn Geotech dated December 22, 2008, to Bowie Resources called *Revised Stability Evaluations for Coal Mine Waste Disposal Area No. 2, Bowie No. 2 Mine*.
