**MINERALS PROGRAM INSPECTION REPORT**  
**PHONE: (303) 866-3567**

<b>MINE NAME:</b> Blair Mesa Pit	<b>MINE/PROSPECTING ID#:</b> M-1996-082	<b>MINERAL:</b> Sand and gravel and borrow material	<b>COUNTY:</b> Rio Blanco
<b>INSPECTION TYPE:</b> Surety Release Inspection	<b>WEATHER:</b> Clear	<b>INSP. DATE:</b> July 3, 2025	<b>INSP. TIME:</b> 09:00
<b>OPERATOR:</b> Oldcastle SW Group, Inc. dba United Companies of Mesa County	<b>OPERATOR REPRESENTATIVE:</b> Jesse Farmer	<b>TYPE OF OPERATION:</b> 112c - Construction Regular Operation	
<b>REASON FOR INSPECTION:</b> Surety Release Requested	<b>BOND CALCULATION TYPE:</b> None	<b>BOND AMOUNT:</b> \$114,211.72	
<b>DATE OF COMPLAINT:</b> NA	<b>POST INSP. CONTACTS:</b> DRMS	<b>JOINT INSP. AGENCY:</b> None	
<b>INSPECTOR(S):</b> Amy Yeldell	<b>INSPECTOR'S SIGNATURE:</b>

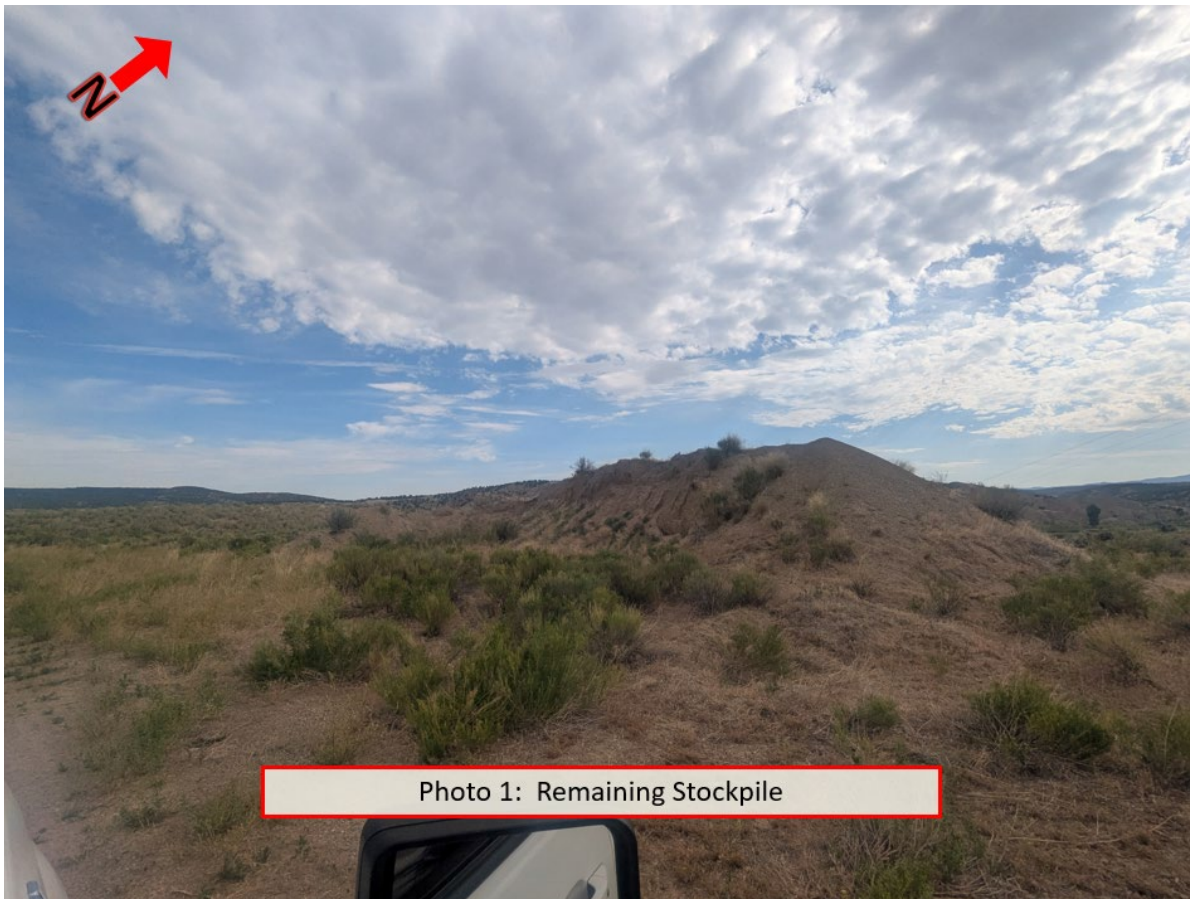
Three stockpiles of processed material remain on site. Mr. Farmer indicated this was per the landowner's request for future use on the ranch. While acceptable this condition has not been added to the permit and therefore the site does not match with the approved Reclamation Plan. In the form of a technical revision please submit a revision to the Reclamation Plan which details the estimated volume, material type and location of any stockpiles to remain. Additionally, please include an updated Reclamation Plan Map which depicts the current site conditions (as-built map). Once this TR is processed the Division can issue a decision on the SL-1 request.

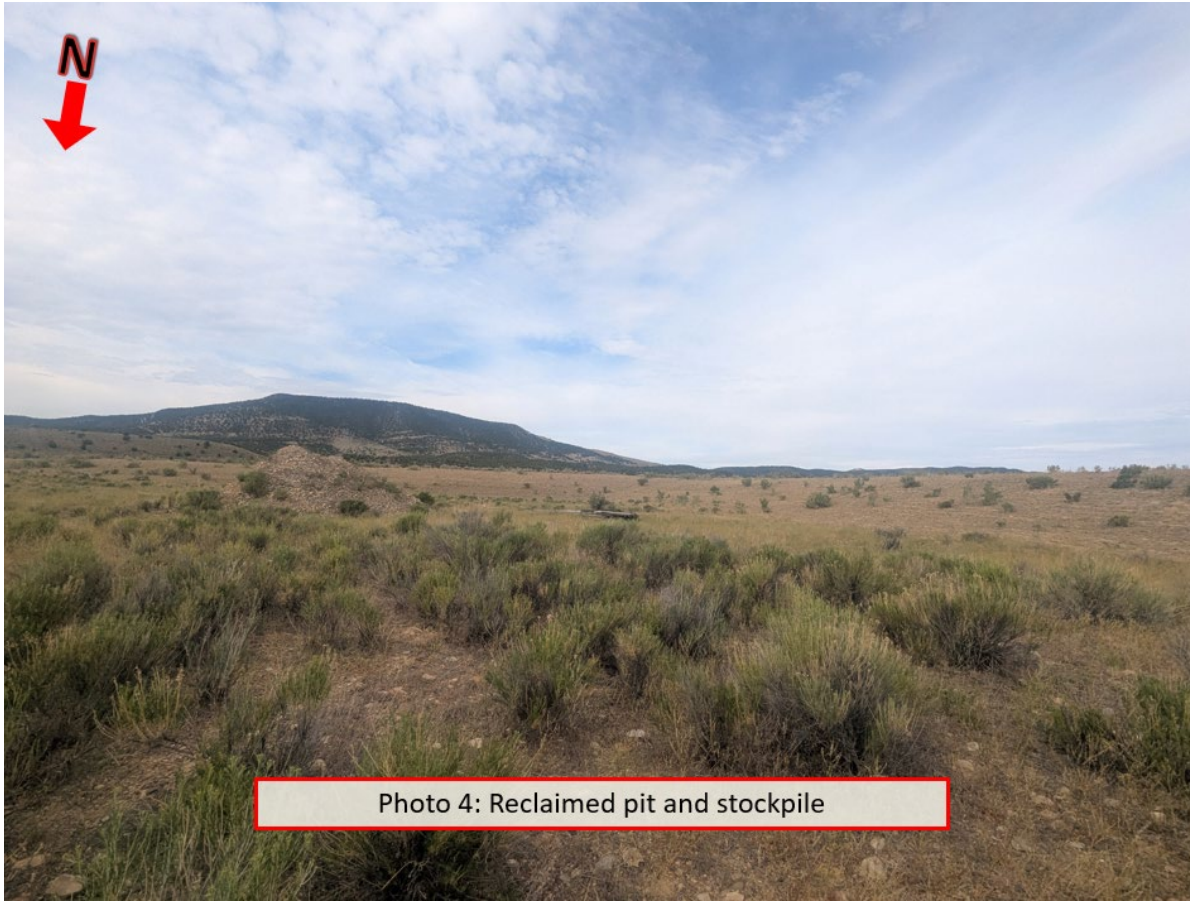
Over all the site has been successfully reclaimed. All contouring naturally blends with the surrounding topography. A diverse and sustainable mix of vegetation has been established, which includes shrub establishment. Vegetation density is comparable to the surrounding undisturbed areas. There are some signs of grazing, but it does not appear to be restricting reclamation success. No noxious weeds were observed.
