C1980007, West Elk Mine, July Inspection Report

PERMIT INFORMATION

Permit Number: C-1980-007 Mine Name: West Elk Mine Operator: Mountain Coal Company, LLC Operator Address: Robert Munz 5174 Highway 133 Somerset, CO 81434	County: Delta, Gunnison Operation Type: Underground Permit Status: Active Ownership: Private
	Operator Representative Present: Bob Munz
Operator Representative Signature: (Field Issuance Only)

Inspection Start Date: July 24, 2025 Inspection Start Time: 09:00 Inspection End Date: Inspection End Time:	Inspection Type: Coal Partial Inspection Inspection Reason: Normal I&E Program Weather: Clear
Joint Inspection Agency: None	Joint Inspection Contacts:
Post Inspection Agency: None	Post Inspection Contacts:
Inspector(s): Leigh Simmons	Inspector's Signature:

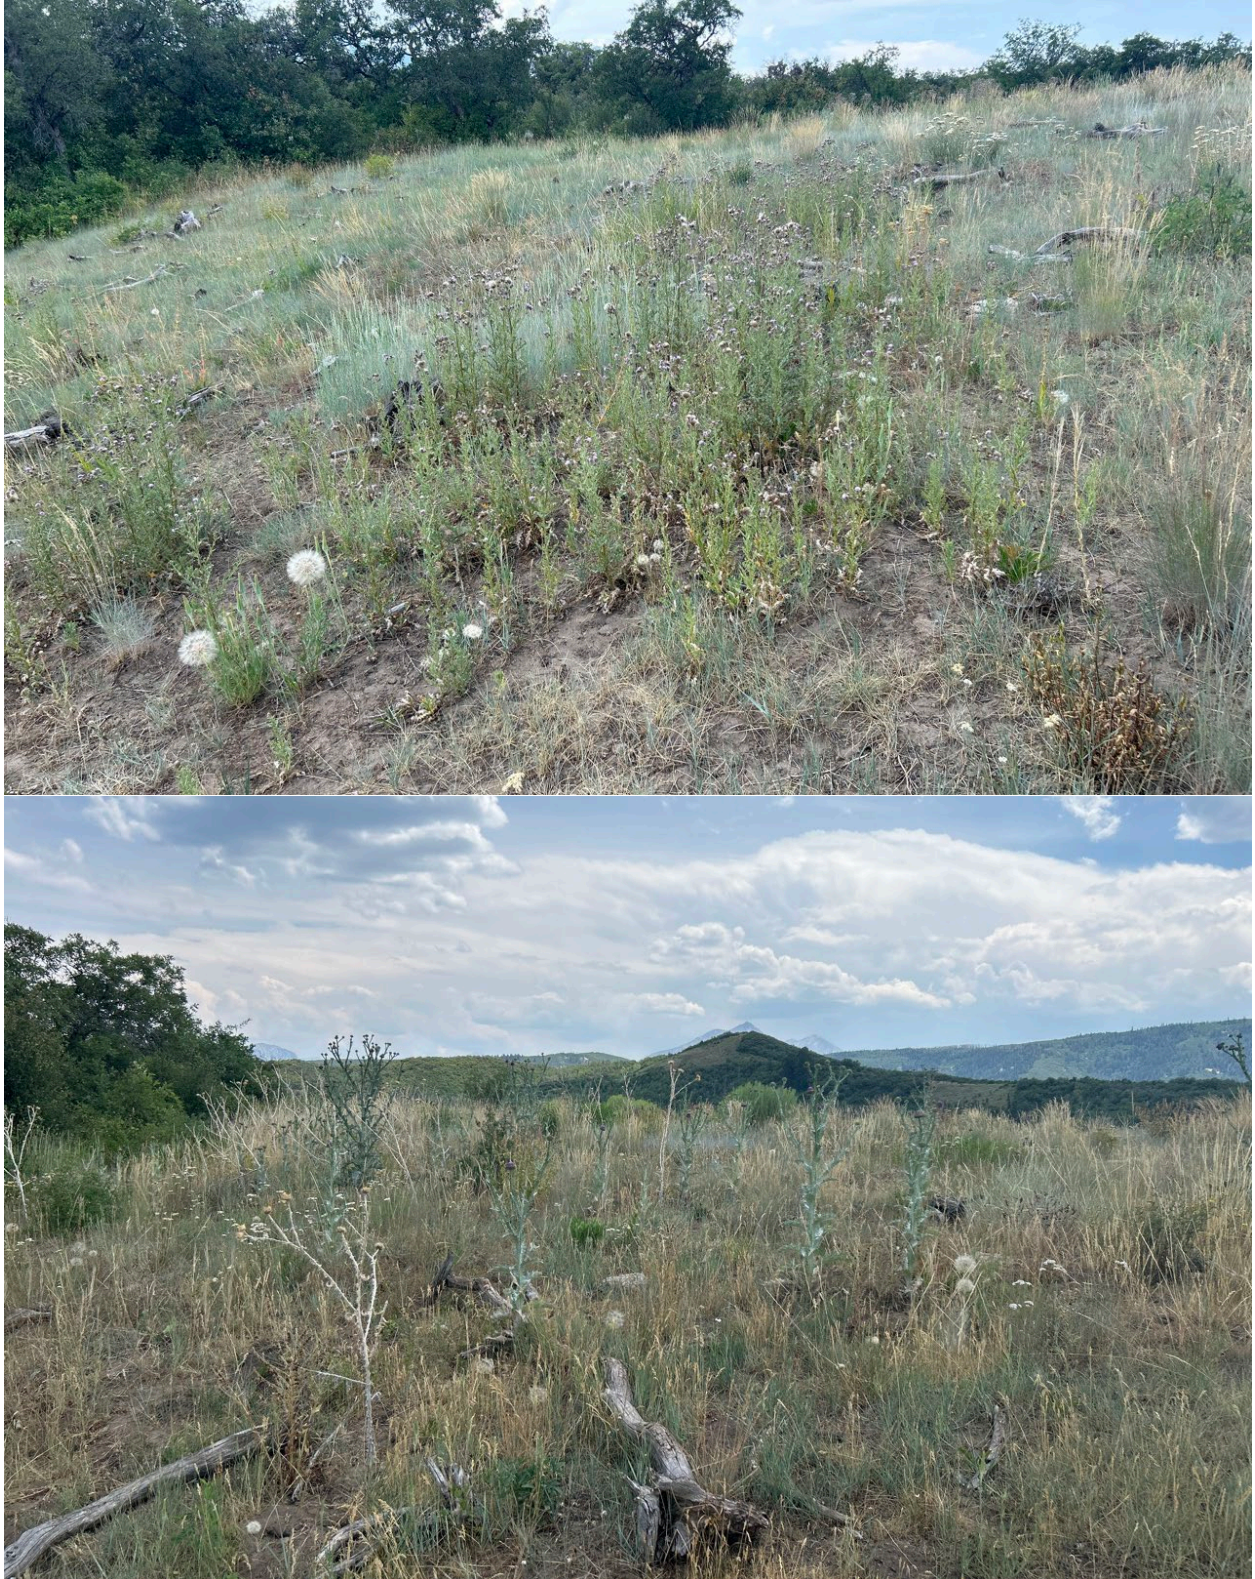
Figure 12: E1-41.5

Label	Comments
E1-26.5	Stable, well vegetated. Grass dominant, with varied forbs, and shrubs on N side. Recommend treating several patches of thistle (Canada?) next season – maybe too late this year
E1-30	Looks like some musk thistle and hounds tongue has been sprayed earlier in year
E1-34	Pad has lots of good vegetation, but also houndstongue, musk, Canada - recommend regular treatment before bond release
E1-38	Fenced. Scotch thistle and Canada thistle
E1-41.5	Scotch thistle on N side, musk and Canada on S side, otherwise great diversity
E2-38	Looks good. Just a little Canada thistle - low priority
E2-42	Looks like houndstongue has been sprayed
E1-45	Just a little Canada thistle on NE side
E2-44.5 & -47.5	Some big thistles on S side of pad. Has been sprayed but will need continued follow up
E2-51, 52, 54	Fine
E3-51	Fine
09WE4X53	Fine
Road damage	Road has not been repaired, but creek would be passable upstream in high clearance vehicle

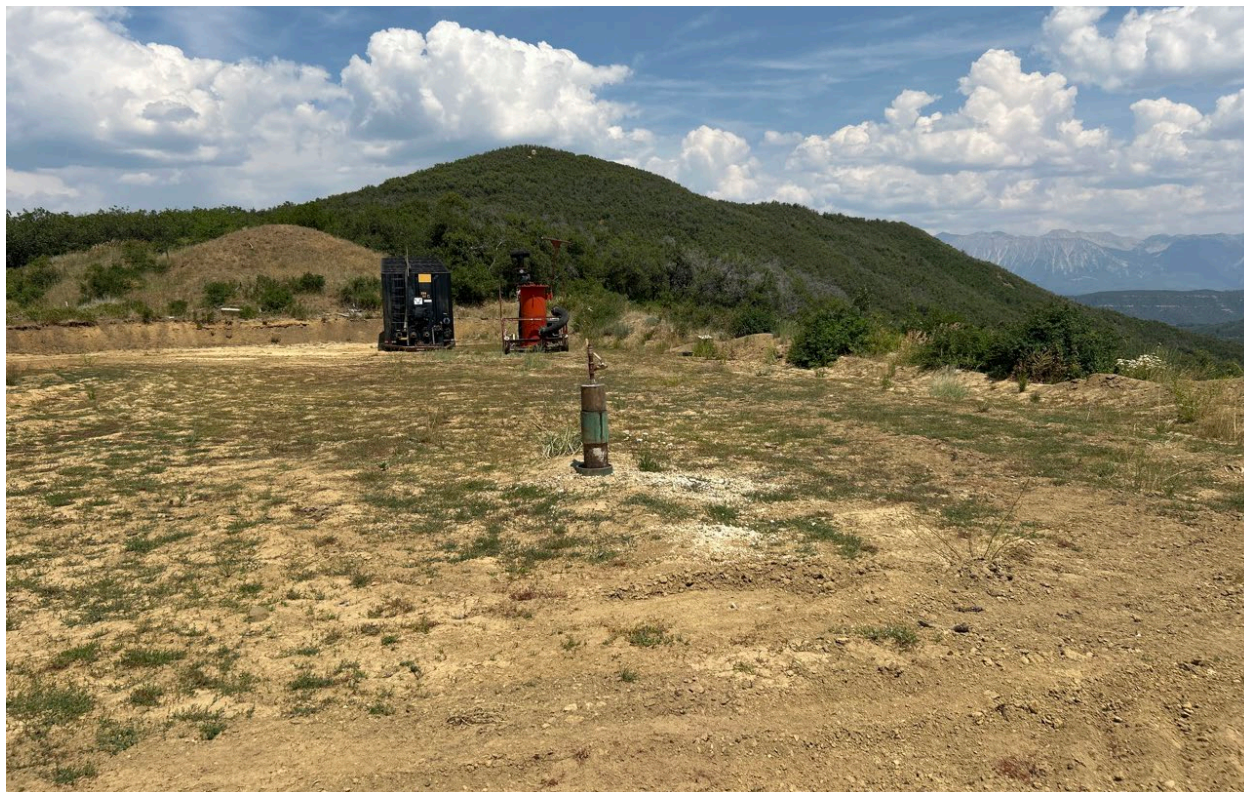
Figure 19: E2-51, -52, -54 (not reclaimed)

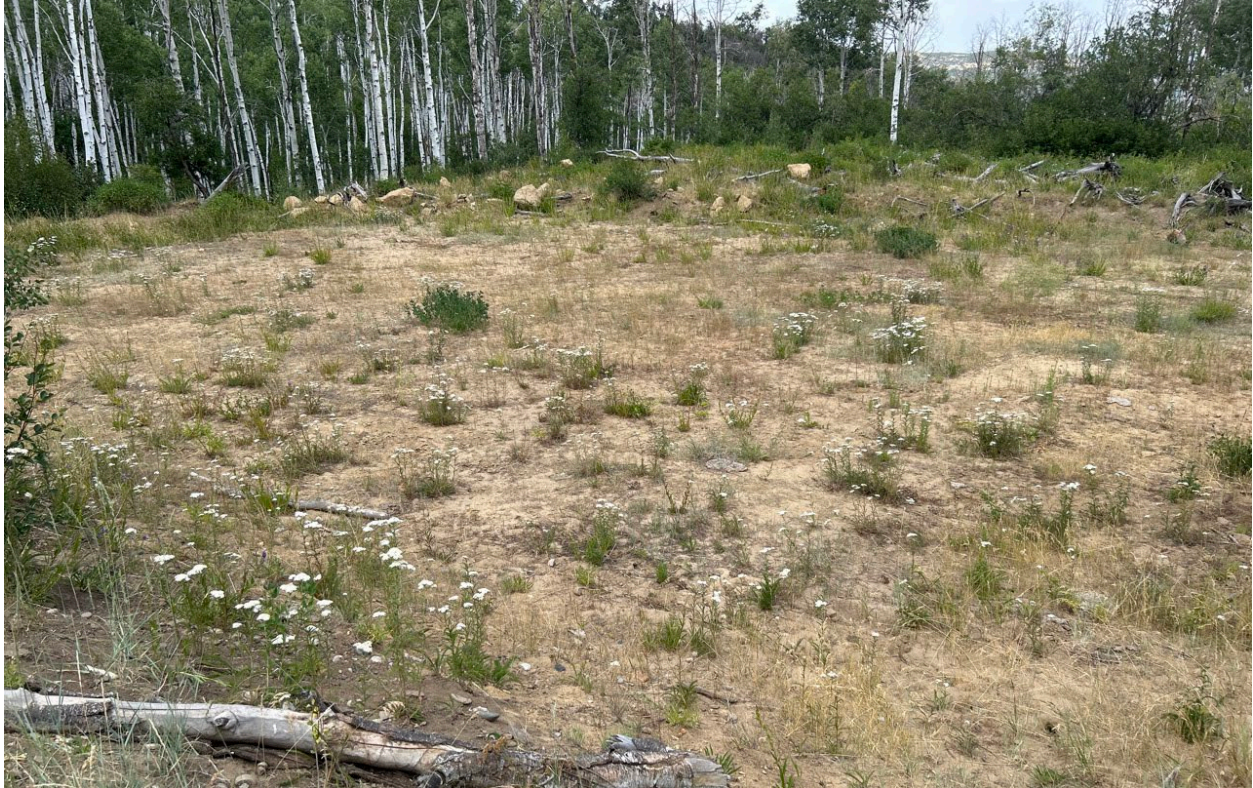
Figure 24: E6-4 (61)

E6-4(61)	Fine
SS1-2	
SS1-1	
Old exploration road	Thistle and houndstongue at junction
Road to sunset trails	Mostly ok, but beginning of road is very sparsely vegetated, with many thistle rosettes and houndstongue. Recommend treatment and supplemental seeding asap
