Re: Geotechnical Addendum  
Deer Creek Quarry Bi-Annual Report  
Morrison, CO  
KUE Project No. P-24079

Appendix A – Quarry Change Detection Inspection Report

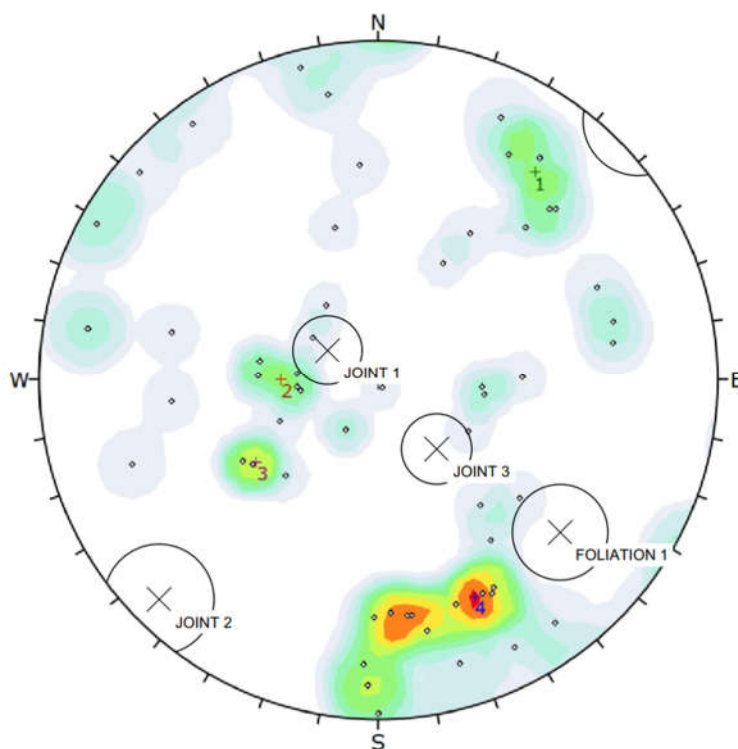
**Figure 8: HDR Discontinuity Contours & Joint Sets Overlayed  
on KUE Field Measured Discontinuity Data**

KUE identified three joint sets, and one foliation set as shown in the stereonet below. HDR previous reports identified note their analysis was through remote means and are approximate. The data results from the HDR analysis are considered only somewhat characteristic of the general slope stability at the Quarry, as their visual observations did not line up with those found during KUE's site investigation. Still, the previous study in 2023 and the associated measurements provide an outline for the major joint and fracture sets existing at the site. As shown below, KUE's strike and dip measurements of rock features observed in the field generally agree with the discontinuity data approximations. For a detailed stereonet, please see Appendix B.
