**MINERALS PROGRAM INSPECTION REPORT**  
**PHONE: (303) 866-3567**

| <b>MINE NAME:</b><br>Henderson Mine | <b>MINE/PROSPECTING ID#:</b><br>M-1977-342 | <b>MINERAL:</b><br>Molybdenum | <b>COUNTY:</b><br>Clear Creek |
| <b>INSPECTION TYPE:</b><br>Monitoring | <b>WEATHER:</b><br>Cloudy | <b>INSP. DATE:</b><br>July 28, 2025 | <b>INSP. TIME:</b><br>09:30 |
| <b>OPERATOR:</b><br>Climax Molybdenum Company | <b>OPERATOR REPRESENTATIVE:</b><br>Ron Hickman | <b>TYPE OF OPERATION:</b><br>112d-3 - Designated Mining Operation | |

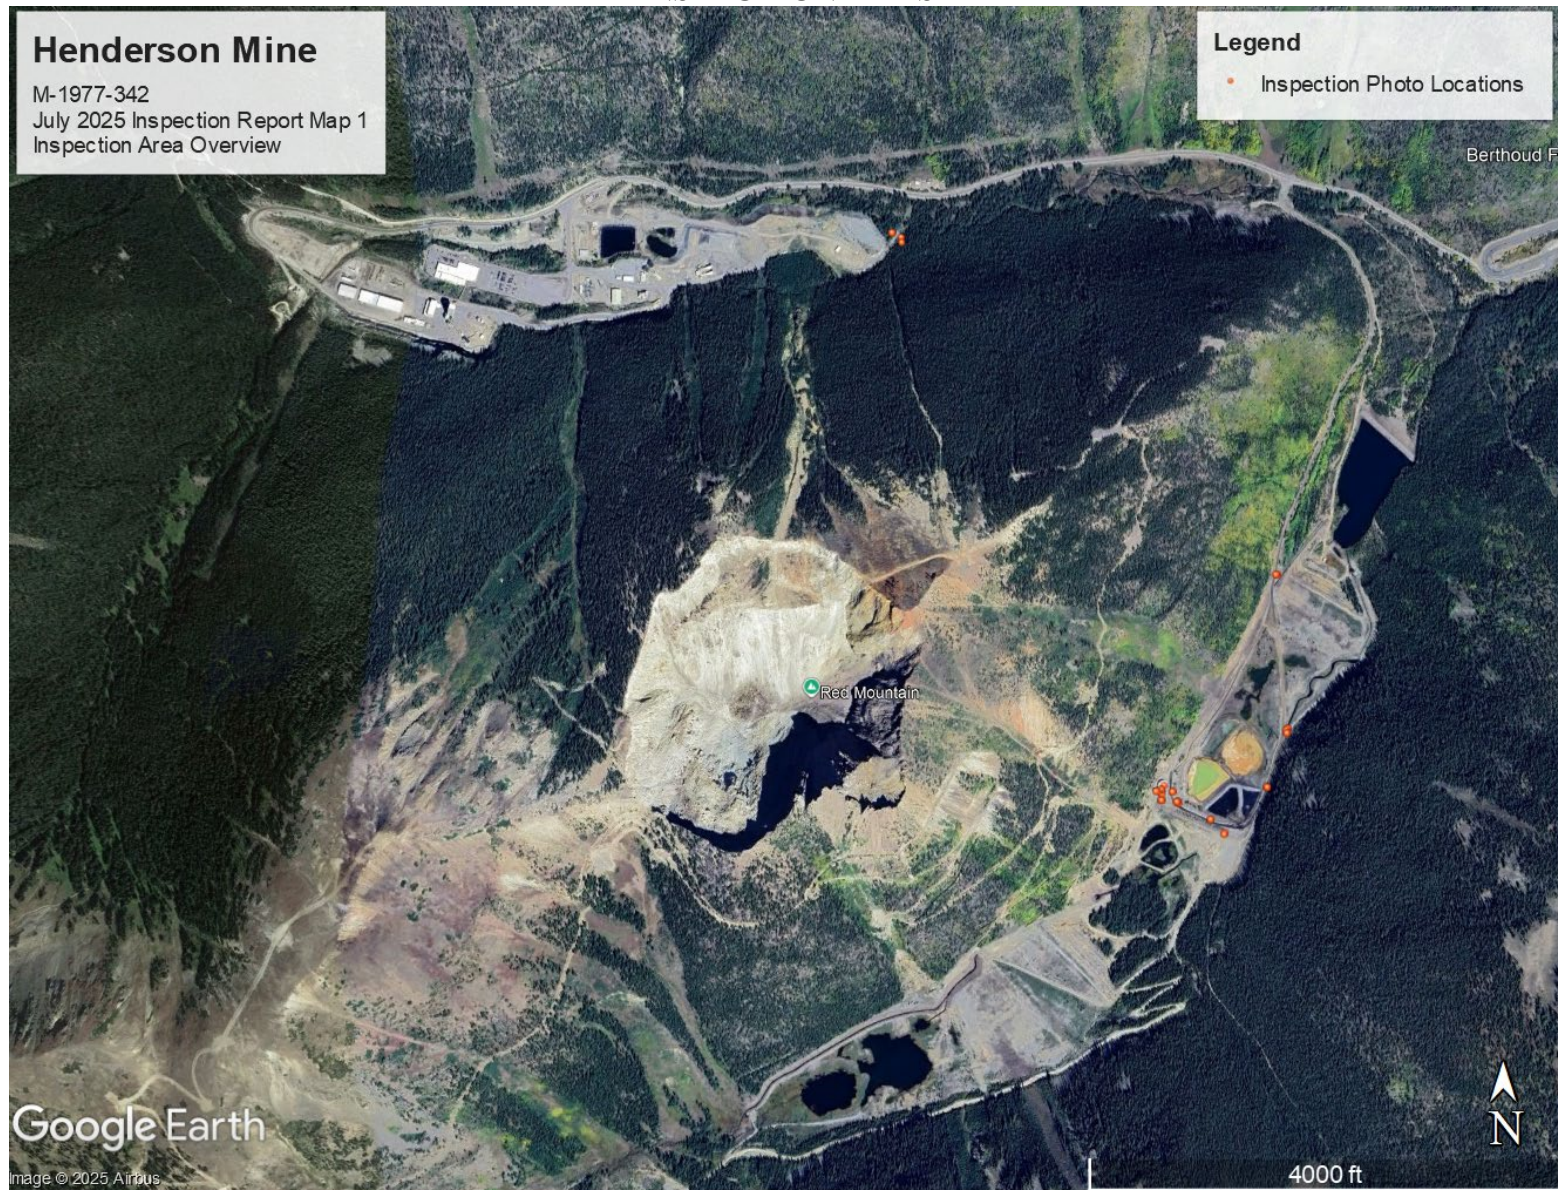
**Map 1:** Overview of the areas inspected during the July 28, 2025 inspection at the Henderson Mine. The red dots indicate inspection photo capture locations. The aerial imagery is dated September 24, 2023.

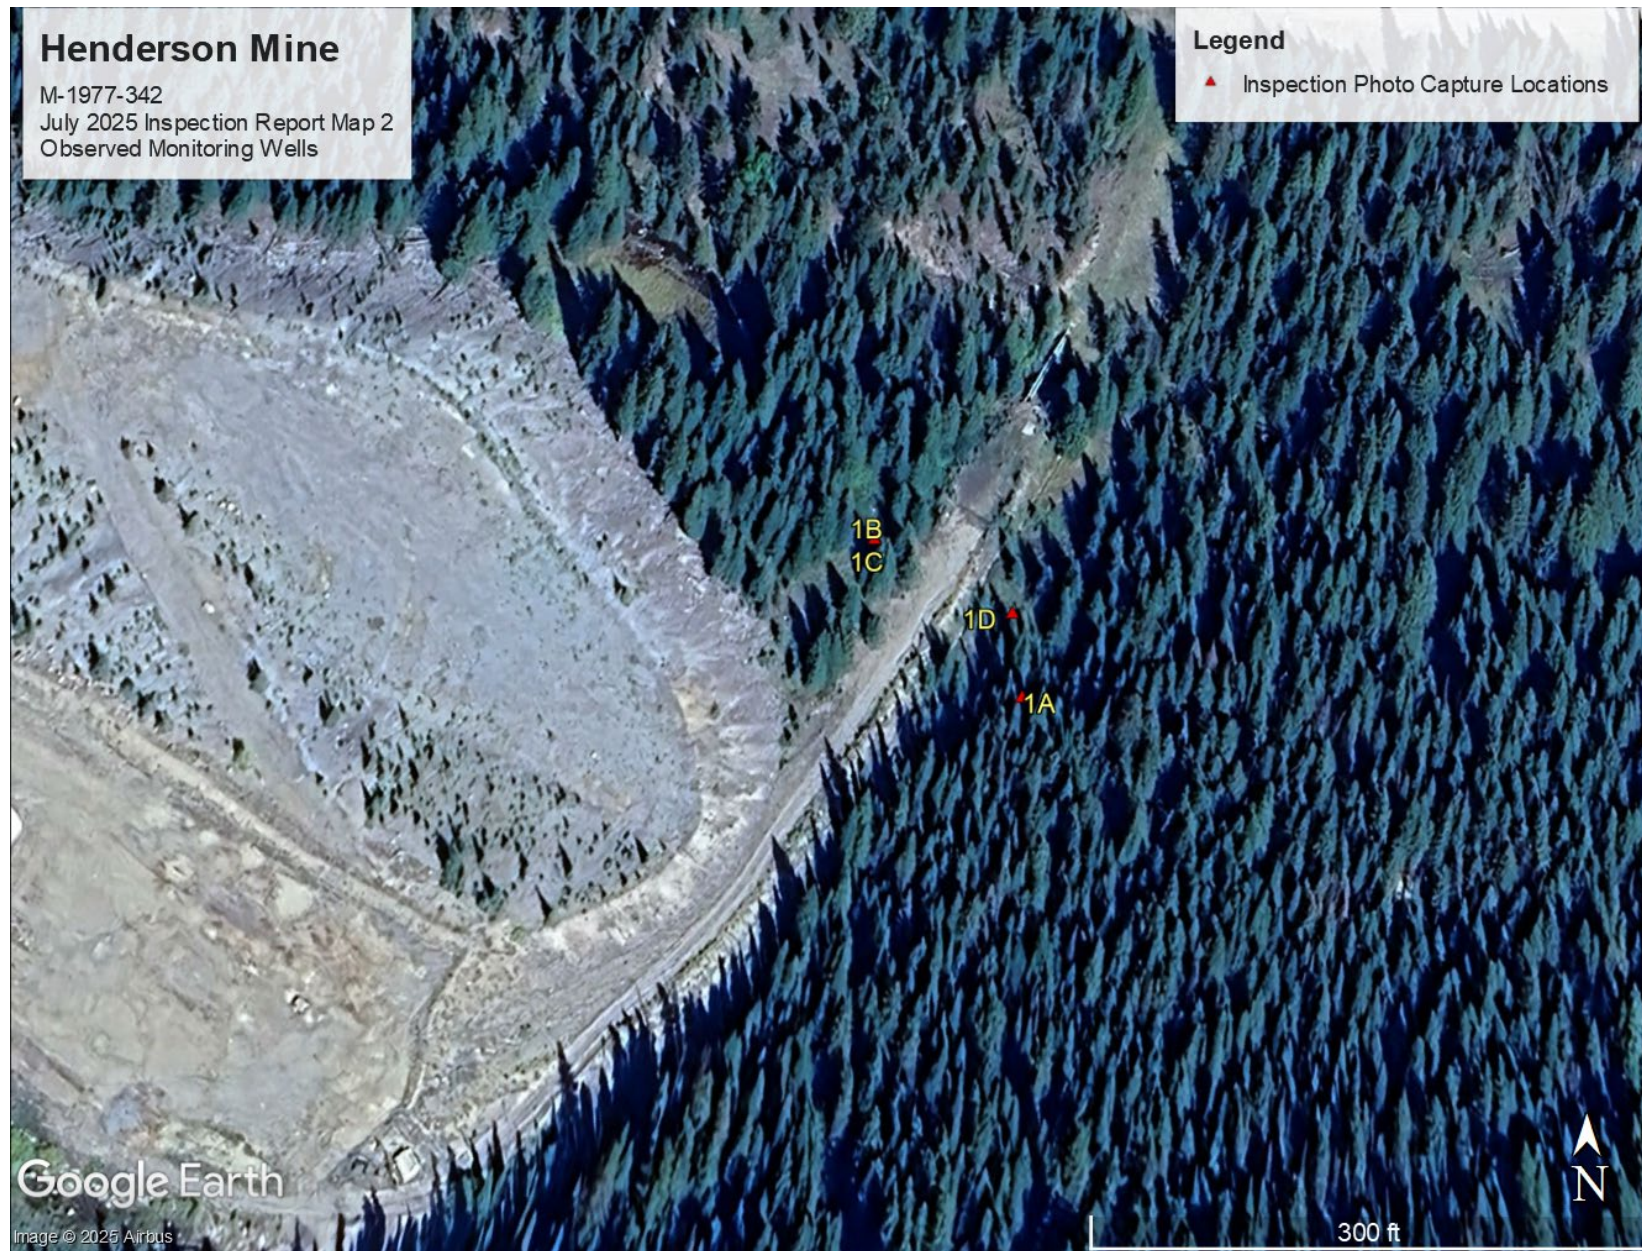
The groundwater monitoring wells, located on the east side of the mine facilities, were observed during the inspection. The Permittee wanted to ensure that samples from mine side's Point of Compliance (POC) well were as accurate and reliable as possible, and had reason to doubt the accuracy of the samples being acquired from MNGW-1 due to the well's inadequate construction. As a result, monitoring well MNGW-5 was installed in 2023, adjacent to and in the same geohydrologic setting downgradient of the mine operations as the current POC well MNGW-1. Since it's installation, the Permittee has been sampling MNGW-5 to collect two years (6 triannual sampling events) of water level and water quality data to establish baseline conditions to and determine the efficacy of the well for its replacement as the POC well. Monitoring wells MNGW-3 and MNGW-4 were also observed during the inspection. MNGW-2 was not observed, but as stated in Technical Revision 37, the well has been dry since it's construction in 1993.

**Map 2:** Zoomed in inspection map for the July 28 2025 inspection of the Henderson mine, highlighting the area where the groundwater monitoring wells were observed. The red triangles indicate inspection photo capture locations. The photo labels correspond with the photo captions within this report. The aerial imagery is dated September 24, 2023.

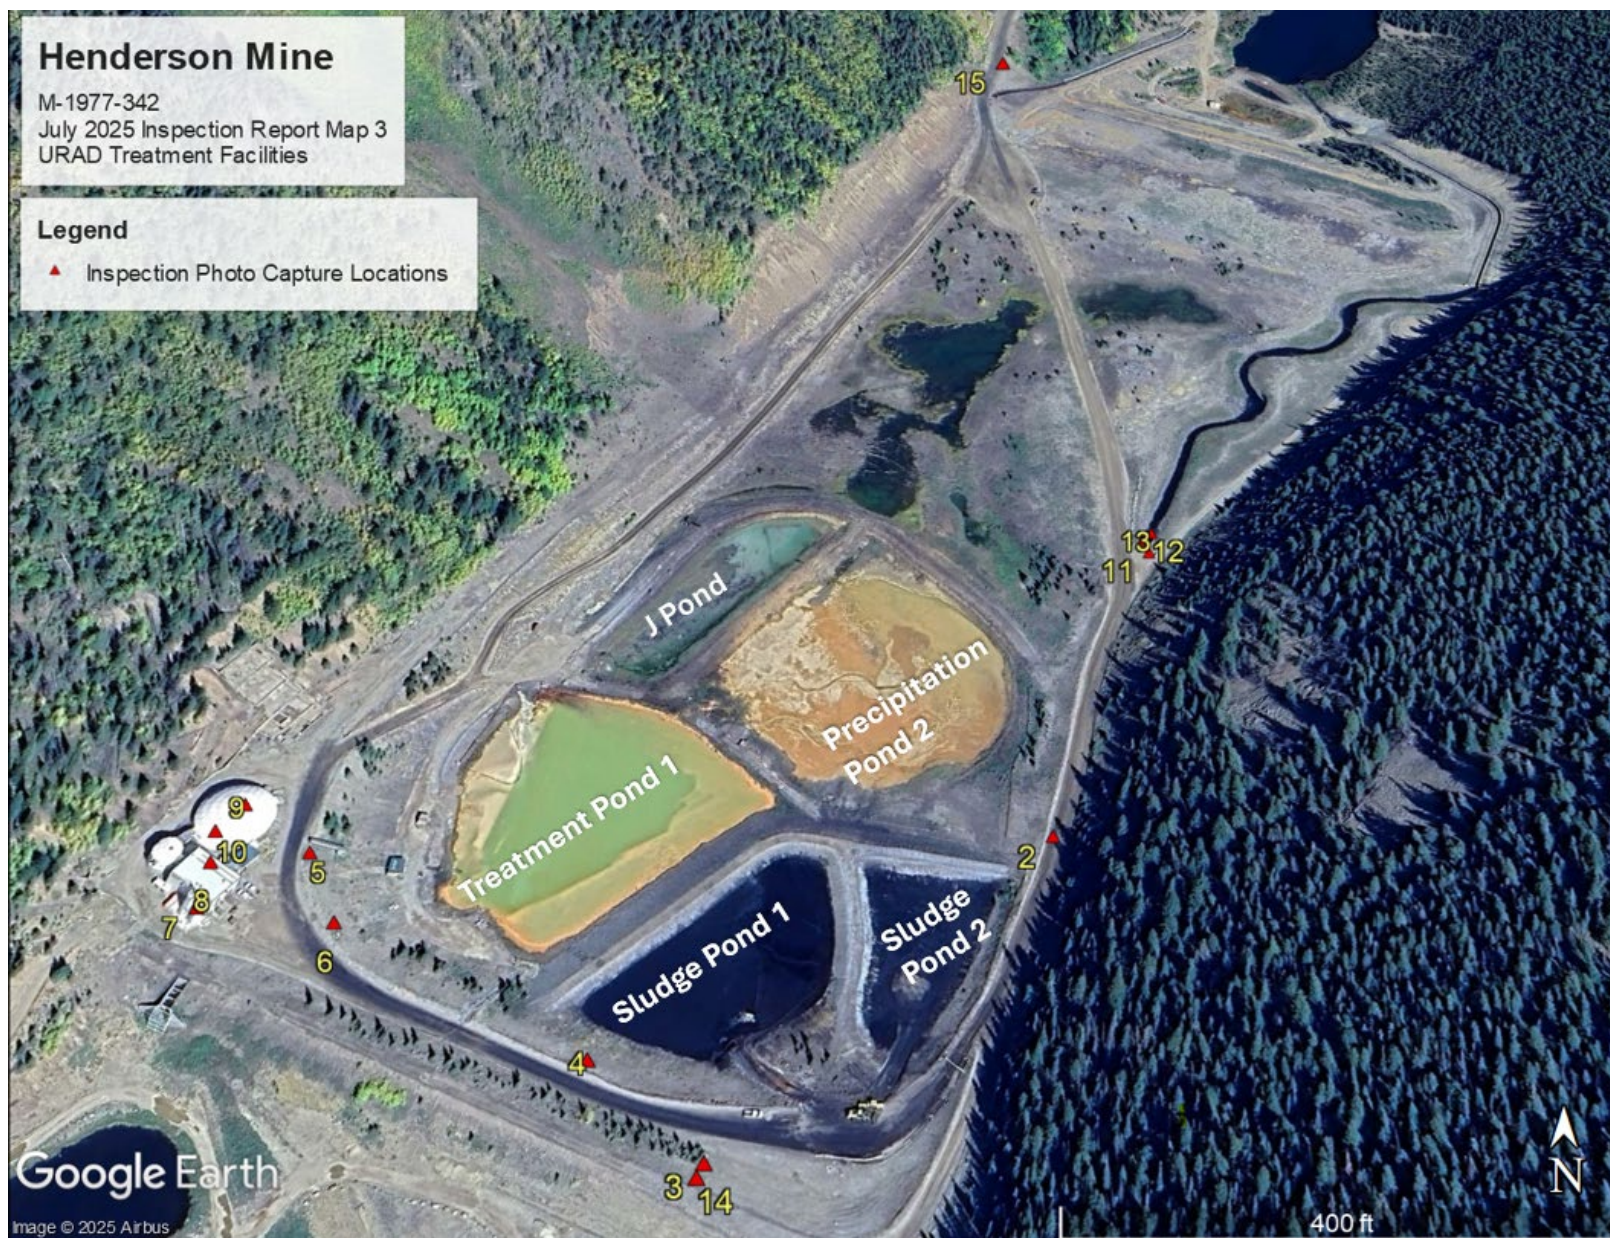
**Map 3:** Zoomed in inspection map for the July 28 2025 inspection of the Henderson mine, highlighting the URAD treatment facilities. The red triangles indicate inspection photo capture locations. The photo labels correspond with the photo captions within this report. The aerial imagery is dated September 24, 2023.
