MINERALS PROGRAM INSPECTION REPORT

MINE NAME: Upper Animas Sand and Gravel Pit	MINE/PROSPECTING ID#: M-2005-065	MINERAL: Sand and gravel	COUNTY: San Juan
INSPECTION TYPE: Monitoring	WEATHER: Clear	INSP. DATE: July 16, 2025	INSP. TIME: 09:53
OPERATOR: Jack Clark, Jr.	OPERATOR REPRESENTATIVE: Jack Clark Jr.	TYPE OF OPERATION: 112c - Construction Regular Operation

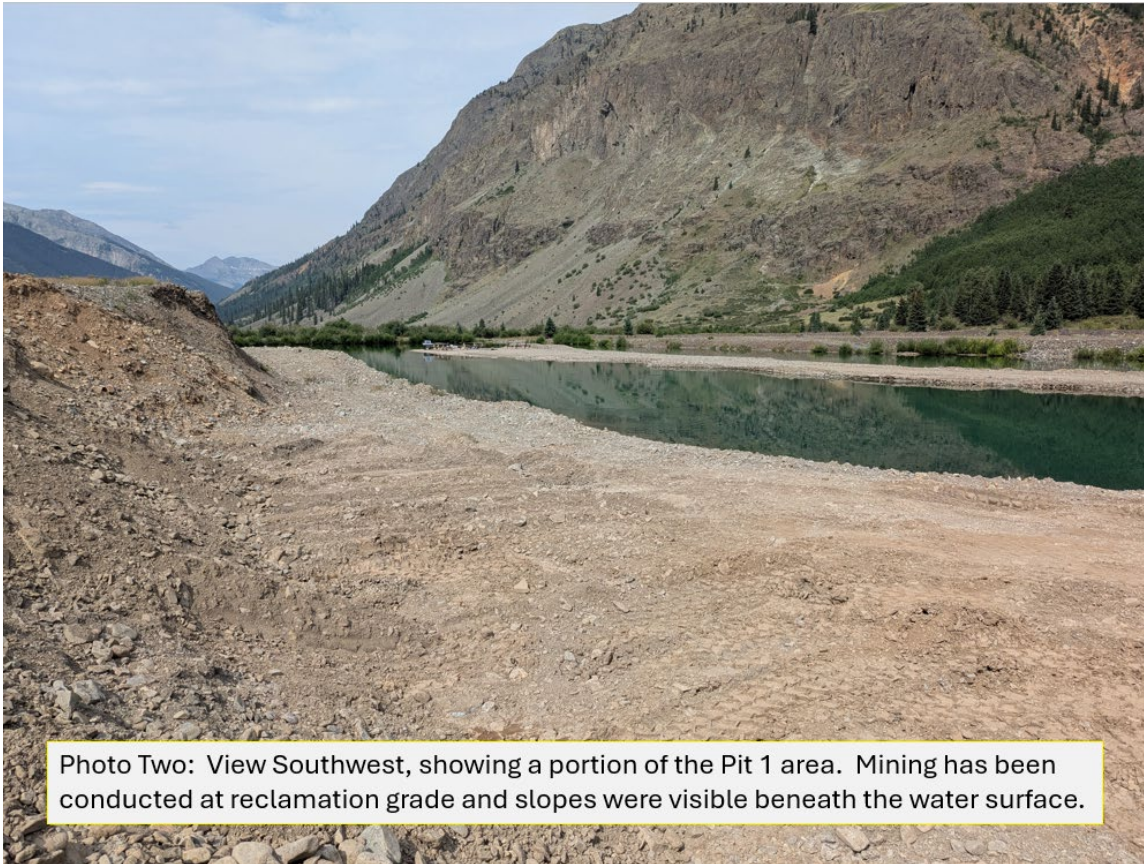
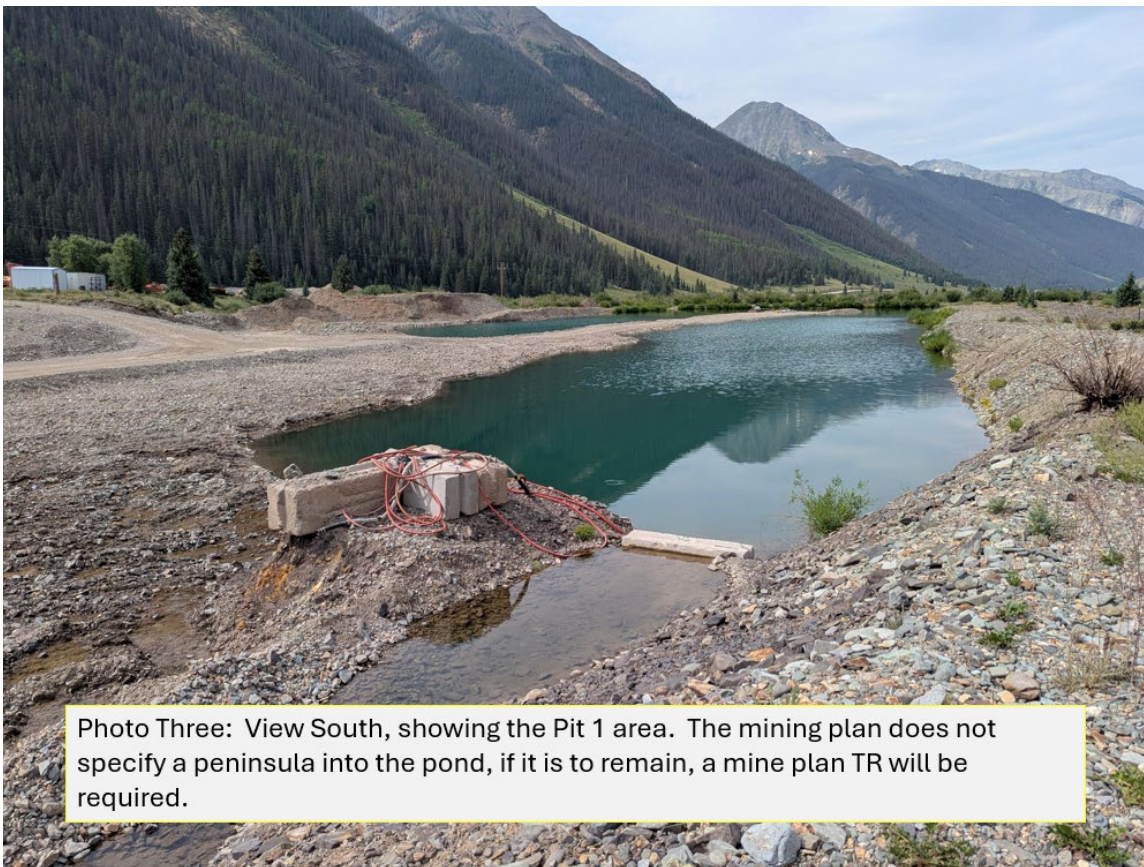
The proper mine identification signage is posted at the entrance to the site and can be seen in Photo One. The permit boundaries are also clearly marked with a combination of T-posts and earthen berms. The active mining area is focused in the northern end of Pit 1 and all of Pit 2. Pit one lies within the active floodplain of the Animas River and will be reclaimed to a developed water resource. The side slopes of the pit appear to be stable, in good condition and are in their final reclamation configuration of 3H: 1V. The Pit 1 Area can be seen in Photos Two and Three. Adequate slope below the ponds water surface was visible and in good condition. The pond currently has a peninsula extending into the pond. The Mining and Reclamation Plans do not show a peninsula in the pond, but it is unclear if Pit 1 is in its final configuration. If the peninsula is desired to remain, it should be addressed through the Division's Technical Revision process. If not, the peninsula should be removed. Pit 2 is the focus of the mining operations at this time. The pit is being mined via highwall mining. Almost the entire perimeter of pit 2 consists of 12-15 foot highwalls. The highwalls appeared to be stable at the time of the inspection and no evidence of sloughing was noted. The pit has not exposed groundwater, minimal amounts of standing water was noted in response to recent precipitation events. The continued mining of the Pit 2 area appears to be consistent with the approved Mining Plan. The Pit 2 area can be seen in Photos Four and Five.
