## McClane Canyon Mine, C-1980-004, September Complete Inspection Report

**PERMIT INFORMATION**

**INSPECTION INFORMATION**

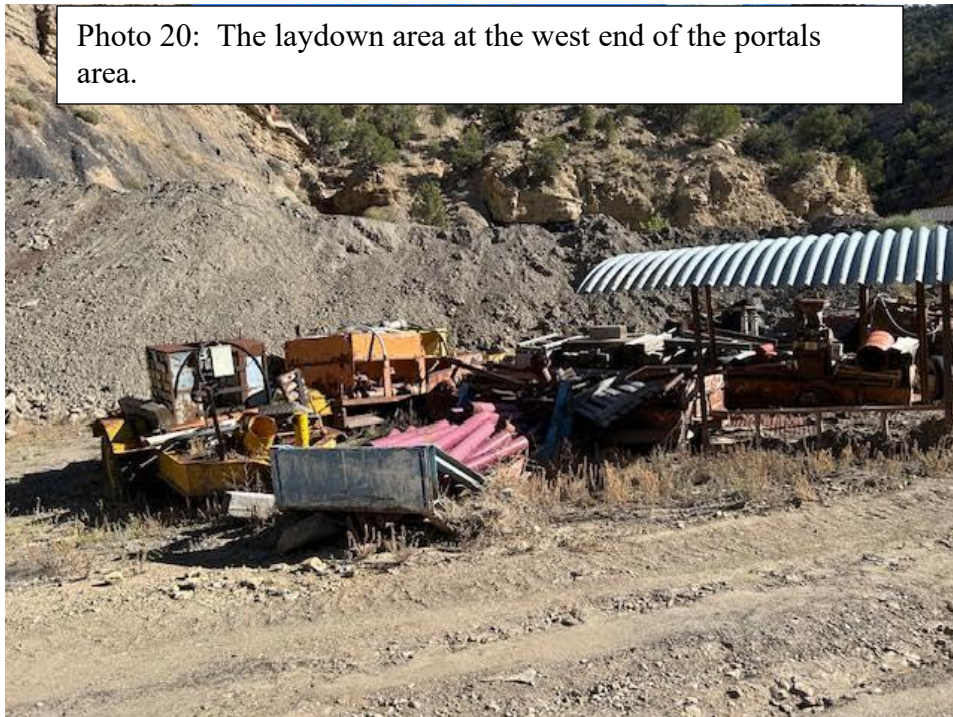
A second laydown area is located on the lower portals area bench. The materials stored in the laydown area were contained within the laydown area (Photo 20). There were no hydrocarbons observed to be within the laydown area.

Photo 20: The laydown area at the west end of the portals area.

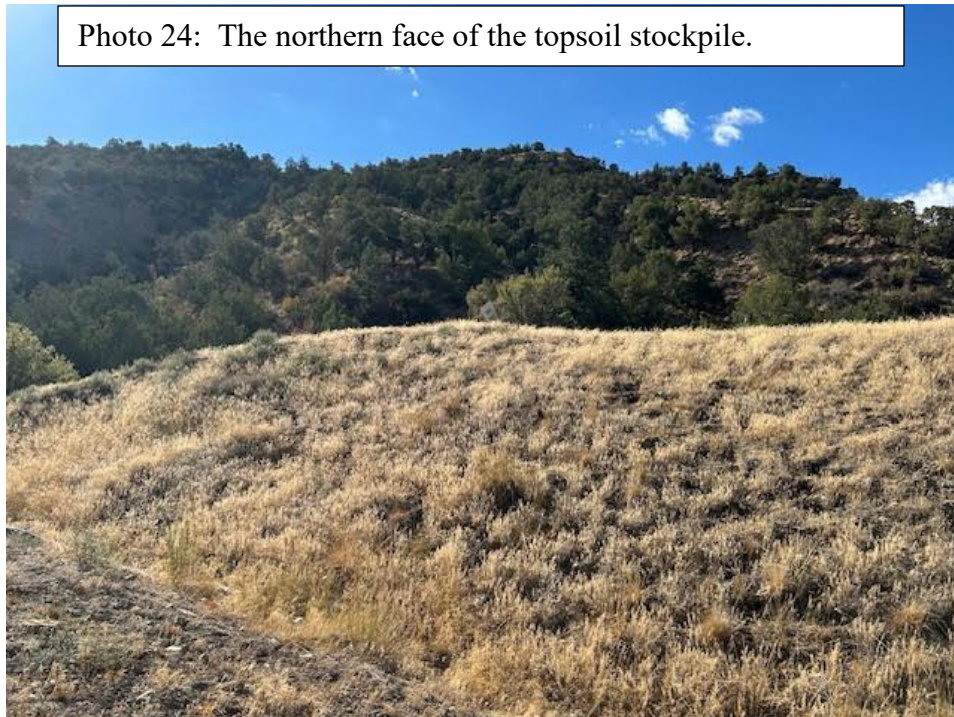
The topsoil stockpile is located to the southwest of the sediment pond. The stockpile was stable and covered with vegetation (Photo 24). The perimeter ditch was also stable and covered with vegetation. There were no blockages in the ditch observed.

Photo 24: The northern face of the topsoil stockpile.
