### MINERALS PROGRAM INSPECTION REPORT

| <b>MINE NAME:</b><br>Velarde Pit | <b>MINE/PROSPECTING ID#:</b><br>M-2002-118 | <b>MINERAL:</b><br>Sand and gravel | <b>COUNTY:</b><br>Huerfano |
| <b>INSPECTION TYPE:</b><br>Monitoring | <b>WEATHER:</b><br>Cloudy | <b>INSP. DATE:</b><br>September 10, 2025 | <b>INSP. TIME:</b><br>12:53 |
| <b>OPERATOR:</b><br>Oldcastle SW Group, Inc. | <b>OPERATOR REPRESENTATIVE:</b><br>Sara Weimer and Kurt Wasinger | <b>TYPE OF OPERATION:</b><br>112c - Construction Regular Operation | |

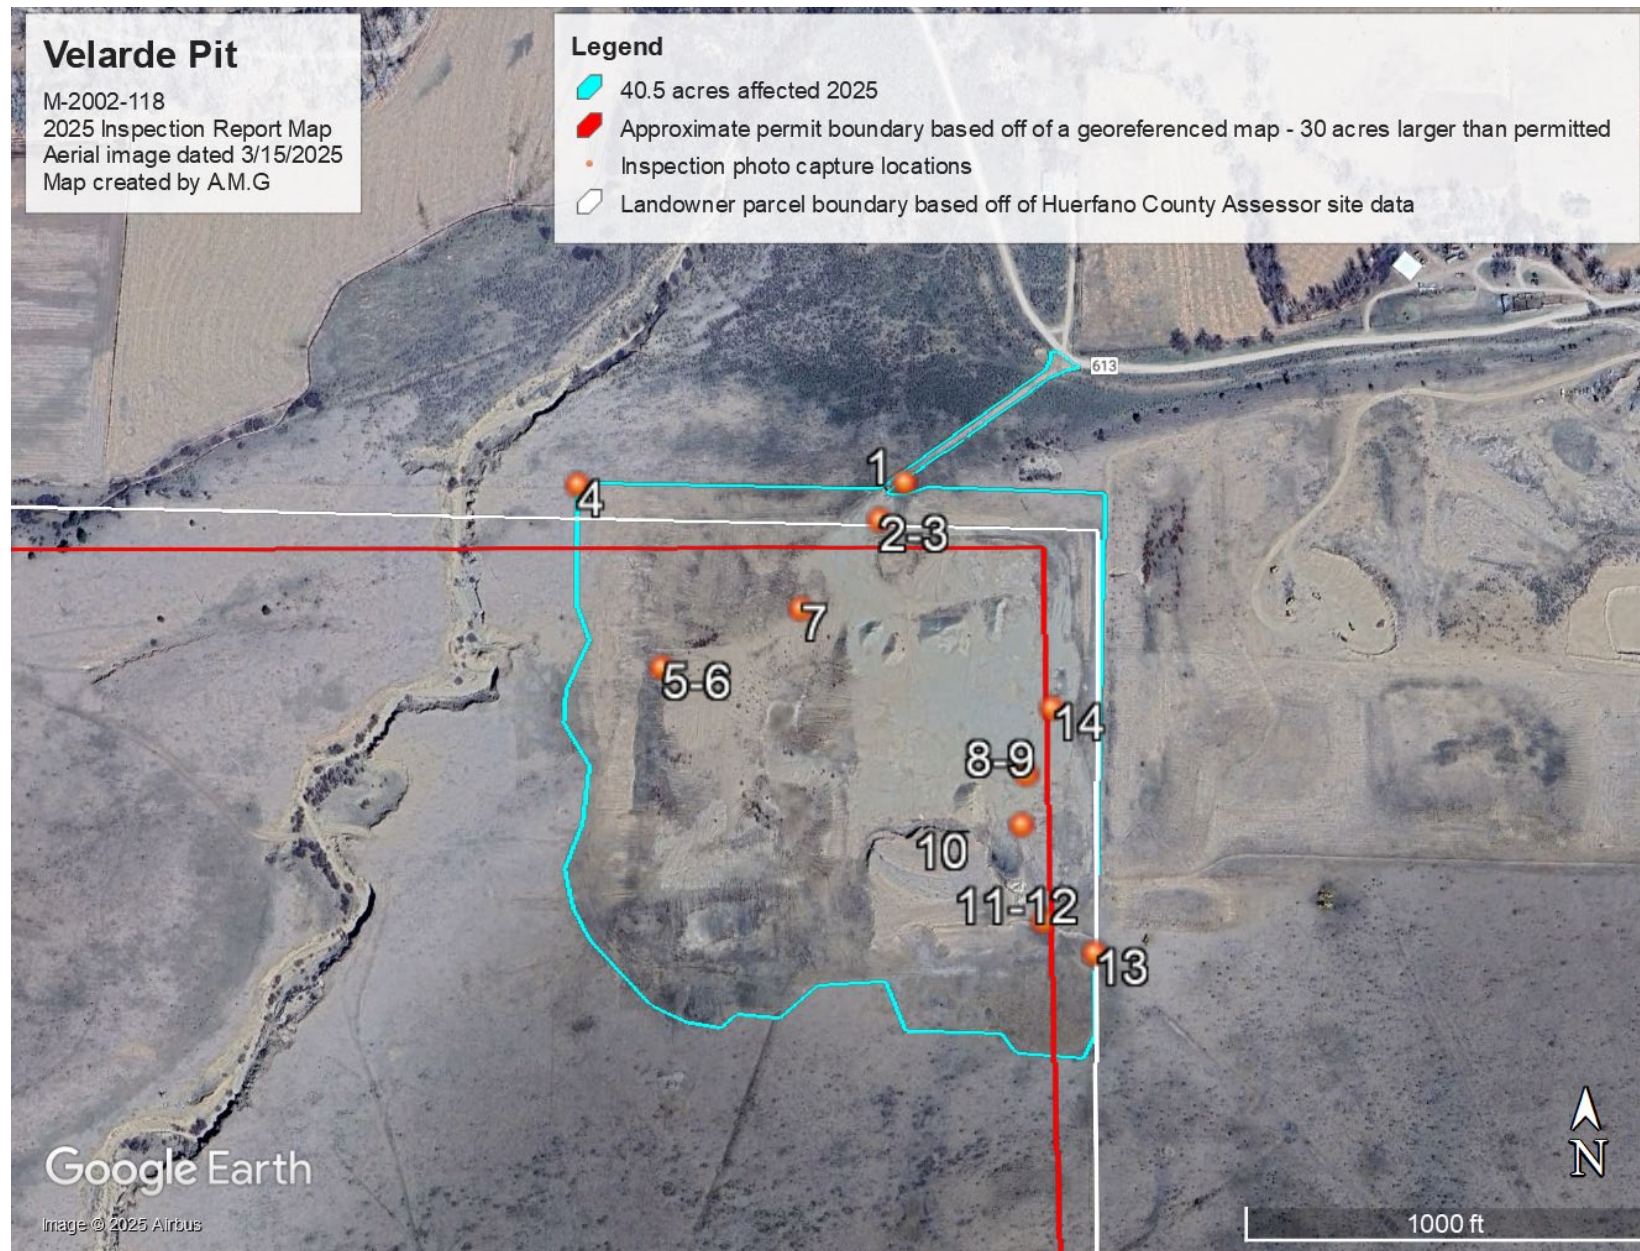
**Map 2:** 2025 Inspection report map, zoomed in on the area that has been affected throughout the life of the mine. The numbers next to the red icons correspond to the inspection photo captions within this report.
