ANNUAL FEE and REPORT REQUEST

PERMITTEE NAME:	Homestake Mining Company	RECEIVED
PERMIT NO .:	M-1977-004	
OPERATION NAME:	Pitch Project	APR 192012
ANNIVERSARY DATE:	April 19, 2012	Division of Reclamation,
ANNUAL FEE DUE:	\$\$1,150.00 (Due on or before your annive	Mining & Safety ersary date)
COUNTY:	Saguache

Notice of Intent to Continue Mining Operations 112 Hard Rock/Metal and DMO Annual Report

Permit	ttee Name:	Homestake Mining Company of California	
Permit	t No.:	M-77-004	
Operat	tion Name:	Pitch Project	
Anniv	ersary Date:	April 19, 2012	
Total:		\$1150.00 (enclosed)

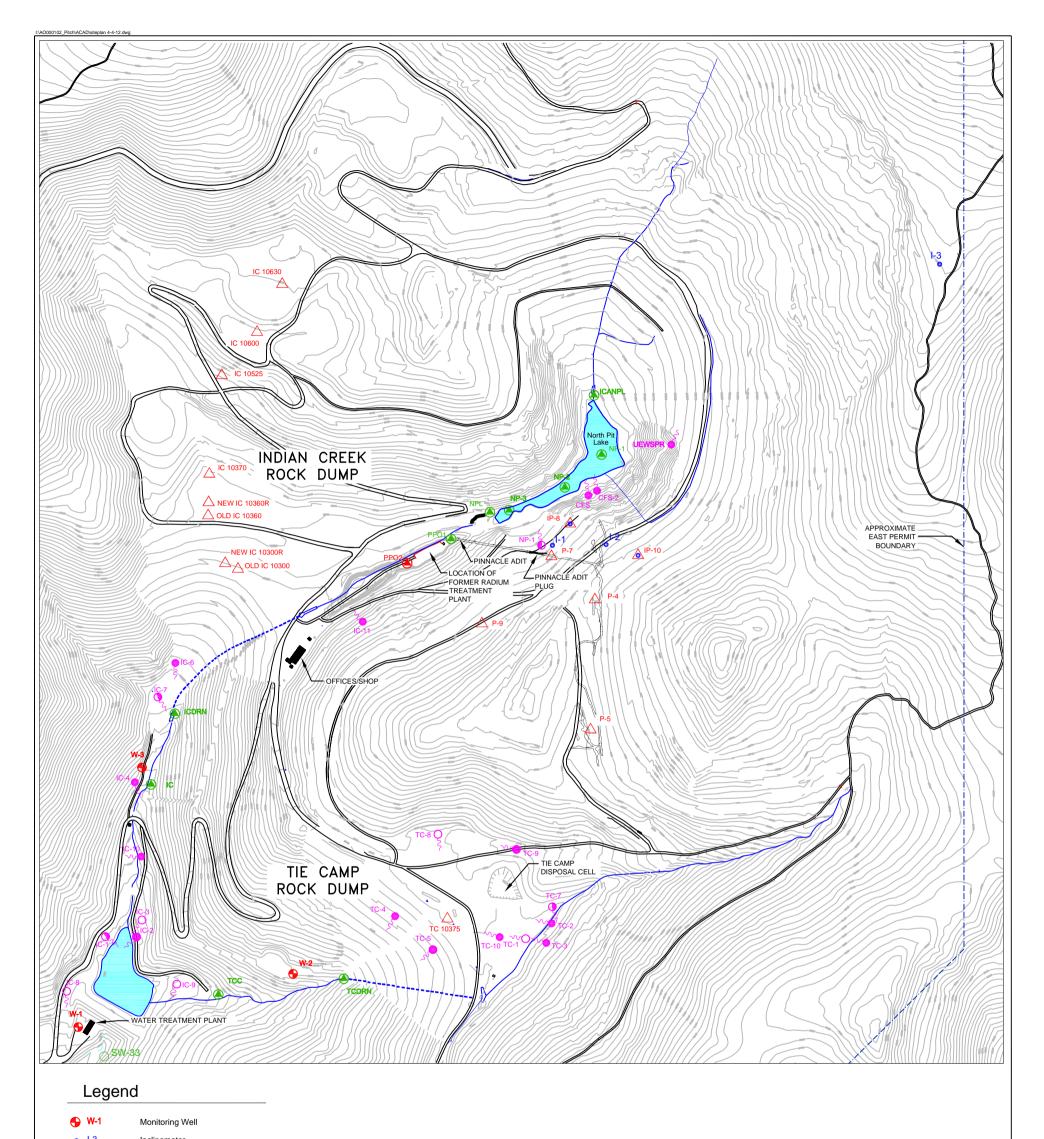
FIGURE 3: SITE PLAN PITCH RECLAMATION PROJECT

In August 2011, both piezometers IC10300 and IC10370 were sealed and were replaced with two new piezometers at approximately the same locations as shown on Figure 3. The replacement piezometer IC10300R is located approximately 30 feet to the west of the former location of IC10300. Piezometer IC10370R is located approximately 67 feet to the west of the former location of IC10370.

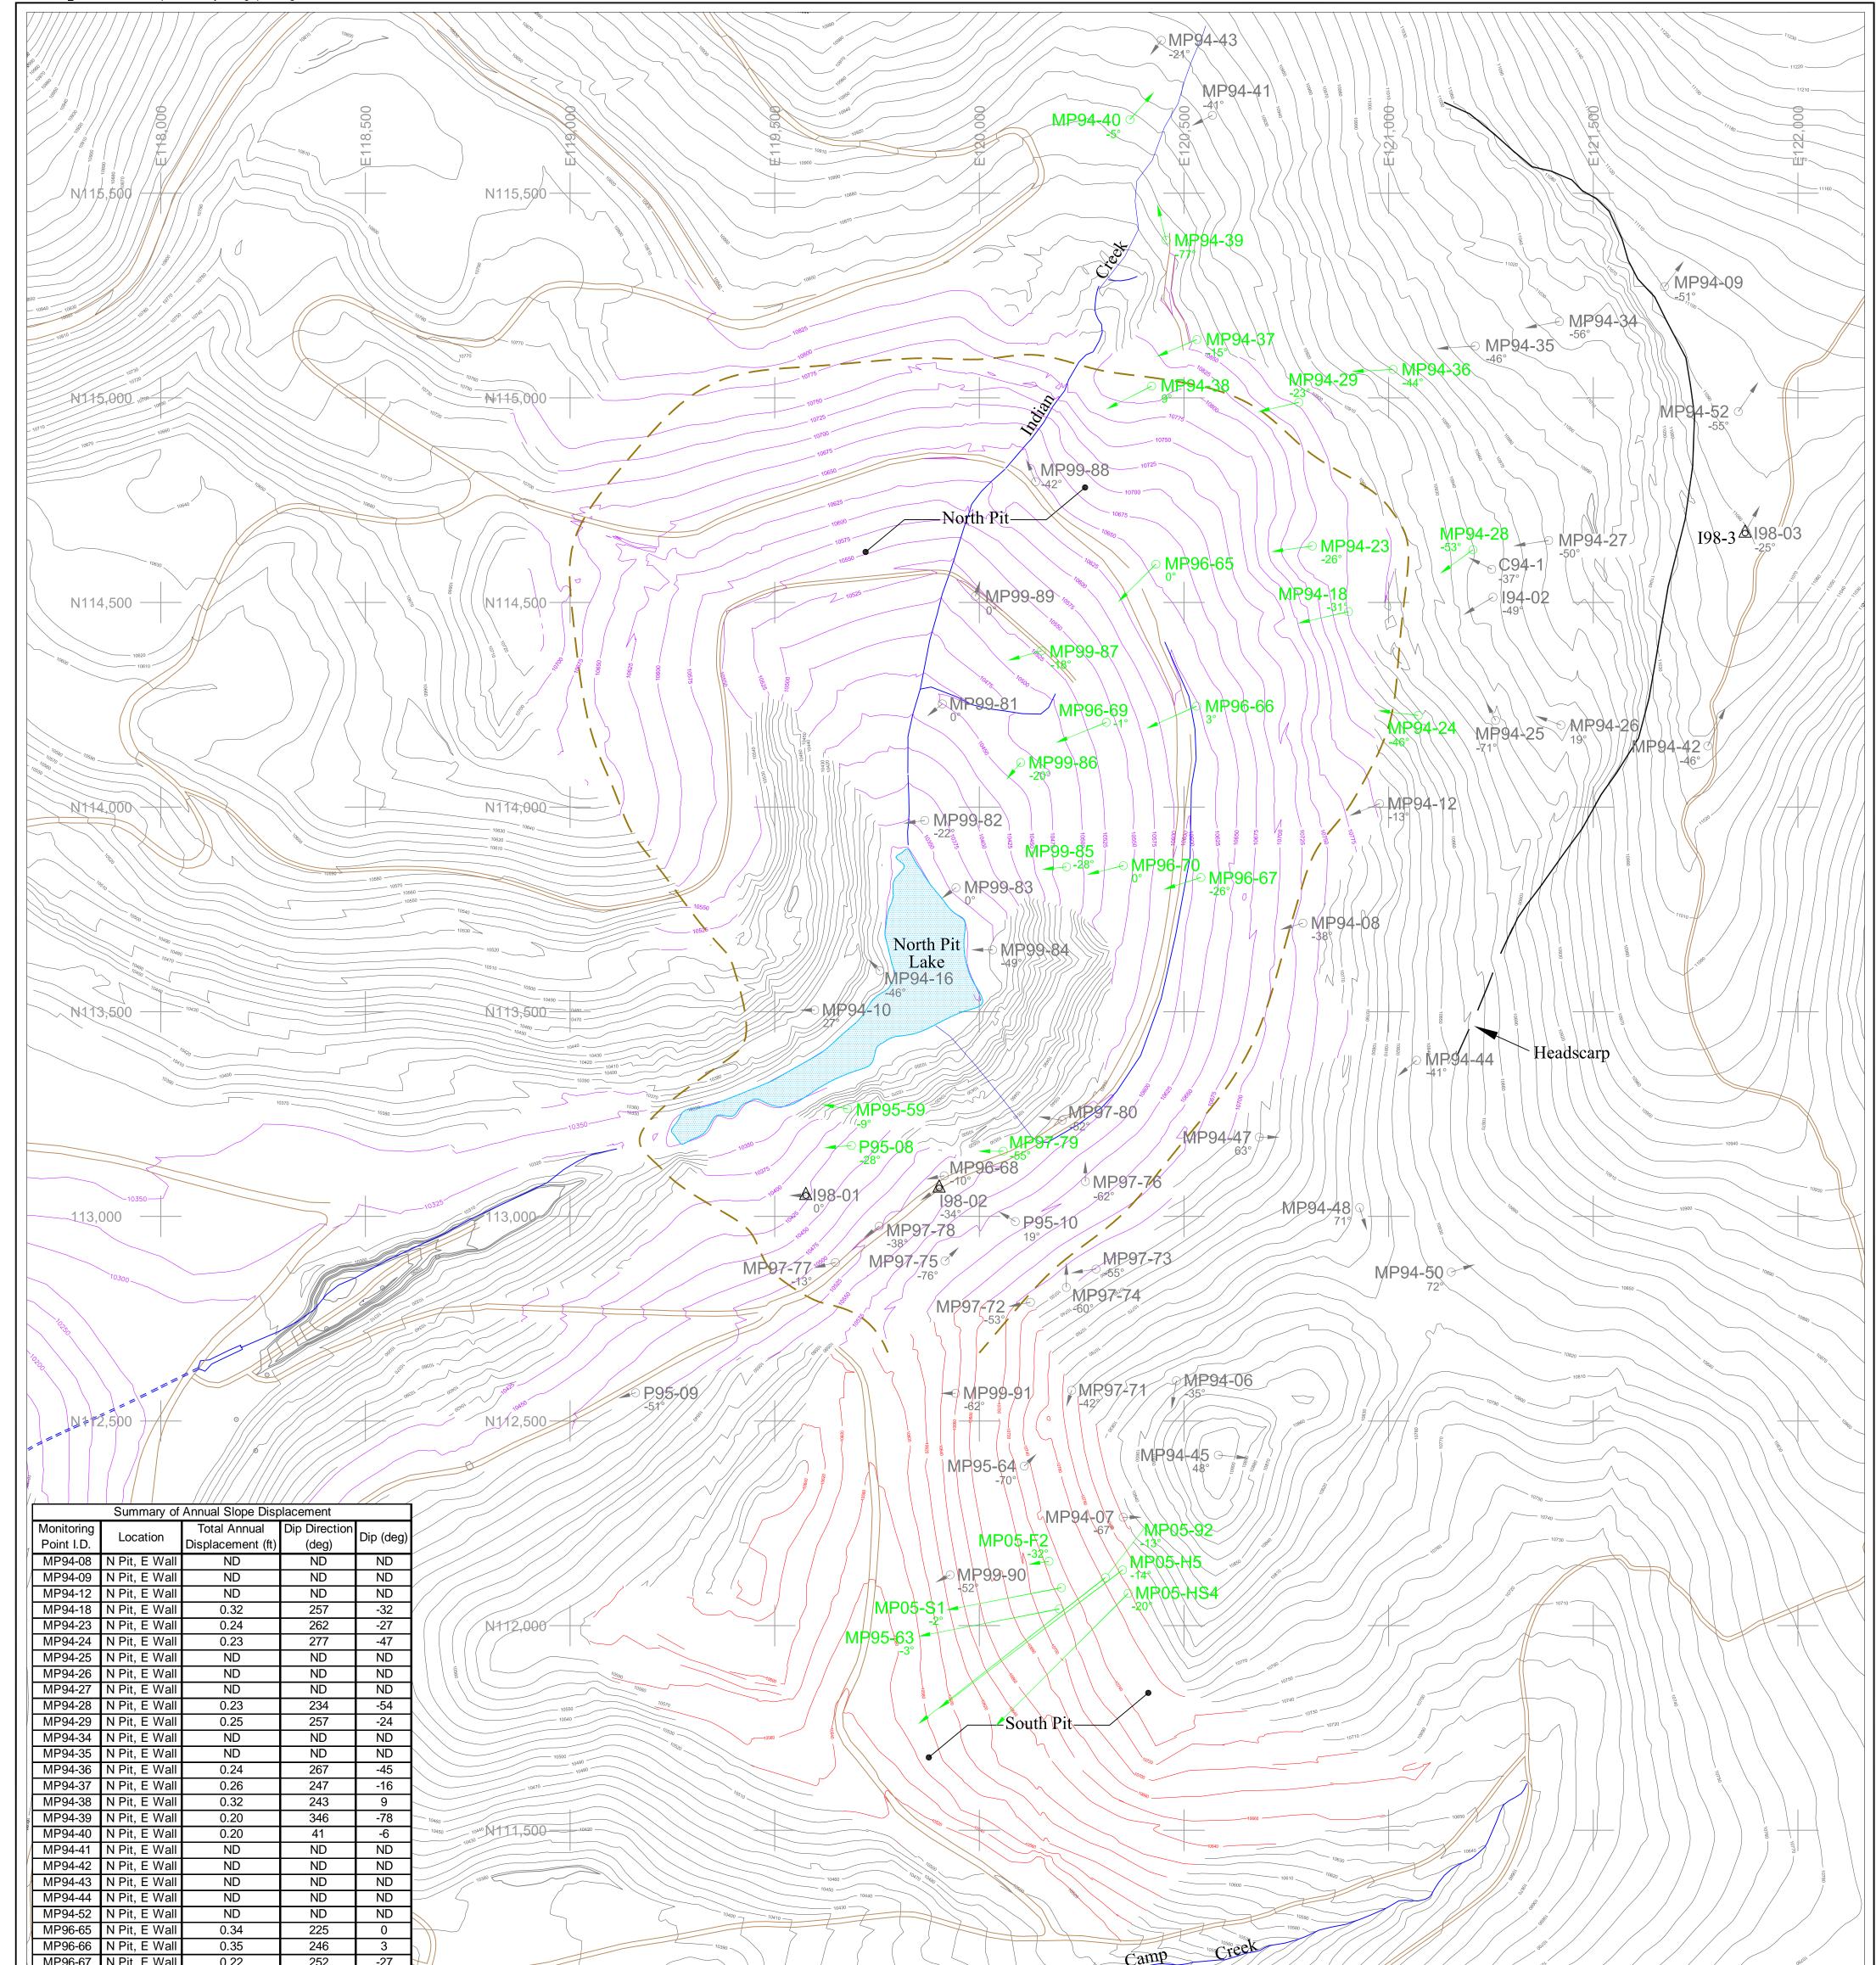
SLOPE DISPLACEMENT VECTORS

The tension cracks and scarps were graded closed during October 2010. Also, the bench that transects the displacement was graded with a central crown to promote drainage in both directions of the bench. Displacement appears to have slowed. The current maximum displacement is 0.72 ft/year at monitoring point S-4, which had a displacement of 1.0 ft/year during the previous monitoring period, and nearly 2 ft in 2008. Grading may have contributed to the slower rate of displacement, but it is likely that other factors prevail. This feature will be monitored closely in 2012 and repairs will be made as necessary. Photograph 3 is a photograph of the slope displacement on the east wall of the South Pit. Linear features contrasted with the light snowfall are traces of Chester Fault structures. The slump is above the upper bench to the right side of the photograph.
