**COLORADO DIVISION OF RECLAMATION, MINING AND SAFETY**  
**MINERALS PROGRAM INSPECTION REPORT**  
**PHONE: (303) 866-3567**

<b>MINE NAME:</b> Buster Moss Rock	<b>MINE/PROSPECTING ID#:</b> M-2012-018	<b>MINERAL:</b> STN	<b>COUNTY:</b> Boulder
<b>INSPECTION TYPE:</b> Illegal(Unpermitted Operation)	<b>INSPECTOR(S):</b> Michael A. Cunningham	<b>INSP. DATE:</b> May 15, 2012	<b>INSP. TIME:</b> 09:00
<b>OPERATOR:</b> Bernard Buster & Brenda Buster	<b>OPERATOR REPRESENTATIVE:</b> Bernard Buster, Brenda Buster	<b>TYPE OF OPERATION:</b> ILL - Illegal

# Buster Moss Rock (M-2012-018)

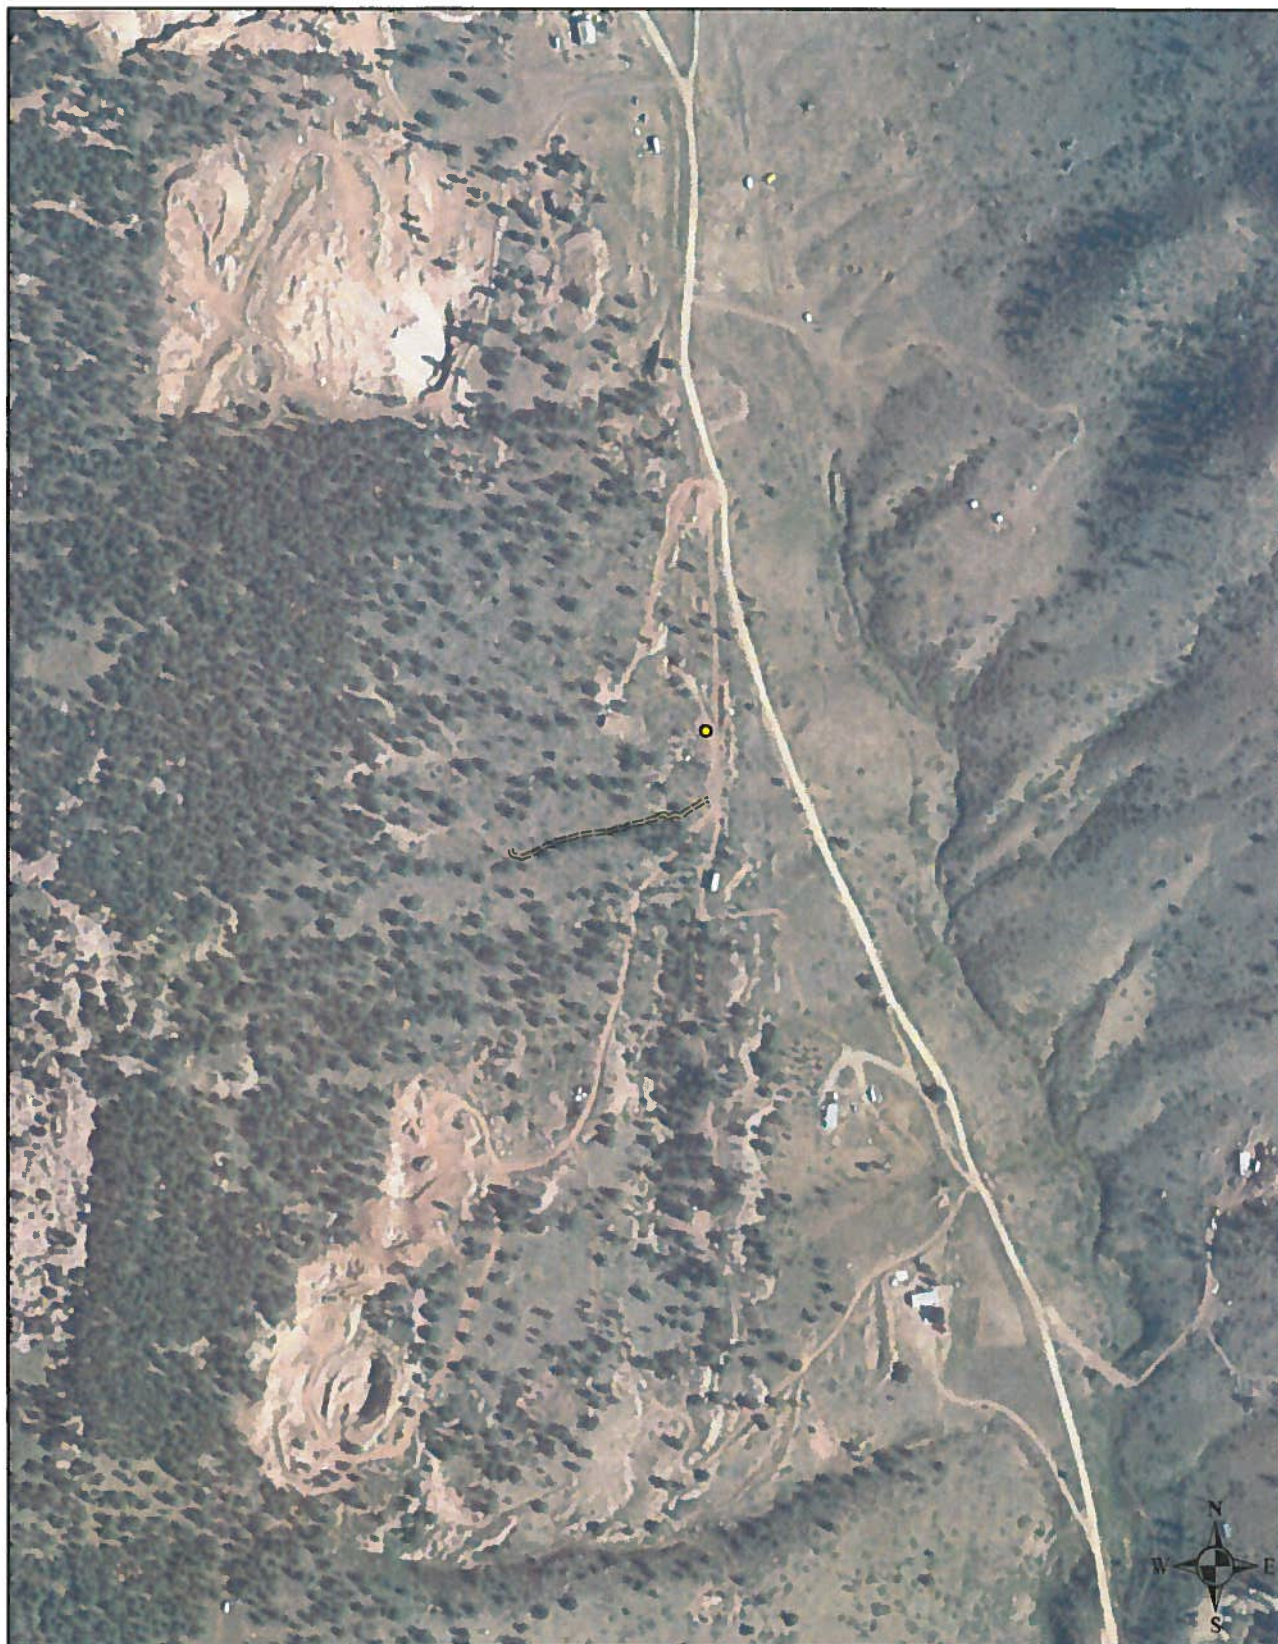
The property owners live on a 35 acre parcel which is located on the west side of Stone Canyon Rd. The site is situated on a ridge with an easterly aspect and is surrounded by sandstone quarries. The access road which leads to their property also serves as an entrance onto other residential properties located immediately south of the 35 acre parcel. The storage area which the Division observed on April 25, 2012 is located on the west side of the access road, approximately 50 ft. in from Stone Canyon Rd. The storage area is approximately 375 square feet. and contained numerous pallets of stacked moss rock. The landowners informed the Division that moss rock has been gathered and sold from the property over the past year and a half. The majority of the stones which have been removed from the property were small enough to remove by hand; however, the landowner indicated that some of the larger stones were removed with a forklift. In addition to the disturbance related to the storage area, the operator has created a road to access the moss rock. The road is located approximately 160 ft. south of the storage area and runs east to west on the ridge; the road is approximately 10 ft. in width and 530 ft. in length. The Division observed piles of moss rock along the entire length of the road. During the inspection, the Division traversed the disturbed area with a Juno Trimble hand-held GPS unit. The data were downloaded into GPS Pathfinder Office software and the disturbed area was found to be 0.14 acres in size.
