COLORADO DIVISION OF RECLAMATION, MINING AND SAFETY COAL PROGRAM INSPECTION REPORT

Permit Number: C-2009-087 Mine Name: Peabody Sage Creek Mine Operator: Peabody Sage Creek Mining LLC Operator Address: Mr B. Scott Cowman P.O. Box 250 36600 Routt County Road 27 Hayden, CO 81639	County: Routt Operation Type: Underground Permit Status: Active Ownership: Federal
Operator Representative Present: Scott Cowman	
Operator Representative Signature: (Field Issuance Only)

Inspection Start Date: October 3, 2012 Inspection Start Time: 08:00 Inspection End Date: October 3, 2012 Inspection End Time: 14:30	Inspection Type: Coal Partial Inspection Inspection Reason: OSM Special Focus Weather: Clear
Joint Inspection Agency: OSM	Joint Inspection Contacts:
Post Inspection Agency: None	Post Inspection Contacts:
Inspector(s): Jason D. Musick	Inspector's Signature:

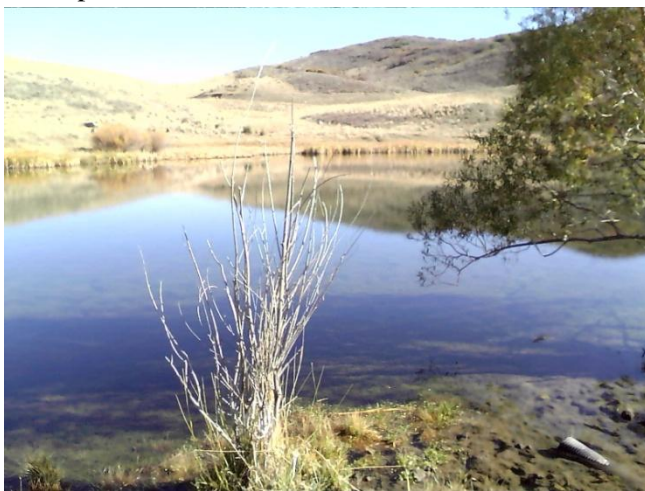
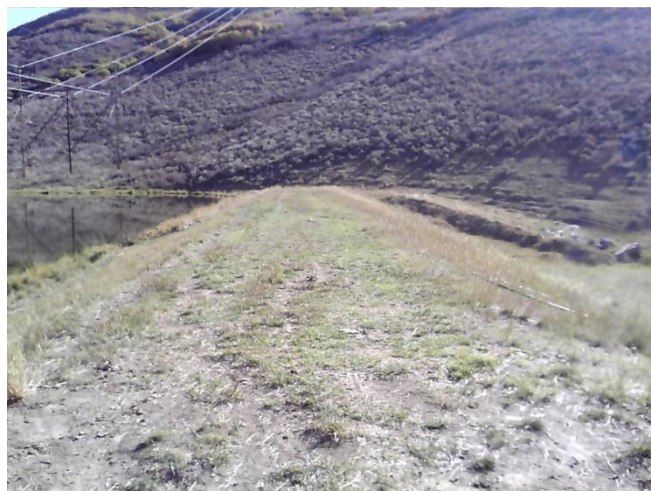
- A small erosion feature was identified at the toe of the emergency spillway. This down cutting will need to be addressed and rip-rap installed as designed.

The pond embankments appeared to be well vegetated and stable with no signs of erosion or damage at the time of the inspection.
