**COLORADO DIVISION OF RECLAMATION, MINING AND SAFETY
COAL PROGRAM INSPECTION REPORT**

Permit Number: C-1996-084 Mine Name: Lorencito Canyon Mine Operator: New Elk Coal Company, LLC Operator Address: Mr Ron Thompson 12250 Highway 12 Weston, CO 81091	County: Las Animas Operation Type: Surface Permit Status: Permanent Cessation Ownership: Private
	Operator Representative Present: Ron Thompson
Operator Representative Signature: (Field Issuance Only)

Inspection Start Date: February 21, 2013 Inspection Start Time: 09:30 Inspection End Date: February 21, 2013 Inspection End Time: 12:00	Inspection Type: Coal Partial Inspection Inspection Reason: Normal I&E Program Weather: Cloudy
Joint Inspection Agency: None	Joint Inspection Contacts: None
Post Inspection Agency: None	Post Inspection Contacts: None
Inspector(s): Zach T. Trujillo	Inspector's Signature:

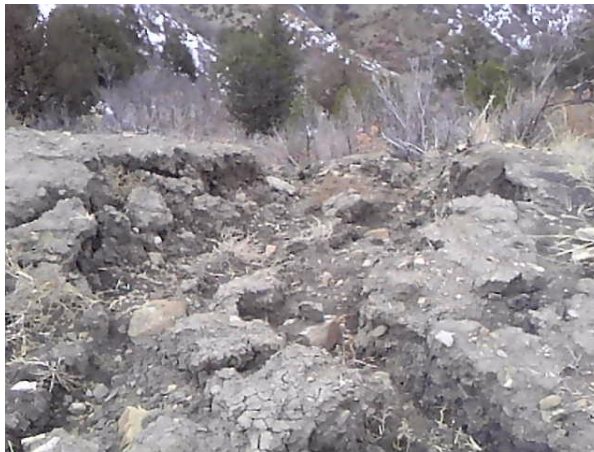
Hay bales above natural drainage to Pond 5.

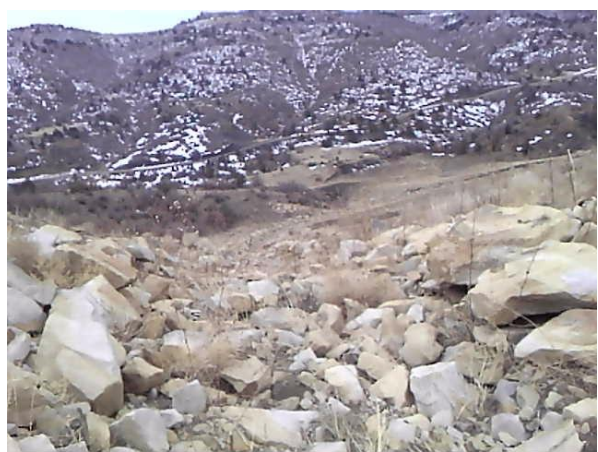
Fills numbered 7, 8 and 9 were inspected. All fills were stable and well vegetated. As previously noted in the January inspection report, a large gully has formed along the north facing slope in the area between pond 8 and pond 9b, near the top of the drainage and should have been repaired. The gully is several feet wide and deep and **will need to be repaired by March 31, 2013.**

Gully between Pond 8 and Pond 9b in need of repair **by March 31, 2013.**

As previously noted in the Excess Spoil and Developmental Waste section of this report and previous inspection reports, the gully formed along is in need of maintenance. **The gully will need to be repaired by March 31, 2013.**
