COLORADO DIVISION OF RECLAMATION, MINING AND SAFETY COAL PROGRAM INSPECTION REPORT

Permit Number: C-1981-014 Mine Name: Southfield Mine Operator: Energy Fuels Coal, Inc. Operator Address: Mr George Patterson P.O. Box 459 Florence, CO 81226	County: Fremont Operation Type: Underground Permit Status: Permanent Cessation Ownership: Private
	Operator Representative Present: George Patterson
Operator Representative Signature: (Field Issuance Only)

Inspection Start Date: September 17, 2012 Inspection Start Time: 12:00 Inspection End Date: September 28, 2012 Inspection End Time: 10:00	Inspection Type: Coal Complete Inspection Inspection Reason: Normal I&E Program Weather: Cloudy
Joint Inspection Agency: None	Joint Inspection Contacts:
Post Inspection Agency: None	Post Inspection Contacts:
Inspector(s): Janet H. Binns Dan Hernandez Leigh D. Simmons	Inspector's Signature:

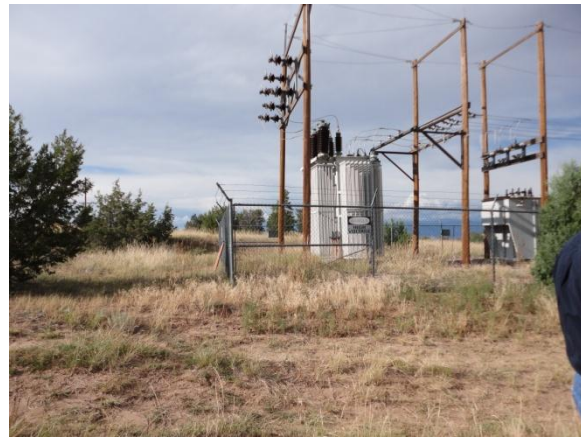
Photo 8: Sub station

Disturbance area boundary markers are needed at the reclaimed rock dust storage area. Disturbance area marker along the access road to the substation have been knocked down and need to be reinstalled. The damaged marker at the turnoff from the substation road to the Thompson ranch is broken as to present a vehicle tire hazard and needs to be removed and replaced.
