## COLORADO DIVISION OF RECLAMATION, MINING AND SAFETY COAL PROGRAM INSPECTION REPORT

<b>Permit Number:</b> C-1996-083 <b>Mine Name:</b> Bowie No. 2 Mine <b>Operator:</b> Bowie Resources, LLC <b>Operator Address:</b> Mr William A Bear P.O. Box 483 Paonia, CO 81428	<b>County:</b> Delta <b>Operation Type:</b> Underground <b>Permit Status:</b> Active <b>Ownership:</b> Federal and Forest
<b>Operator Representative Present:</b>  Bill Bear	
<b>Operator Representative Signature:</b> (Field Issuance Only)

<b>Inspection Start Date:</b> May 9, 2013 <b>Inspection Start Time:</b> 08:30 <b>Inspection End Date:</b> May 9, 2013 <b>Inspection End Time:</b> 11:30	<b>Inspection Type:</b> Coal Partial Inspection <b>Inspection Reason:</b> Normal I&E Program <b>Weather:</b> Cloudy
<b>Joint Inspection Agency:</b>  None	<b>Joint Inspection Contacts:</b>
<b>Post Inspection Agency:</b>  None	<b>Post Inspection Contacts:</b>
<b>Inspector(s):</b>  Susan L. Burgmaier	<b>Inspector's Signature:</b>  <i>Susan Burgmaier</i> <b>Signature Date:</b>  05/16/2013

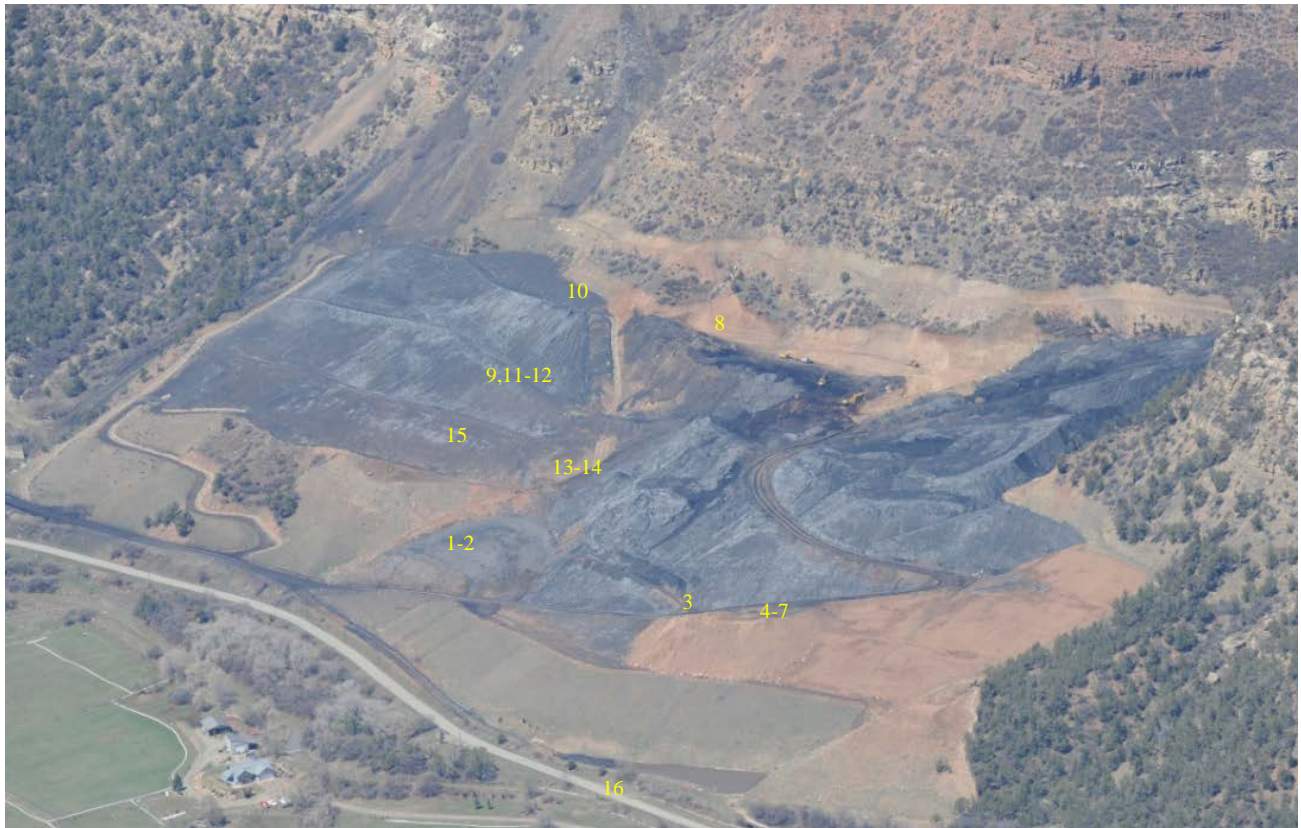
Photo 19

Description: Failure to construct Gob Pile #2 in a controlled manner to ensure stability of the fill; failure to control surface water runoff on Gob Pile #2 and Gob Pile #4.

Gob Pile 2 from just east of D Portal Bench

Abatement Description: Remove cover fill material from ditches D-F5 and D-F6 and repair or reconstruct all lateral ditches on Gob Piles 2 and 4 to ensure positive drainage as designed in the approved permit application package.
