**COLORADO DIVISION OF RECLAMATION, MINING AND SAFETY
COAL PROGRAM INSPECTION REPORT**

Permit Number: C-1994-082 Mine Name: Yoast Mine Operator: Seneca Coal Company, LLC Operator Address: Mr. Roy Karo 37796 Routt County Road 53 P.O. Box 670 Hayden, CO 81639	County: Routt Operation Type: Surface Permit Status: Permanent Cessation Ownership: Federal
	Operator Representative Present: Dennis Jones
Operator Representative Signature: (Field Issuance Only)

Inspection Start Date: May 14, 2013 Inspection Start Time: 10:43 Inspection End Date: May 15, 2013 Inspection End Time: 09:00	Inspection Type: Coal Complete Inspection Inspection Reason: Normal I&E Program Weather: Clear
Joint Inspection Agency: None	Joint Inspection Contacts:
Post Inspection Agency: None	Post Inspection Contacts:
Inspector(s): Jared L. Ebert	Inspector's Signature:

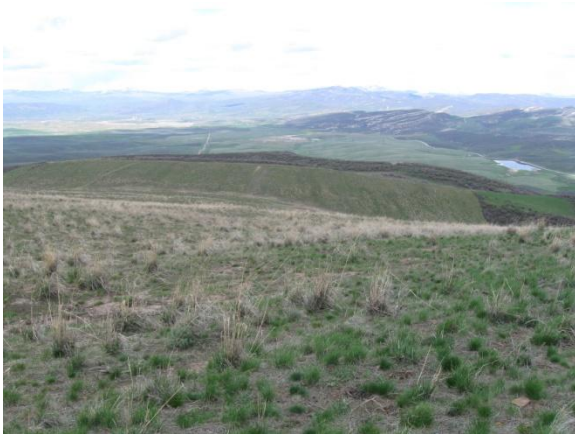
North Mine Area.

Spring germination is occurring throughout the reclaimed area. Several bare areas were observed in the north pit area above YPM-10. Very few weedy species were observed at this time.

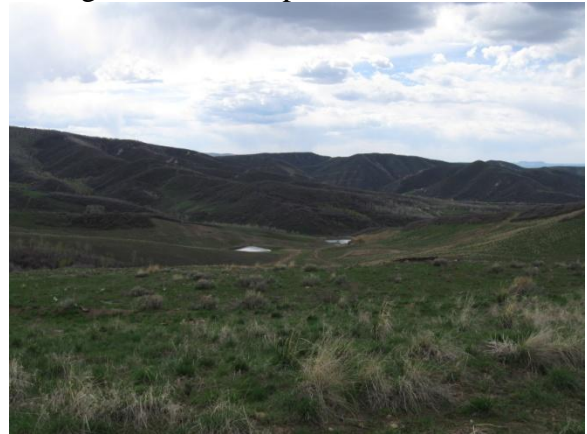
Pond 012 and 012a drainage basin.

A shrub planting area was observed above Pond 012. Overall, the shrubs appear to have been significantly browsed but many of the plants appear to be alive and are budding out.

There is a slump that was identified in 2011 above Pond 012A, this slump was observed. Overall there is a two to three foot scarp and a toe bulge. The area is vegetated primarily with annual forbs.
