BREACH INUNDATION MAPPING REPORT

LONG LAKE DAM
ROUTT COUNTY, COLORADO

December 2013
Project 13117

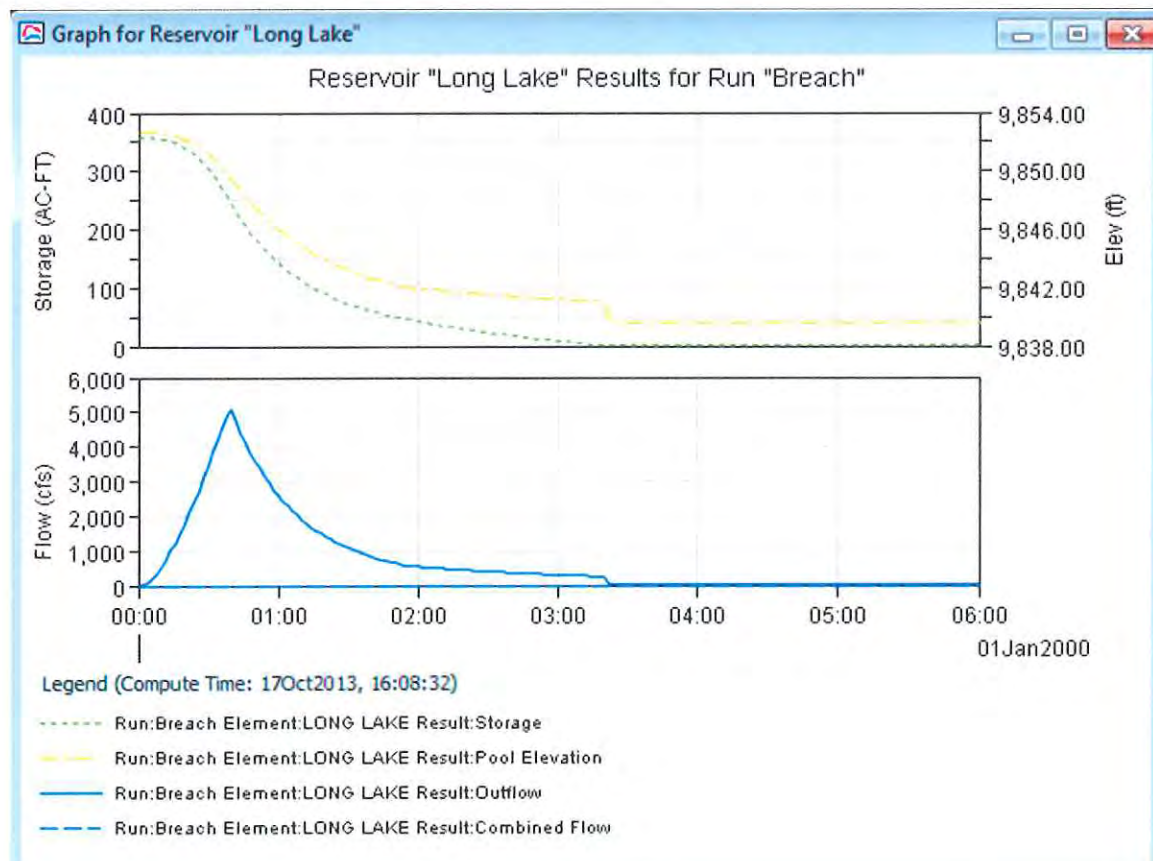
Breach Hydrograph

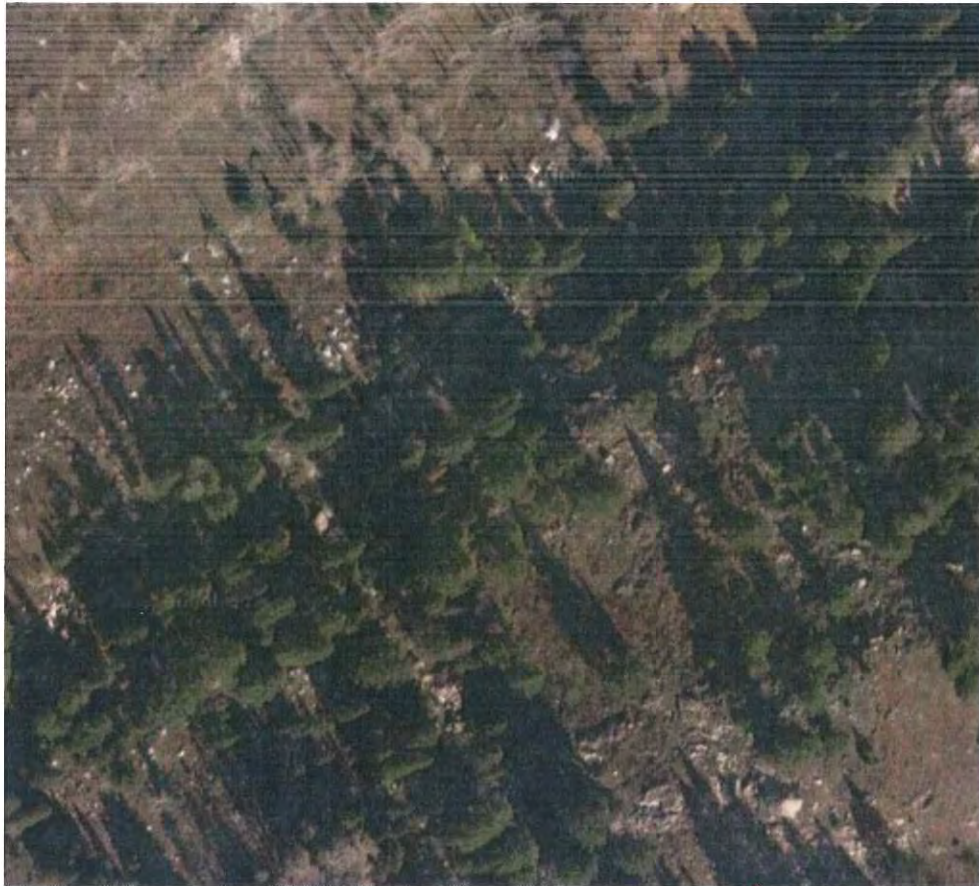
Fish Creek – Aerial photograph ✓

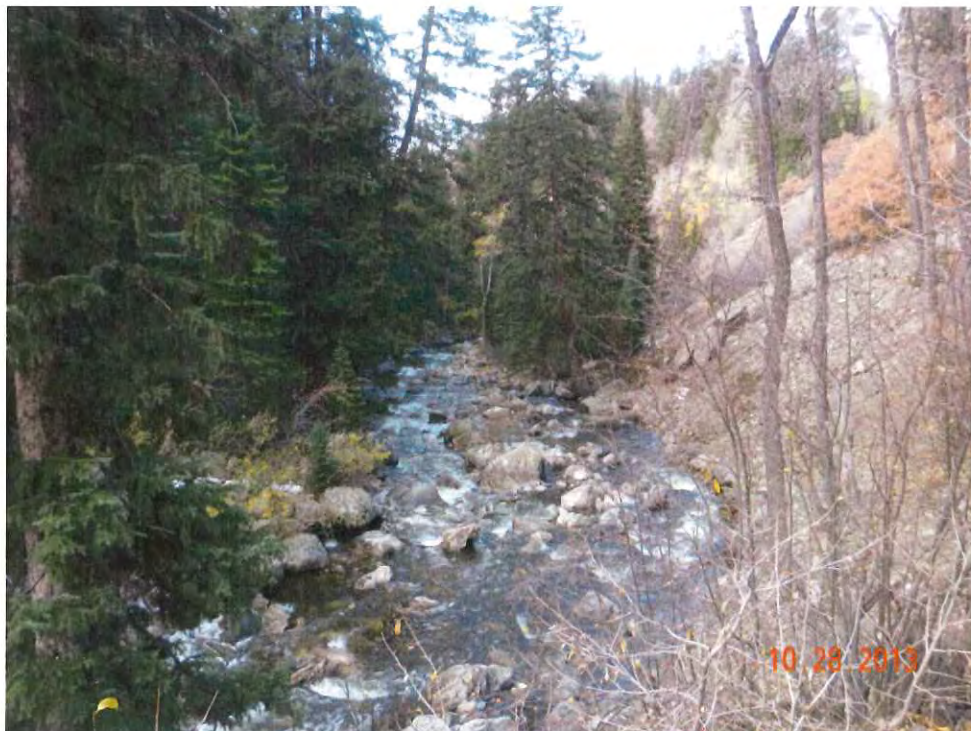
Fish Creek near XS -7.5 ✓

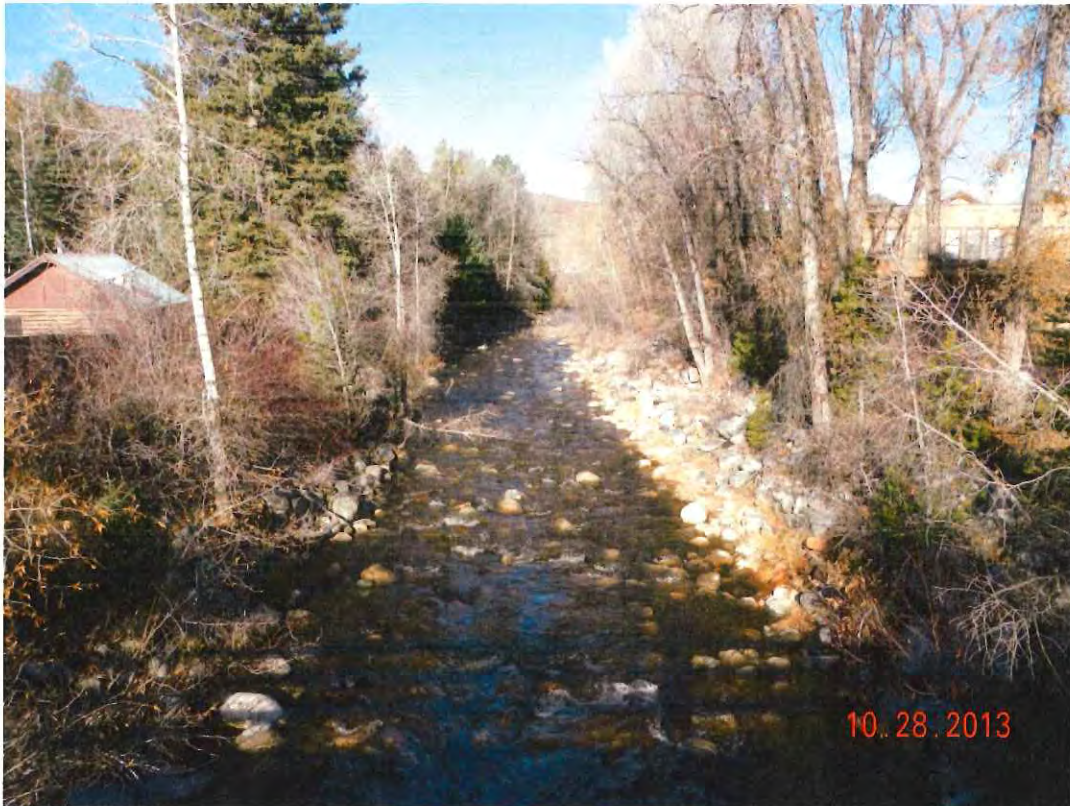
Fish Creek near XS -8.8 ✓

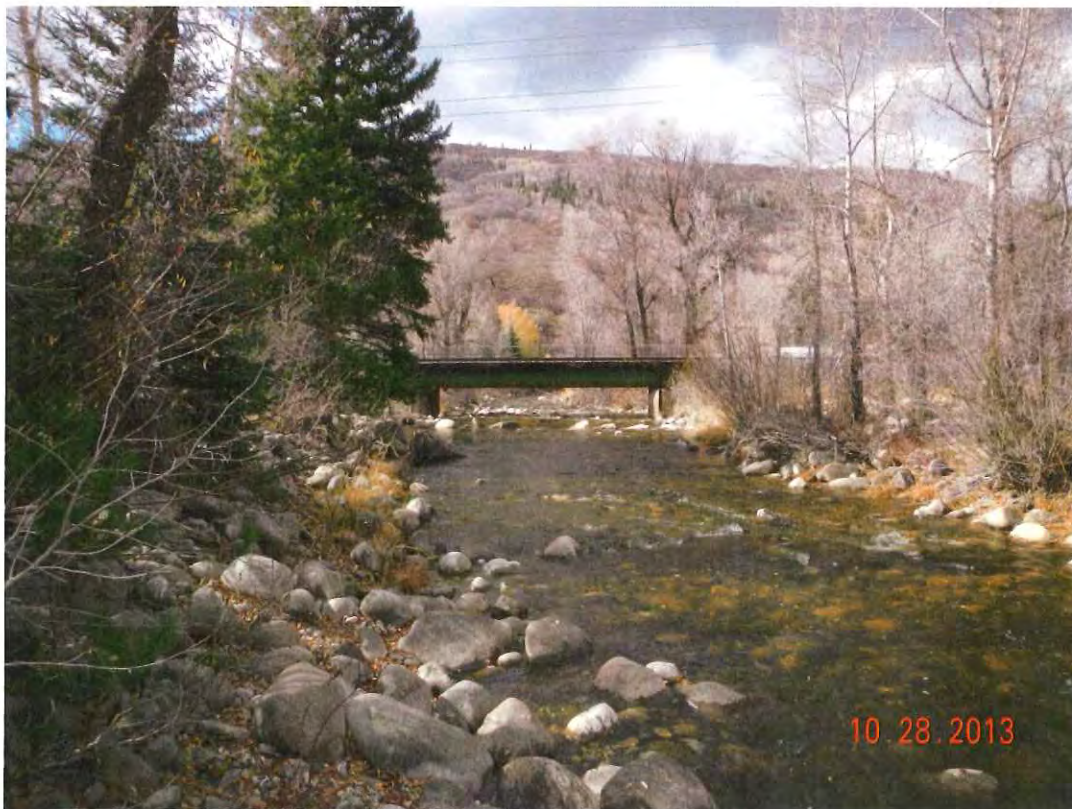
Fish Creek near XS -9.2 ✓

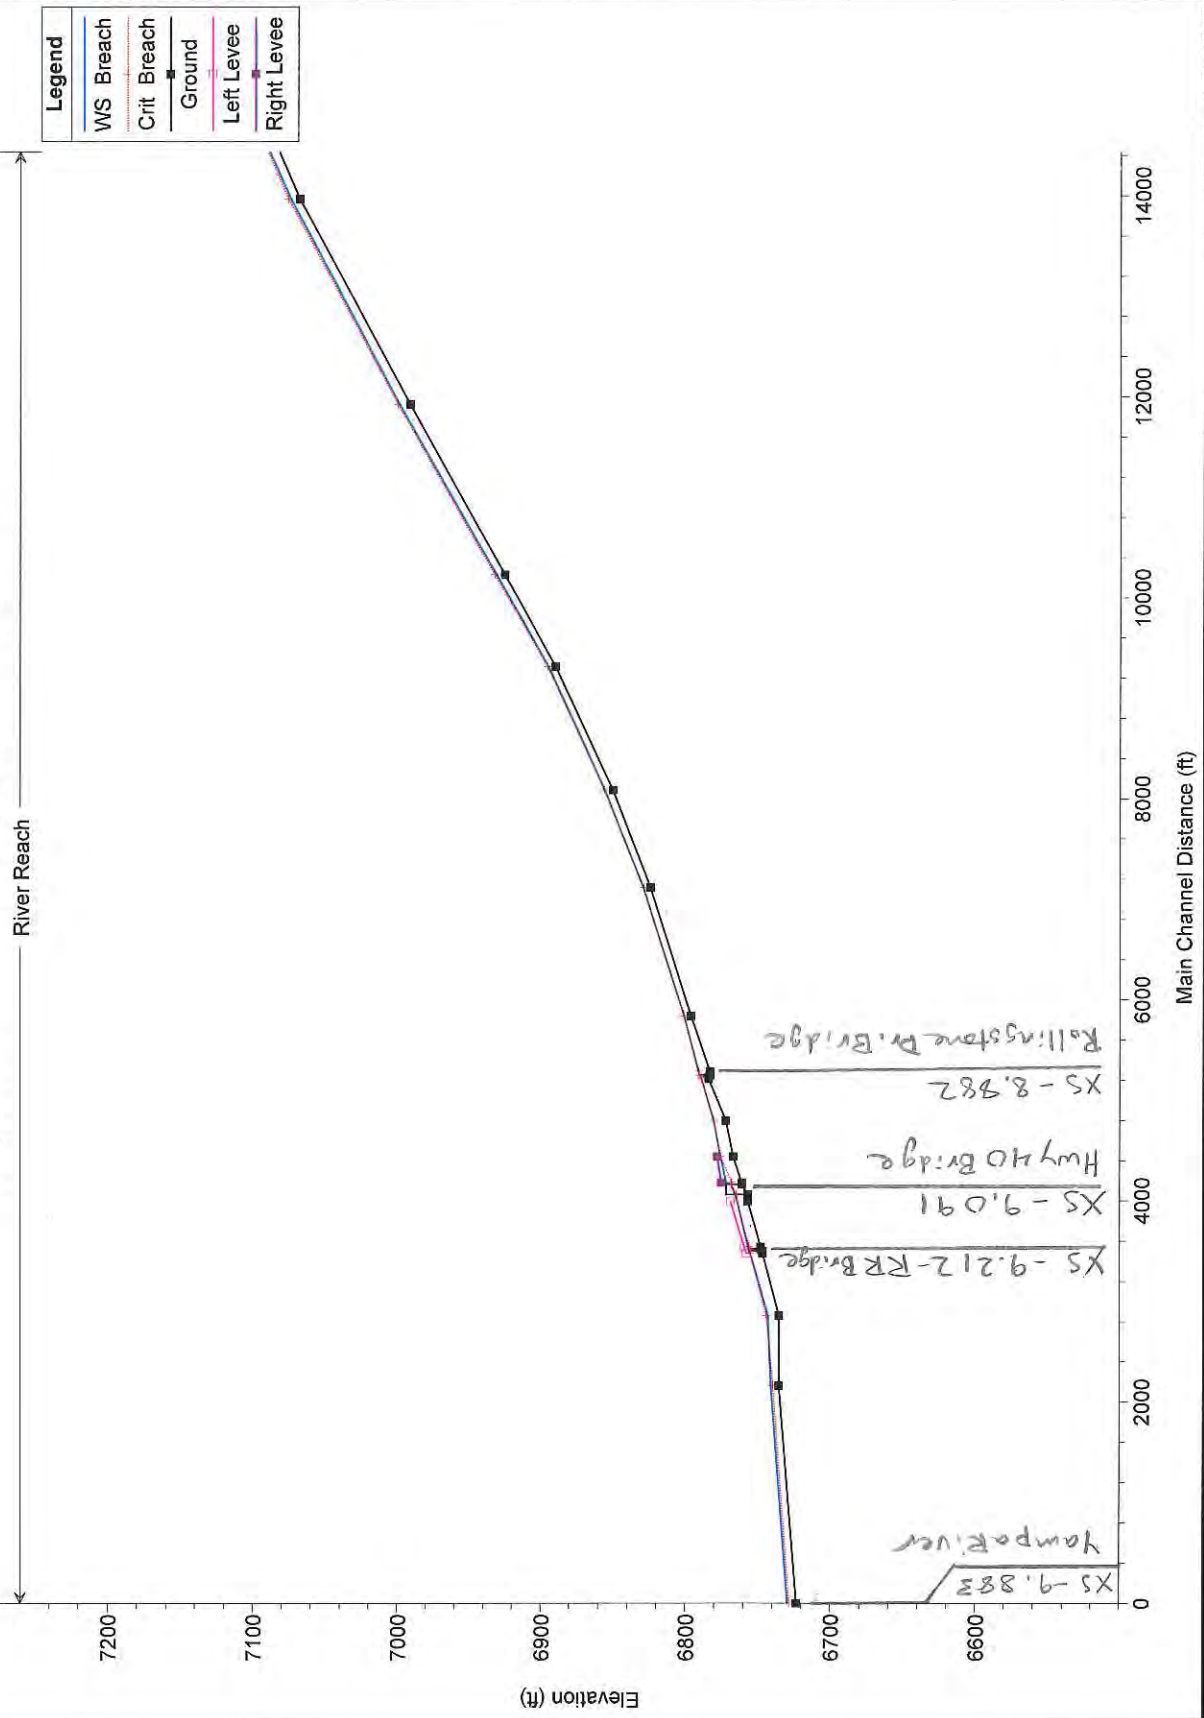
Detailed HEC-RAS Profile

Long Lake Dam Plan: Breach - Steady 11/11/2013

- Normal depth was used for the downstream boundary condition (at Yampa River) and critical depth for upstream boundary condition ✓
- See HEC-RAS results on p. 3-33 ✓
- QA/QC
 - Check in Arc GIS
 - Cross-Section Layout ✓
 - Reach Lengths ✓
 - Check in HEC-RAS
 - Reach lengths ✓
 - Manning's n values ✓
 - Flow Data ✓
 - Cross-Section topography ✓
 - Bridge Data ✓
 - General Model Performance ✓
