**Re: Application for Additional Loan Funding - Mount Pisgah Dam/Wrights Reservoir Outlet Works Rehabilitation**

WATER DIVISION 2, WATER DISTRICT 12; DAMID: 120129

TELLER COUNTY, COLORADO

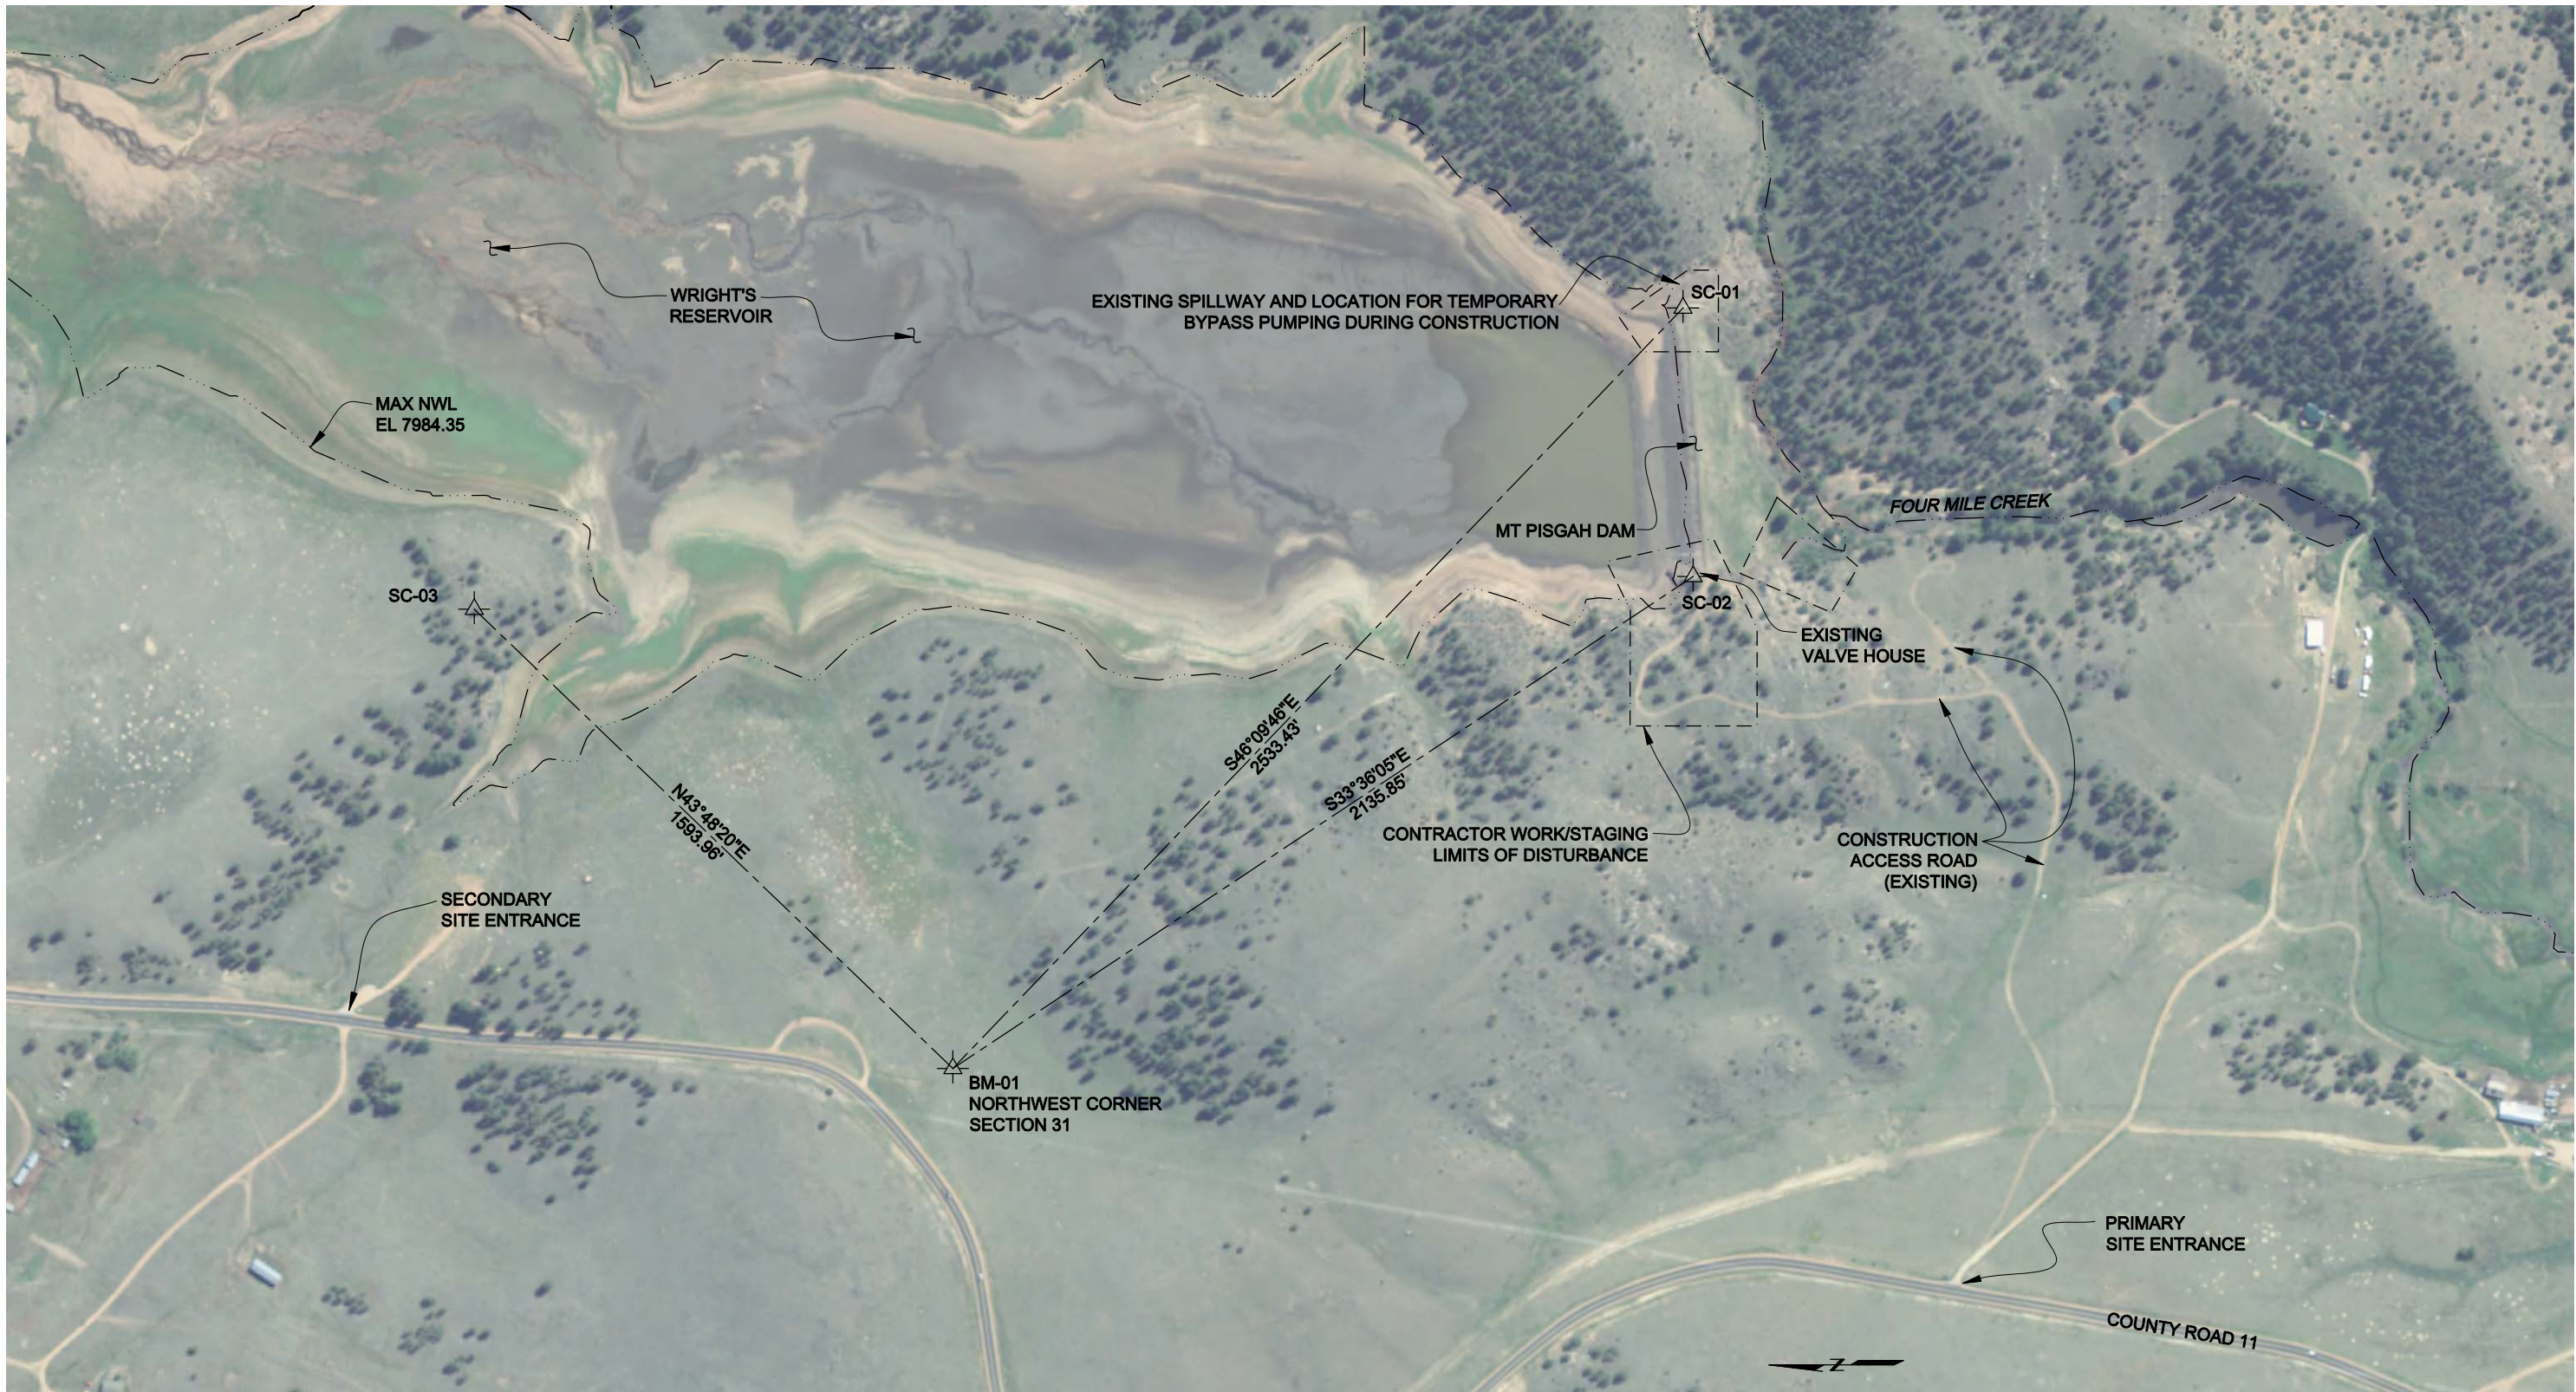
SITE ACCESS AND  
SURVEY CONTROL

- AERIAL PHOTOGRAPH FROM NATIONAL AGRICULTURE IMAGERY PROGRAM (NAIP), TELLER COUNTY, COLORADO (2011).
- SURVEY CONTROL POINT INFORMATION FROM WACHOB AND WACHOB, INC. 2008 SURVEY.
