Hartland Diversion Dam Fish Passage

Final Report

Introduction

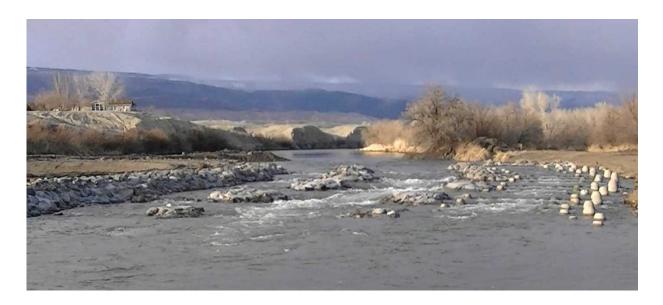
Figure 2 – Hartland Dam Fish and Boat Passage

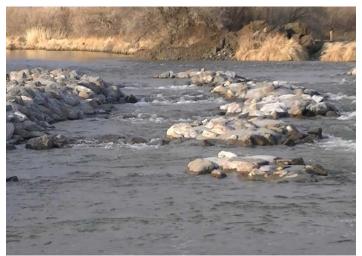
Two fish passage channels were designed for this project to provide flow variation and multiple options for fish movement. A Confined Loose Boulder (CLB) roughened fish passage concept was designed for the "Right Fish Passage" (river right of the boat passage). This concept utilizes large boulders (36"+) placed randomly in the channel to provide highly roughened flow and interstitial spaces between boulders for fish movement. Smaller boulders are used to fill voids at the surface between larger boulders to reduce foot/hand entrapment hazards. Adjacent banks are roughened with large grouted boulders extending into the flow for additional passage. Figure 3 illustrates the Right Fish Passage. The "Chevron Fish Passage" channel utilizes concrete cylinders placed in a controlled chevron pattern to provide fish passage along the river-left bank. The concept creates long narrow eddies behind cylinders that assists fish in orientating upstream and through the structure. Three rows of chevrons at each drop structure create headlosses that maintain the 12-inch water surface elevation difference between pools (hydraulic drop). Chevrons have been designed to distribute the headlosses between each row and to maintain low velocities. The chevron boulder pattern/slots are based upon research performed by B. W. Mefford at the United States Bureau of Reclamation for passing non-salmonid species (Ref: "USBR Experience with Multiple-Slot-Baffled Fishways", B.W. Mefford, 2009). MWE adapted the USBR design to reduce the hazard to river users and provide "skimming flow" over the concrete cylinders to reduce debris accumulation (See Figure 4).

Figure 3 – Right Fish Passage

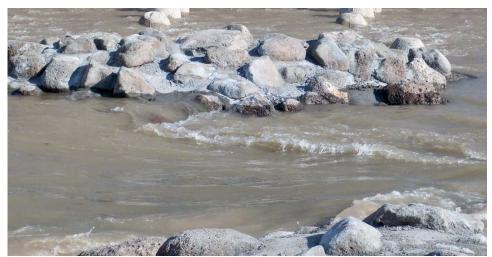
A grouted boulder mat of rounded locally available materials was used as the primary armoring type for most of the structure. The mats have various thicknesses and cementations grout is kept as low as structurally prudent. Calculation of riprap size and lack of locally available angular rock (quarry produced) led to this armoring approach. This is reflective of other river projects on the Western Slope. Boulder diameters range from 18" up to 48" - depending on where they are placed in the grouted boulder mat, and their projection above the river bottom.

Figure 6 – Grouted Boulders

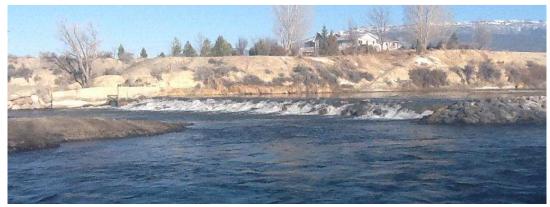
The remaining section of the existing Hartland Dam, approximately 150', was modified to improve the structural stability and reduce the hazard to river users. A roughened grouted boulder slope was constructed extending from the face of the existing dam downstream approximately 20'. Painted Sky and Hartland Irrigation Company worked directly with Kissner General Contractors to develop the dam modifications. MWE did not provide the design, engineering or construction observation for the dam modifications.

Figure 7 – Dam Modifications
