BIG THOMPSON RIVER RESTORATION MASTER PLAN

January 2015

AYRES
ASSOCIATES

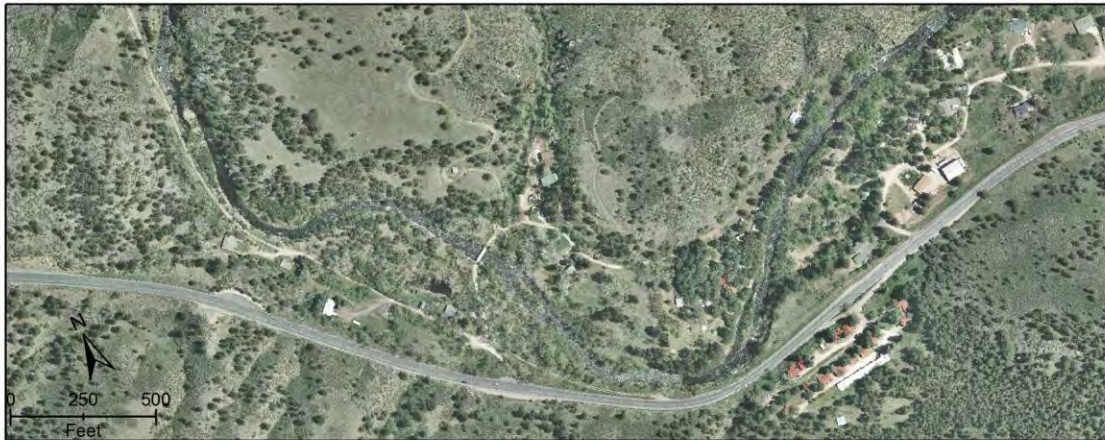
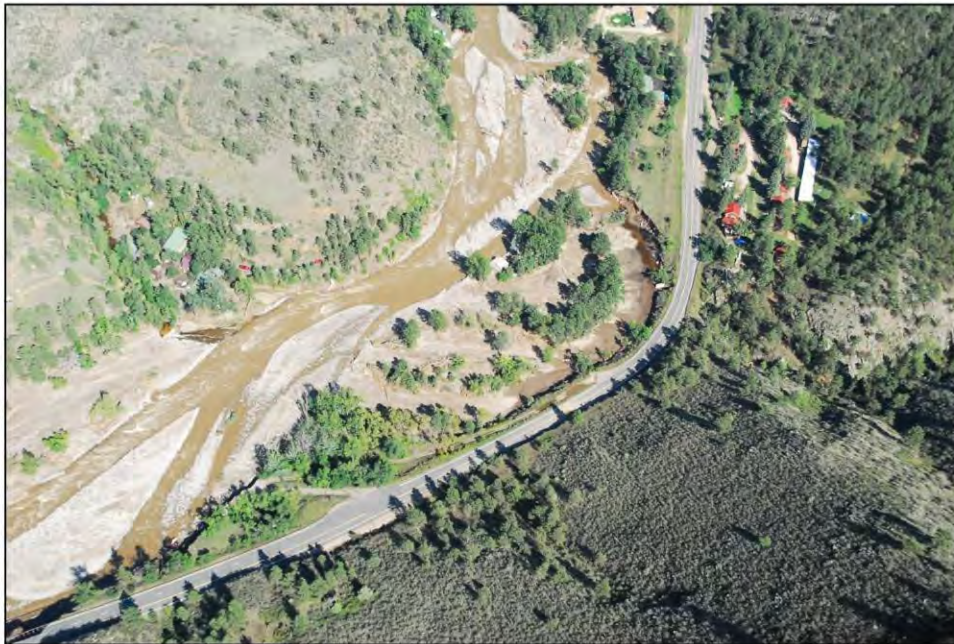
Figure 3.2. Example GR = 5 at Cedar Cove.

Pre-Flood Image - 05-2013

Post-Flood Image - 10-2013

Civil Air Patrol (CAP) Photo - 9-22-2013

Example areas showing pre- and post-flood imagery of GR scores of 5, 3, and 1 are provided in **Figures 3.2, 3.3, and 3.4**, respectively. The example images for areas with a GR score of 5 include areas of deposition, channel migration, new split flow development, severely eroded embankments, and removal and transport of a large amount of sediment. The example images for areas with a GR score of 3 include areas of channel widening, moderate floodplain deposition, bank erosion, channel widening, headcuts developing in floodplain, and local areas of erosion. The example images for areas with a GR score of 1 show minor bank erosion along the channel and no channel movement.

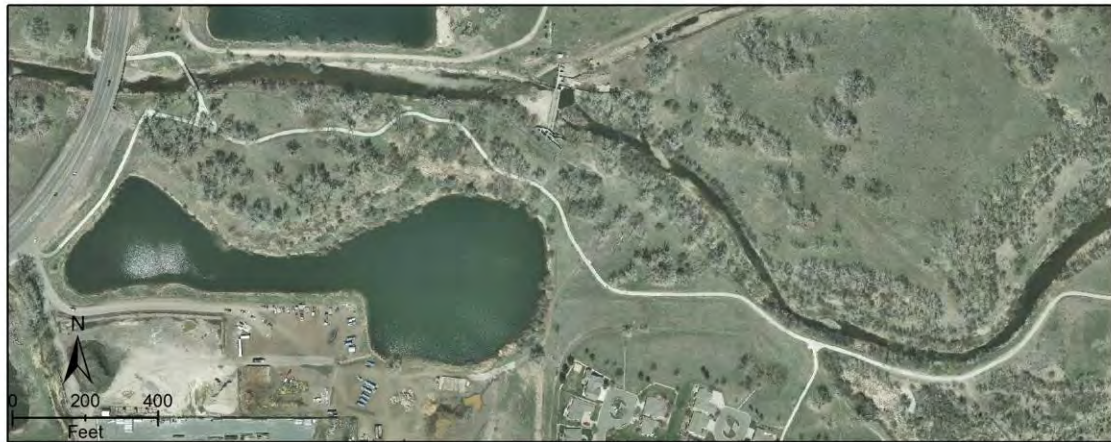
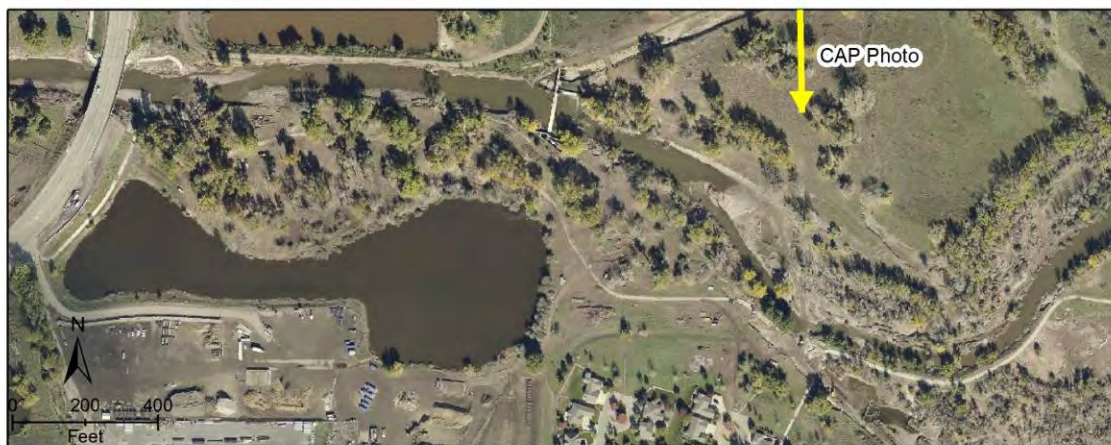
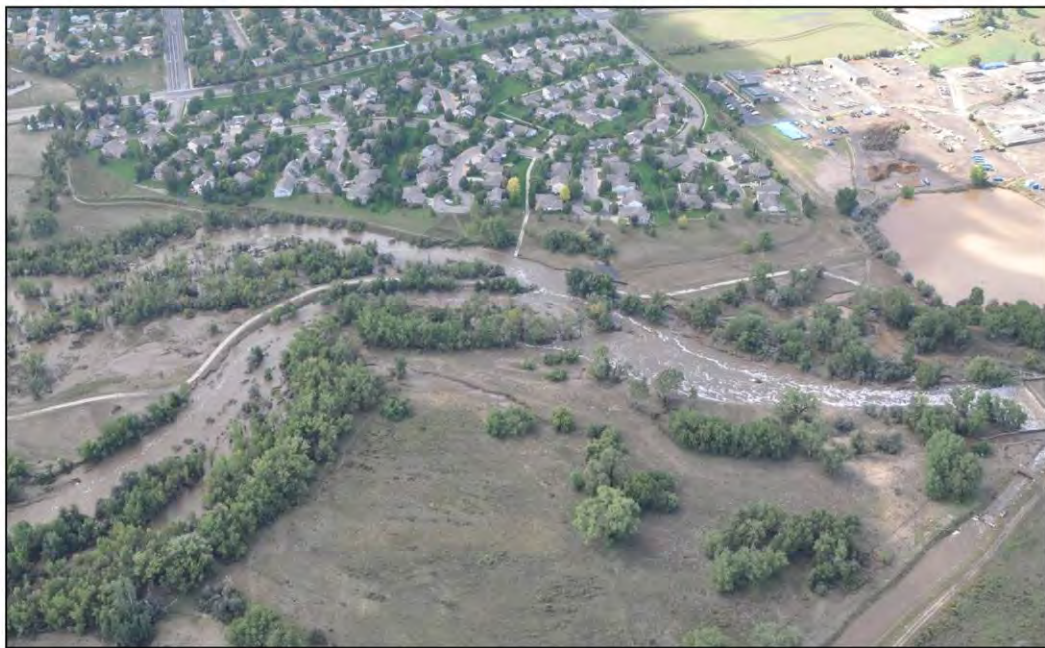
Figure 3.3. Example channel and floodplain GR = 3 downstream of Wilson Avenue in Loveland.

Pre-Flood Image - 05-2013

Post-Flood Image - 10-2013

Civil Air Patrol (CAP) Photo - 9-16-2013

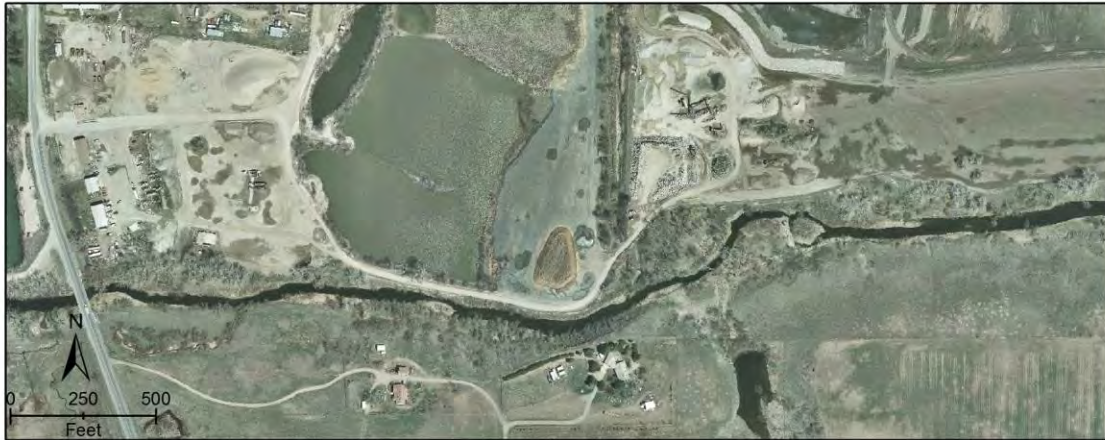
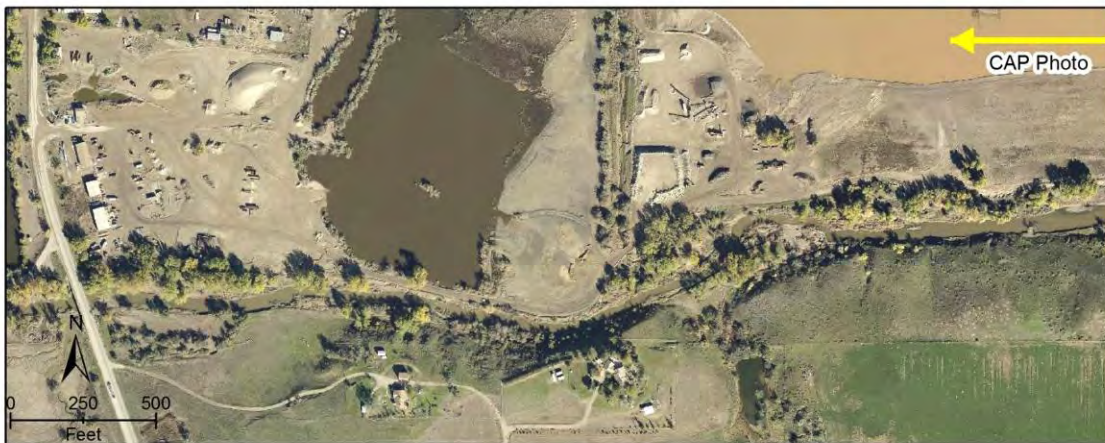
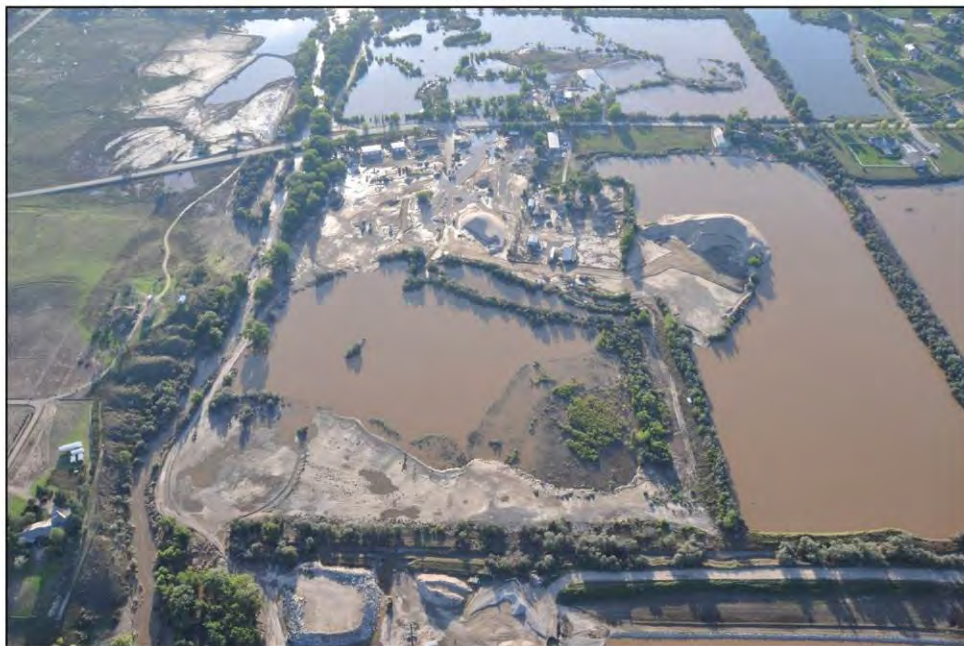
Figure 3.4. Example channel GR = 1 and floodplain GR = 3 downstream of County Road 9E in Loveland.

Pre-Flood Image - 05-2013

Post-Flood Image - 10-2013

Civil Air Patrol (CAP) Photo - 9-19-2013

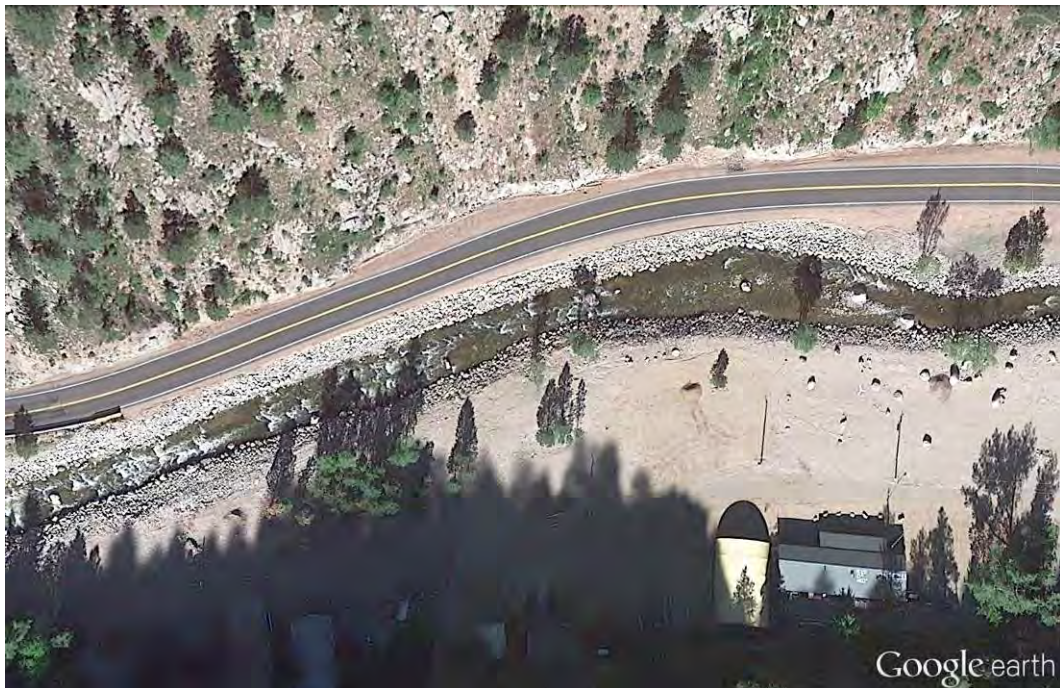
Figure 3.10. Example of post flood channel modification and bank stabilization, but with good in-channel features. (Drake).

The temporary road and channel work conducted by the CDOT and others has modified the post-flood channel conditions in some areas. Most of these sections have large boulder riprap placed along the channel banks to prevent channel movement and erosion. While the channel banks and overbank areas need restoration, the in-channel features in most of these areas do provide habitat typical of this high gradient river (**Figure 3.10**). The channel contains large boulders that create drops and pools similar to the habitat in the undisturbed areas. There is a lack of riparian vegetation in these areas which has a negative impact on the aquatic habitat.

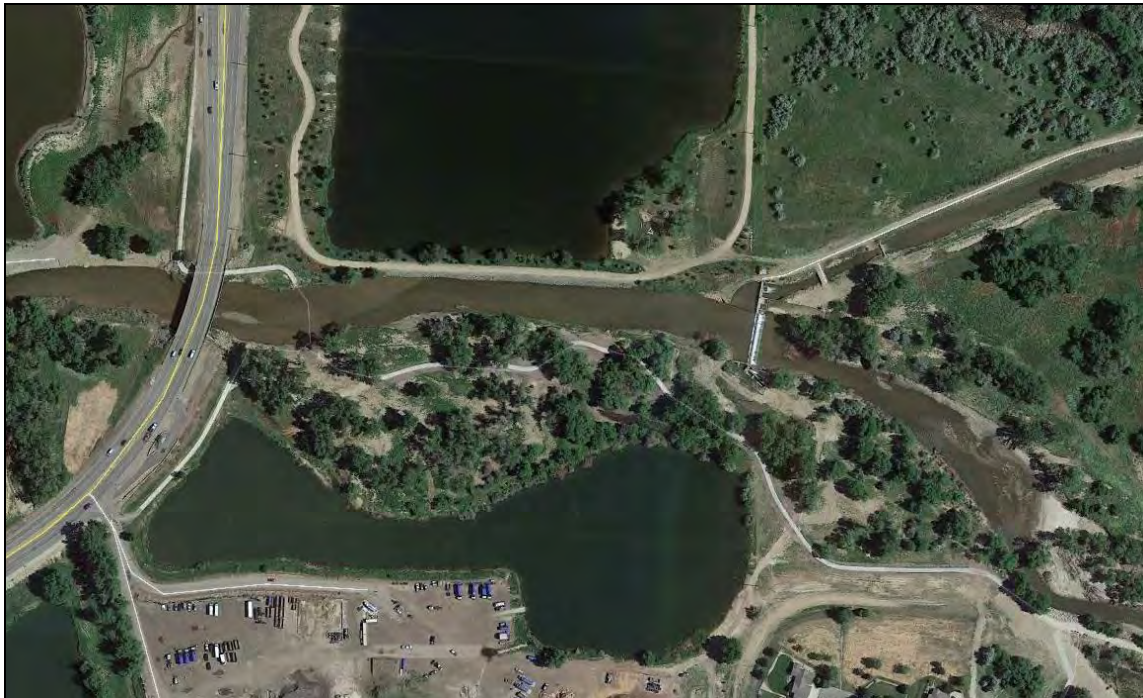
Figure 3.14. Example of post-flood stream channel at downstream of Wilson Avenue, AHIP = 1 - 3.

Loveland. The AHIP assessment relied on aerial imagery for the assessments downstream of Glade Road through Loveland. The reach from Glade Road downstream to I-25 has some need for restoration although it is less than the needs upstream of Glade Road. There are sections with some damage to in-channel habitat but they are smaller, localized sections. The channel is confined through much of this segment, and lacks access to the floodplain for low flood flows. The channel is also over widened at some locations due to flooding and/or post flood repairs (**Figure 3.14**).

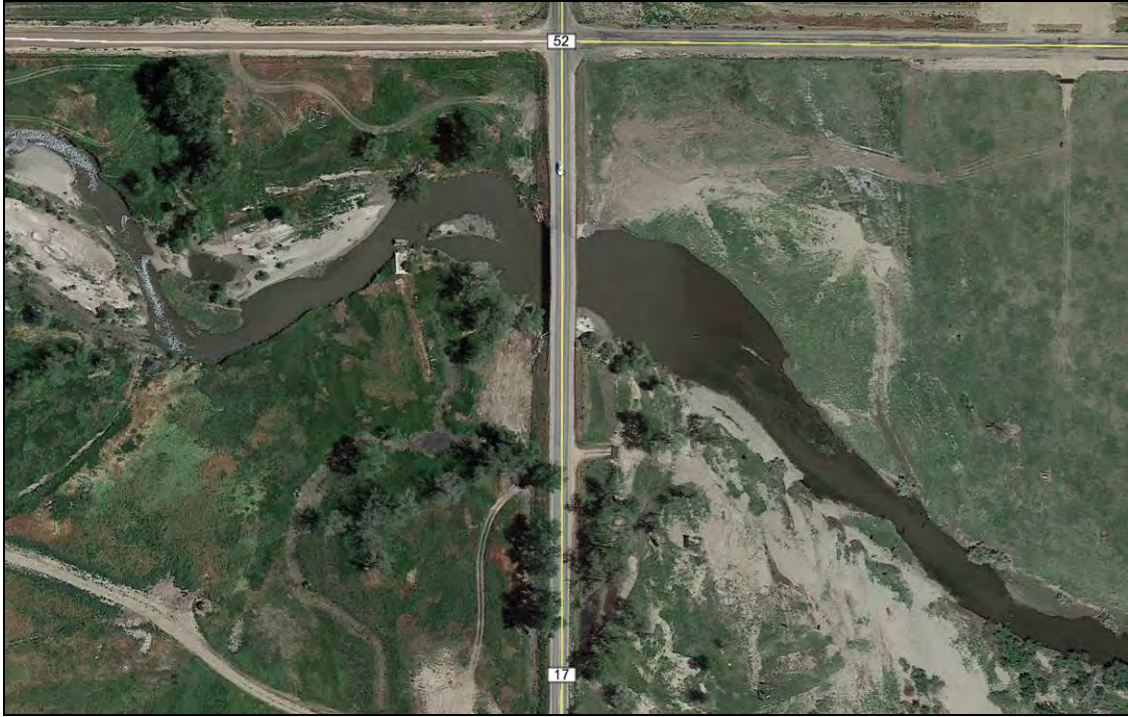
Figure 3.15. Example of post-flood stream channel at Weld County Rd 17, AHIP = 3.

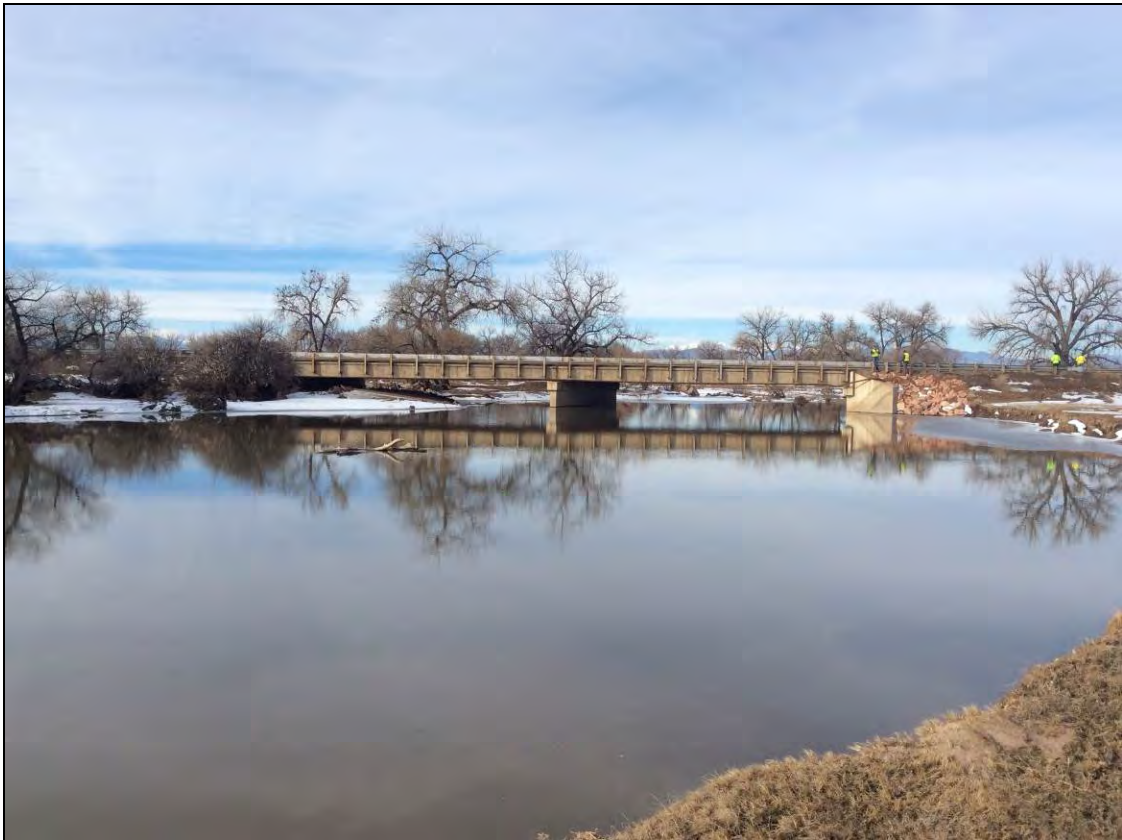
Figure 3.16. Example of post-flood stream channel at Weld County Rd 17, AHIP = 3.

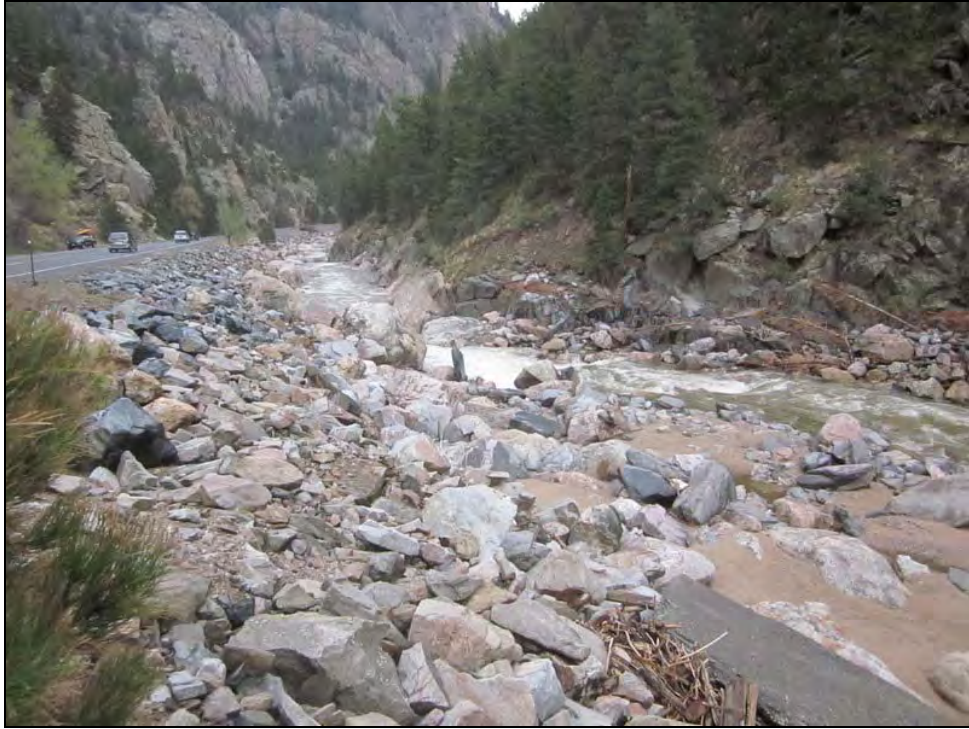
Figure 3.17. Upper Canyon, narrow rocky section with little to no floodplain, REIP = 1.

Field surveys were conducted for the western four segments of the BTRRMP corridor on May 5, 8, and 9, 2014 and the eastern two segments during January 2014. Most field surveys were performed in areas accessible by roads; various areas were walked to collect additional data on plant species present and severity of flood damage. Each assessment reach was given a score of 1 to 5, with 1 having low potential for restoration and 5 having high potential. Rating of river reaches for riparian vegetation restoration potential is based on many factors. **Table 3.5** summarizes these factors in the list of characteristics. Representative photographs for each rating are shown in **Figures 3.15 – 3.29**.

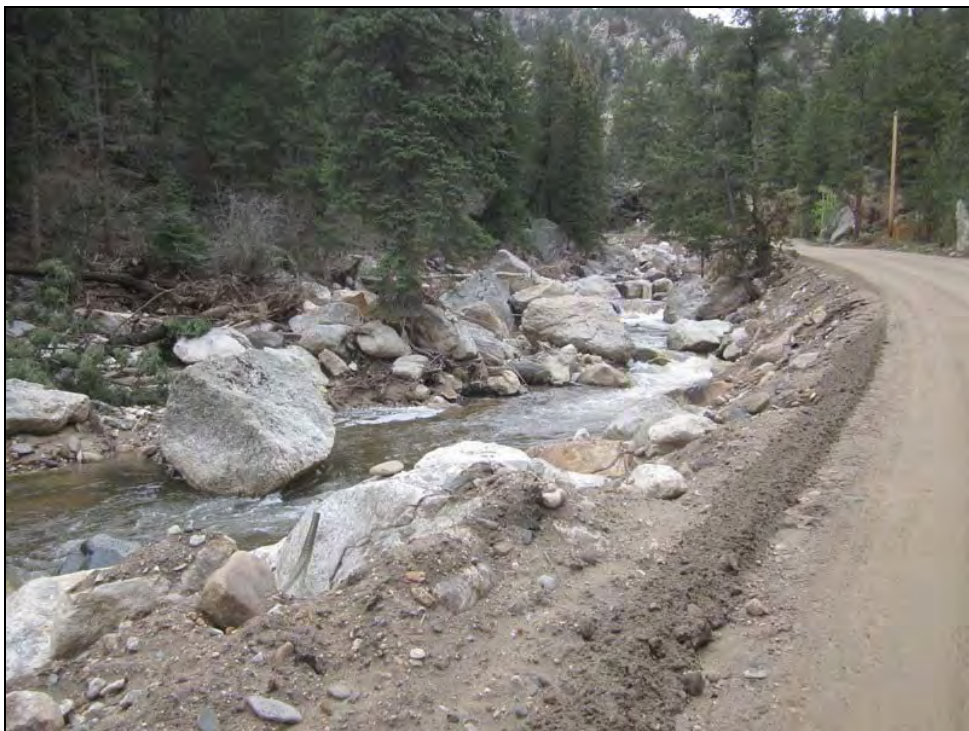
Figure 3.18. North Fork, narrow rocky section with little to no floodplain, REIP = 1.

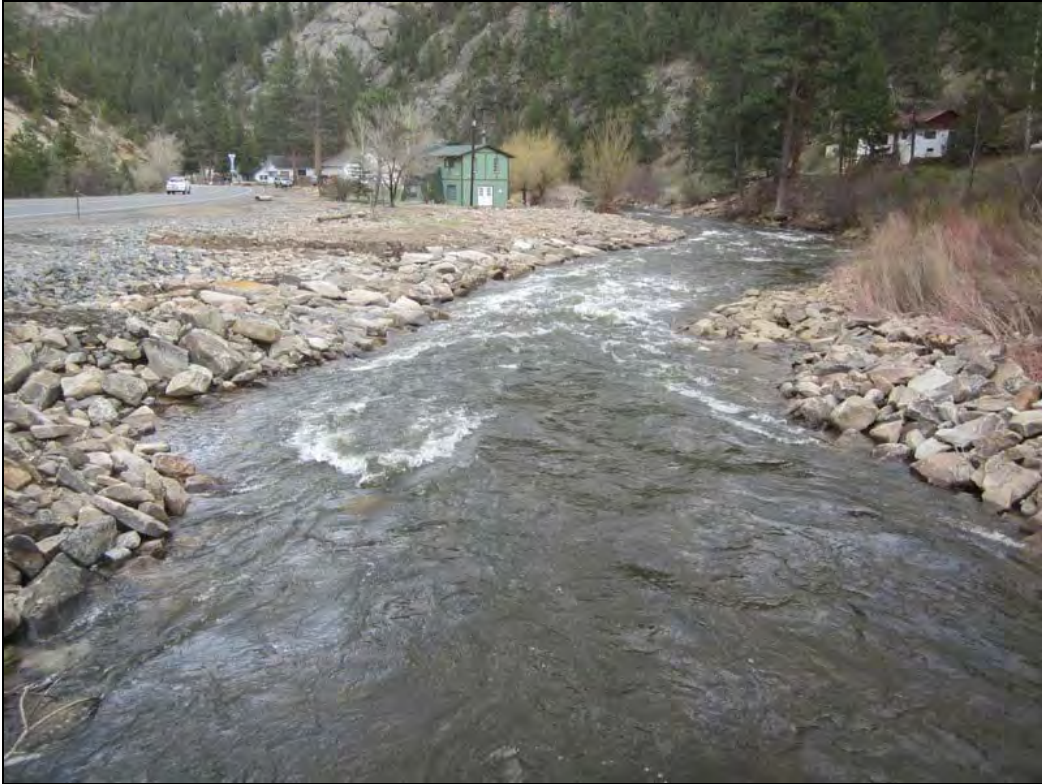
Figure 3.19. Upper Canyon, narrow floodplain area including road and structures, REIP = 2.

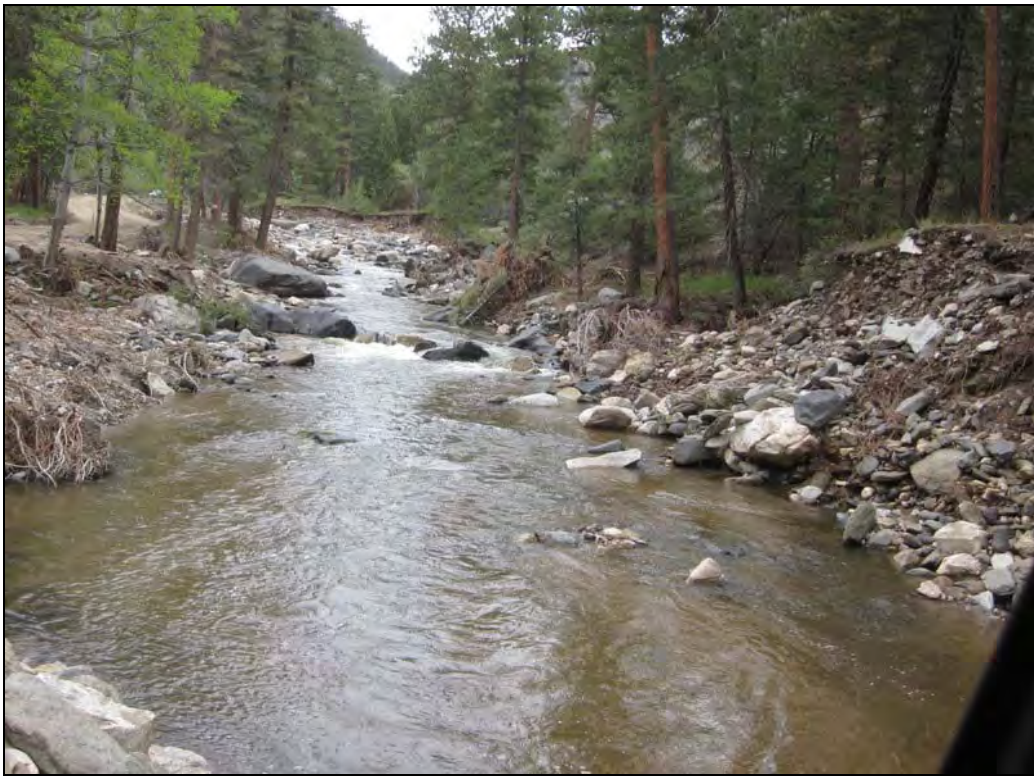
Figure 3.20. North Fork, narrow floodplain area, REIP = 2.

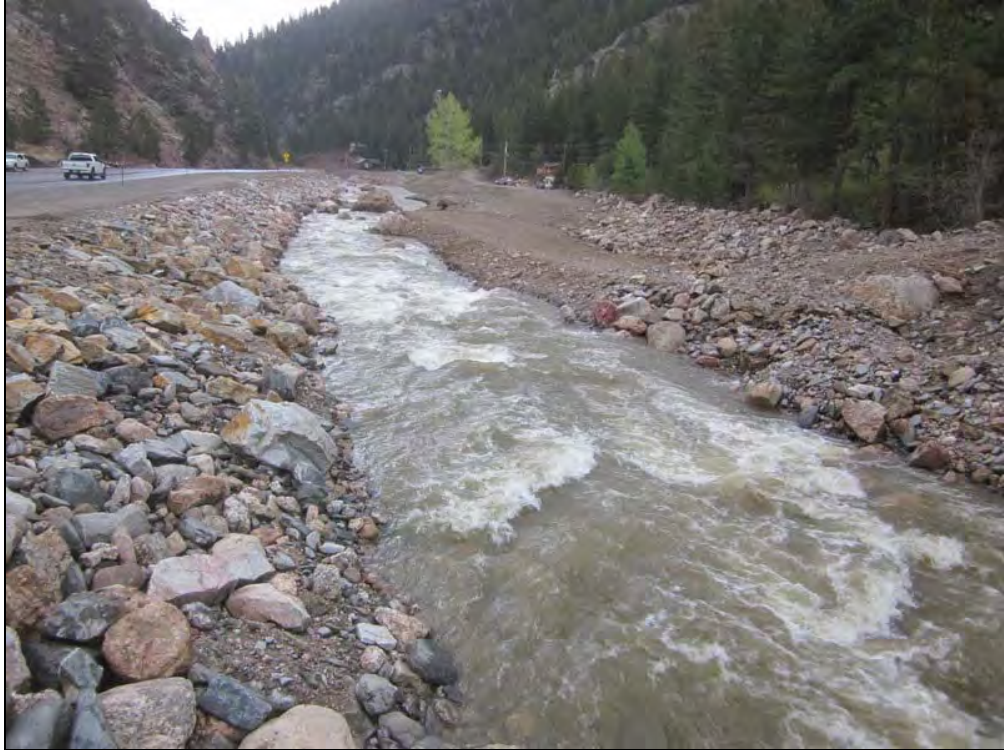
Figure 3.21. Upper Canyon (Waltonia), some undeveloped floodplain with little vegetation, REIP = 3.

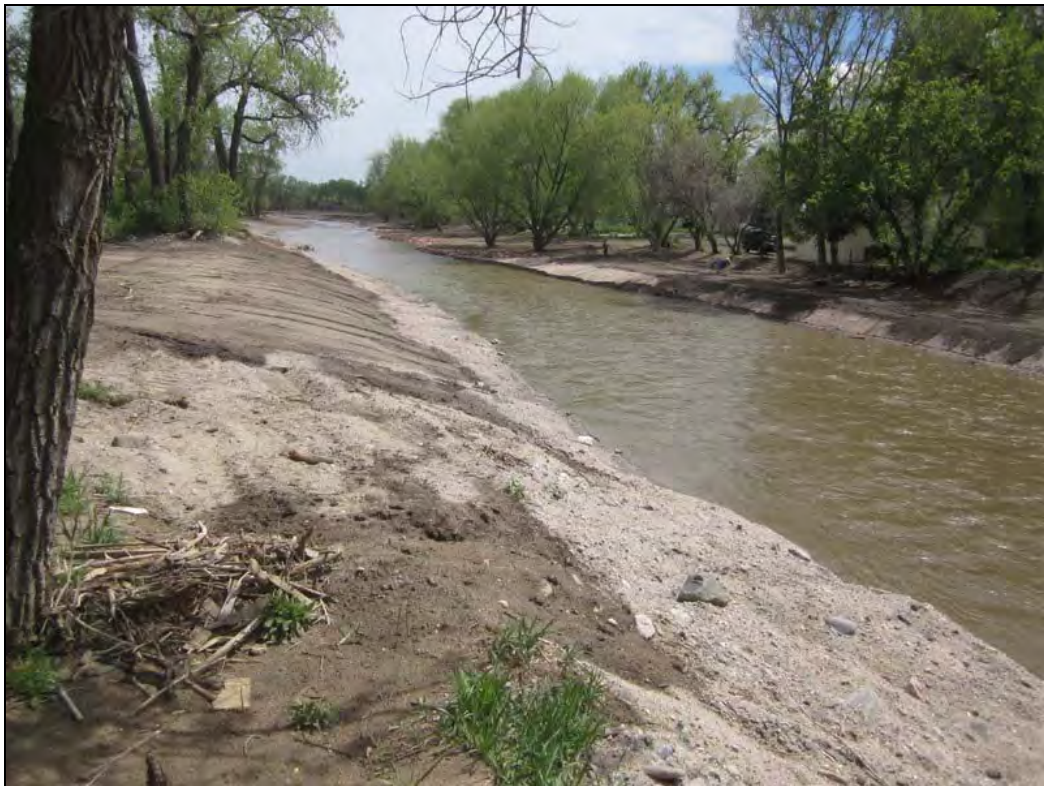
Figure 3.22. Loveland area, some undeveloped floodplain with little vegetation, REIP = 3.

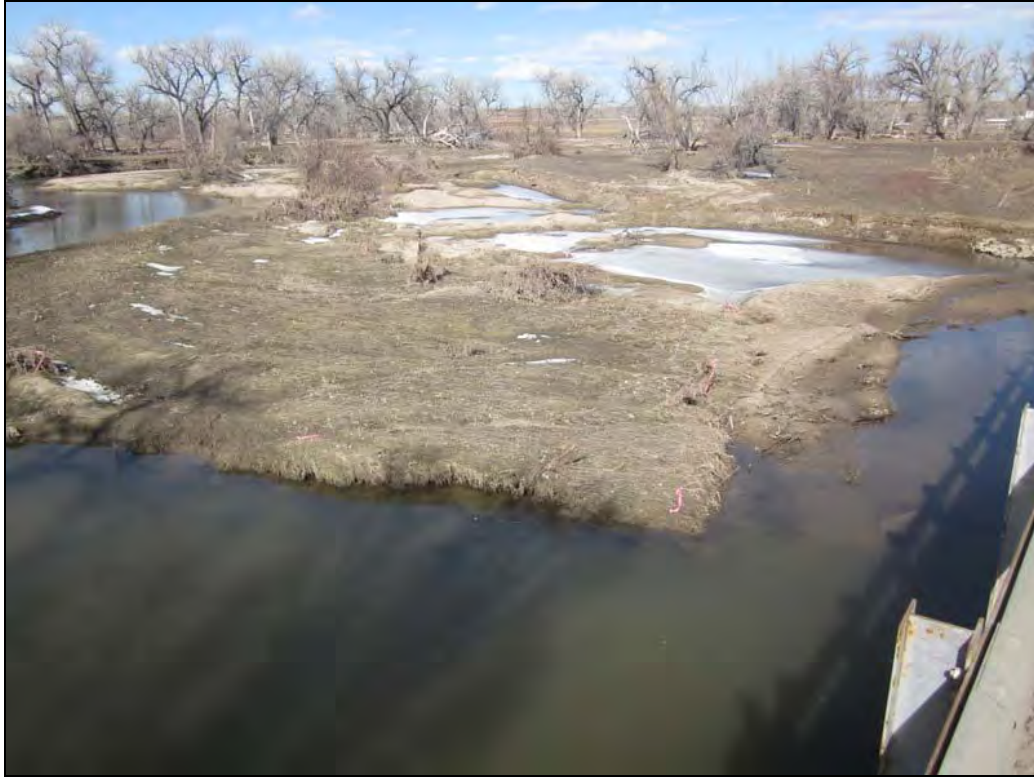
Figure 3.23. Eastern Plains, upstream of CR 27.5, REIP = 3.

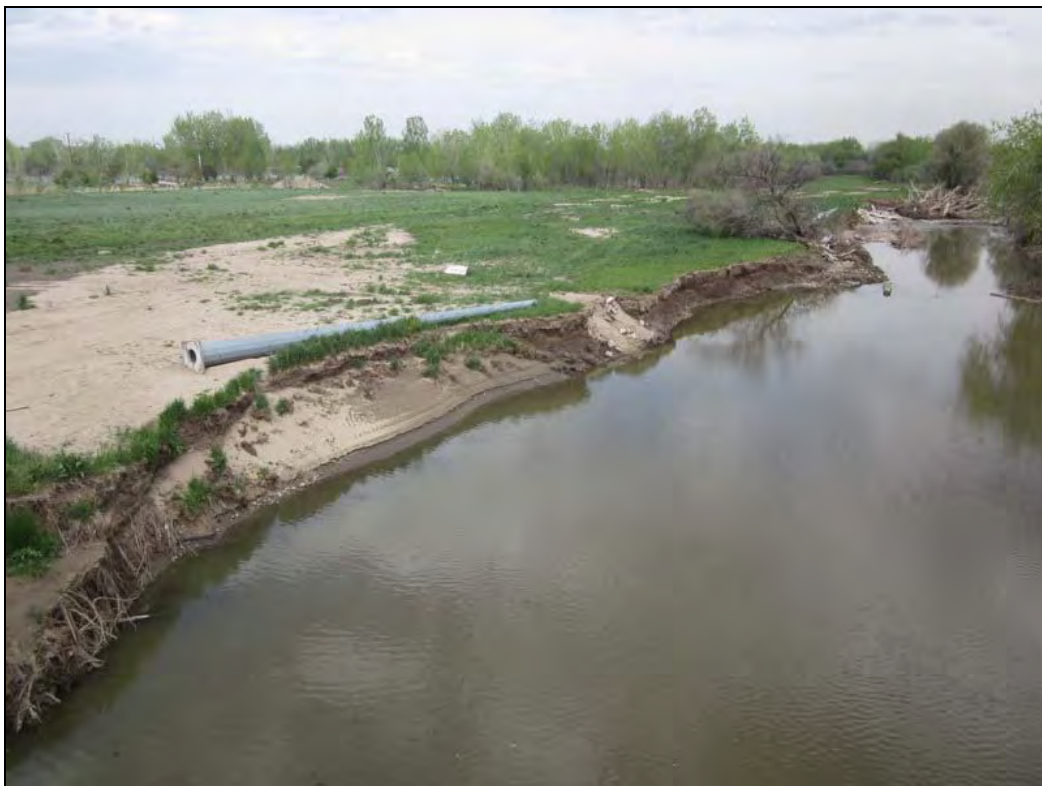
Figure 3.24. Loveland area, wide undeveloped floodplain, REIP = 4.

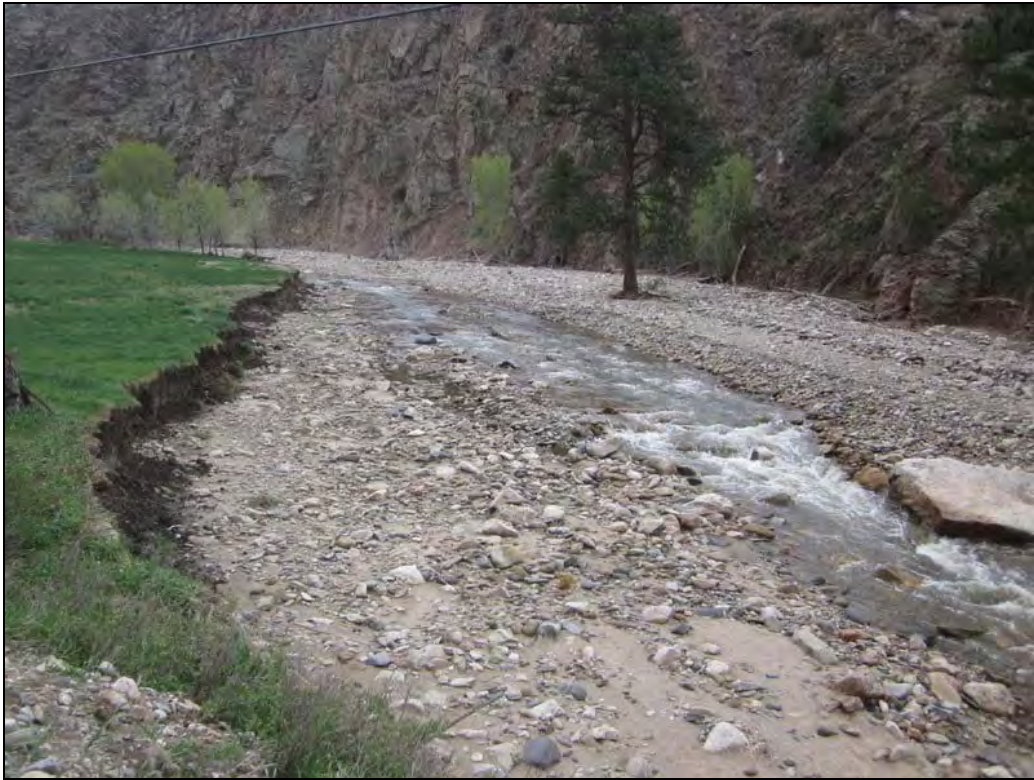
Figure 3.25. North Fork, wide undeveloped floodplain, REIP = 4.

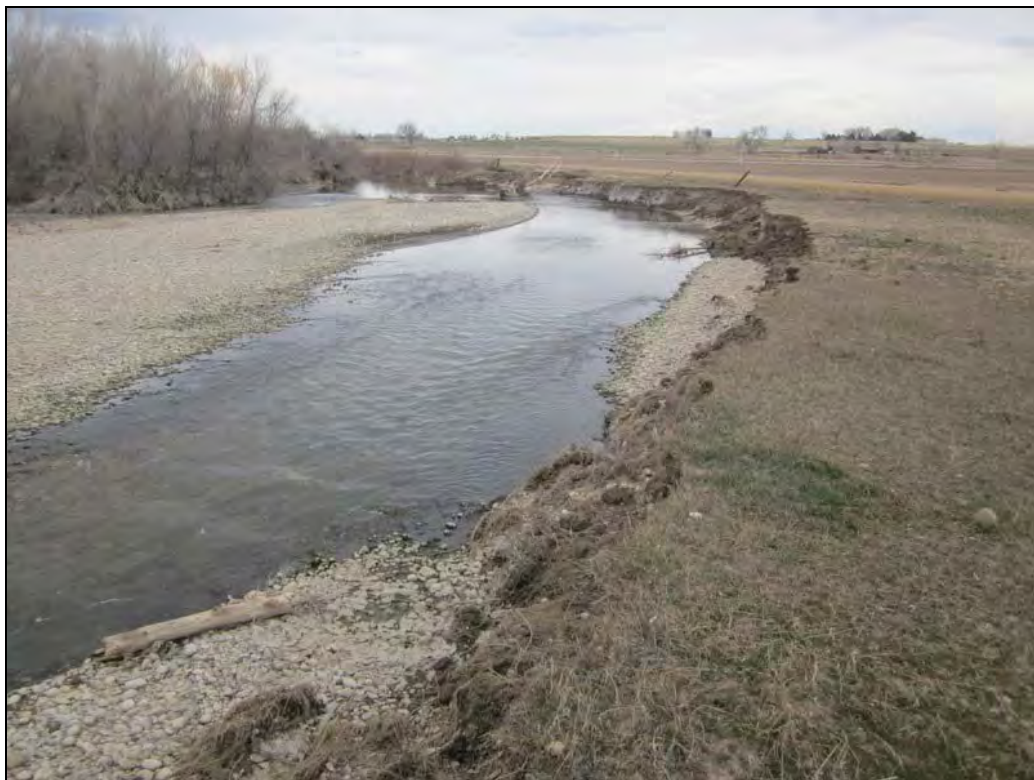
Figure 3.26. Eastern Plains, near CR 52, REIP = 4.

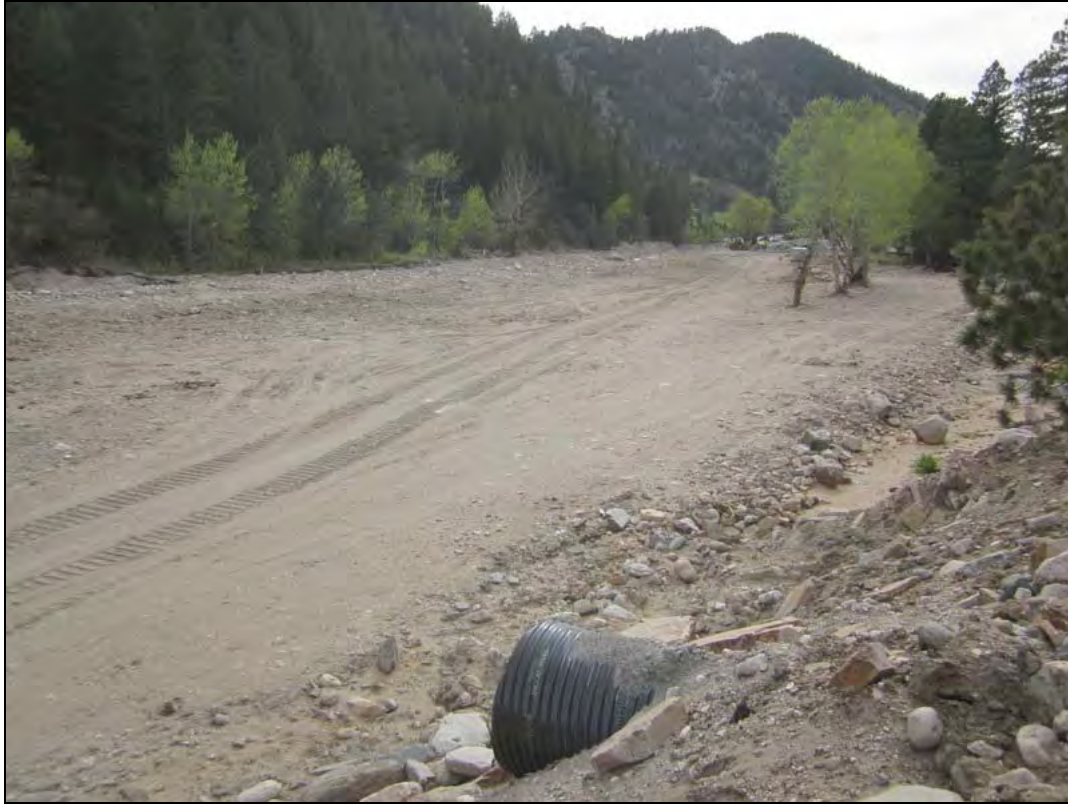
Figure 3.27. Lower Canyon, very large floodplain almost no vegetation, REIP = 5.

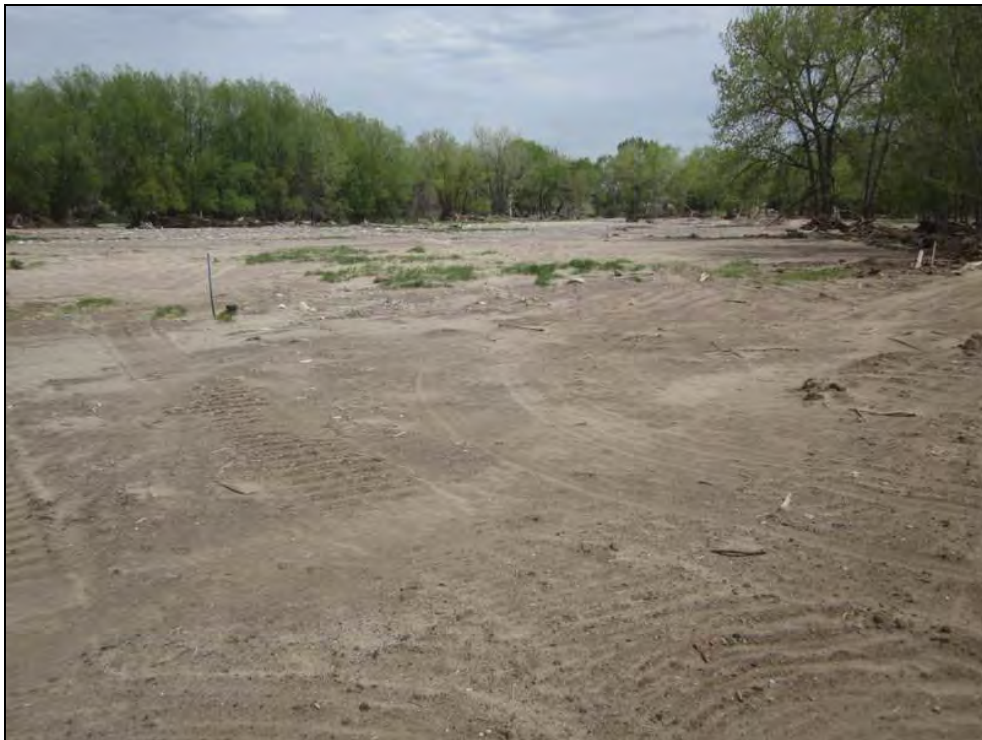
Figure 3.28. Loveland area, very large floodplain almost no vegetation, REIP = 5.

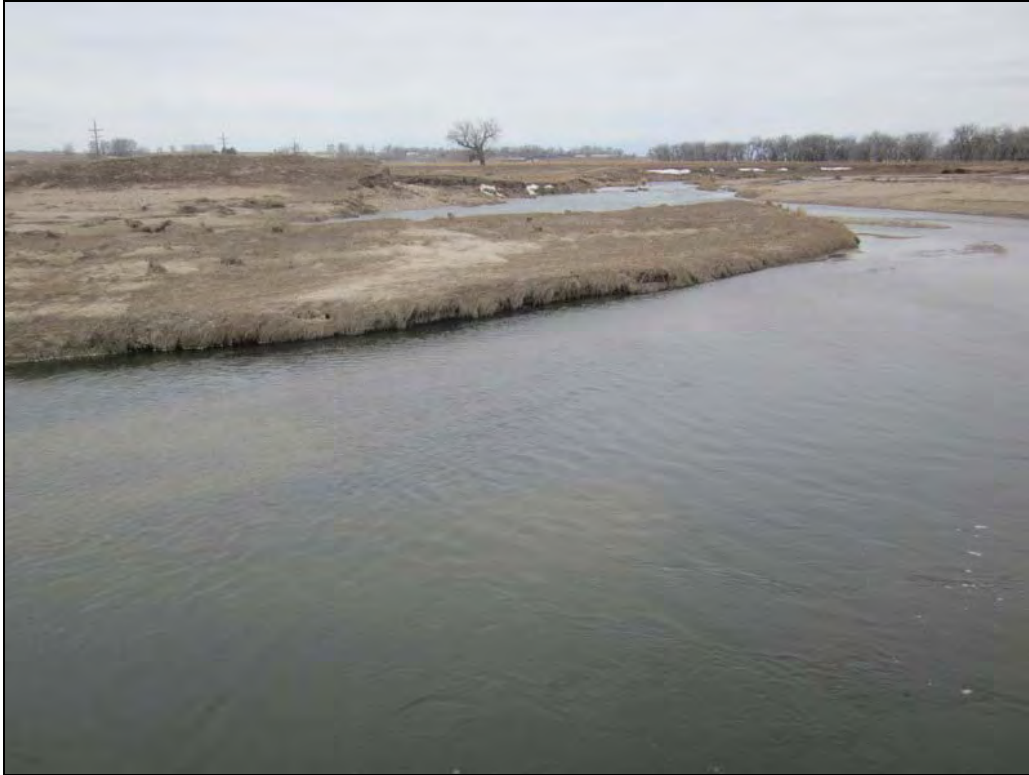
Figure 3.29. Eastern Plains, downstream of CR 54, REIP = 5.

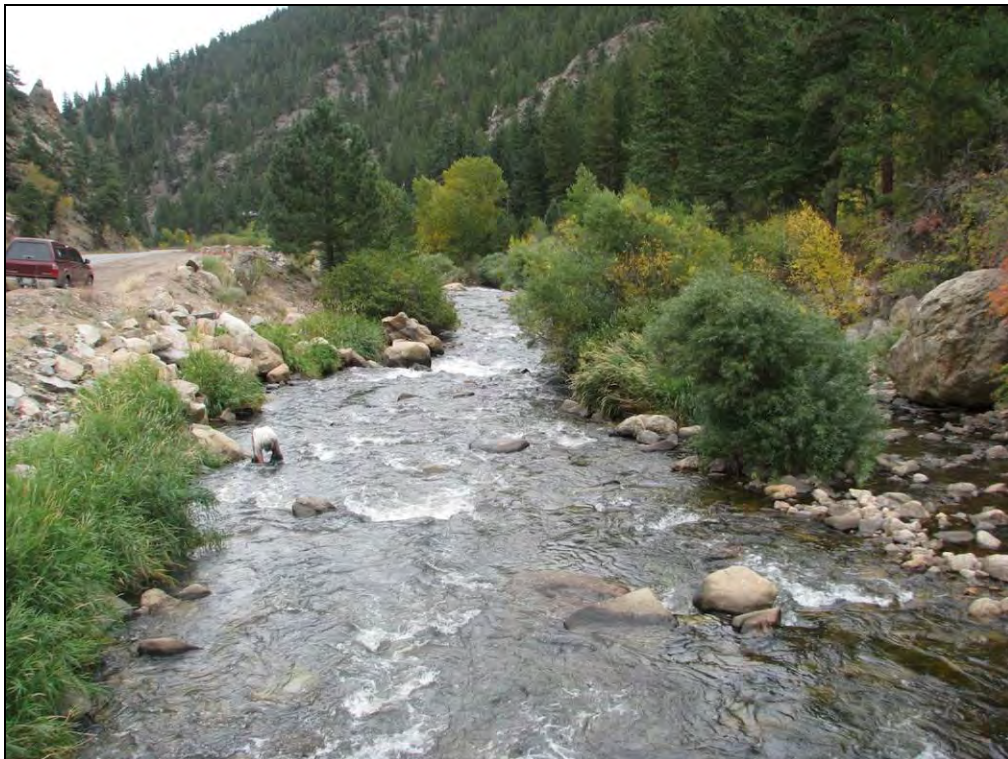
Figure 5.1. Big Thompson downstream of Waltonia Bridge, 9-24-2012.

The Big Thompson River in the upper and lower canyons prior to the flood of September 2013 supported a robust aquatic ecosystem. The aquatic habitat conditions in the canyons consisted of high-gradient riffles, low-gradient riffles, pocket water (small pools formed downstream of large boulders) and pools, as depicted in **Figures 5.1** and **5.2**. More than 50% of the pre-flood habitat was high gradient riffles and pocket water (Miller 1993). These photographs show the generally large substrate present in the higher gradient areas and the abundance of riparian vegetation along the channel. These are two characteristics needed for aquatic habitat restoration. Areas with typical lower-gradient riffles are shown in **Figures 5.3** and **5.4**, and consist of large cobble substrate. Low-gradient channel types are less frequent due to the overall steep, canyon-bound river channel.

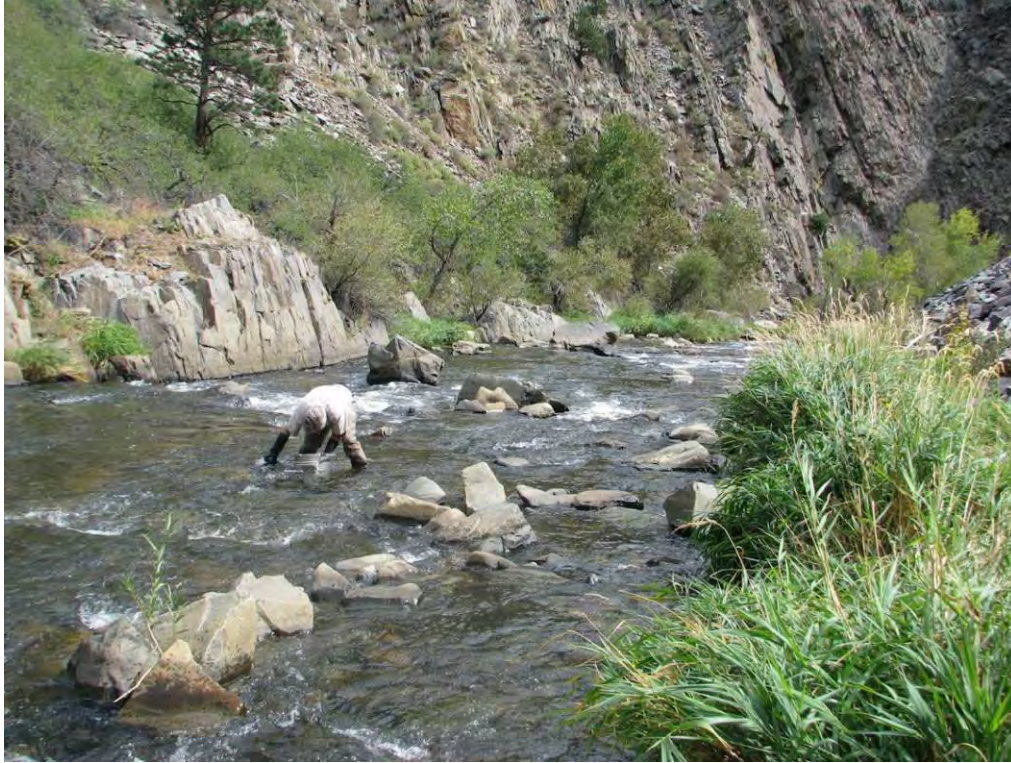
Figure 5.2. Big Thompson River approximately ½ mile upstream of the mouth of the canyon, 9-24-2012.

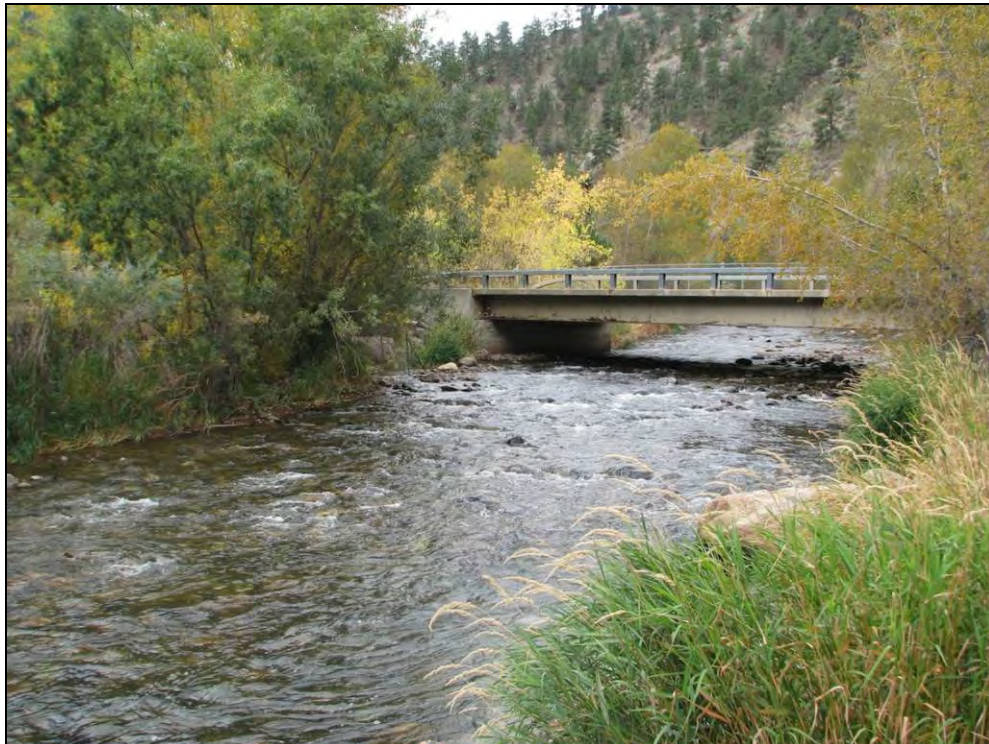
Figure 5.3. Big Thompson River low gradient riffle near Drake, 9-12-2014.

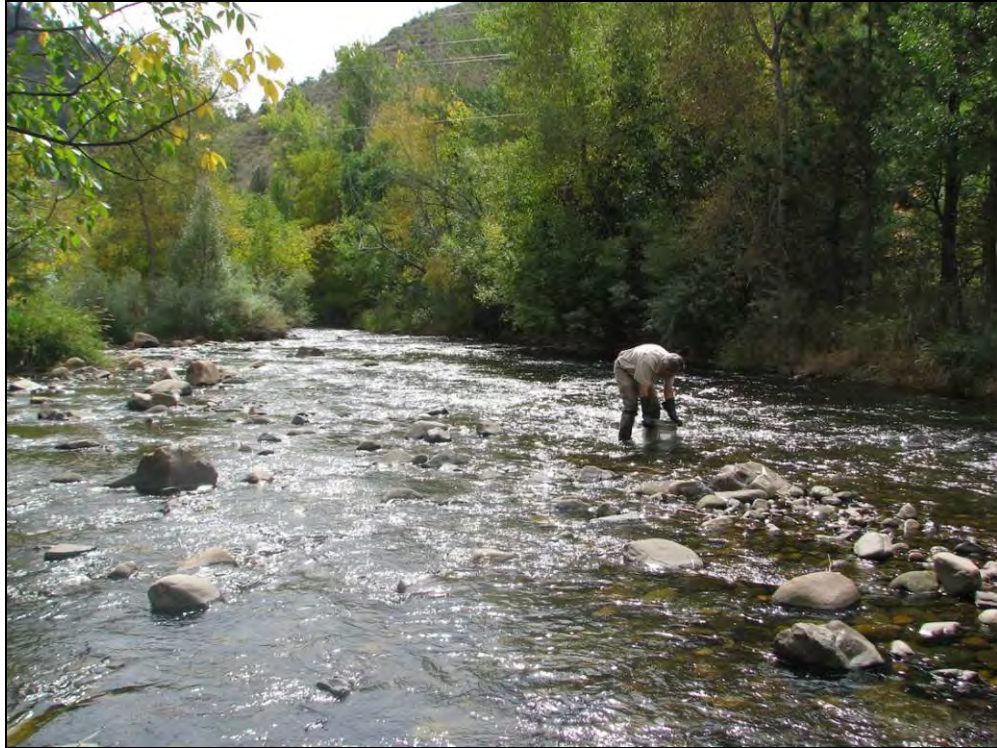
Figure 5.4. Big Thompson River low gradient riffle near Cedar Cove, 9-12-2014.
