BIG THOMPSON RIVER RESTORATION MASTER PLAN

January 2015

AYRES
ASSOCIATES

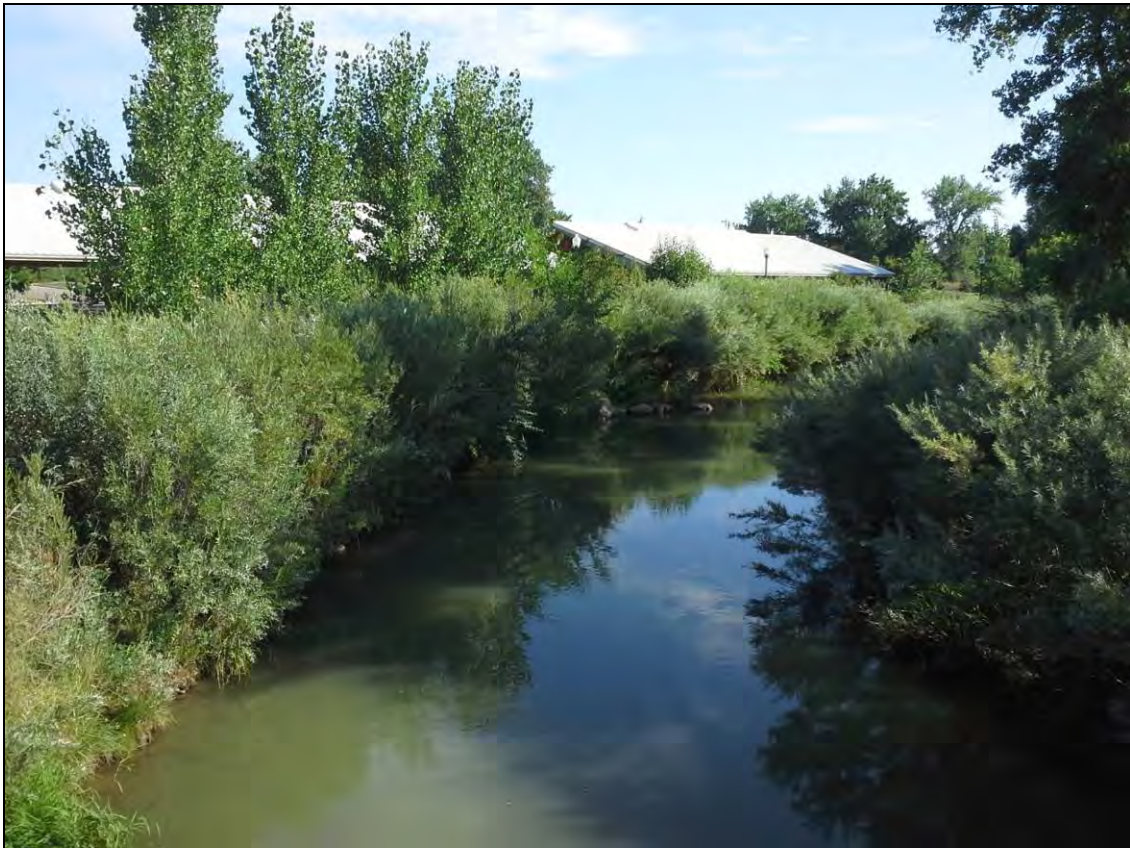
Figure 5.9. Planted riprap bank protection (left side), taken 8-29-2013, Fairgrounds Park, Loveland, CO.

In some locations the riparian restoration and bank stabilization measures can use the same treatment, **Figure 5.8**. Boulders and/or riprap planted with willows can increase the resiliency of the bank while improving the riparian and aquatic habitat as well. This approach may be useful in areas with no room for a floodplain bench. The left bank shown in **Figure 5.9** is a planted riprap bank protection used at Fairgrounds Park in Loveland. This treatment performed well during the 2013 flood event.

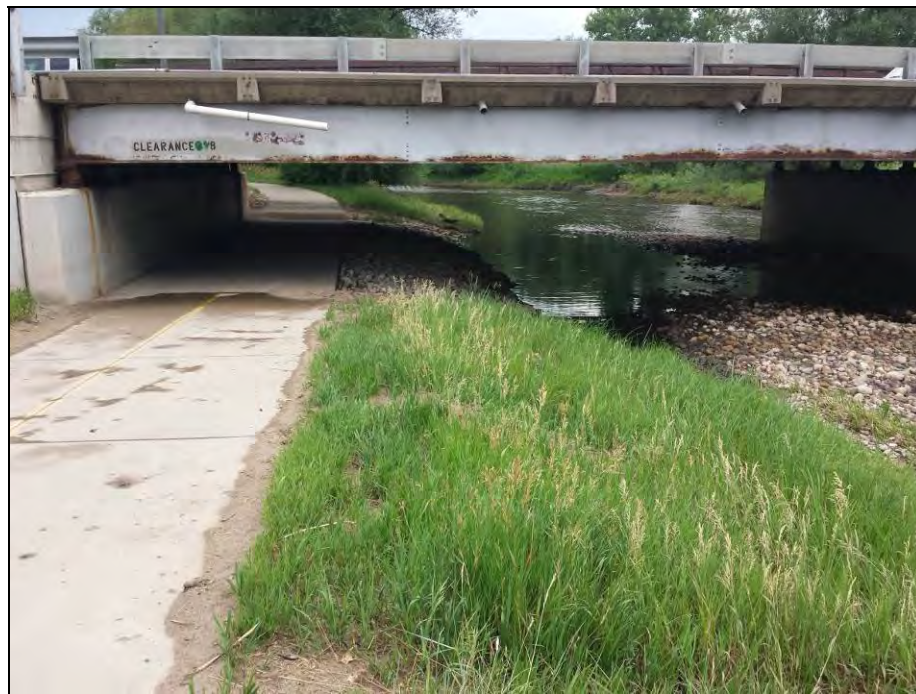
Figure 5.12. ACBs at bridge abutment, vegetated area in foreground covers ACBs.

Articulated concrete blocks (ACB) are a manufactured bank stabilization treatment (**Figure 5.11**). They can be installed at a 2H:1V slope or flatter. The benefit of ACBs compared to riprap is that they can provide similar protection to other treatments, but are not as thick and can allow vegetation to establish after installation. Even without significant soil cover, ACBs may allow sufficient vegetation to establish that they are completely covered (**Figure 5.12**).

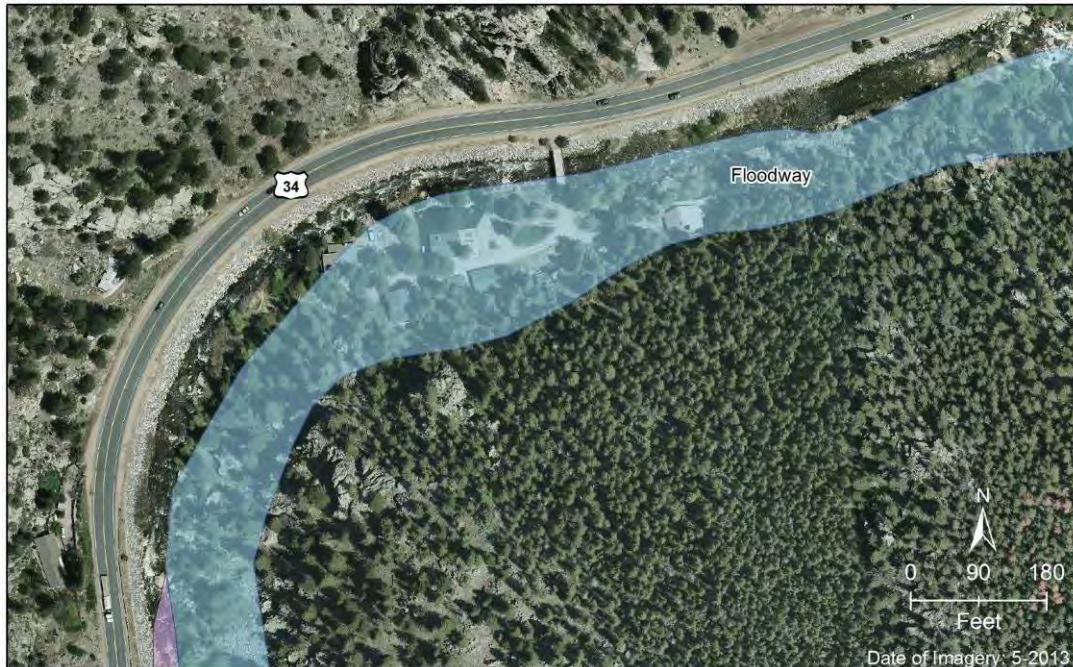
Figure 7.1. Illustration of inaccurate digital floodplain data.

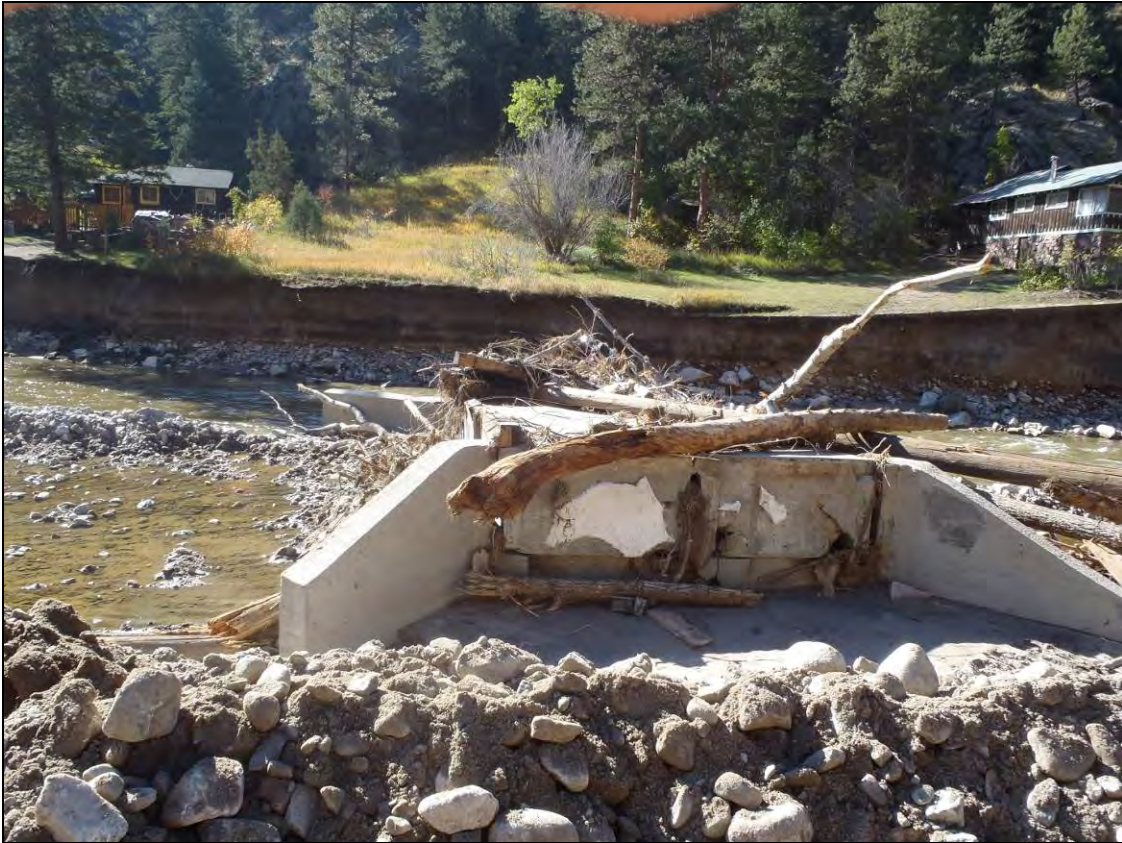
In the canyon reaches of the Big Thompson River, several of the access bridges to private properties were damaged or destroyed in the September 2013 flood. Many of these structures were completely or partially blocked by debris, causing the flows to flank the bridge around one or both abutments. The flanking of the bridges destroyed their approaches, but also caused extensive damage to US Highway 34 and to properties on the opposite side of the river. At the bridge shown below (**Figure 7.2**), the flooding around the bridge formed a new channel and left a vertical cut bank over 100 feet south of the pre-flood channel bank location.

Figure 7.2. Flanked access bridge in Big Thompson Canyon.
