LEFT HAND CREEK WATERSHED MASTER PLAN

December 9, 2014

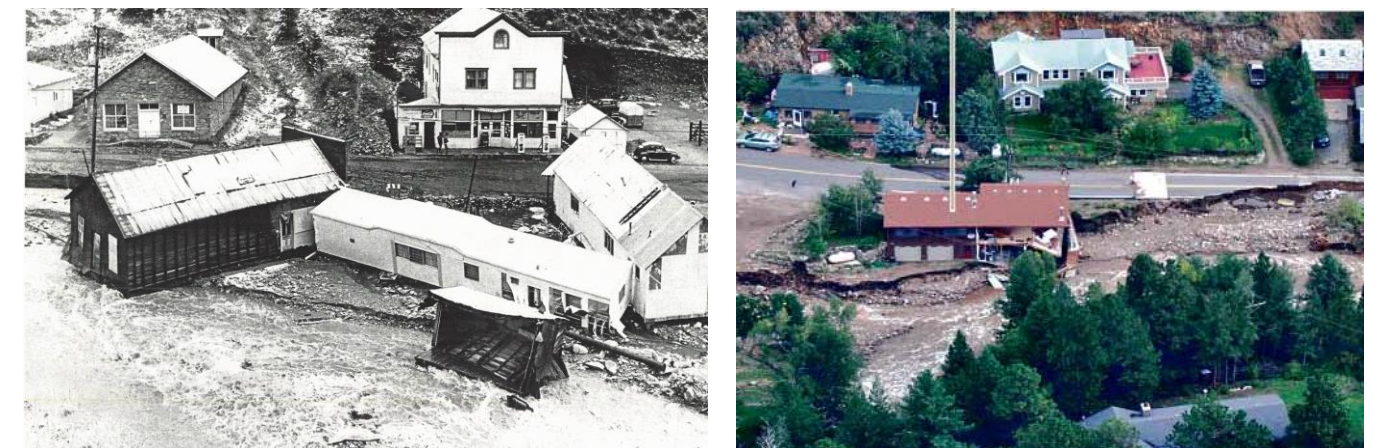
Figure 8. Flood Damage in Jamestown in 1969 (left) and 2013 (right)
(source: University of Colorado 2014 and New York Times 2013, respectively)

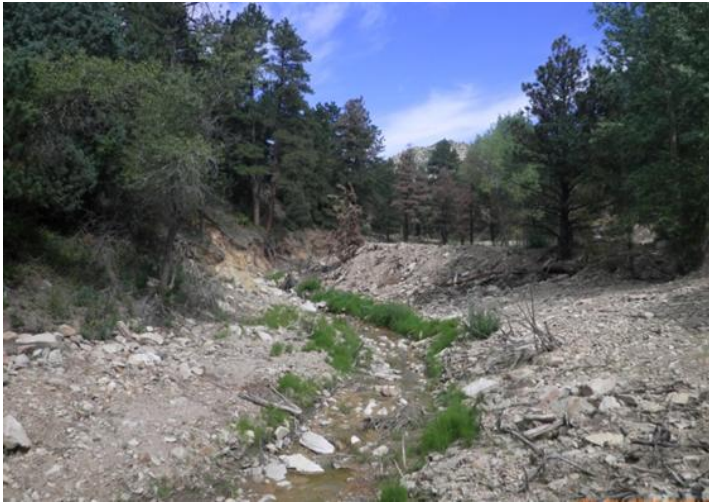
Headwater	
Properties: Reaches are generally quite steep and located high in the drainage with no significant tributaries. Channel is fully confined, abutting the valley wall through its length.

Reaches Observed:	15, 21, 22, 23, 24, 25, 26
RIVER CHARACTER	
Valley Setting	Confined
Channel Planform	Channel is generally straight and laterally stable, being fully confined by the valley walls. Channel adjustments are usually vertical, in response in increased discharge and sediment supply.
Bed Morphology	Bed morphology reflects the channel gradient - step-pool with elements of cascade and rapids.
Geomorphic Units	Pools Bedrock Outcrops and Steps Jams - Located at constrictions Slackwater Deposits - behind and below boulders, LWD Glides or Shallow Pools
RIVER BEHAVIOR	
Flood Response	Flood response in headwater reaches is generally downcutting and scour with the potential for significant influences from culverts and other infrastructure. Plugged culverts can cause backwater impacts leading to extensive deposition.

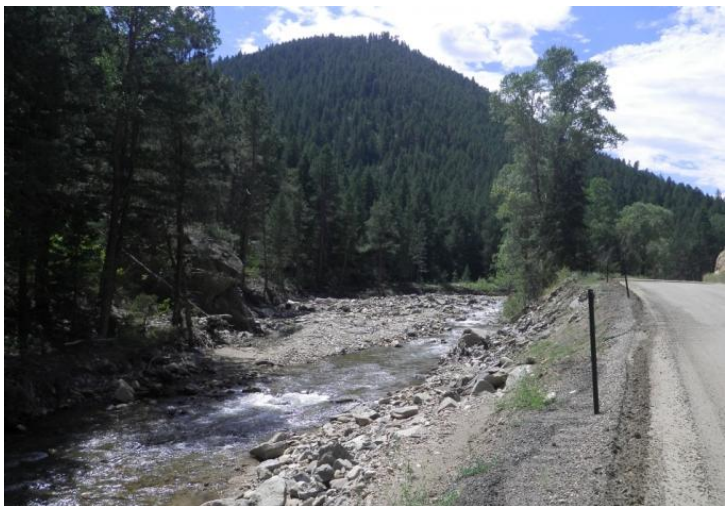
Properties: Reaches are generally tightly confined by the valley margin except for breaks in the bedrock where the valley widens. This channel type mainly occurs in the canyon landscape zone. The breaks in the bedrock accumulate alluvium (and colluvium, which causes a local decrease in channel gradient. These areas act as floodplain, storing sediment, capturing debris and dissipating flood energy.

Reaches Observed: 9, 10, 13, 16, 18, 19

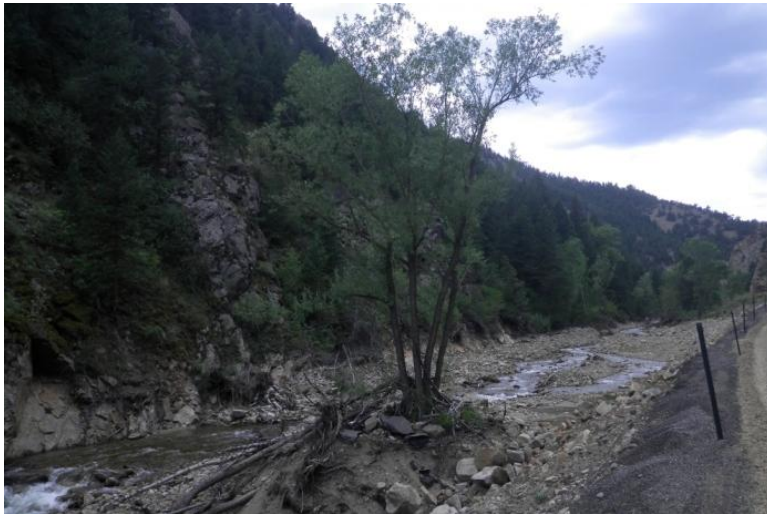
Confined Valley, Limited Floodplain	
Properties: Channel is fully confined throughout its length and located in the moderate relief upland and canyon landscape units. Reaches are generally steep and well armored. Primary modes of adjustment are vertical.

Reaches Observed:	8, 11, 12, 14, 17, 20
RIVER CHARACTER	
Valley Setting	Confined
Channel Planform	Channel is generally single thread and straight. Channel adjustments are vertical - mainly incision and expansion.
Bed Morphology	Bed morphology is generally step-pool, but may have elements of pool-riffle, rapid and cascade.
Geomorphic Units	Pools Bedrock Outcrops and Steps Jams - Located at constrictions Relatively deep pools Structural LWD
RIVER BEHAVIOR	
Flood Response	The response of these channels to the flood involved the complete destruction of the channel, stripping of the channel margins, and/or the flushing of alluvium. These reaches are still adjusting to the September flood and yet to re-establish bedforms.

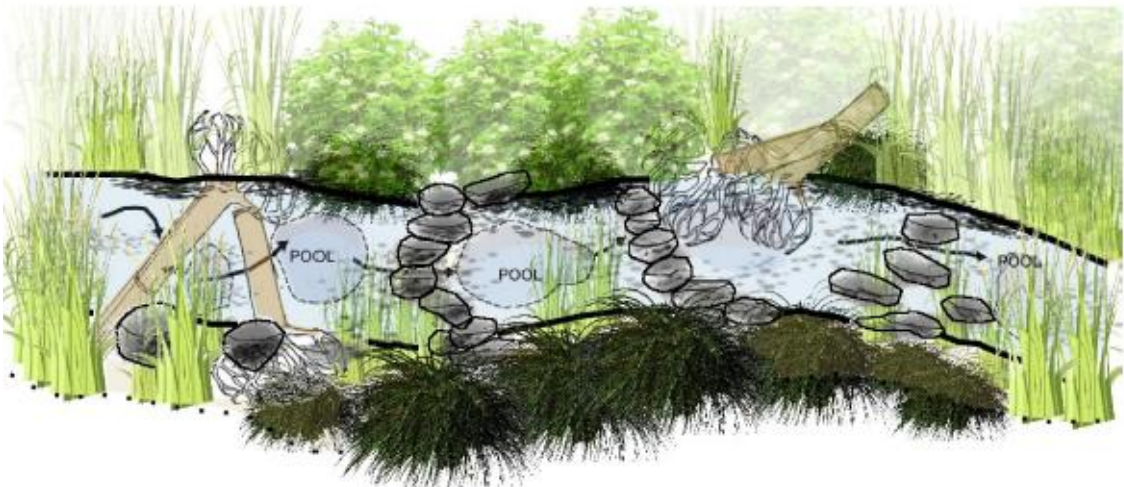
Confined Valley, Limited Floodplain River Style (Cont.)	Recommended Restoration Plan

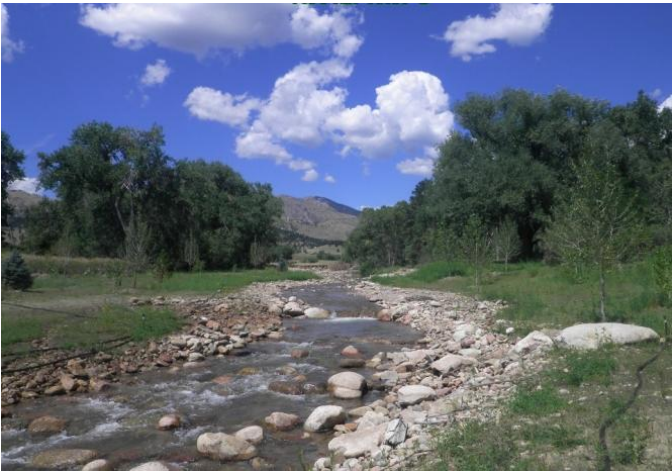
Partly Confined, Wandering	
Properties: Partly confined, wandering channels occupy the transition from the canyon to alluvial plain landscape units. They are partly confined by valley walls, old terraces and anthropogenic sources such as roads, bridges, and developments.

Reaches Observed:	5, 6, 7
RIVER CHARACTER	
Valley Setting	Partly confined
Channel Planform	Channel has low sinuosity. It may have islands and/or side and overflow channels, backwater ponds and possibly wetlands in areas of lower local gradient.
Bed Morphology	Bed morphology is composed of pool-riffle sequences with step-pool in higher gradient areas.
Geomorphic Units	Pools, riffles, glides Bedrock Outcrops and Steps LWD Lateral and longitudinal bars Glides and Pools Islands, benches, terraces
RIVER BEHAVIOR	
Flood Response	Channel avulsions and migrations were the primary flood response as sediment-laden flood flows responded to local changes in gradient and confinement (e.g., crossings). Channel changes are both vertical and lateral.

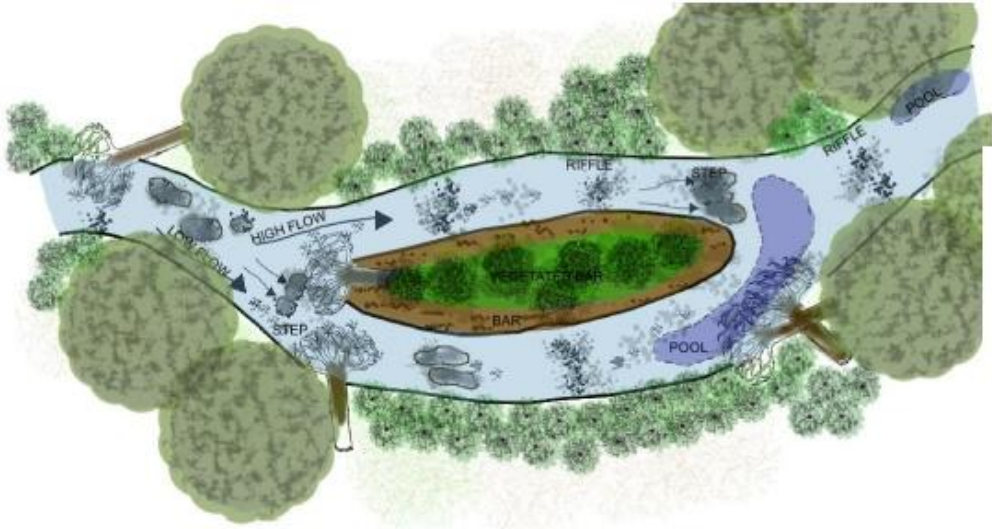
Partly Confined, Wandering River Style (Cont.)	Recommended Restoration Plan

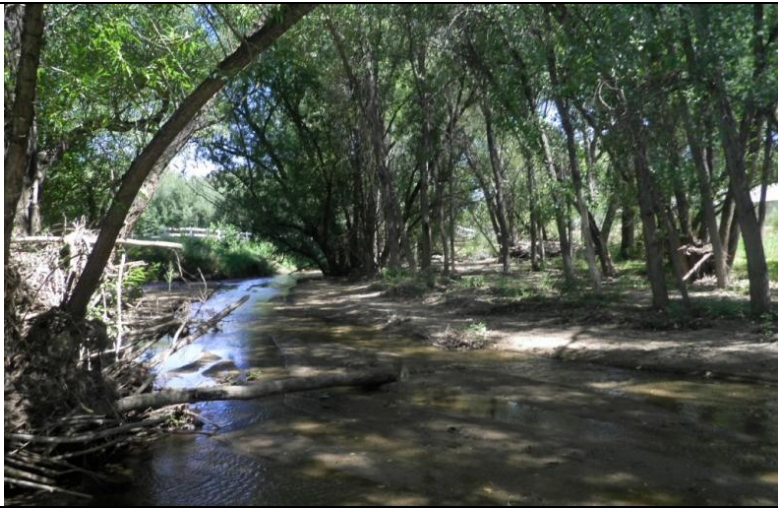
Unconfined, Continuous Floodplain	
Properties: These reaches sit low in the watershed, in the alluvial plain landscape zone. They are generally unconfined laterally, but adjacent land use has narrowed the riparian corridor and likely straightened the channel.	
Reaches Observed:	3, 4
RIVER CHARACTER	
Valley Setting	Unconfined
Channel Planform	Channel has low sinuosity. It may have islands and/or side and overflow channels, backwater ponds and possibly wetlands in areas of lower local gradient.
Bed Morphology	Pool-riffle transitioning to sand bed.
Geomorphic Units	Pools, riffles, glides Bedrock Outcrops and Steps LWD Lateral and longitudinal bars Islands, benches, terraces
RIVER BEHAVIOR	
Flood Response	These reaches generally responded to the flood by in-channel aggradation and extensive floodplain deposition. The blocking of channel crossings added to the aggradation with adjacent sections of channel displaying a braided morphology.

Stage Behavior	Low flows are generally confined to a single thread, accumulating on the outside of meander bends and in pools. Bankfull flows inundate secondary channels and transfer sediment downstream, re-working bars and banks. Flood flows will inundate all channel features and extensive areas of the floodplain, depositing fine sediments.
Restoration Considerations	Restoration of the channels should focus on establishing a low flow channel to encourage sediment transport. Development in floodplains should be limited and reserved for dissipating flood energy and storing sediment. Opportunities to use low flow crossings instead of bridges and culverts should be considered. Native riparian vegetation should be used to expand the (currently) limited riparian corridor.

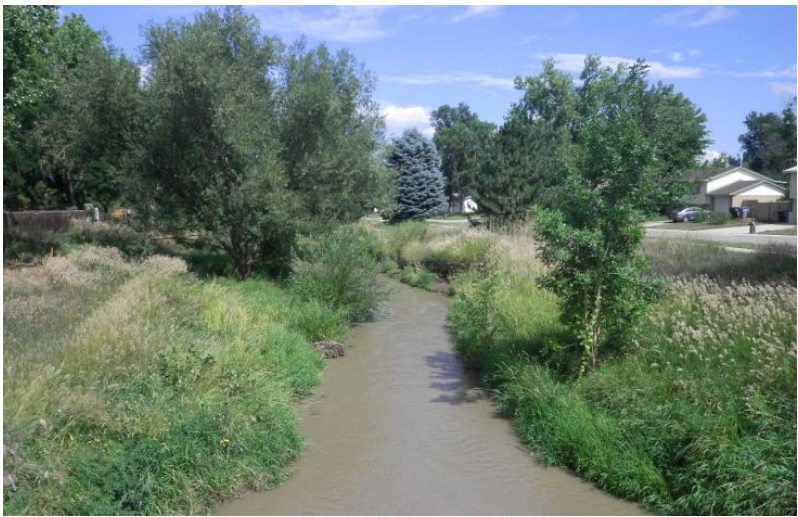
Entrenched, Residential	
Properties: The entrenched, residential river style is found at the bottom of the watershed, in the alluvial plain landscape unit. These are unconfined, continuous floodplain channels that have been modified to maximize capacity for flood control in highly populated areas.	
Reaches Observed:	1, 2
RIVER CHARACTER	
Valley Setting	Confined
Channel Planform	Channels are generally single thread and straight, but depending on the design width, may develop low sinuosity within the constructed width.
Bed Morphology	Sand bed, fairly homogenous channels that may contain pool-riffle sections in meanders.
Geomorphic Units	Pools, riffles, glides sand sheets, sediment slugs Islands, benches, terraces Lateral and longitudinal bars
RIVER BEHAVIOR	
Flood Response	Flood response is limited to aggradation and the re-working of a low caliber bed. Restrictions at crossings may initiate bank failure.

Stage Behavior	Generally single thread in low, bankfull, and flood stages. Sections of channel that develop some sinuosity and complexity may appear multithread at or near the bankfull stage.
Restoration Considerations	Restoration is generally limited as the channel must first meet flood control and capacity requirements. Developing a low flow channel will help with sediment transport issues and also provide conditions to maintain aquatic organisms. To the degree possible, channel complexity should be increased through the use of habitat features (e.g., rootwads, boulders, logs). Increasing channel complexity will need to be accompanied by increased width, as the additional roughness will decrease capacity.

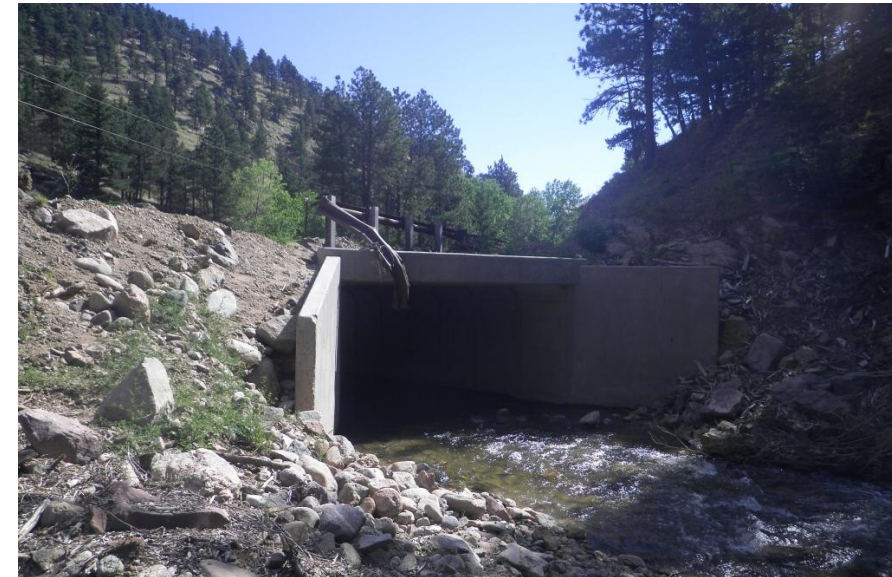
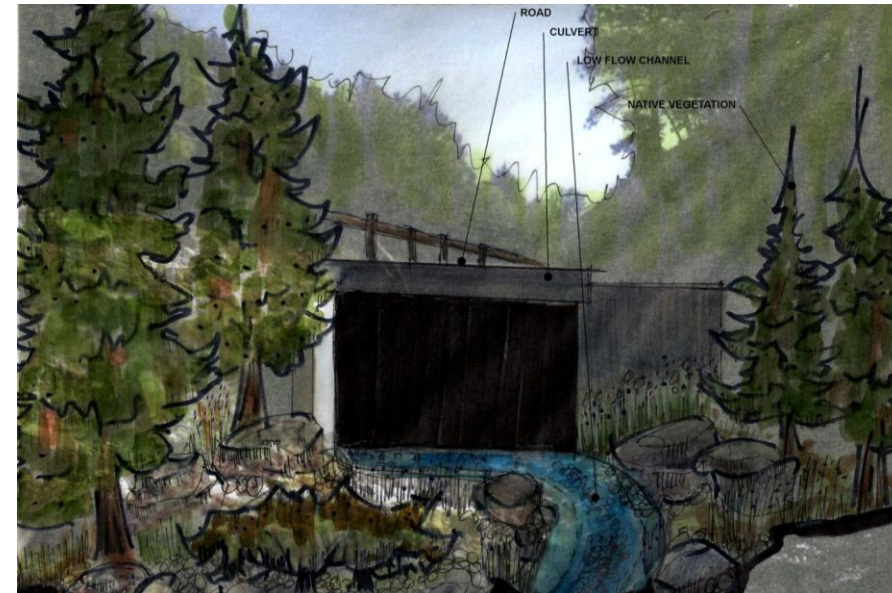
Figure 28. Graphical example of existing crossing constructed with low-flow channel that facilitates aquatic organism passage and sediment transport.

Moving forward, local jurisdictions and regulatory agencies should consider stream crossing designs that provide adequate flow conveyance and also effective sediment and debris transport and aquatic organism passage through the crossing (**Figure 28**). Resources commonly used to design crossings that facilitate the transport of debris and aquatic organisms include the USFS Stream Simulation (Forest Service Stream-Simulation Working Group, 2008) or FHWA (Federal Highway Administration) HEC-26 methodologies (FHWA, 2010). In addition to the design guidance provided by the federal government and the State of Colorado, many good references exist in other localities. One such example is the 2013 Water Crossing Design Guidelines document available from Washington State Department of Fish & Wildlife. These tools should help size structures to emulate the function of the adjacent stream channel by minimizing the disruption of the movement of water, sediment, debris, and aquatic organisms. However, the magnitude and duration of the September 2013 flood was such that designing crossings to handle the debris load of a flood of that magnitude is likely not realistic or practical. Crossings, while necessary for vehicular traffic, typically concentrate stream flows to a small portion of the former stream floodplain and therefore increase the risk that sediment and debris could cause problems there.

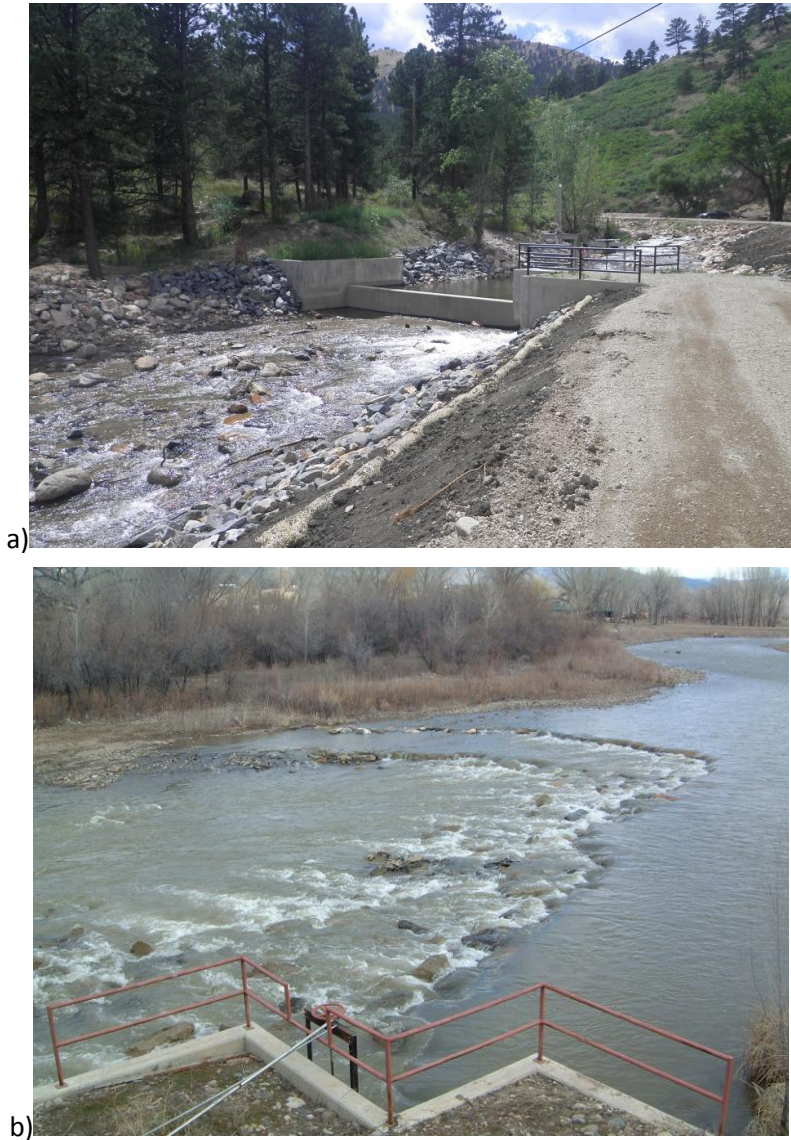
Figure 29. New Diversion Structure at Canyon Mouth

a) Photograph looking upstream at the newly constructed diversion structure at the canyon mouth, on the border of reaches 7 and 8. b) Photograph of diversion structure that facilitates aquatic organism passage and sediment transport.
