Middle South Platte River Restoration Master Plan

The Middle South Platte River Alliance

CDM Smith

November 2015

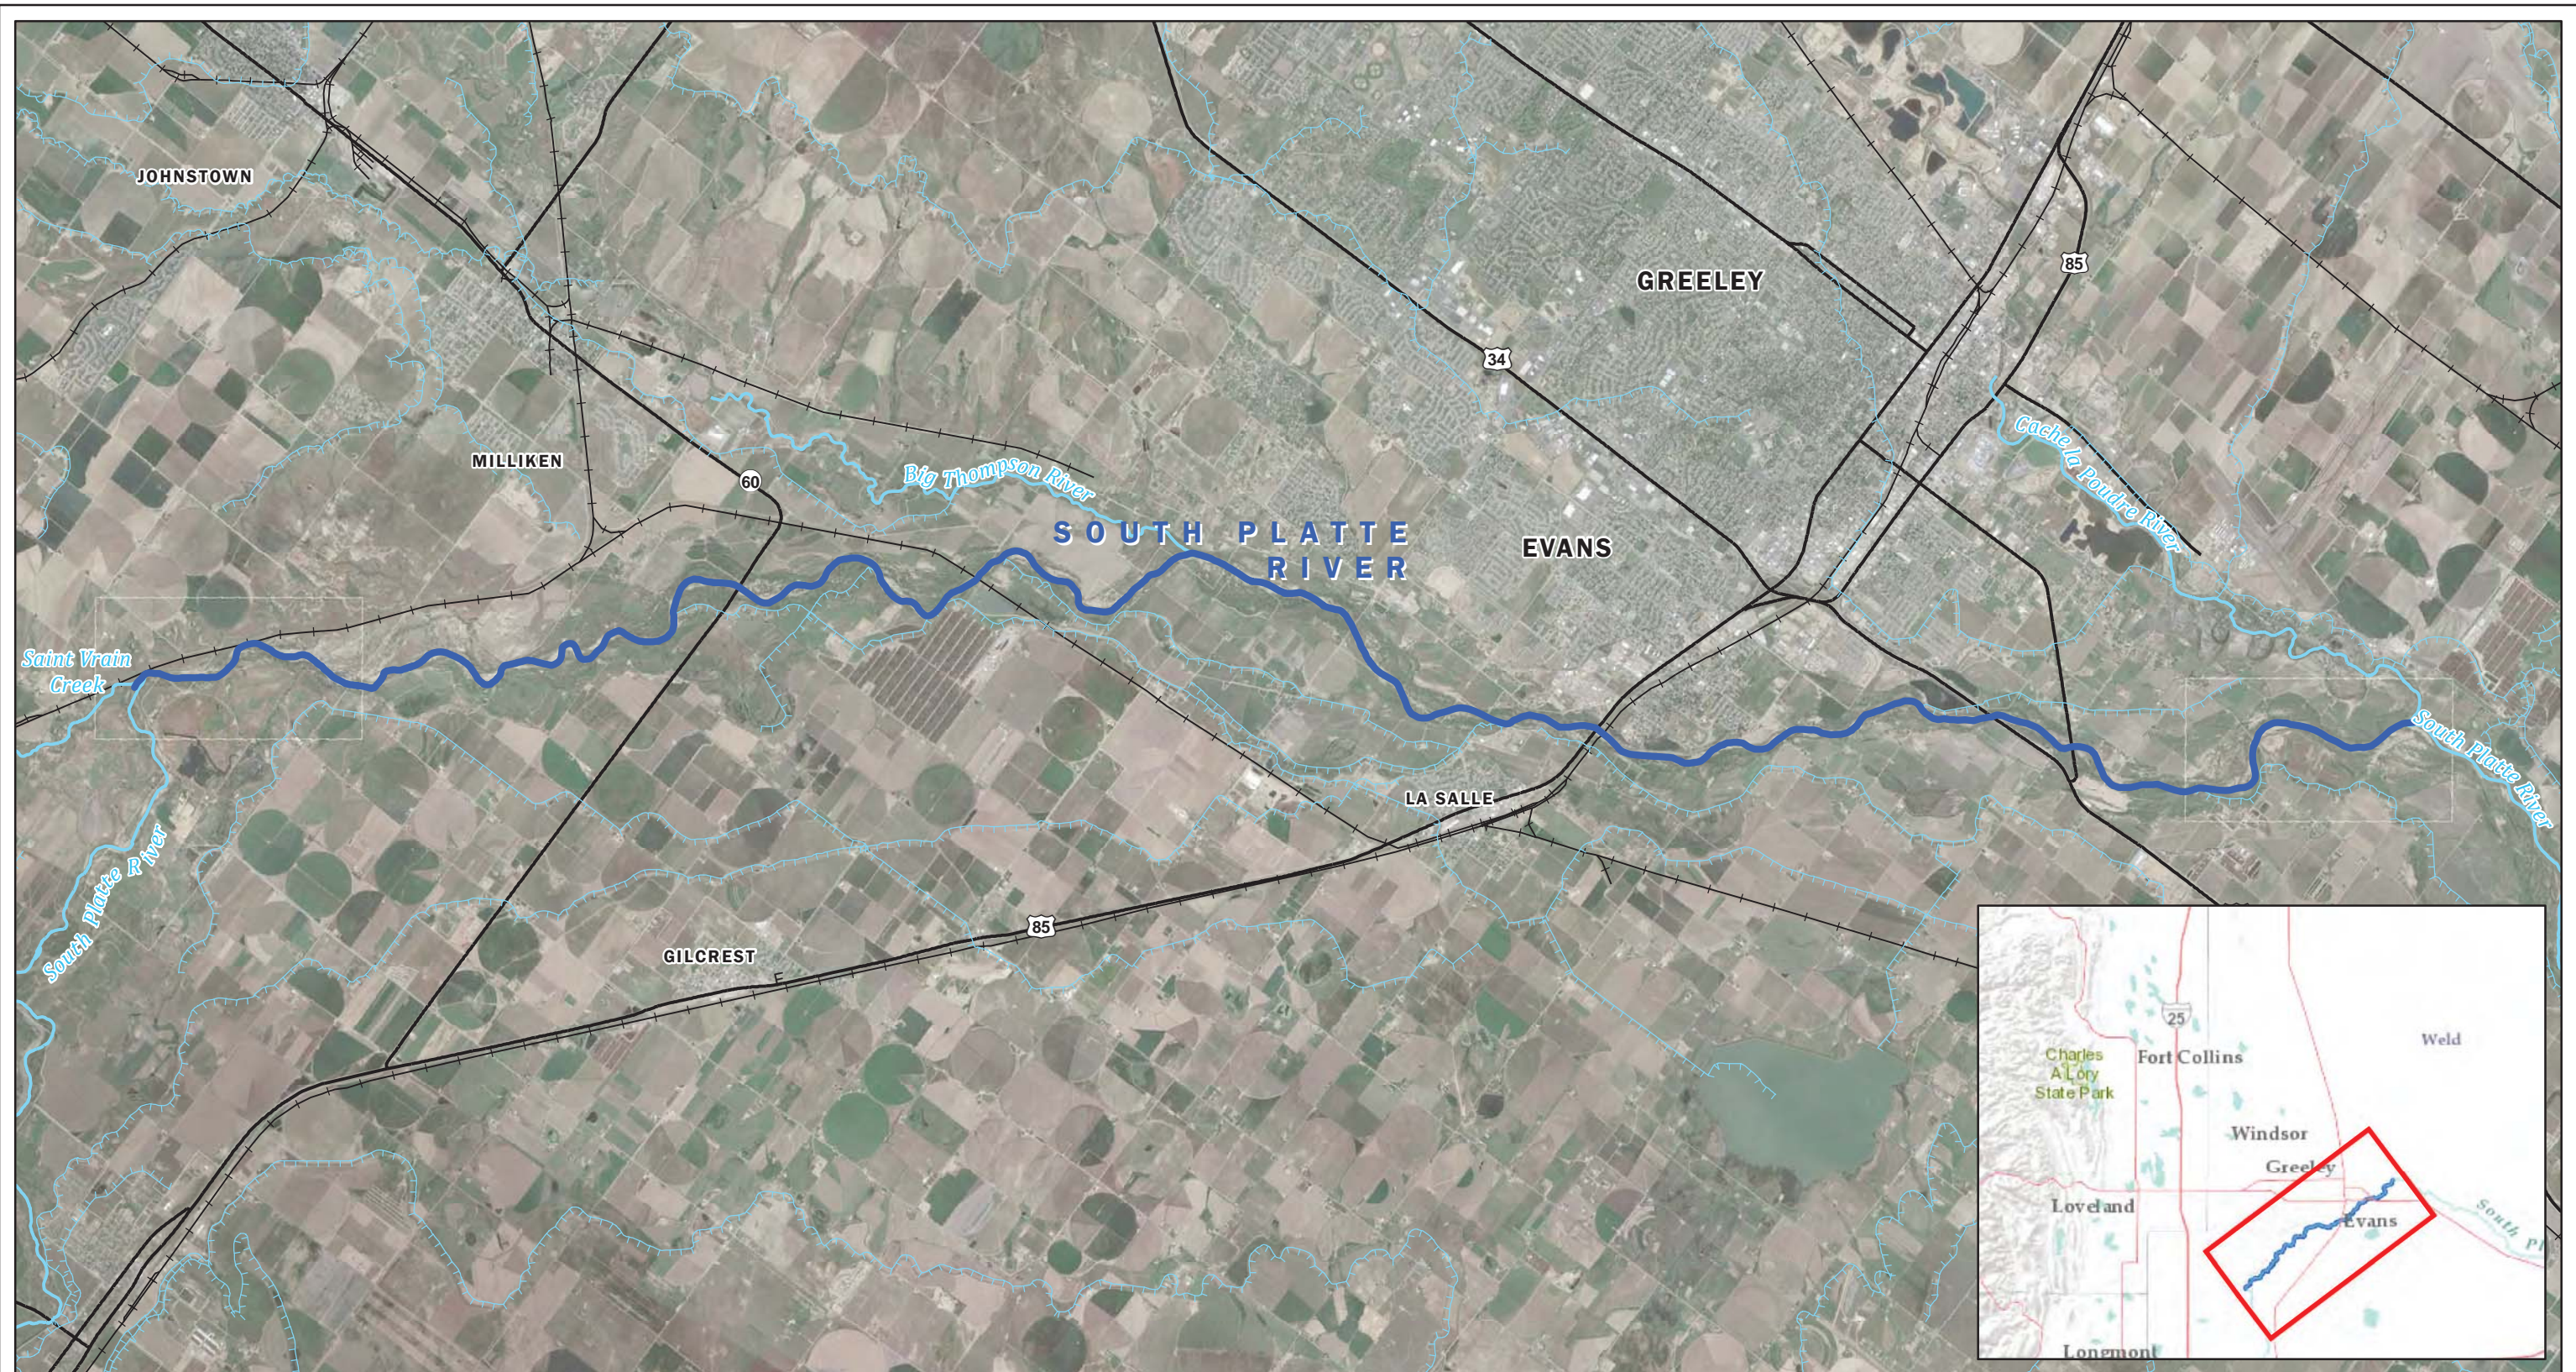
Middle South Platte River Restoration Master Plan
Figure 1-3: Project Area

The Middle South Platte River plays an important role in the communities and economies of Weld County. The South Platte River Restoration Master Plan (Master Plan) was initiated by the City of Evans and the Middle South Platte River Alliance following the September 2013 flood. The purpose of the Master Plan is to provide guidance to the City of Evans, the Alliance, and local communities to identify and prioritize stream restoration and rehabilitation projects to reduce impacts from future flooding events. The project area includes the main stem of the South Platte River corridor from St. Vrain Creek to the confluence with the Cache La Poudre River; a distance of approximately 20 miles. **Figure 1-1** shows the watershed for the South Platte River at the confluence with the Cache La Poudre (generated from the USGS StreamStats website). **Figure 1-2** shows the approximate subwatershed for the study area based on hydrologic unit data from the USGS National Hydrography Dataset, this is the approximate subbasin boundary for the study area as it extends past the confluence with the Cache La Poudre River. **Figure 1-3** shows the extent of the study reach.

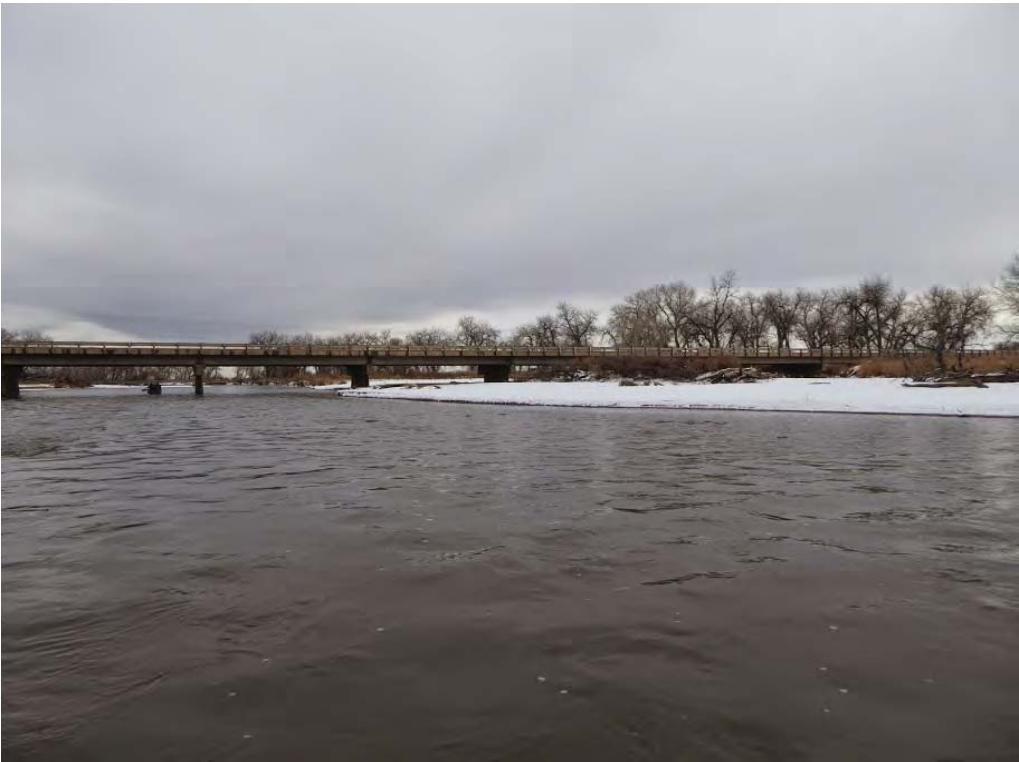
Figure 4-1. State Highway 60 Bridge

CDM Smith and DHM conducted several reconnaissance site visits between October 2014 and March 2015 along the project reach to document current conditions of the reach and riparian zone. A summary of observations and field notes is included in **Appendix B**. Field photographs of each reach (similar to **Figures 4-1** and **4-2**) are included in Section 5 of this report.

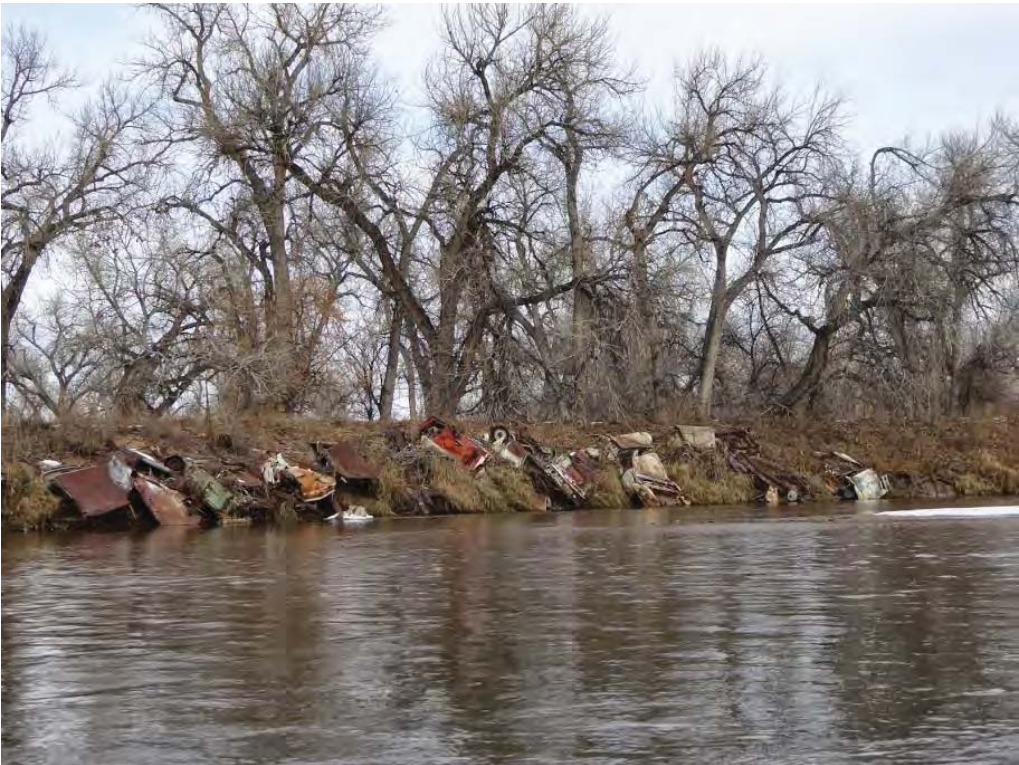
Figure 4-2. Bank Protection with Car Bodies

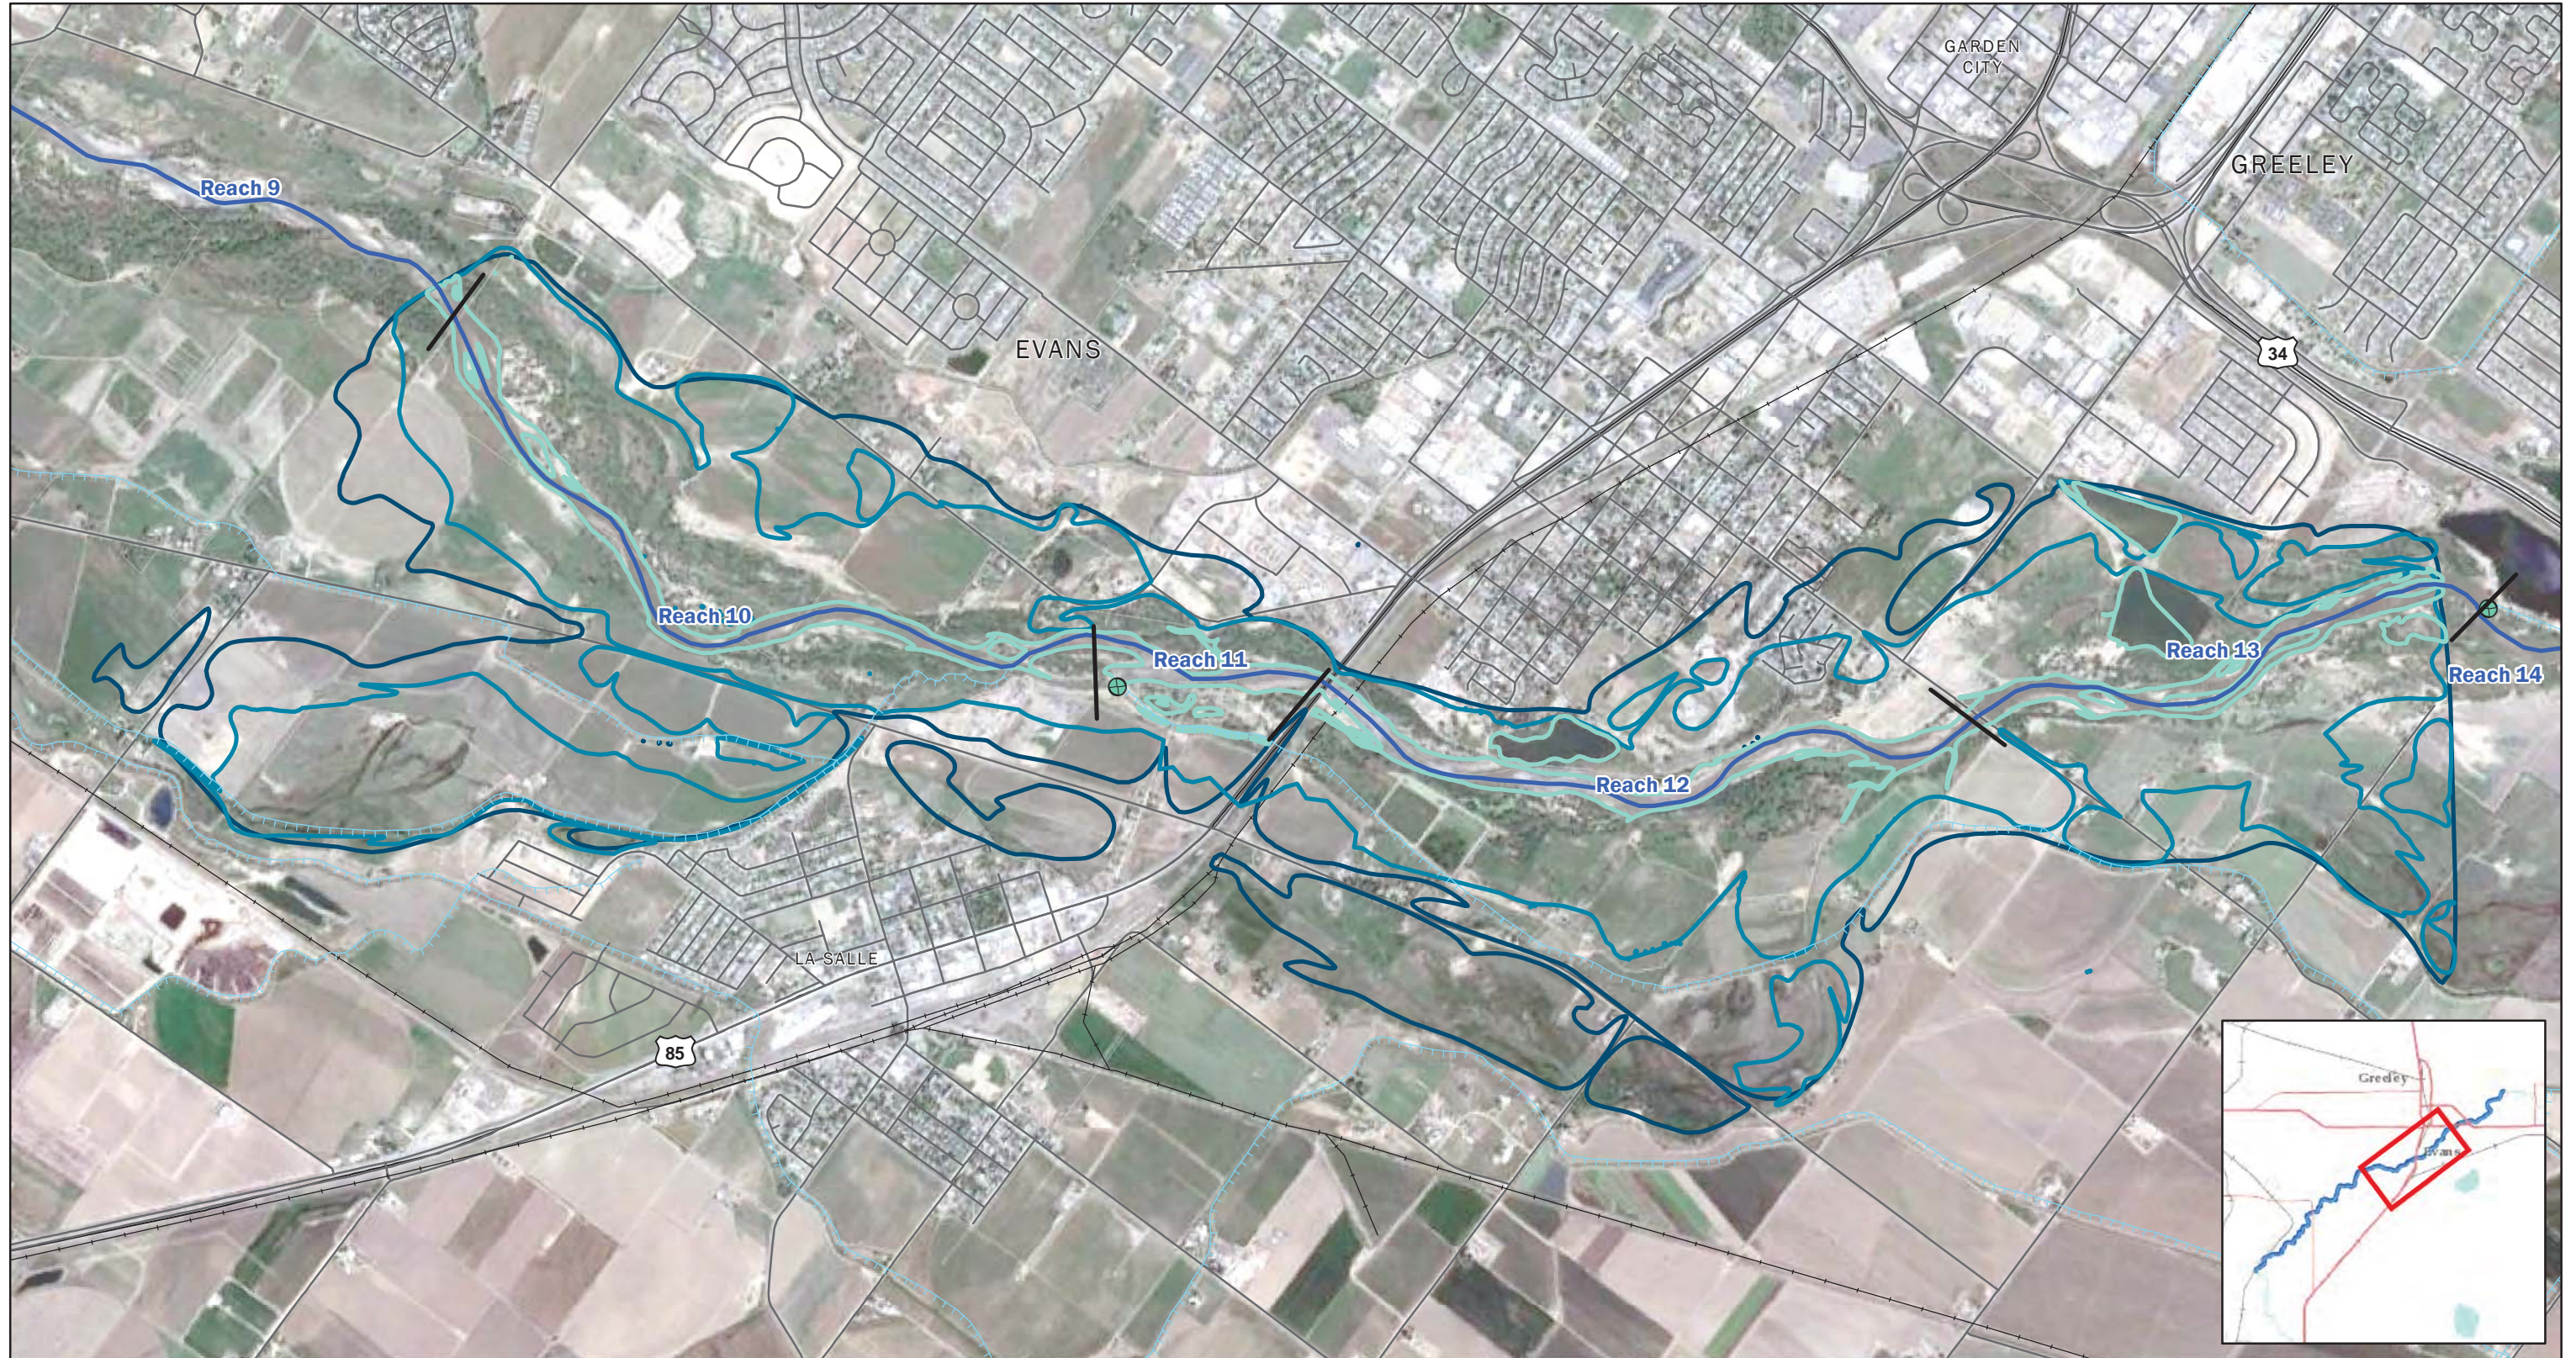
South Platte River Restoration Master Plan
Figure 4-5: HEC-RAS Modeled Floodplains

As part of the recovery effort for the 2013 September Flood, the CWCB developed a HEC-RAS model through the City of Evans. CDM Smith used this model to evaluate the floodplains of the effective discharge (discussed in the next section), the 10-year, and 50-year floods. **Figure 4-5** shows the approximate limits of flooding during these events.

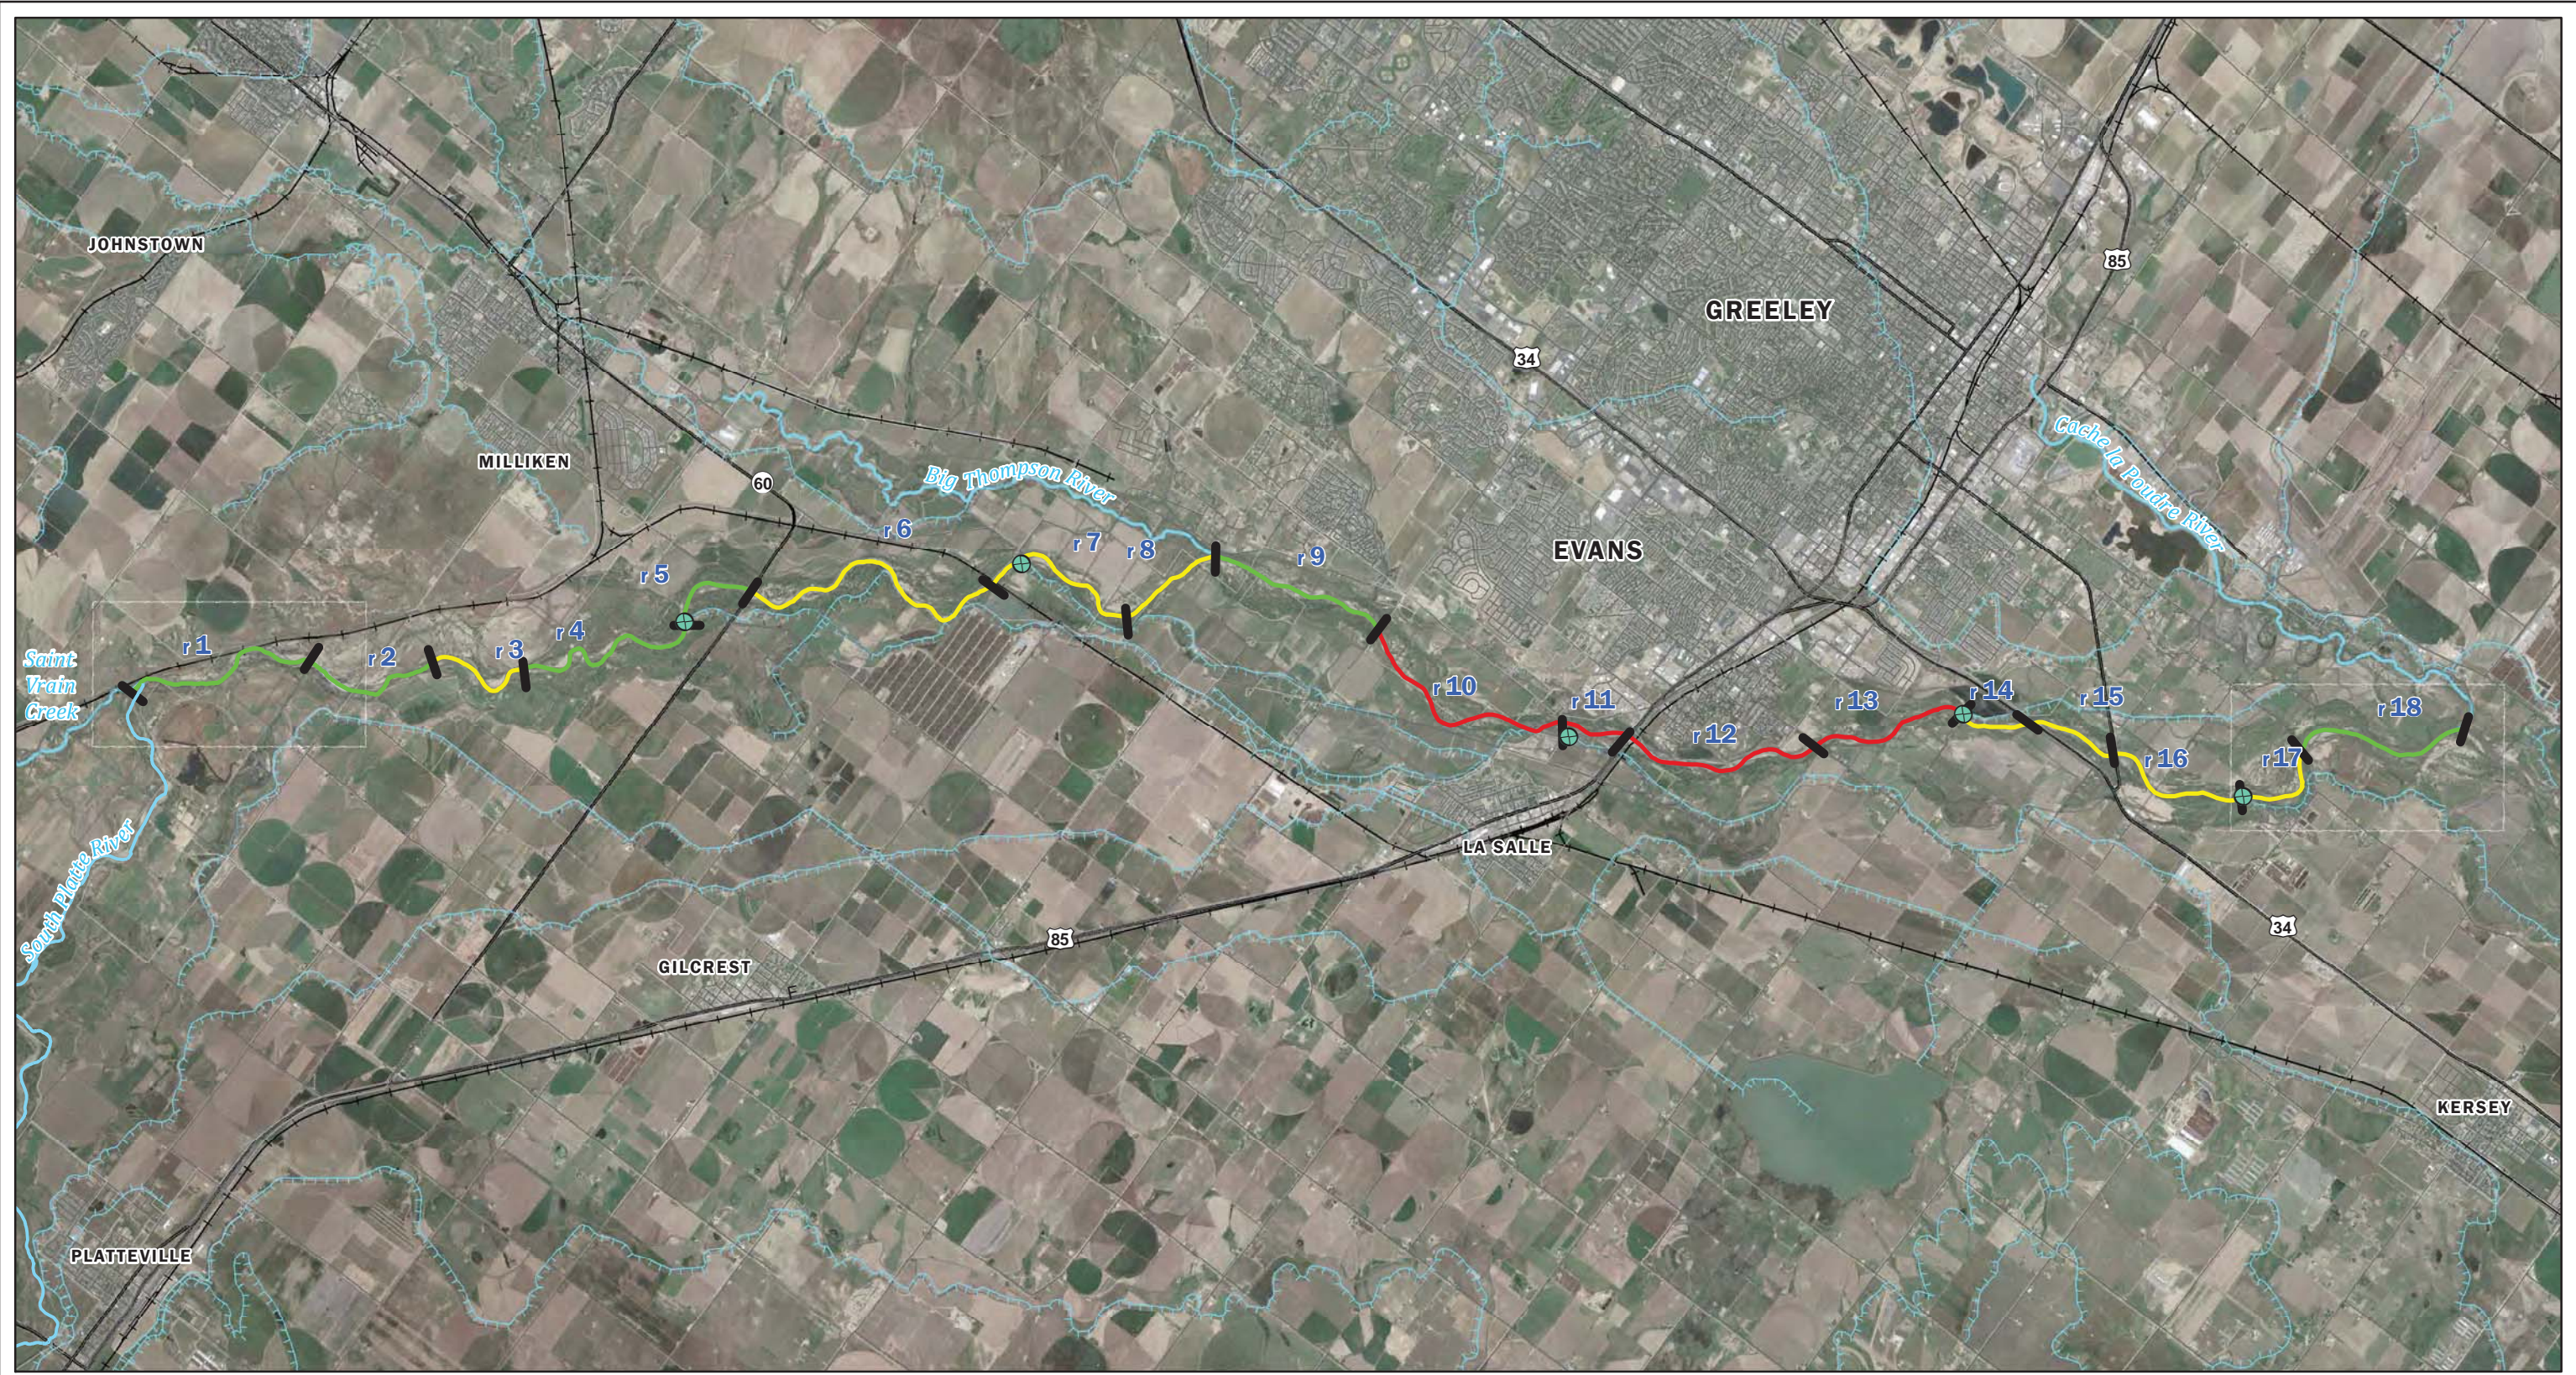
South Platte River Restoration Master Plan
Figure 5-1: Flood Risk

Based on the flood risk potential and flood severity scores criteria discussed in Section 5.1.2, an overall rank of Low, Medium, or High risk was assigned to each reach according to the flood risk score matrix (Table 5-2). The flood risk for each reach is shown in Figure 5-1 on the following page.

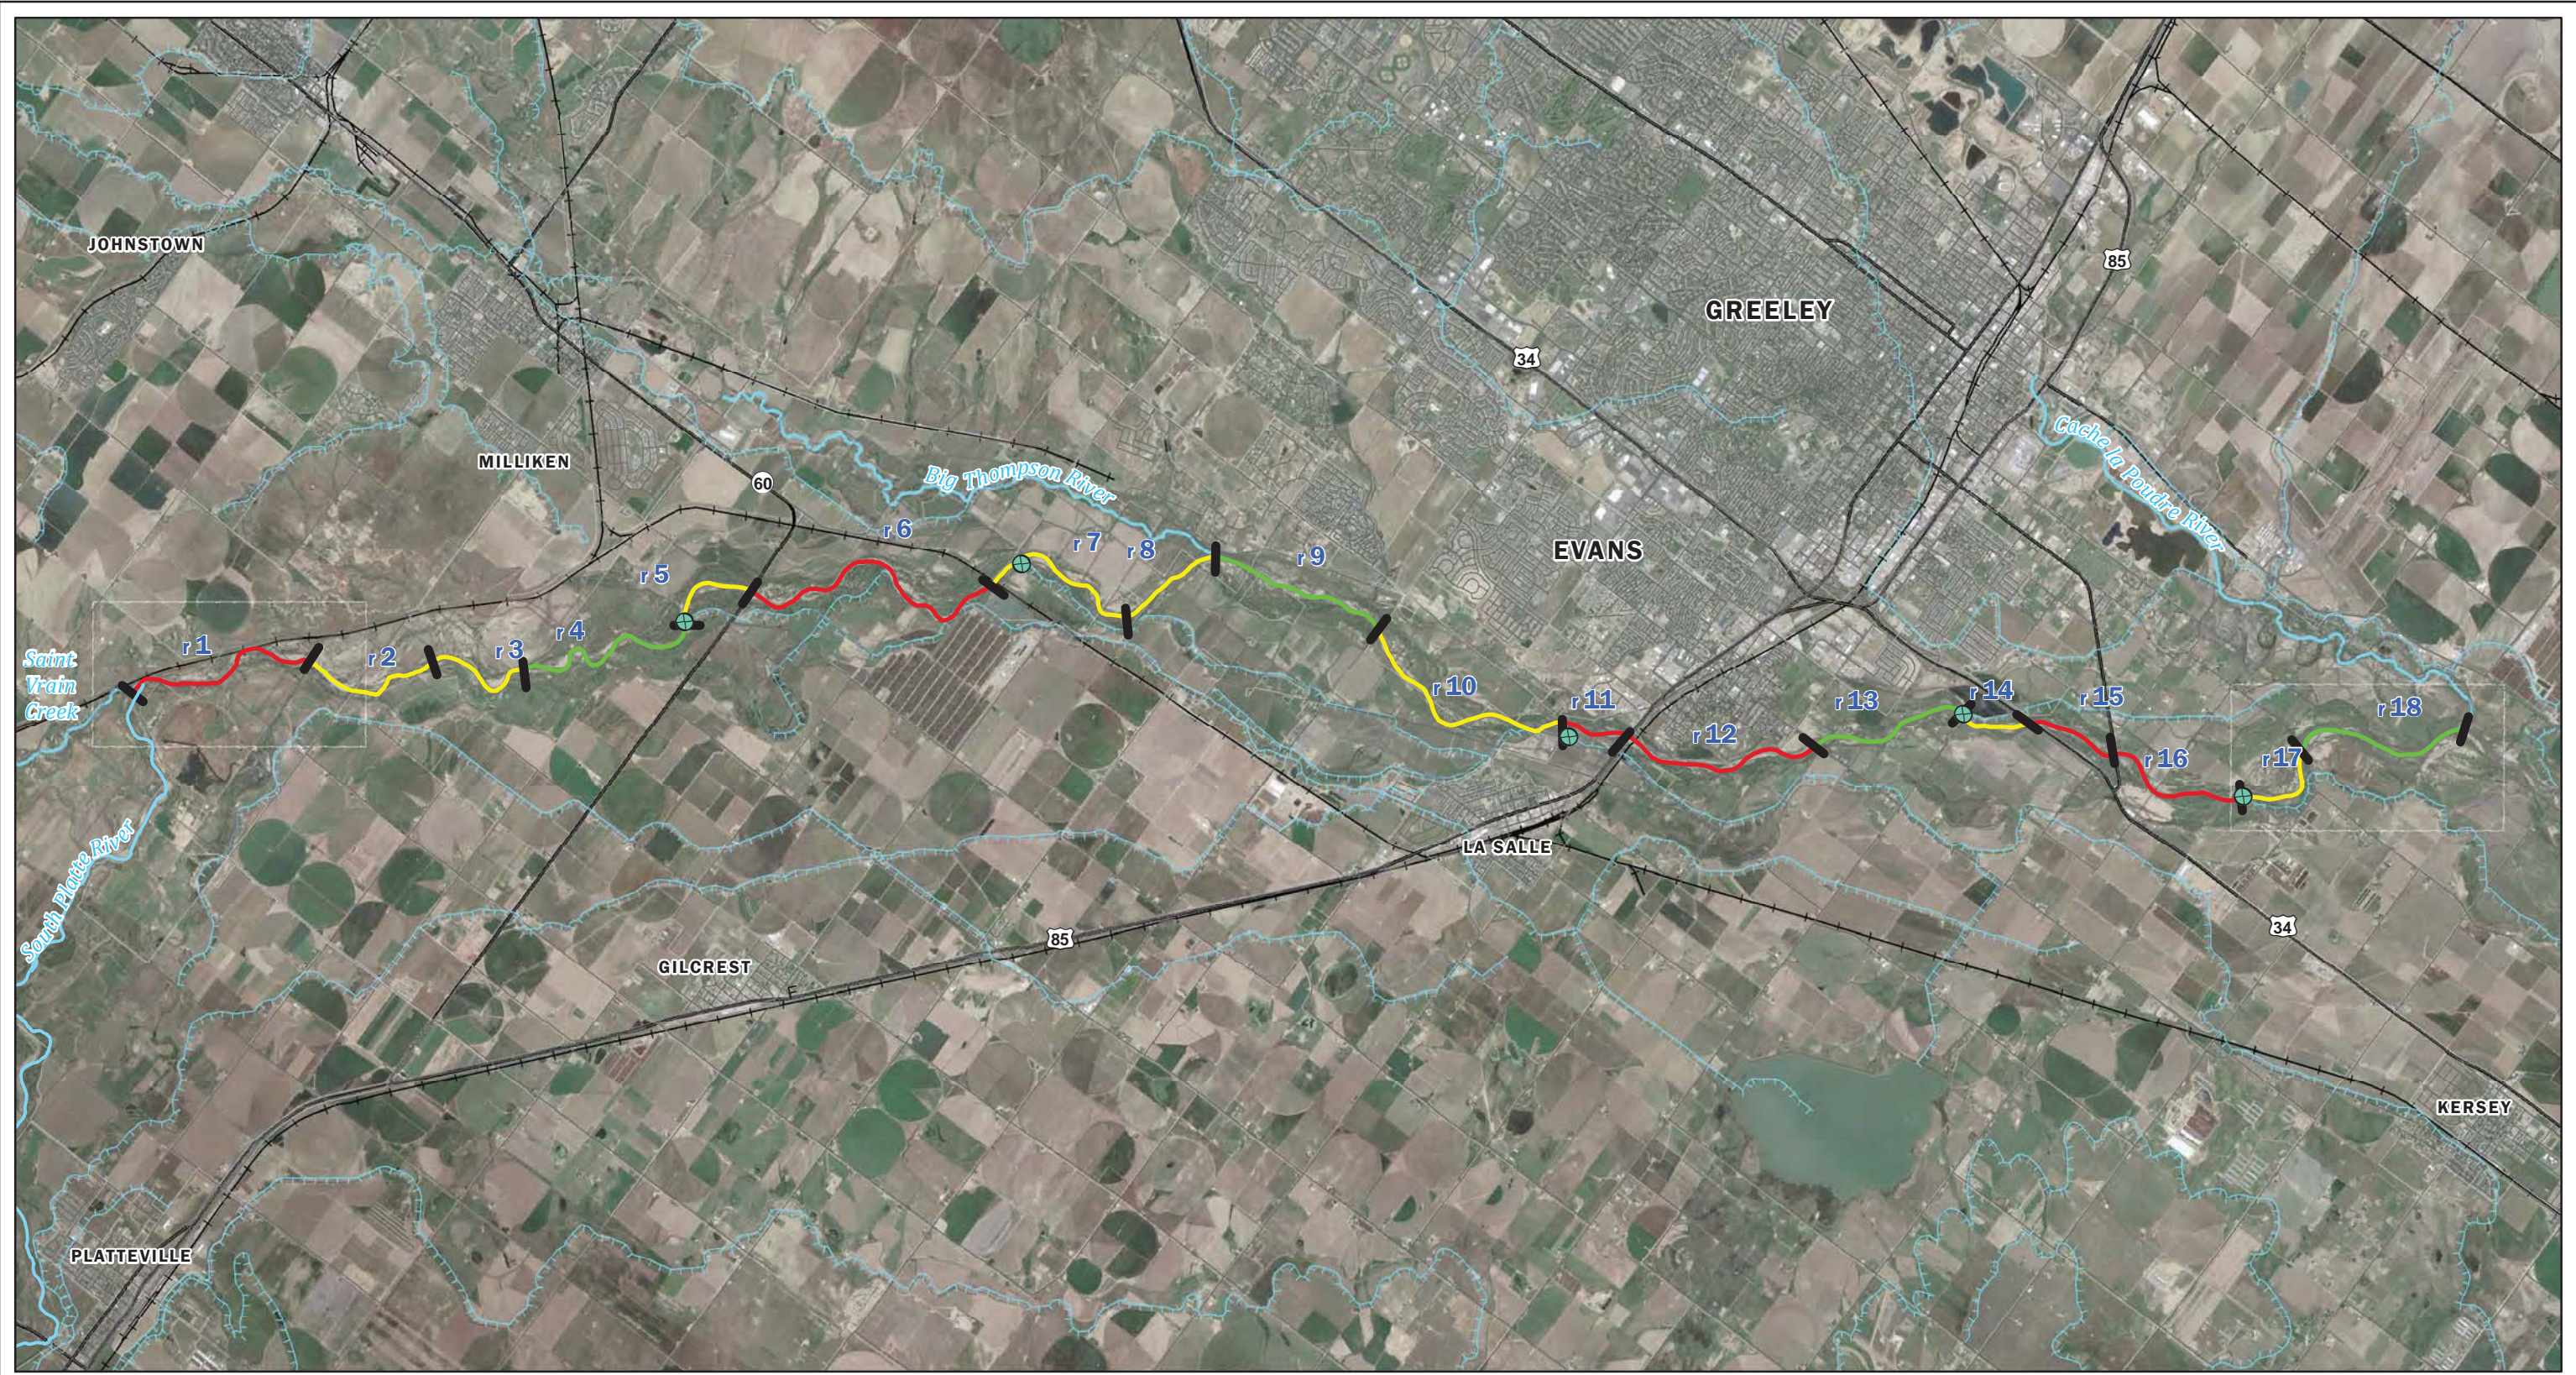
South Platte River Restoration Master Plan
Figure 5-4: Fluvial Geomorphic Risk

Based on the fluvial geomorphic risk potential and fluvial geomorphic risk severity scores criteria described in Section 5.2.2, an overall rank of Low, Medium, or High risk was assigned to each reach according to the fluvial geomorphic risk score matrix (**Table 5-3**). The fluvial geomorphic risk for each reach is shown in **Figure 5-4** on the following page.

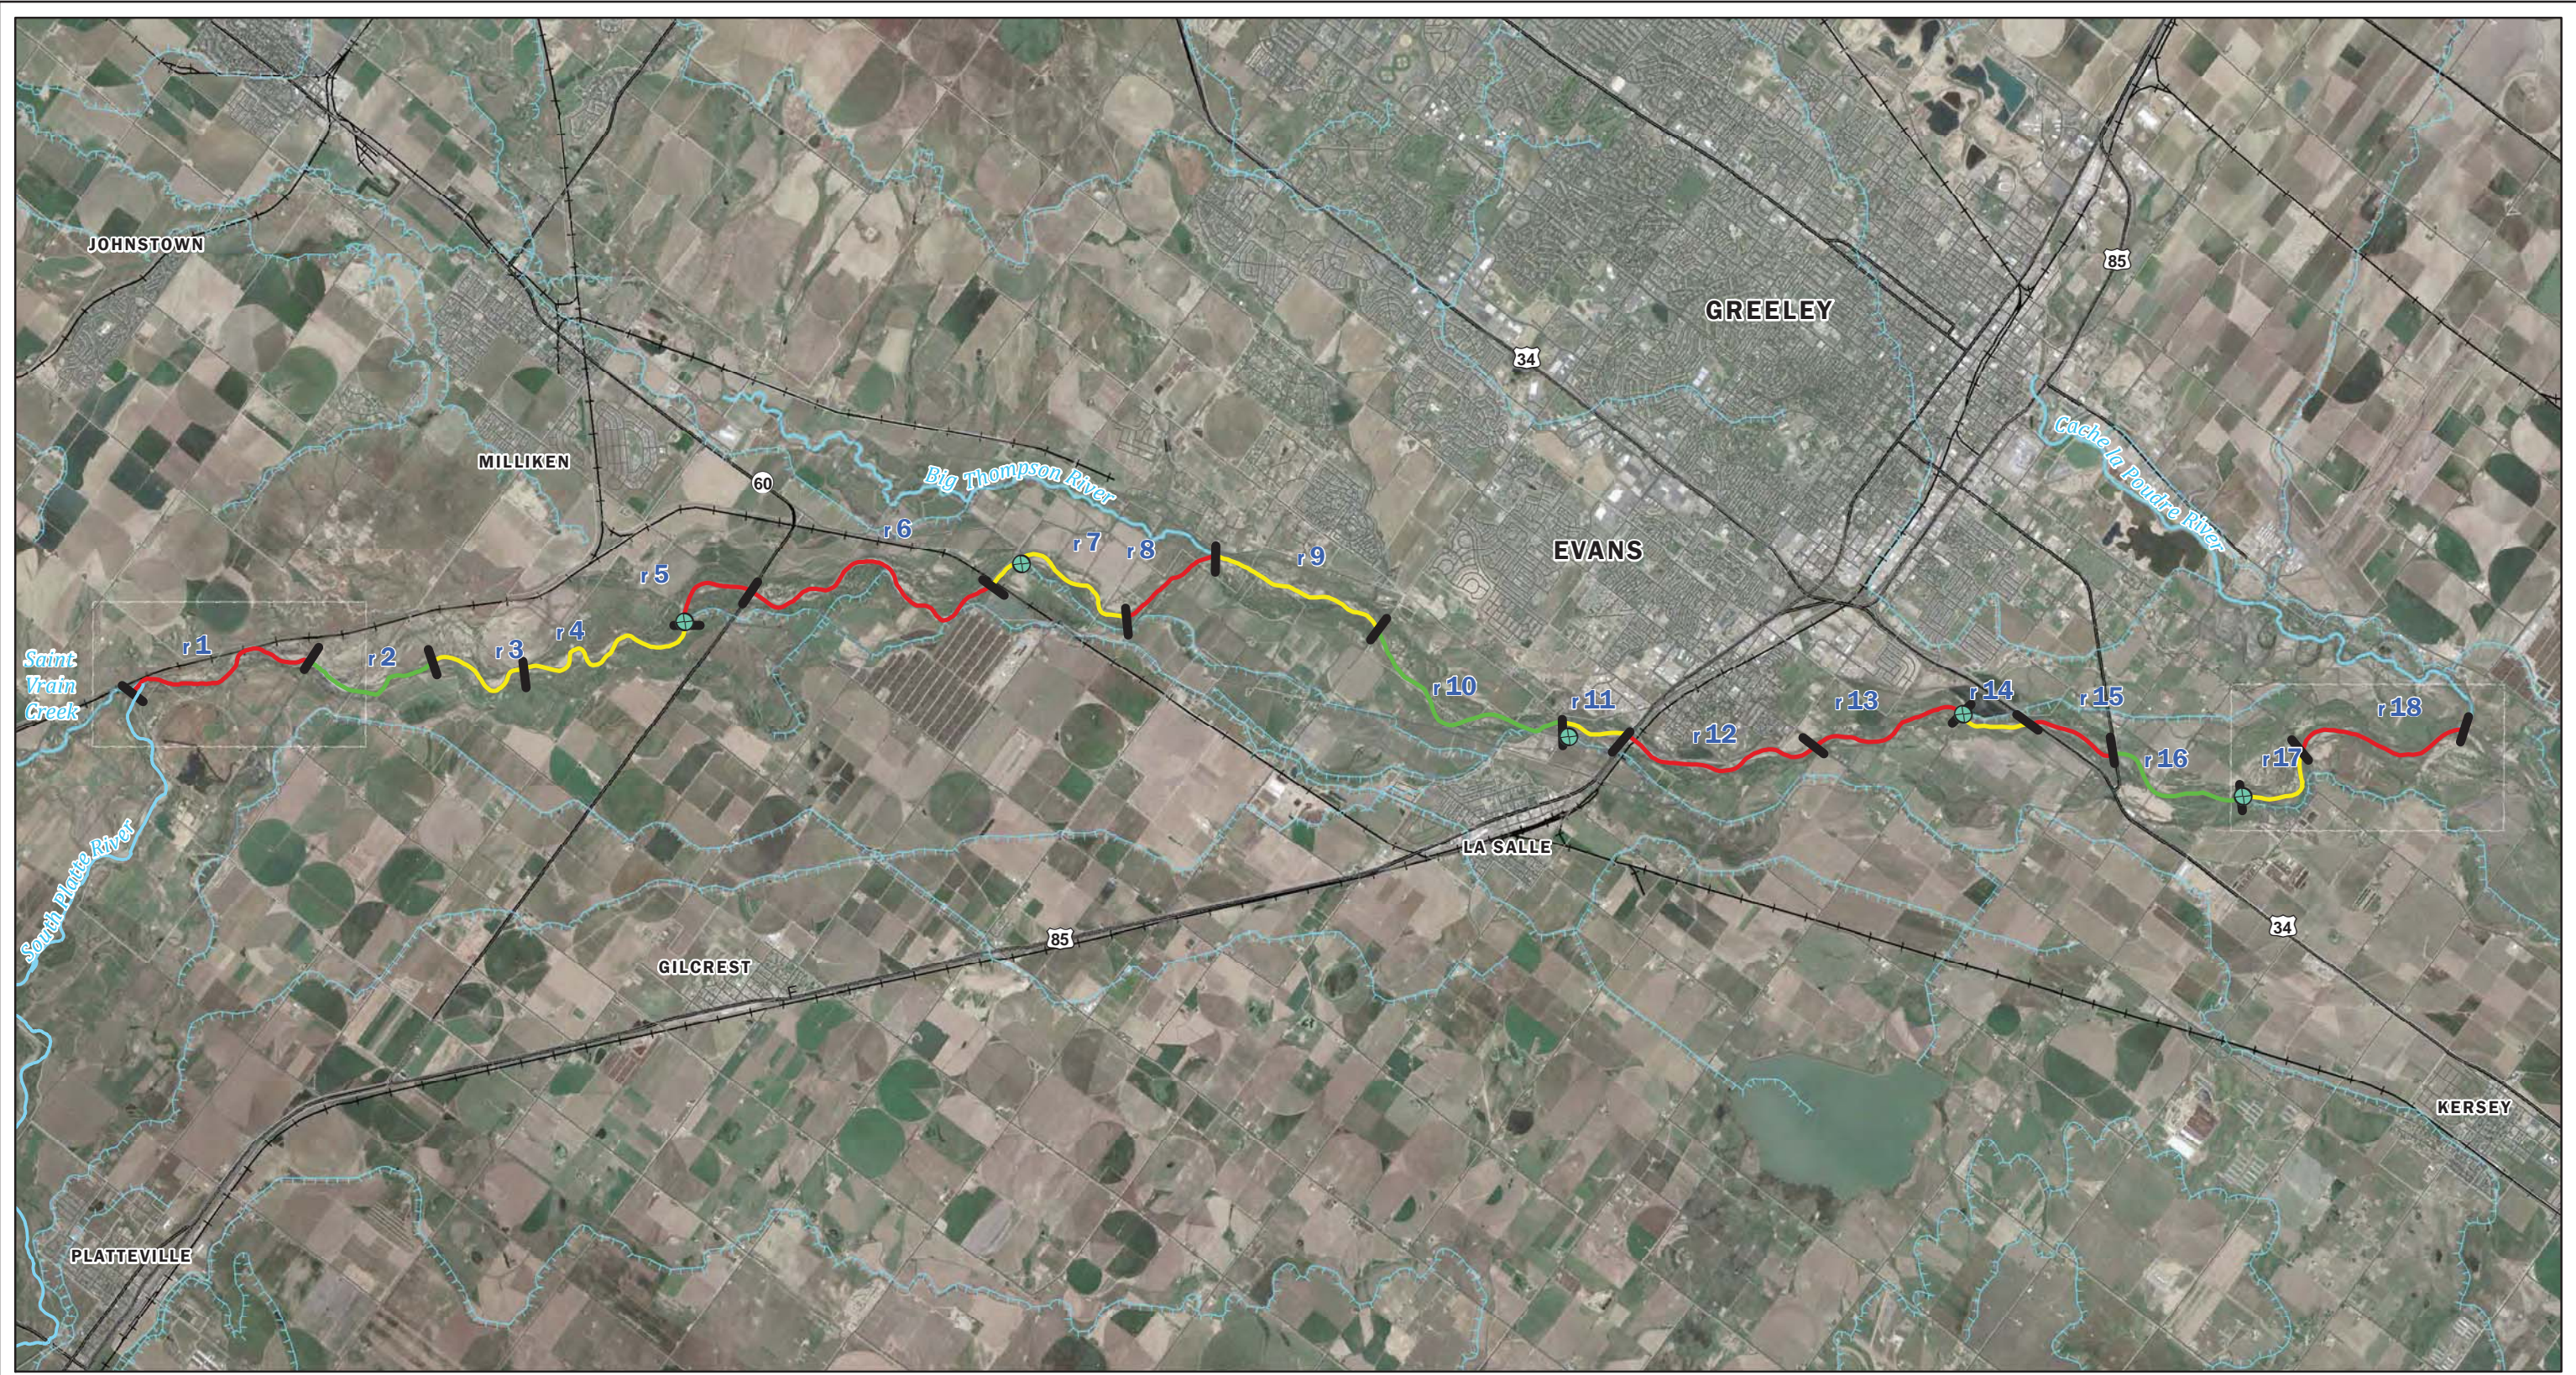
South Platte River Restoration Master Plan
Figure 5-5: Ecological Risk

An overall rank of Low, Medium, or High risk was assigned to each reach according to the ecological potential and severity scores shown in the ecological risk score matrix (**Table 5-6**). The ecological risk for each reach is shown in **Figure 5-5**.

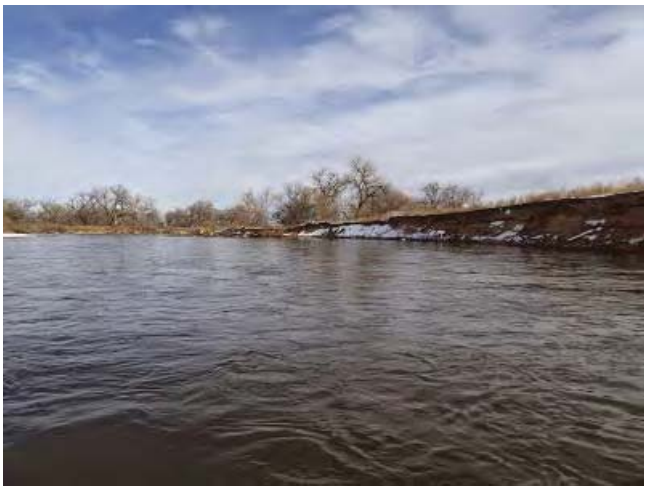
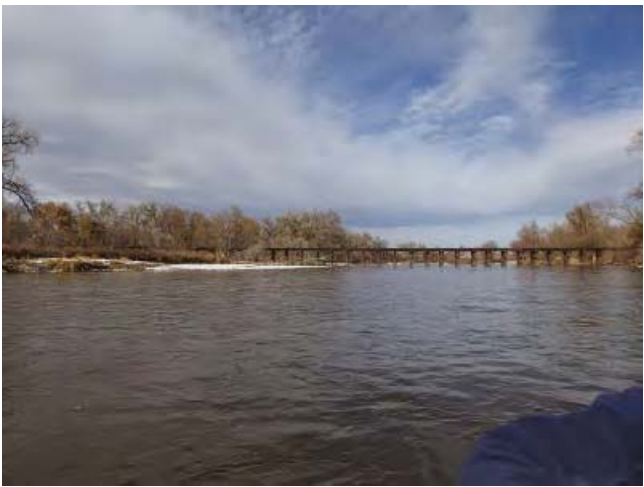
Table 5-13. Reach 7: Railroad Crossing to 6,900 Feet Downstream of the Railroad Crossing
