Middle South Platte River Restoration Master Plan

The Middle South Platte River Alliance

CDM Smith

November 2015

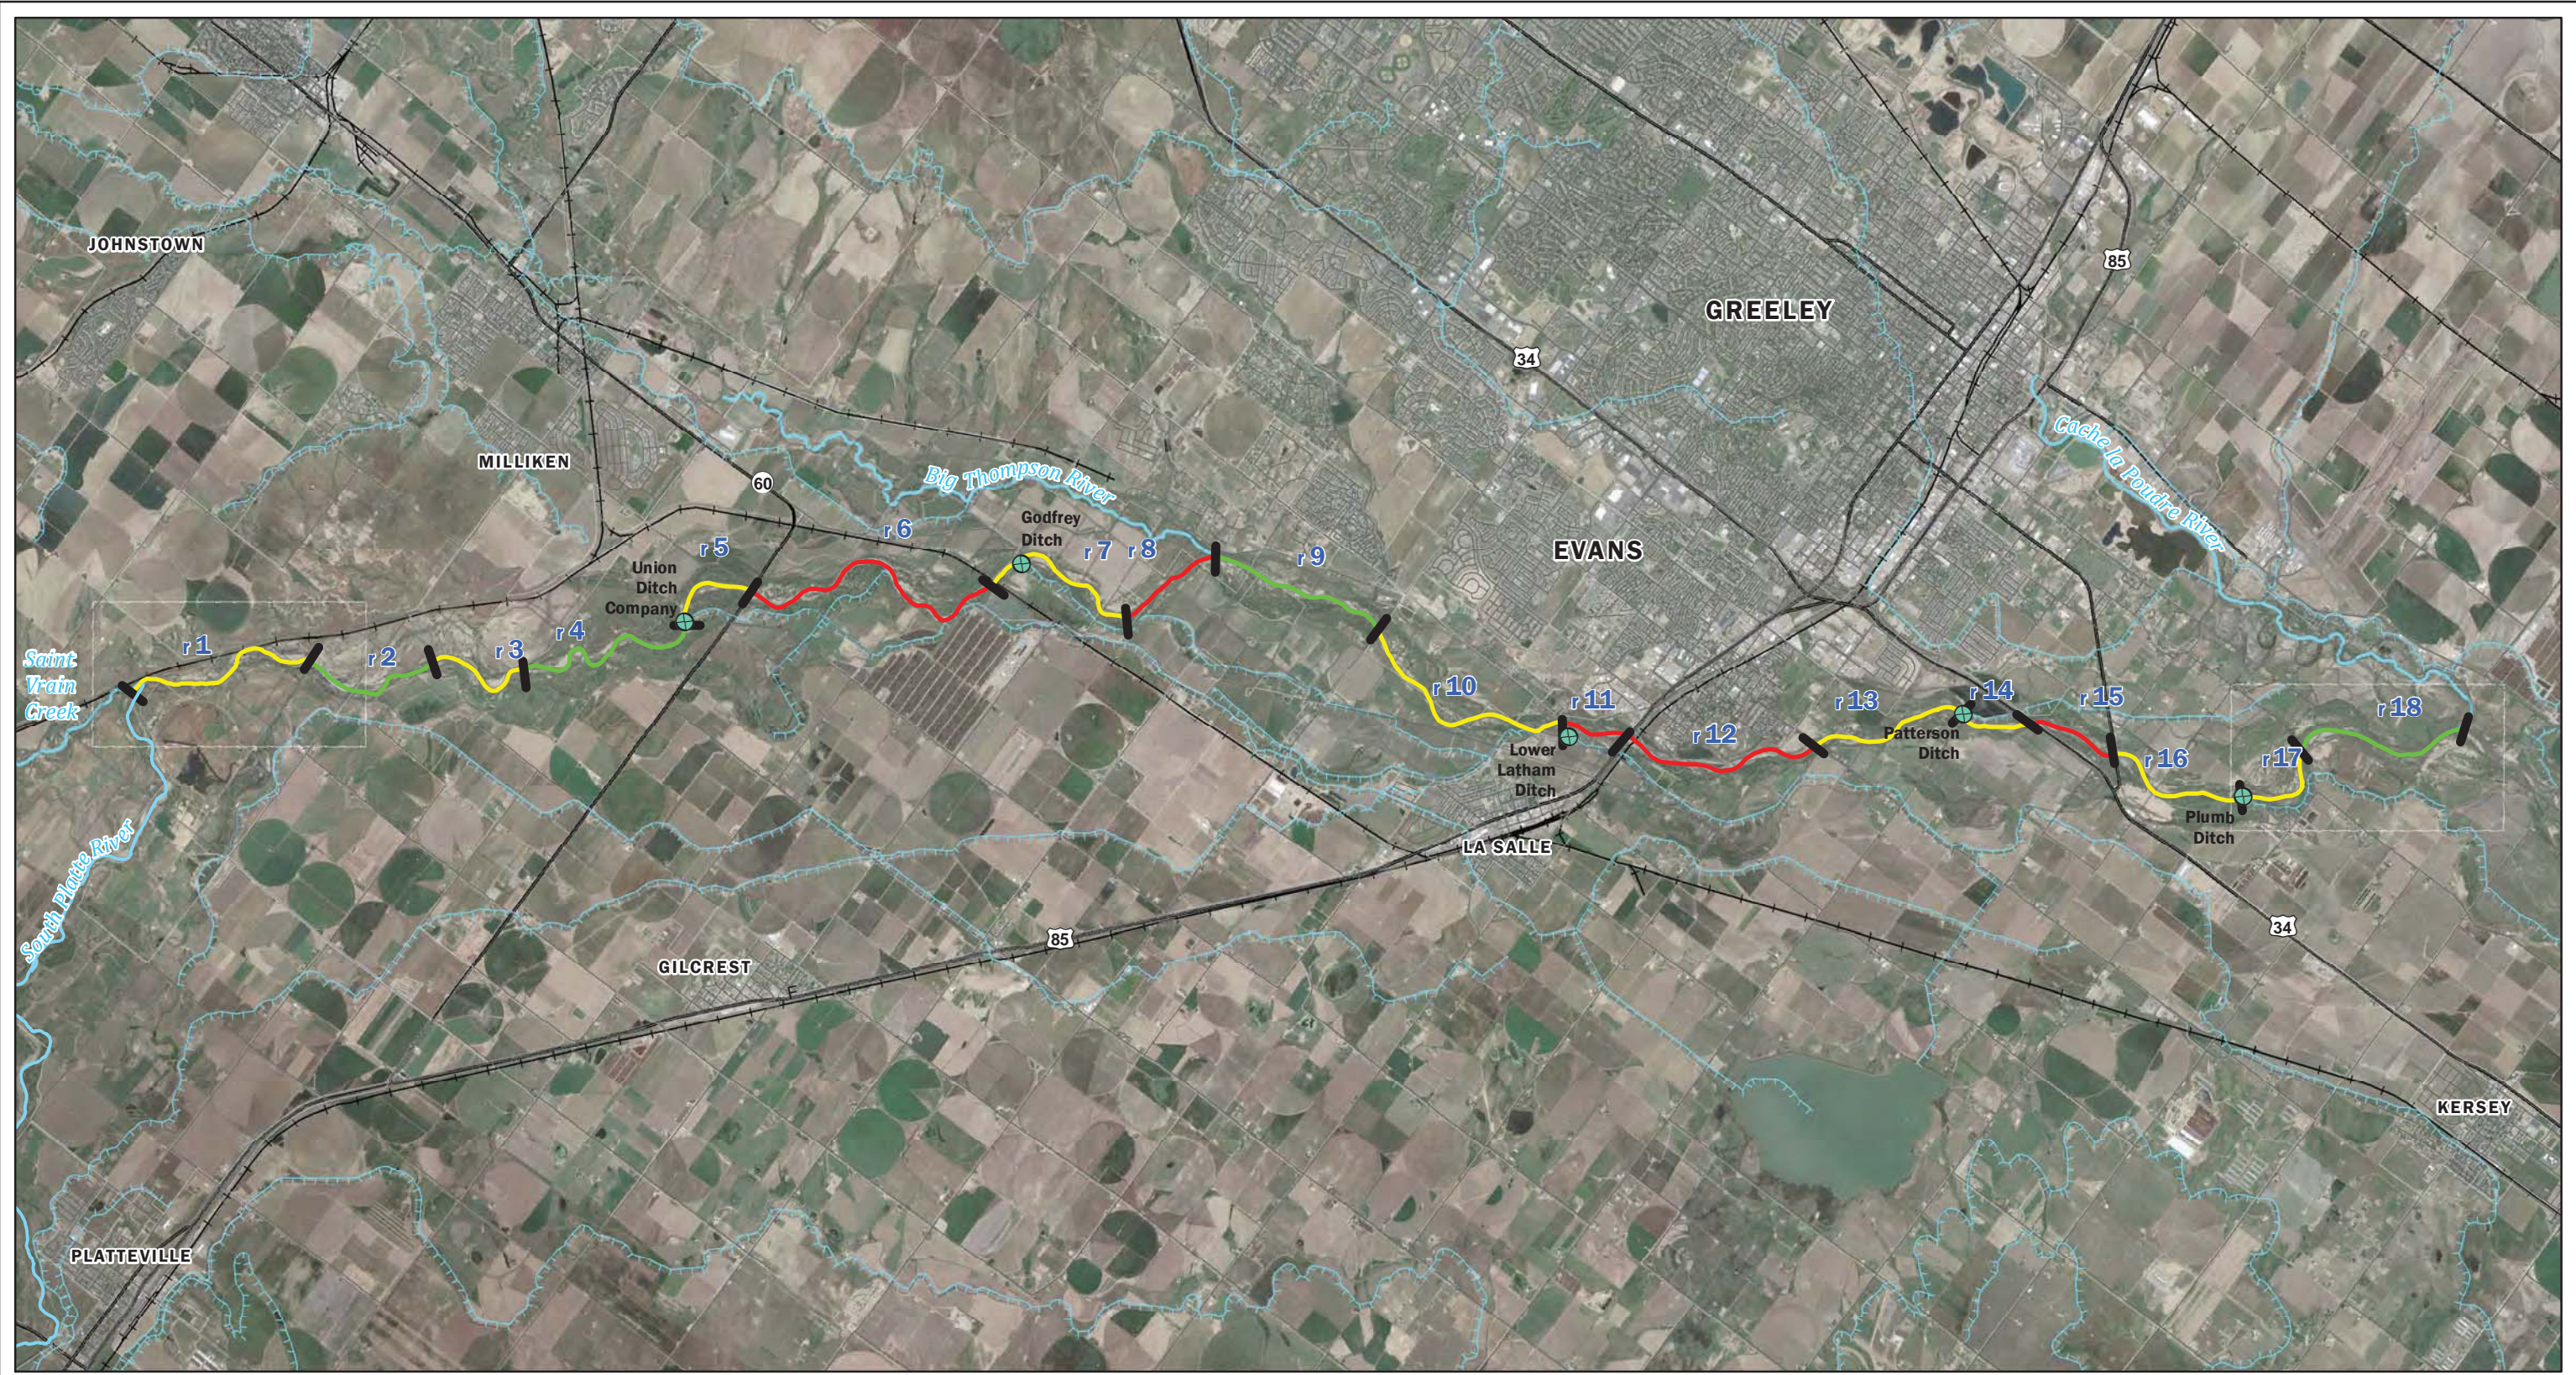
South Platte River Restoration Master Plan
Figure 6-1: Overall Risk Designation

Table 6-1 summarizes each reach’s fluvial geomorphic hazard, flood hazard, and ecological risk designation and **Figure 6-1** illustrates the findings for the overall project area.

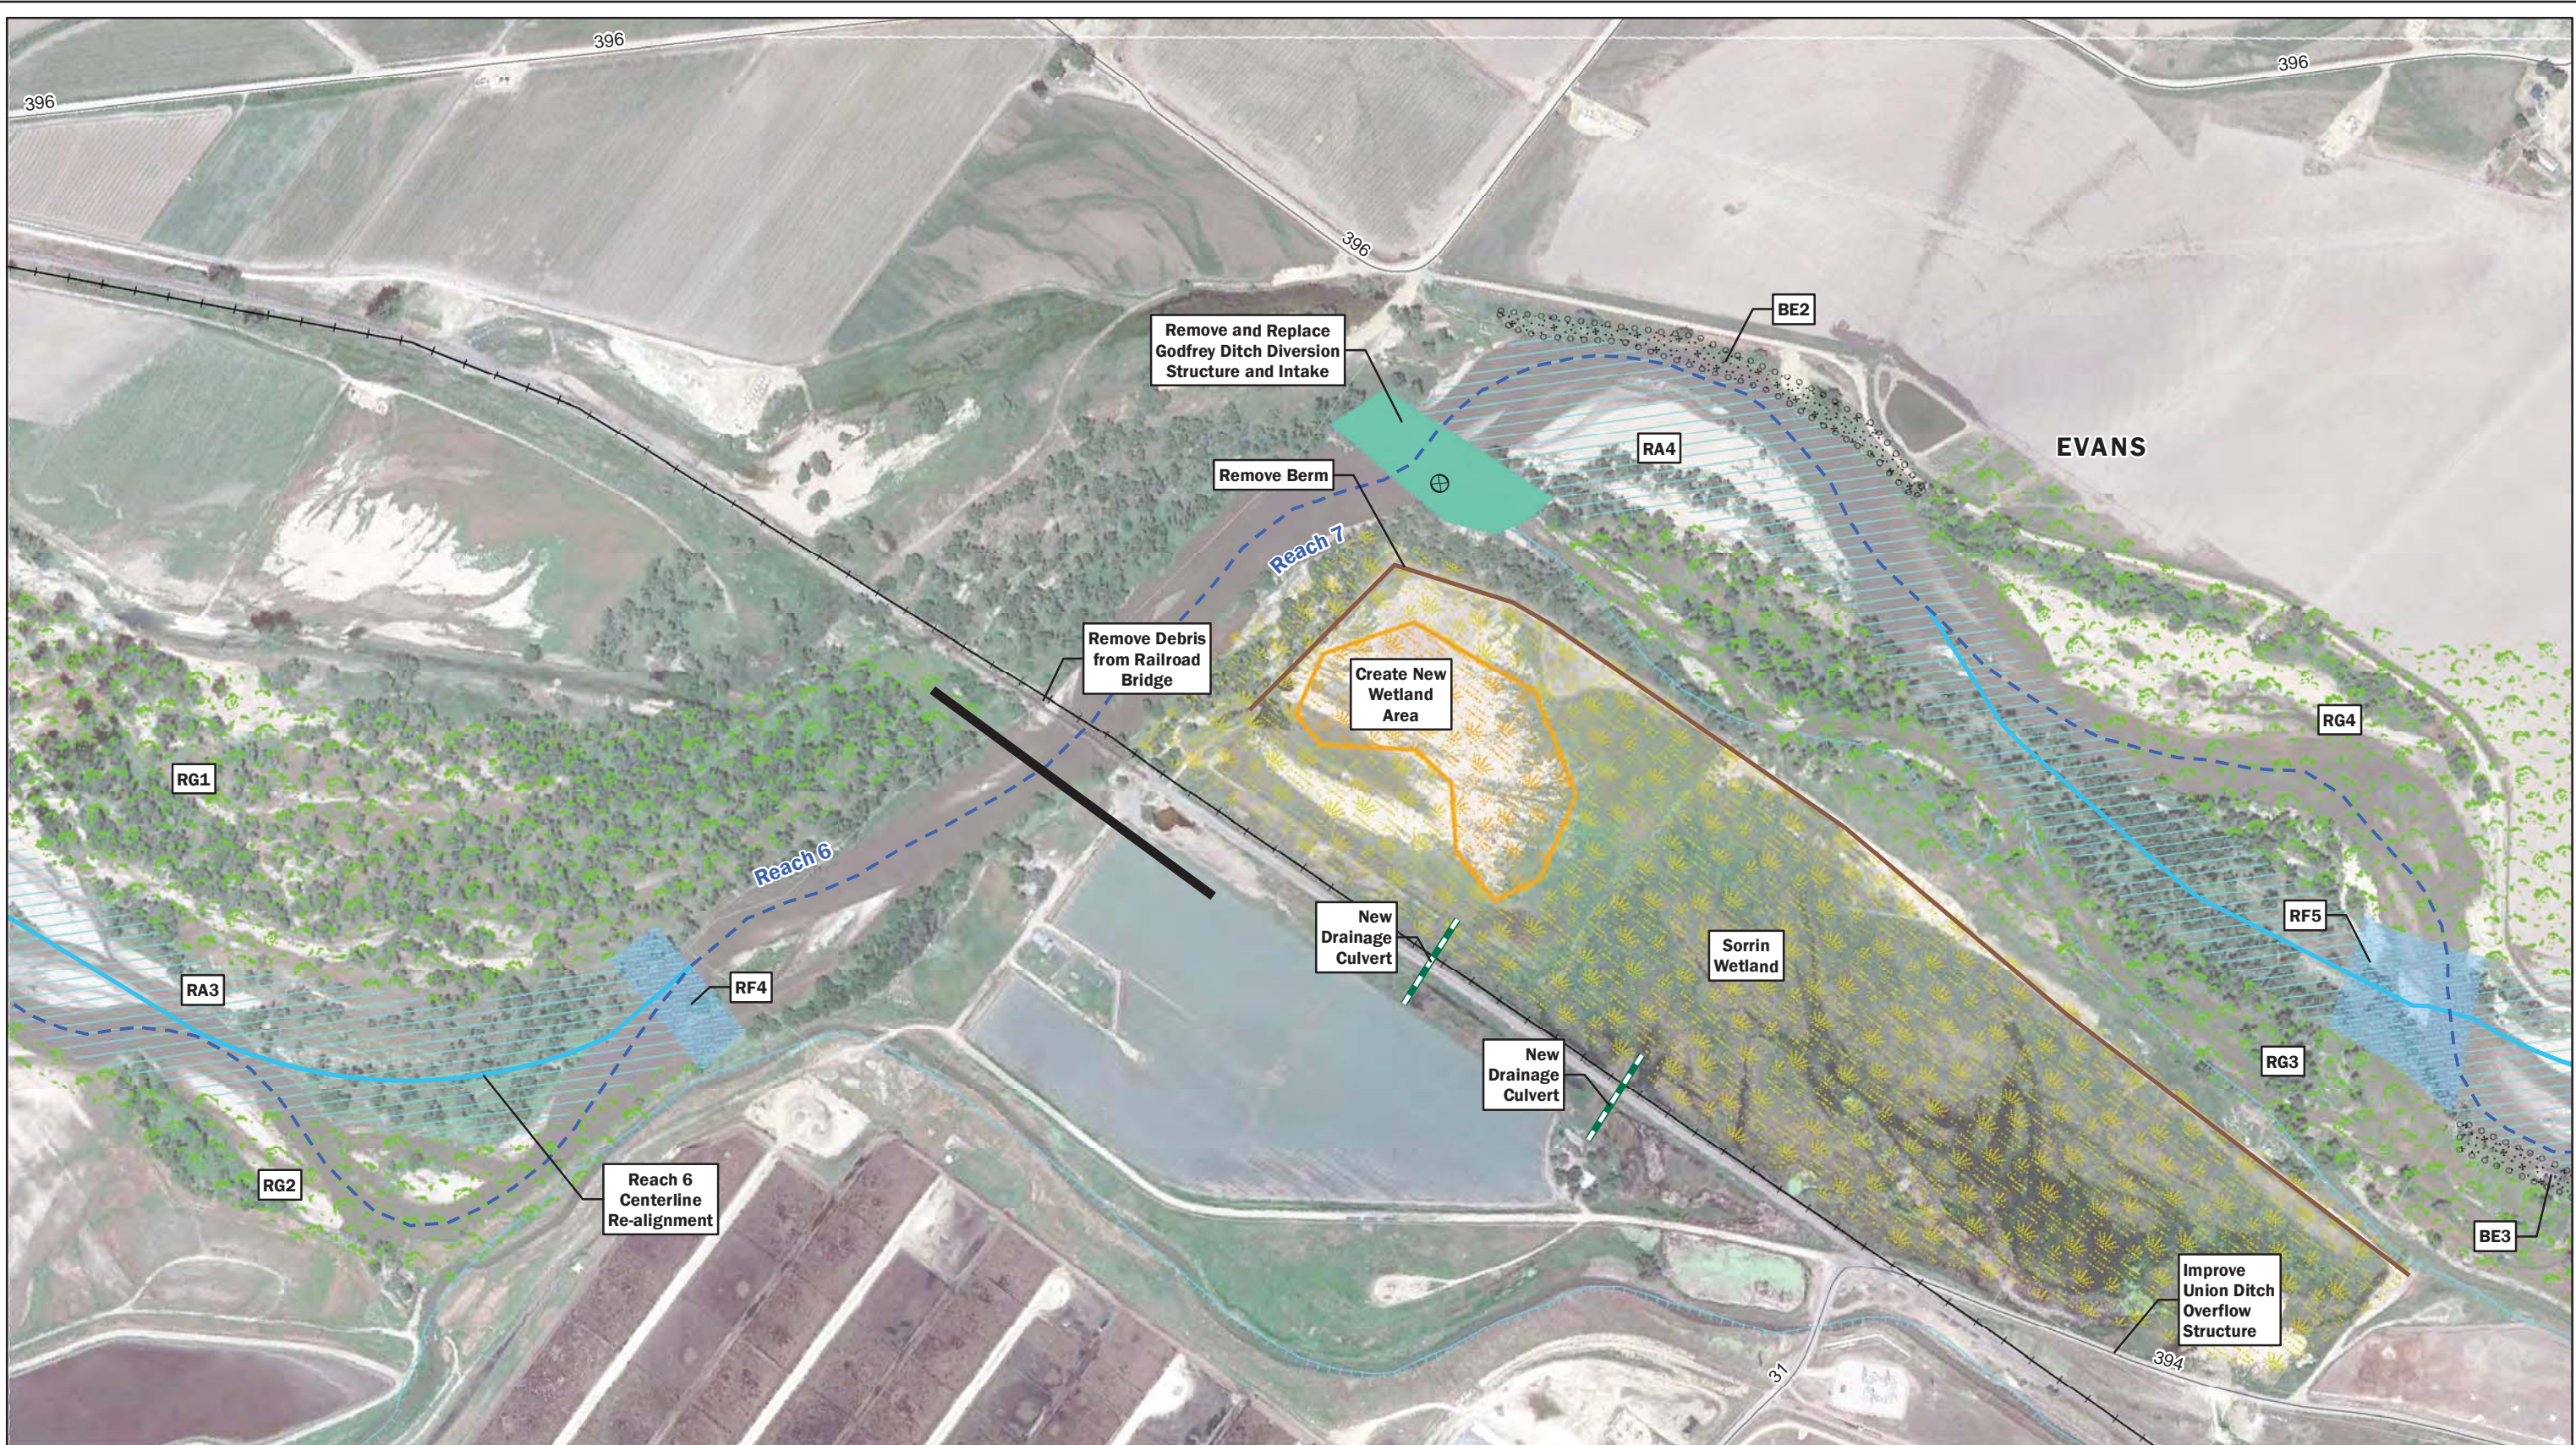
Figures 7-10 through 7-11 show proposed improvements to Reach 6. Projects within this reach include channel modifications, riffles and pools, regrading and revegetation, and bioengineered bank protection.

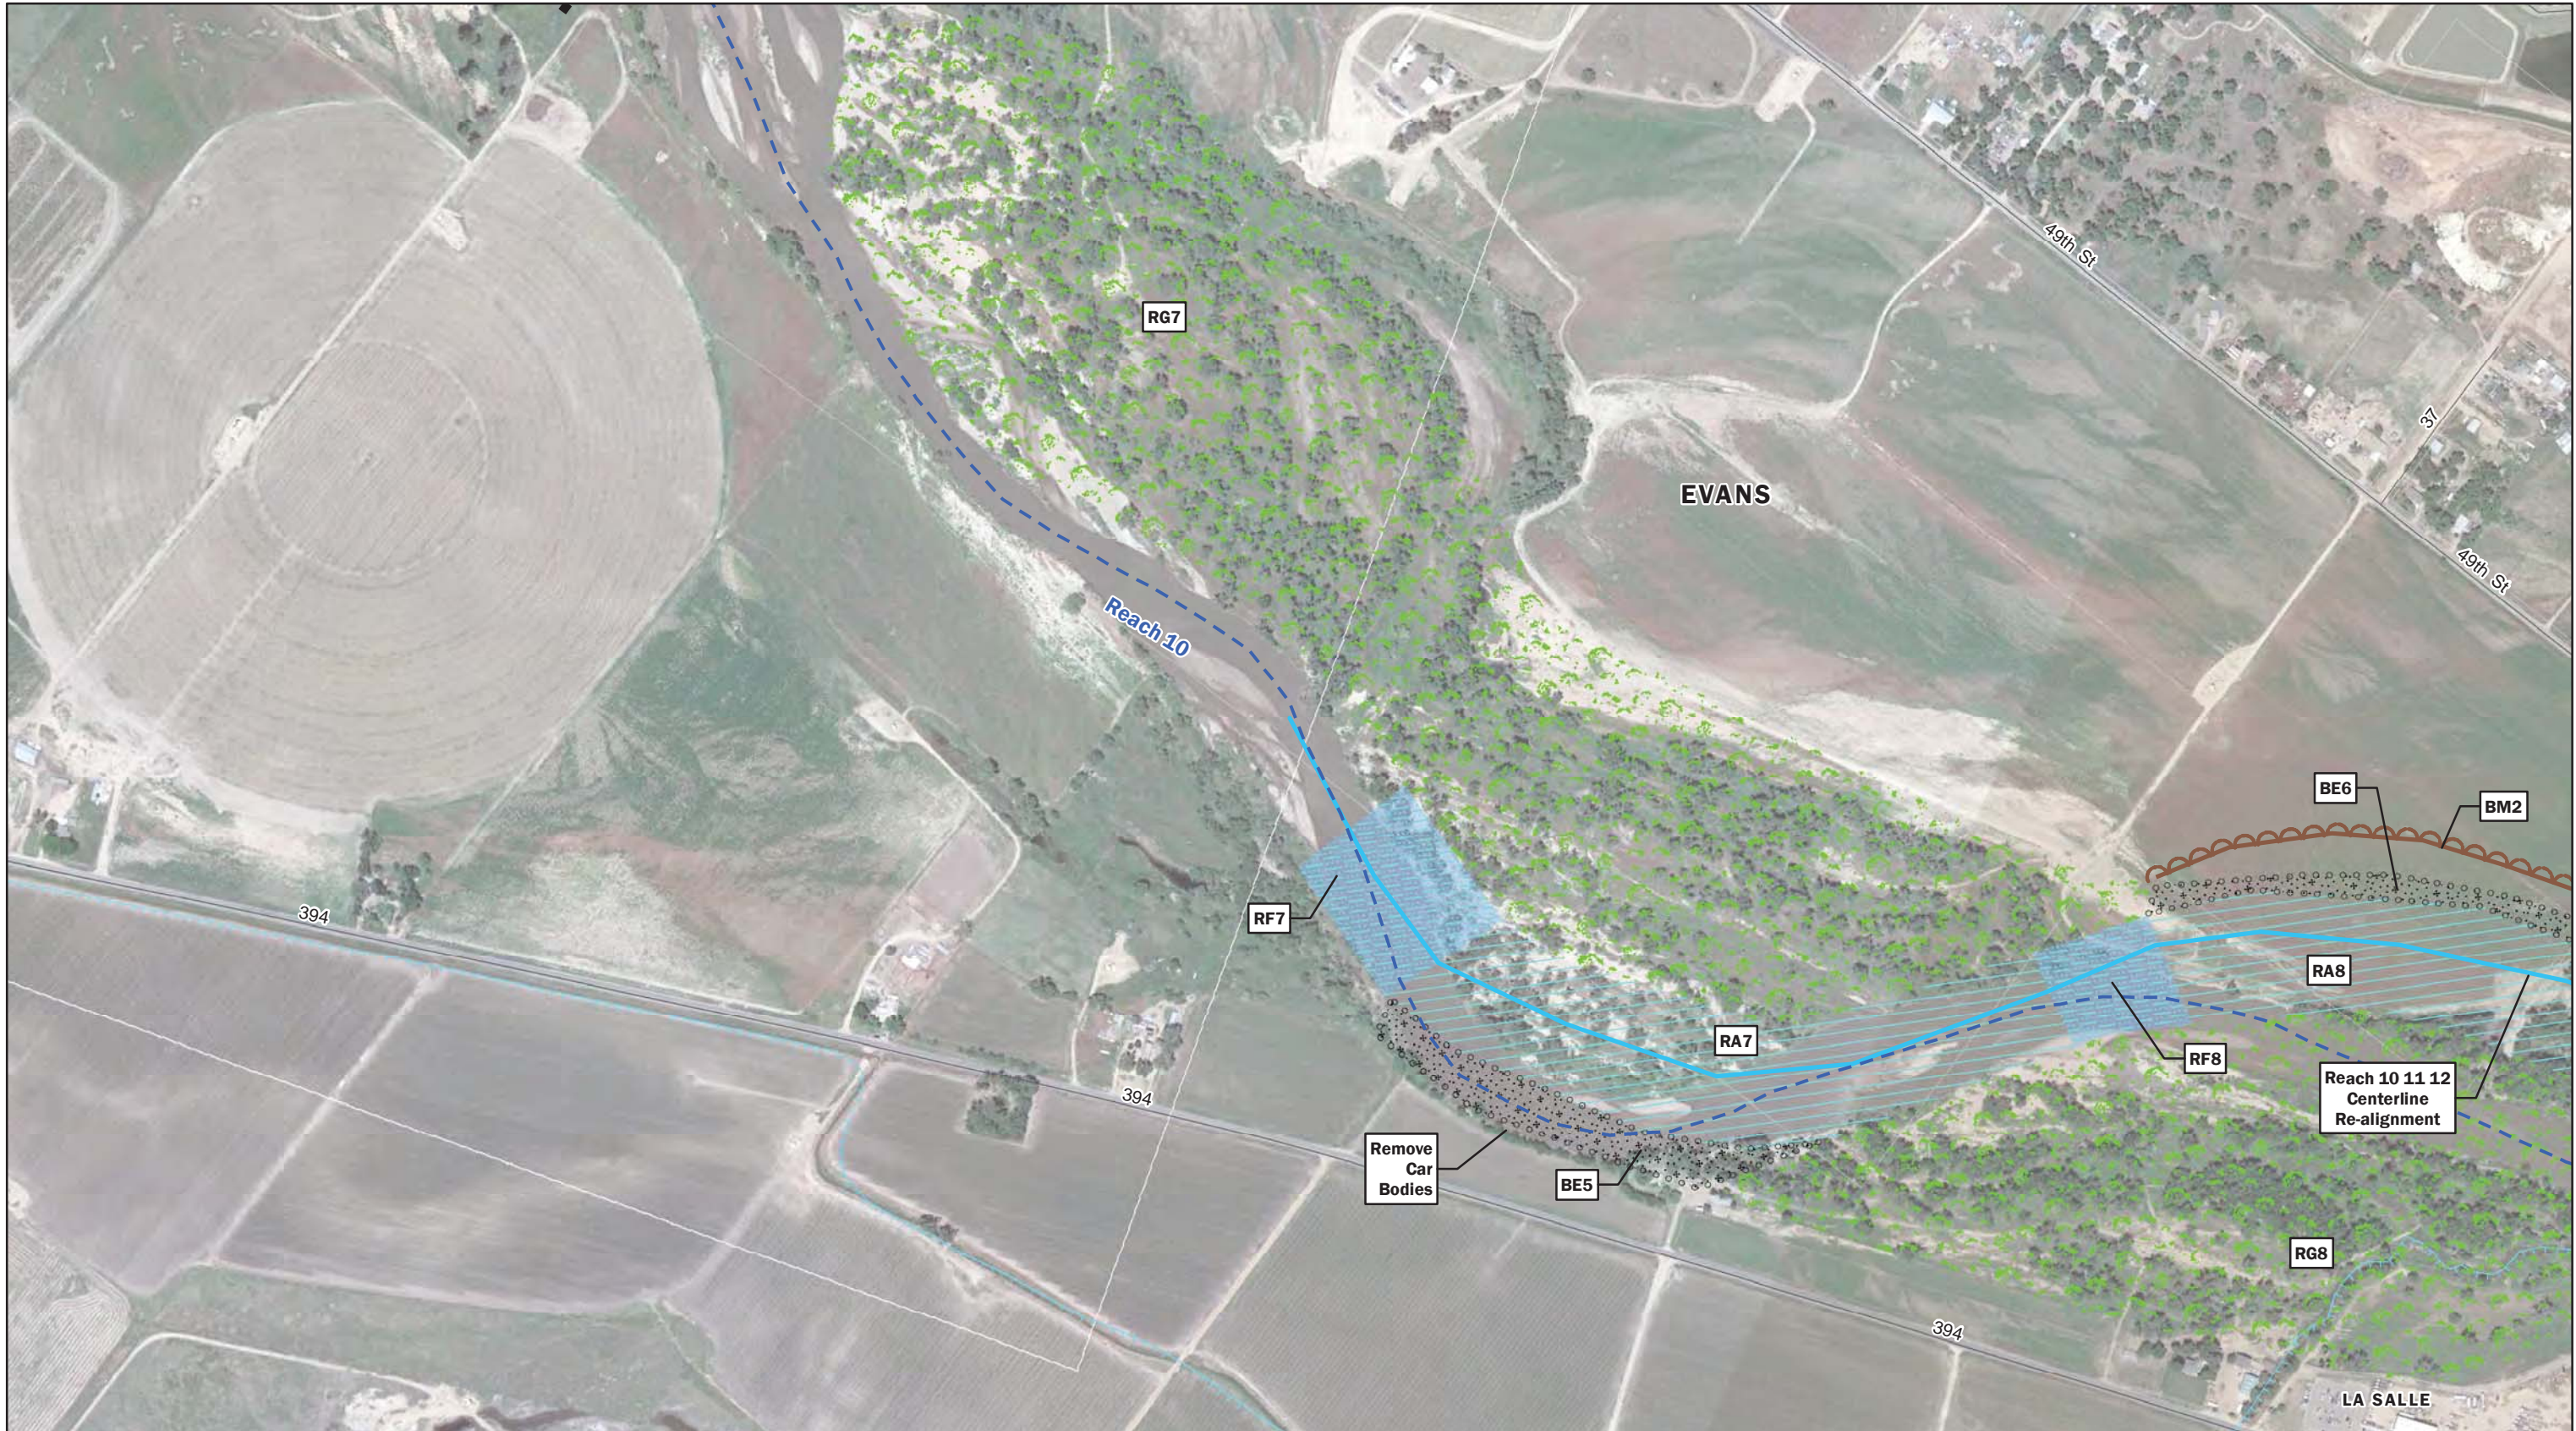
Figure
7-13

Figures 7-13 through 7-16 show proposed improvements to reaches 10, 11, and 12. Projects within this reach include channel modifications, riffles and pools, regrading and revegetation, and bioengineered bank protection. Specific projects in this section are removing car bodies that are protecting some banks within this reach and replacing them with bioengineered bank protection, constructing an earthen berm to protect private property, improving the Latham ditch diversion structure, and removing debris and sediment from the Highway 85 and railroad bridges.

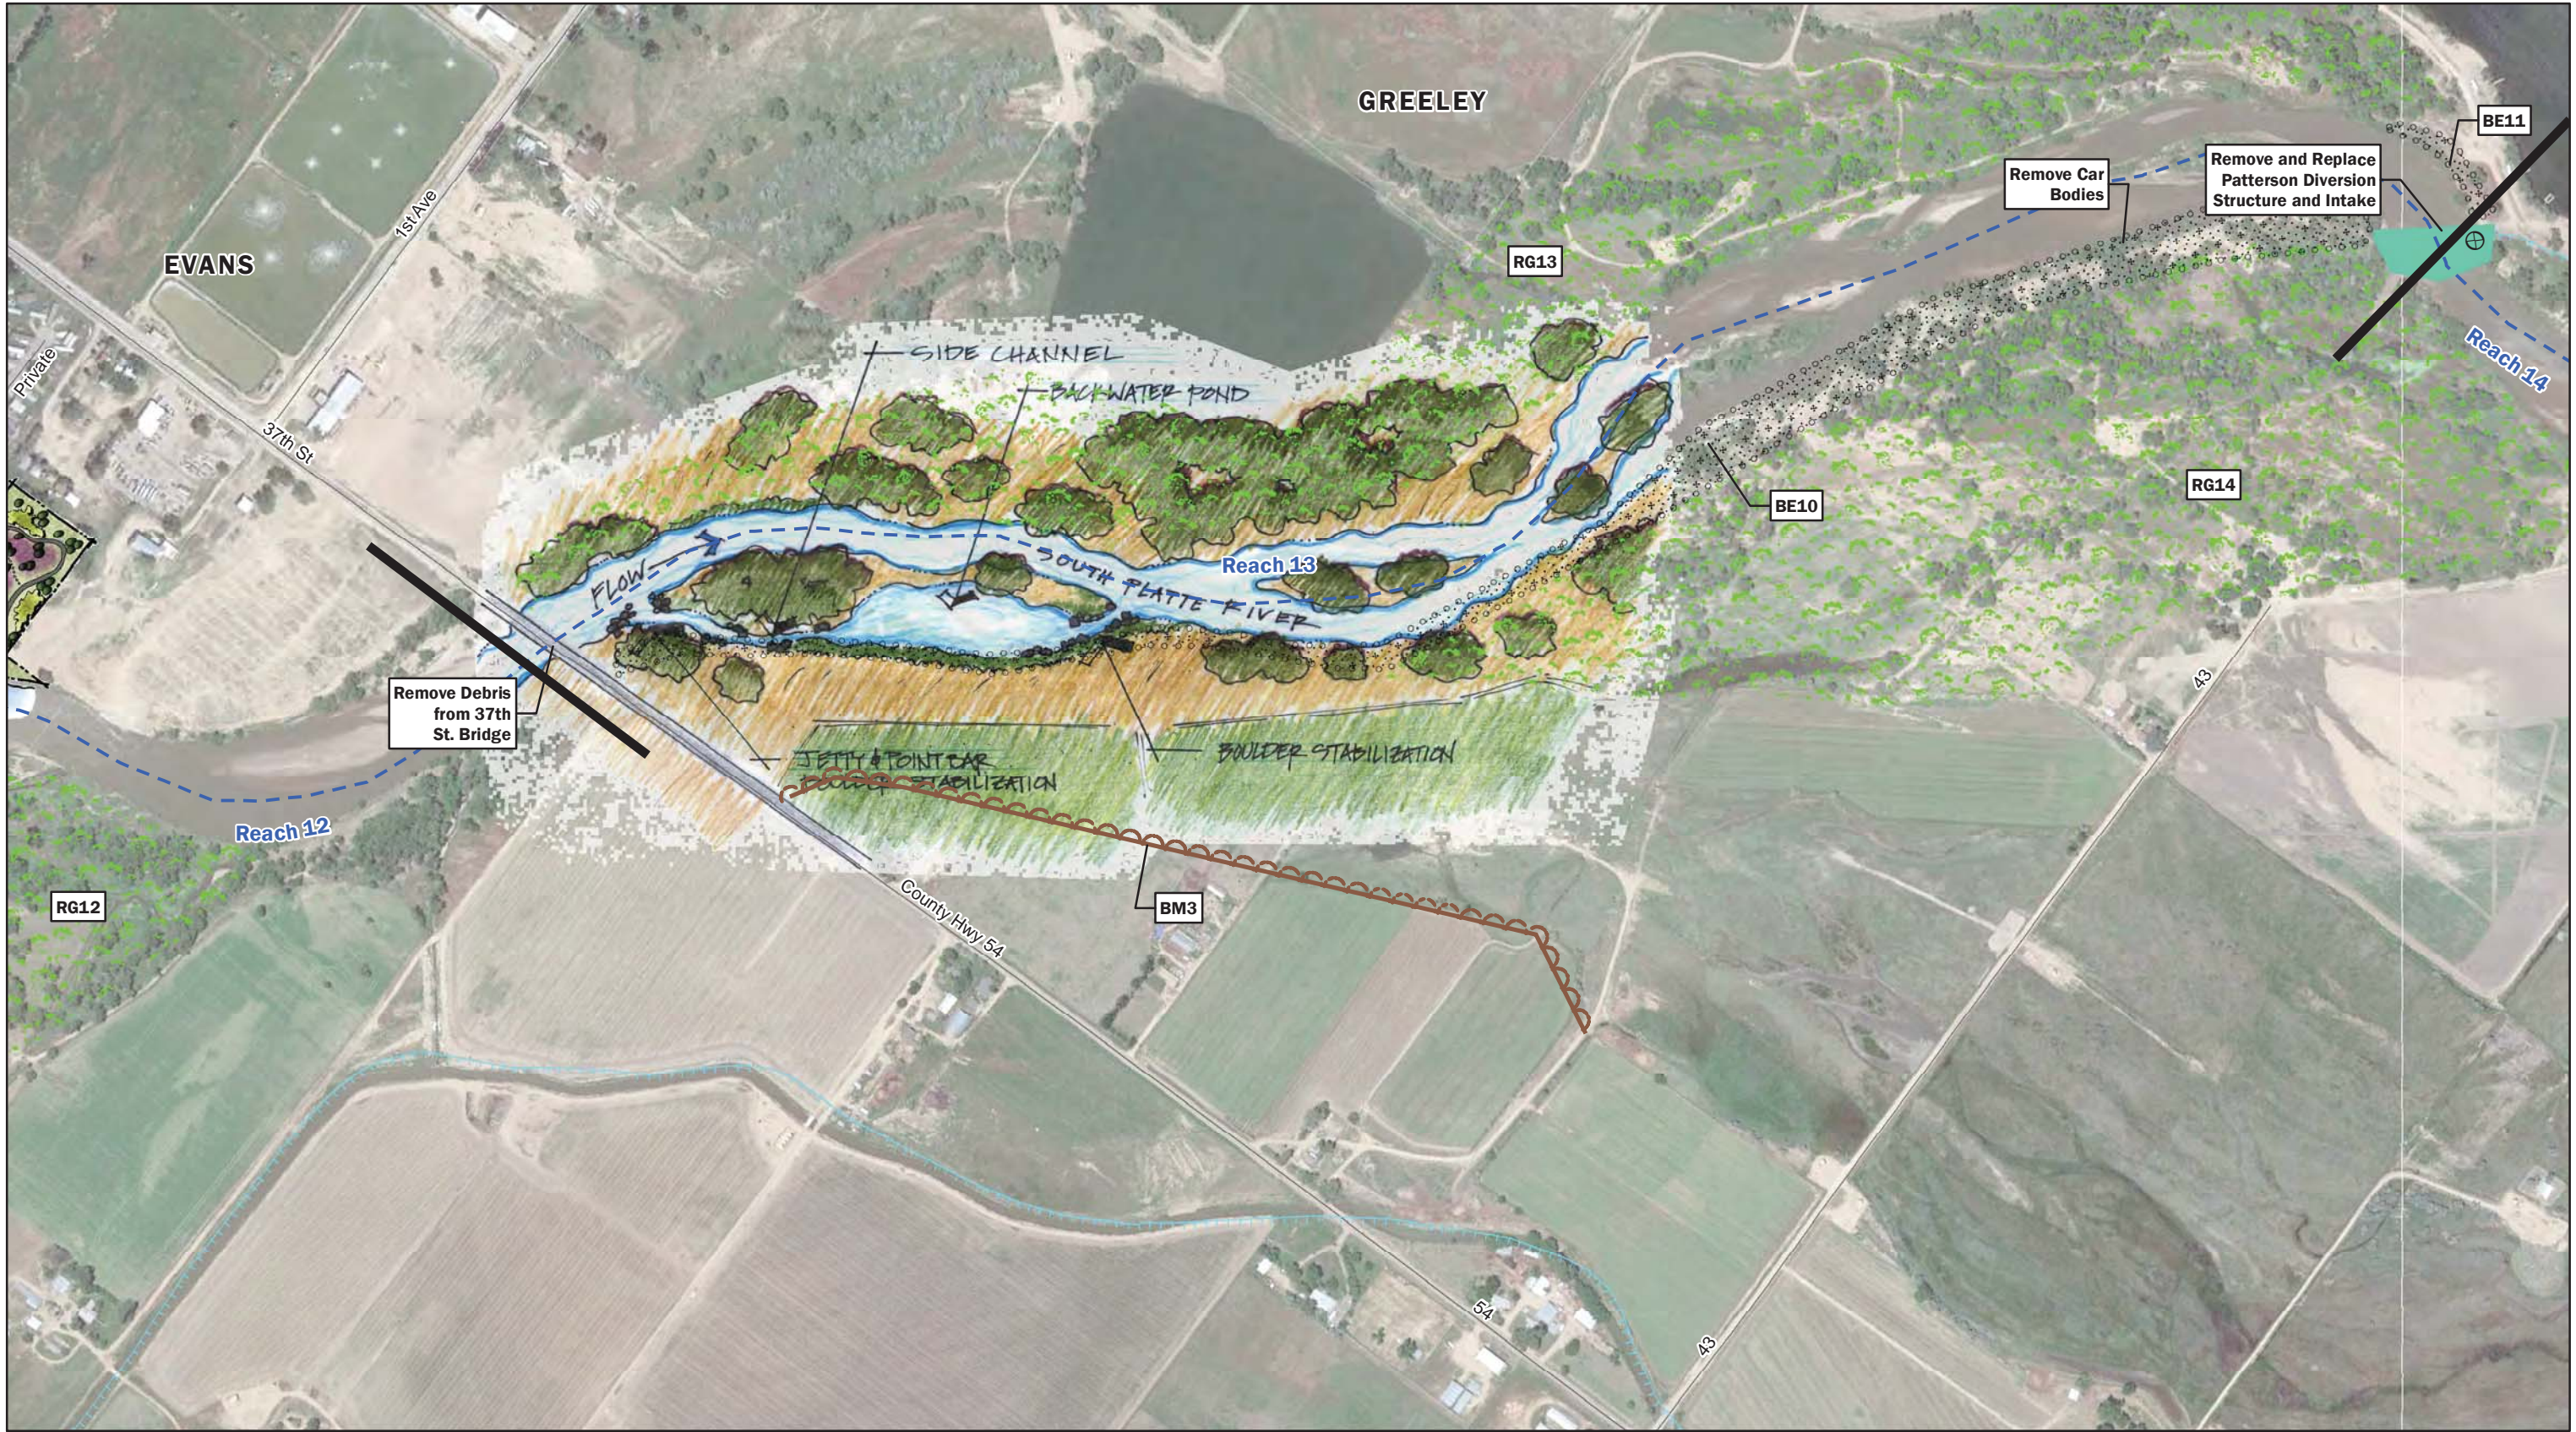
Figure
7-16

Figures 7-16 through 7-17 show proposed improvements to reaches 13 and 14. Projects within this reach include regrading and revegetation, and bioengineered bank protection. Specific projects in this section are removing car bodies that are protecting some banks within this reach and replacing them with bioengineered bank protection, constructing an earthen berm to protect the private property, improving the Patterson ditch diversion structure, and removing debris and sediment from the 37th Street Bridge.
