**RE: FINAL PROGRESS REPORT
WHITE RIVER-HIGHLAND DITCH DIVERSION PROJECT, YAMPA BASIN
POGGI PDAA 2015 0000000000000164**

30% Design Report
White River - Highland Ditch Diversion Modification Project (HDDMP)
February 2016

HIGHLAND DITCH DIVERSION
MODIFICATION PROJECT (HDDMP)
PRELIMINARY DESIGN ITERATION 1

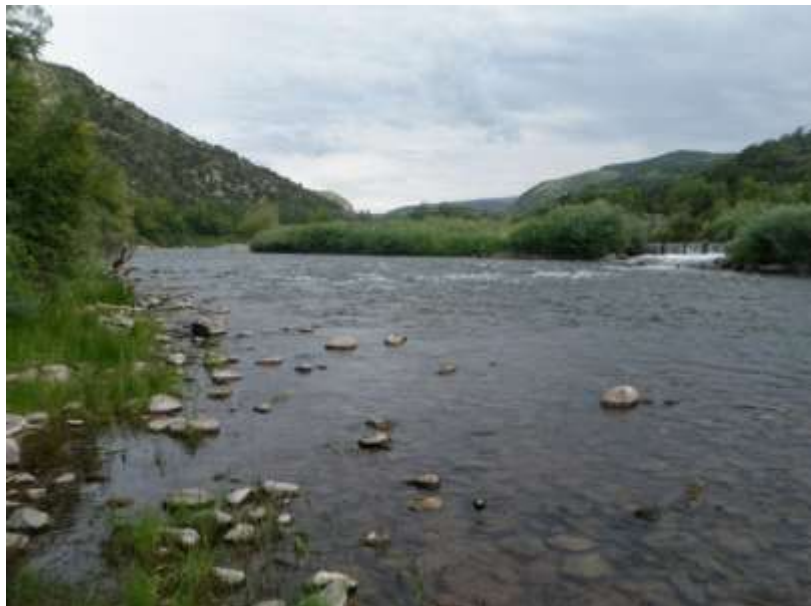
White River substrate appears to be fairly well-armored and is comprised of river cobble as well as sand and silt. From field inspection and review of site photos, it is estimated that the D₅₀ of the bed material is on the order of 4" to 6" with many large boulders present predominantly along the north bank near the toe of the slope. Substrate in Highland ditch itself is smaller and has a larger percentage of fines and silts due to lower grades and velocities. Ditch substrate is

estimated to have the D₅₀ on the order of 3" to 5". Substrate in both the river and the ditch are likely mobile during higher flows and runoff. Substrate classification is anecdotal based on observations made during the field channel survey. No samples were collected and no gradation analysis was performed.

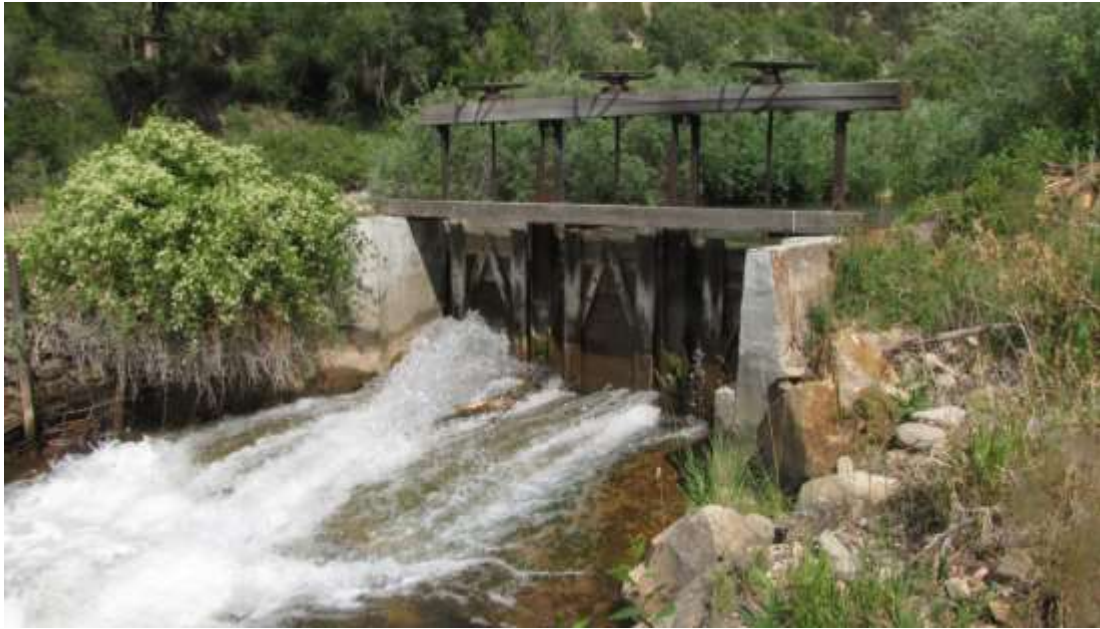
Figure 6: Existing headgate structure at beginning of Highland Ditch.

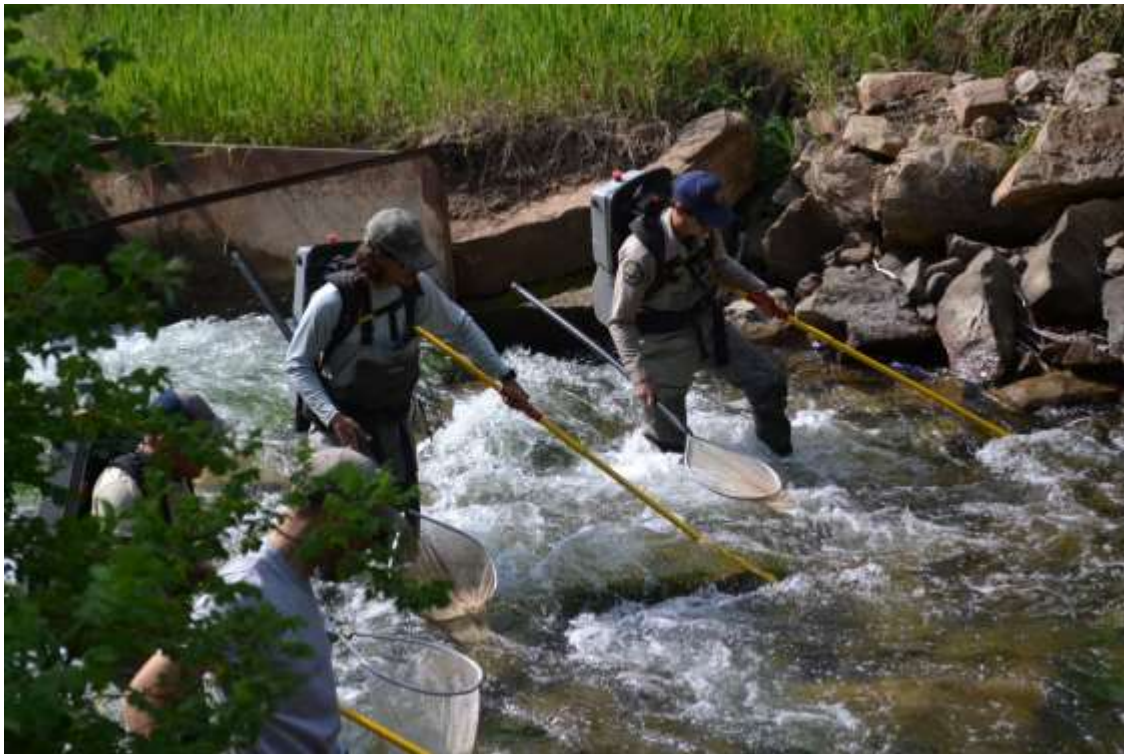
Figure 7: District Wildlife Manager Evan Jones and an Elk Creek Ranch Guide use backpack electrofishing units to salvage fish from the Highland Ditch.

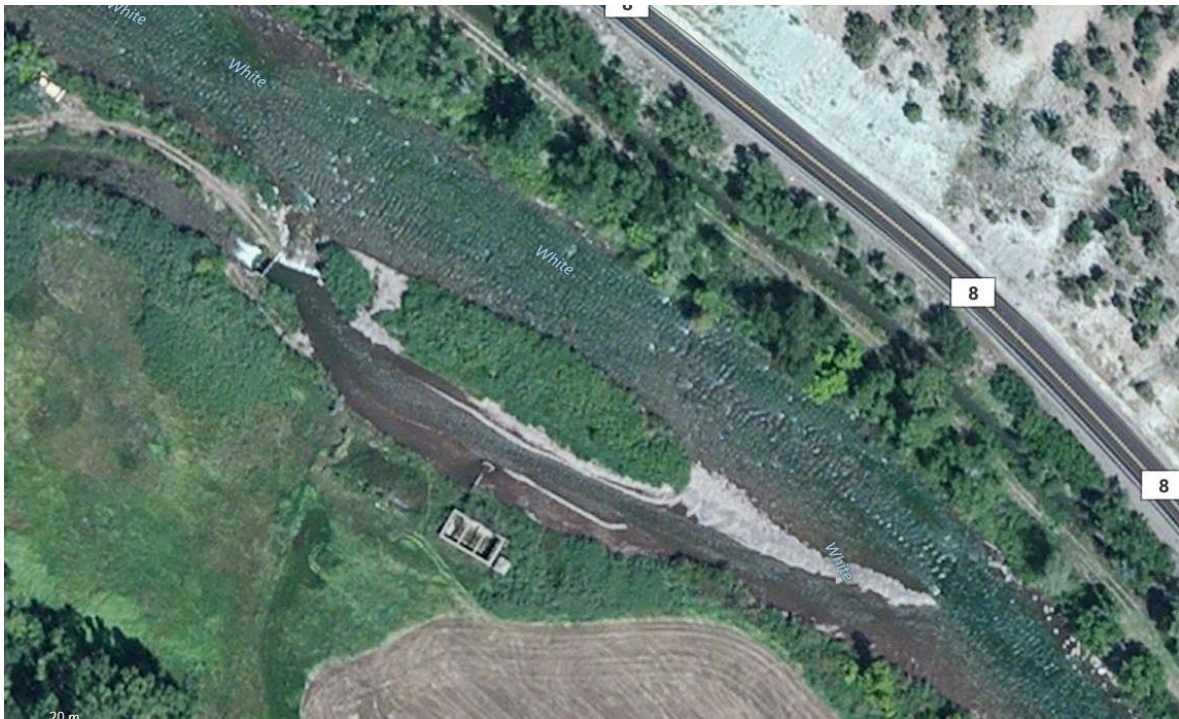
Figure 1 - Aerial View of Highland Ditch Diversion

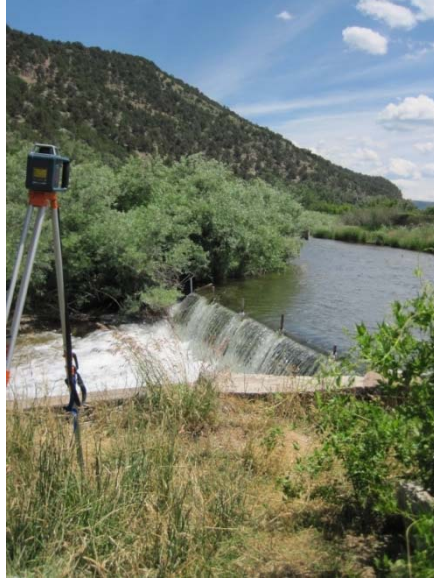
Figure 4 - Existing Stanchion Dam

At the downstream most point of the island is the return channel, see Figure 3. This channel allows water that was diverted into the left channel to be returned to the main White River if it will not be used for irrigation purposes. This return channel can be dammed with the use of an existing stanchion dam which is roughly 35 feet across. This dam uses wooden flash boards that can be adjusted to create more water head on the upstream side of the head gate structure. It appears that the maximum height of the dam is roughly 3 feet above the existing ground level in the left channel.

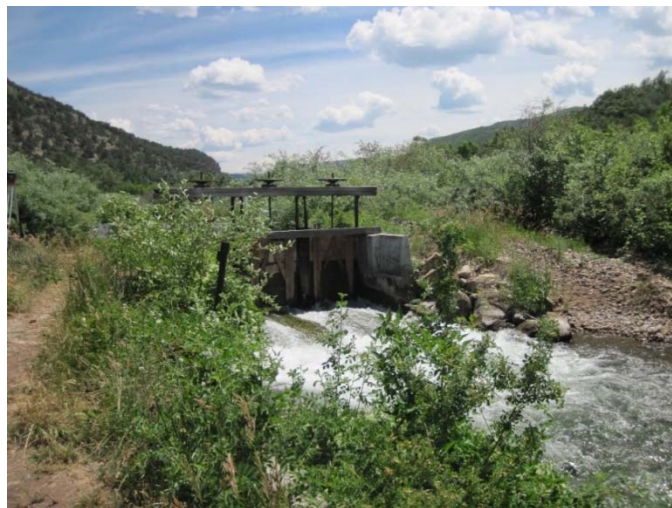
Figure 5 - Existing Head Gate Structure

The head gate structure consists of three rectangular slide gates which are used to regulate the amount of flow entering the Highland Ditch. The existing structure is a headwall made from concrete with concrete abutments. Culverts through the headwall are regulated with slide gates. There is a grouted spillway between the head gates and main canal.

The access road to the head gate structure and stanchion dam follows the north side of the ditch and ends at the right abutment of the head gate structure. Approximately 700 yards down the ditch is a 10 foot Parshall flume for measuring the amount of diverted water.

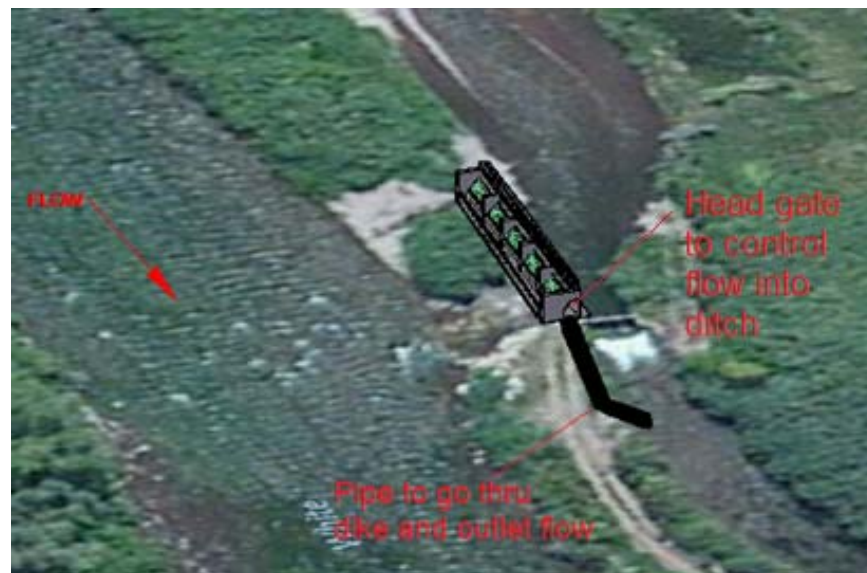
Figure 9 - Original placement of Coanda Screen

The next step in the design process was to determine the layout of the coanda screen. At this point in the design process, it was determined that the original notion to place the screen perpendicular to the head gates at the location of the stanchion dam presented an issue. Visual cues during the site visit and results of flow monitoring during the irrigation season of 2014 suggested that a pipe placed through the existing dike on the east side of the canal would be feasible. Calculations and further study, however, showed that it would not be feasible. This caused the layout to change as shown in Figures 9 and 10.

The original orientation of the coanda screen was especially beneficial because it provided an easy means of bypassing the fish screen and diverting water if an issue with the fish screen were to arise. Rather than using the fish screen, one would just open up the existing head gates (or upgraded head gates) and take the water directly from the left channel. Additionally, when using the coanda screen, controlling the amount of flow into the ditch was fairly straightforward and just necessitated using the proposed head gate on the screen.

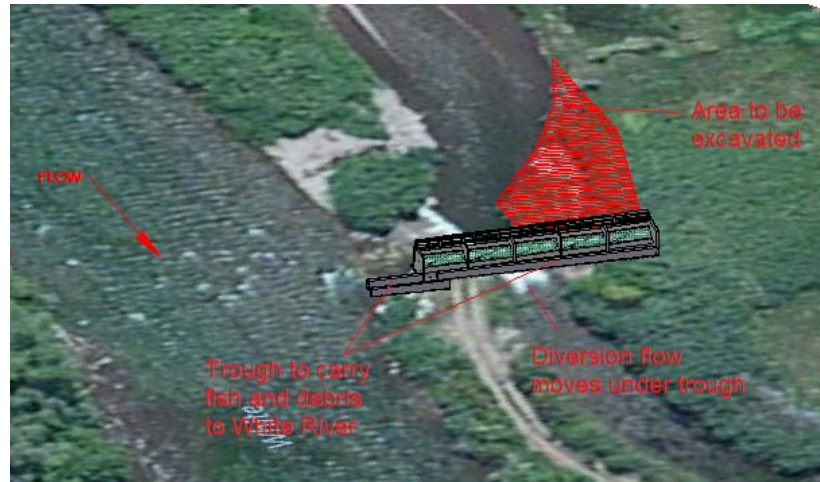
Figure 10 - Altered placement of the Coanda Screen

As one can see, the easy method of bypassing the fish screen in the original layout was no longer an option. The resolution to this issue was to place head gates on the back of the structure so that water could just flow under the screen. Additionally, it was no longer straightforward to control the flow into the ditch. Several possibilities exist to control the water into the ditch, but without water user input this was not resolved.

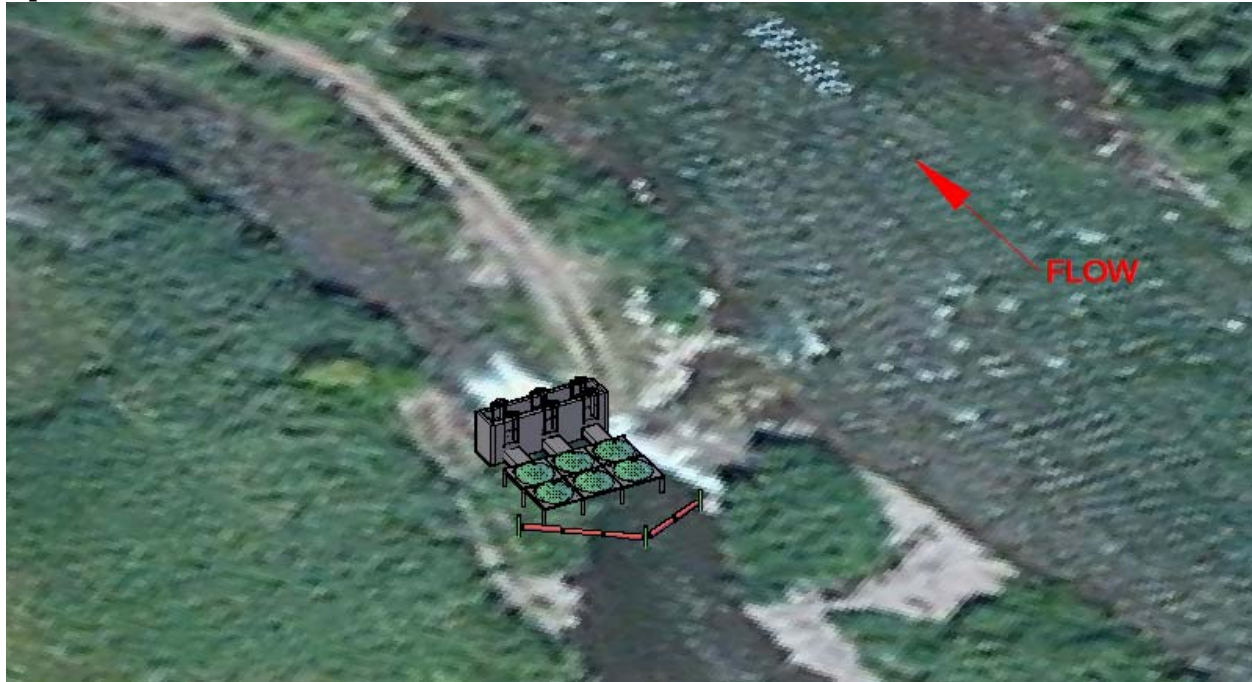
Figure 11 - Cone Screen Layout

- The screens would be located just upstream of the head gate, in the pool above the stanchion dam (3).
- The cone screens would be 12' in diameter and 3' tall. They would be cleaned by a brush system and powered by a solar electric system.

- In addition to solar panels, the installation will have an enclosure to house batteries and a control panel to regulate the operation of the screen.
- It may be necessary to remove the screen from the water during the winter to avoid potential damage from ice in the creek.

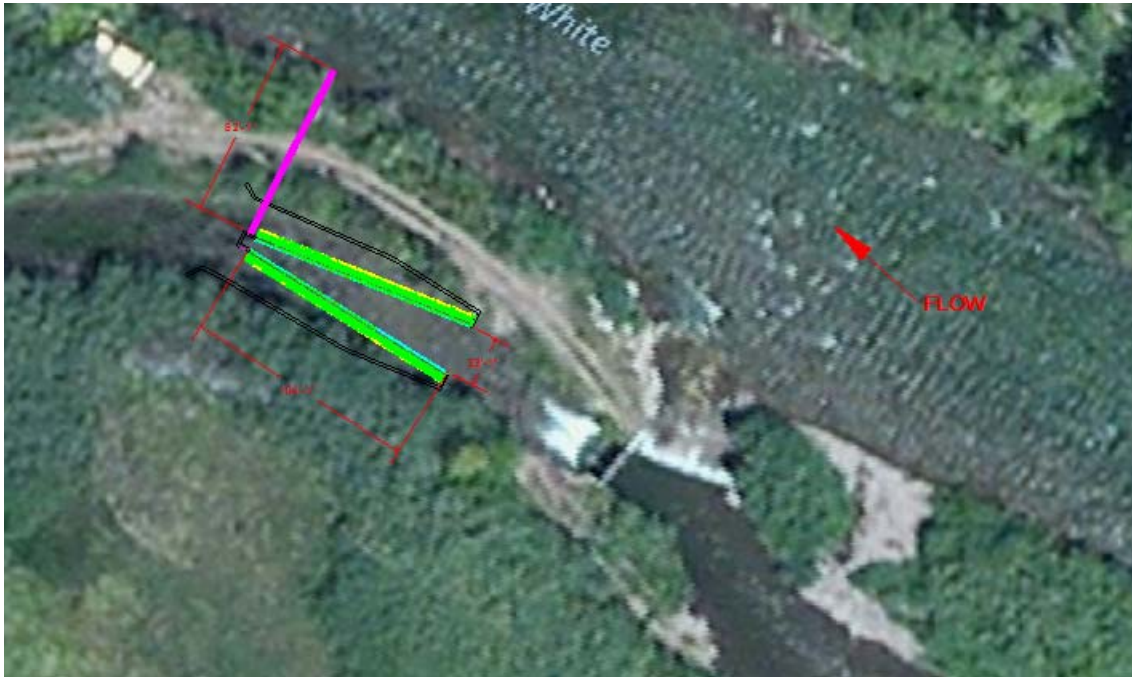
Figure 12 - Vertical Plate Screen

(Note: Depiction is from original analysis and has since been updated and relocated)

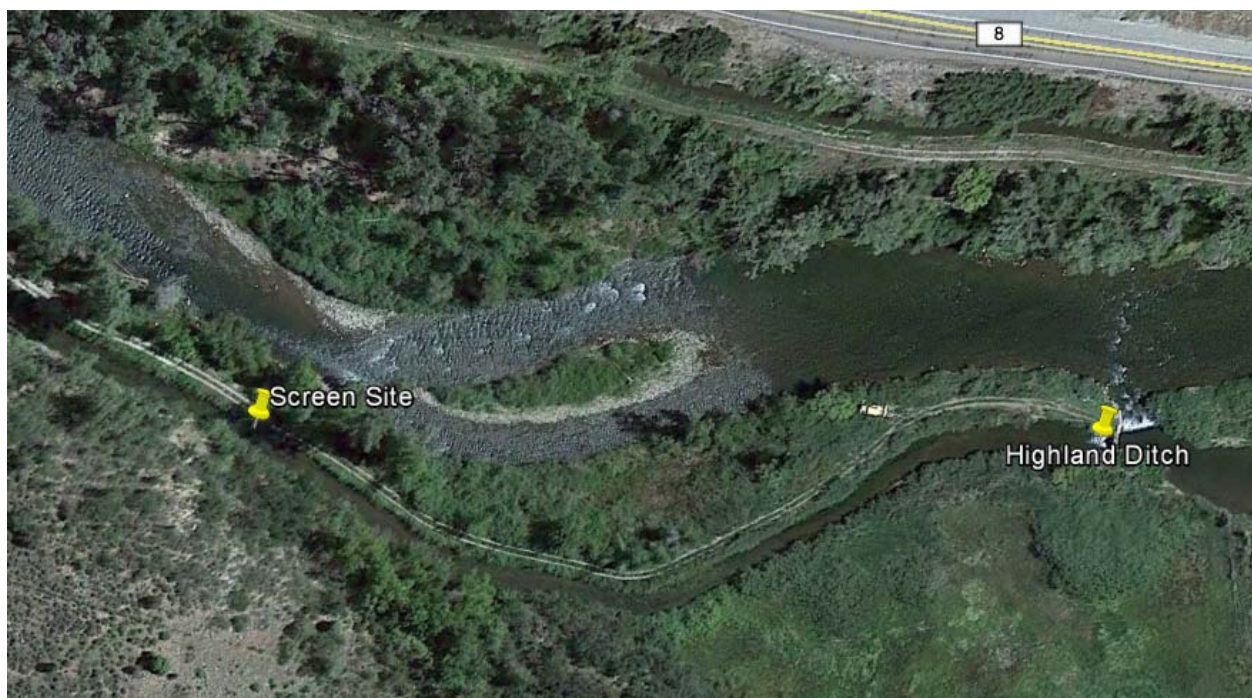
Figure 13 - Proposed Screen Site

During initial conversations the screen site was located immediately downstream of the Highland ditch head gates. This is common practice to allow for easier maintenance of fish screens. However, because head gate operations require driving along the ditch and turning around and driving out along the ditch, it does not appear to be overly onerous to place the screen approximately 750 feet down the ditch (see Figure 13).
