Worster Dam – DAM I.D. # 030401

Dam Breach Analysis and Flood Inundation Mapping

TETRA TECH PROJECT No. 114-910349

MAY 23, 2016

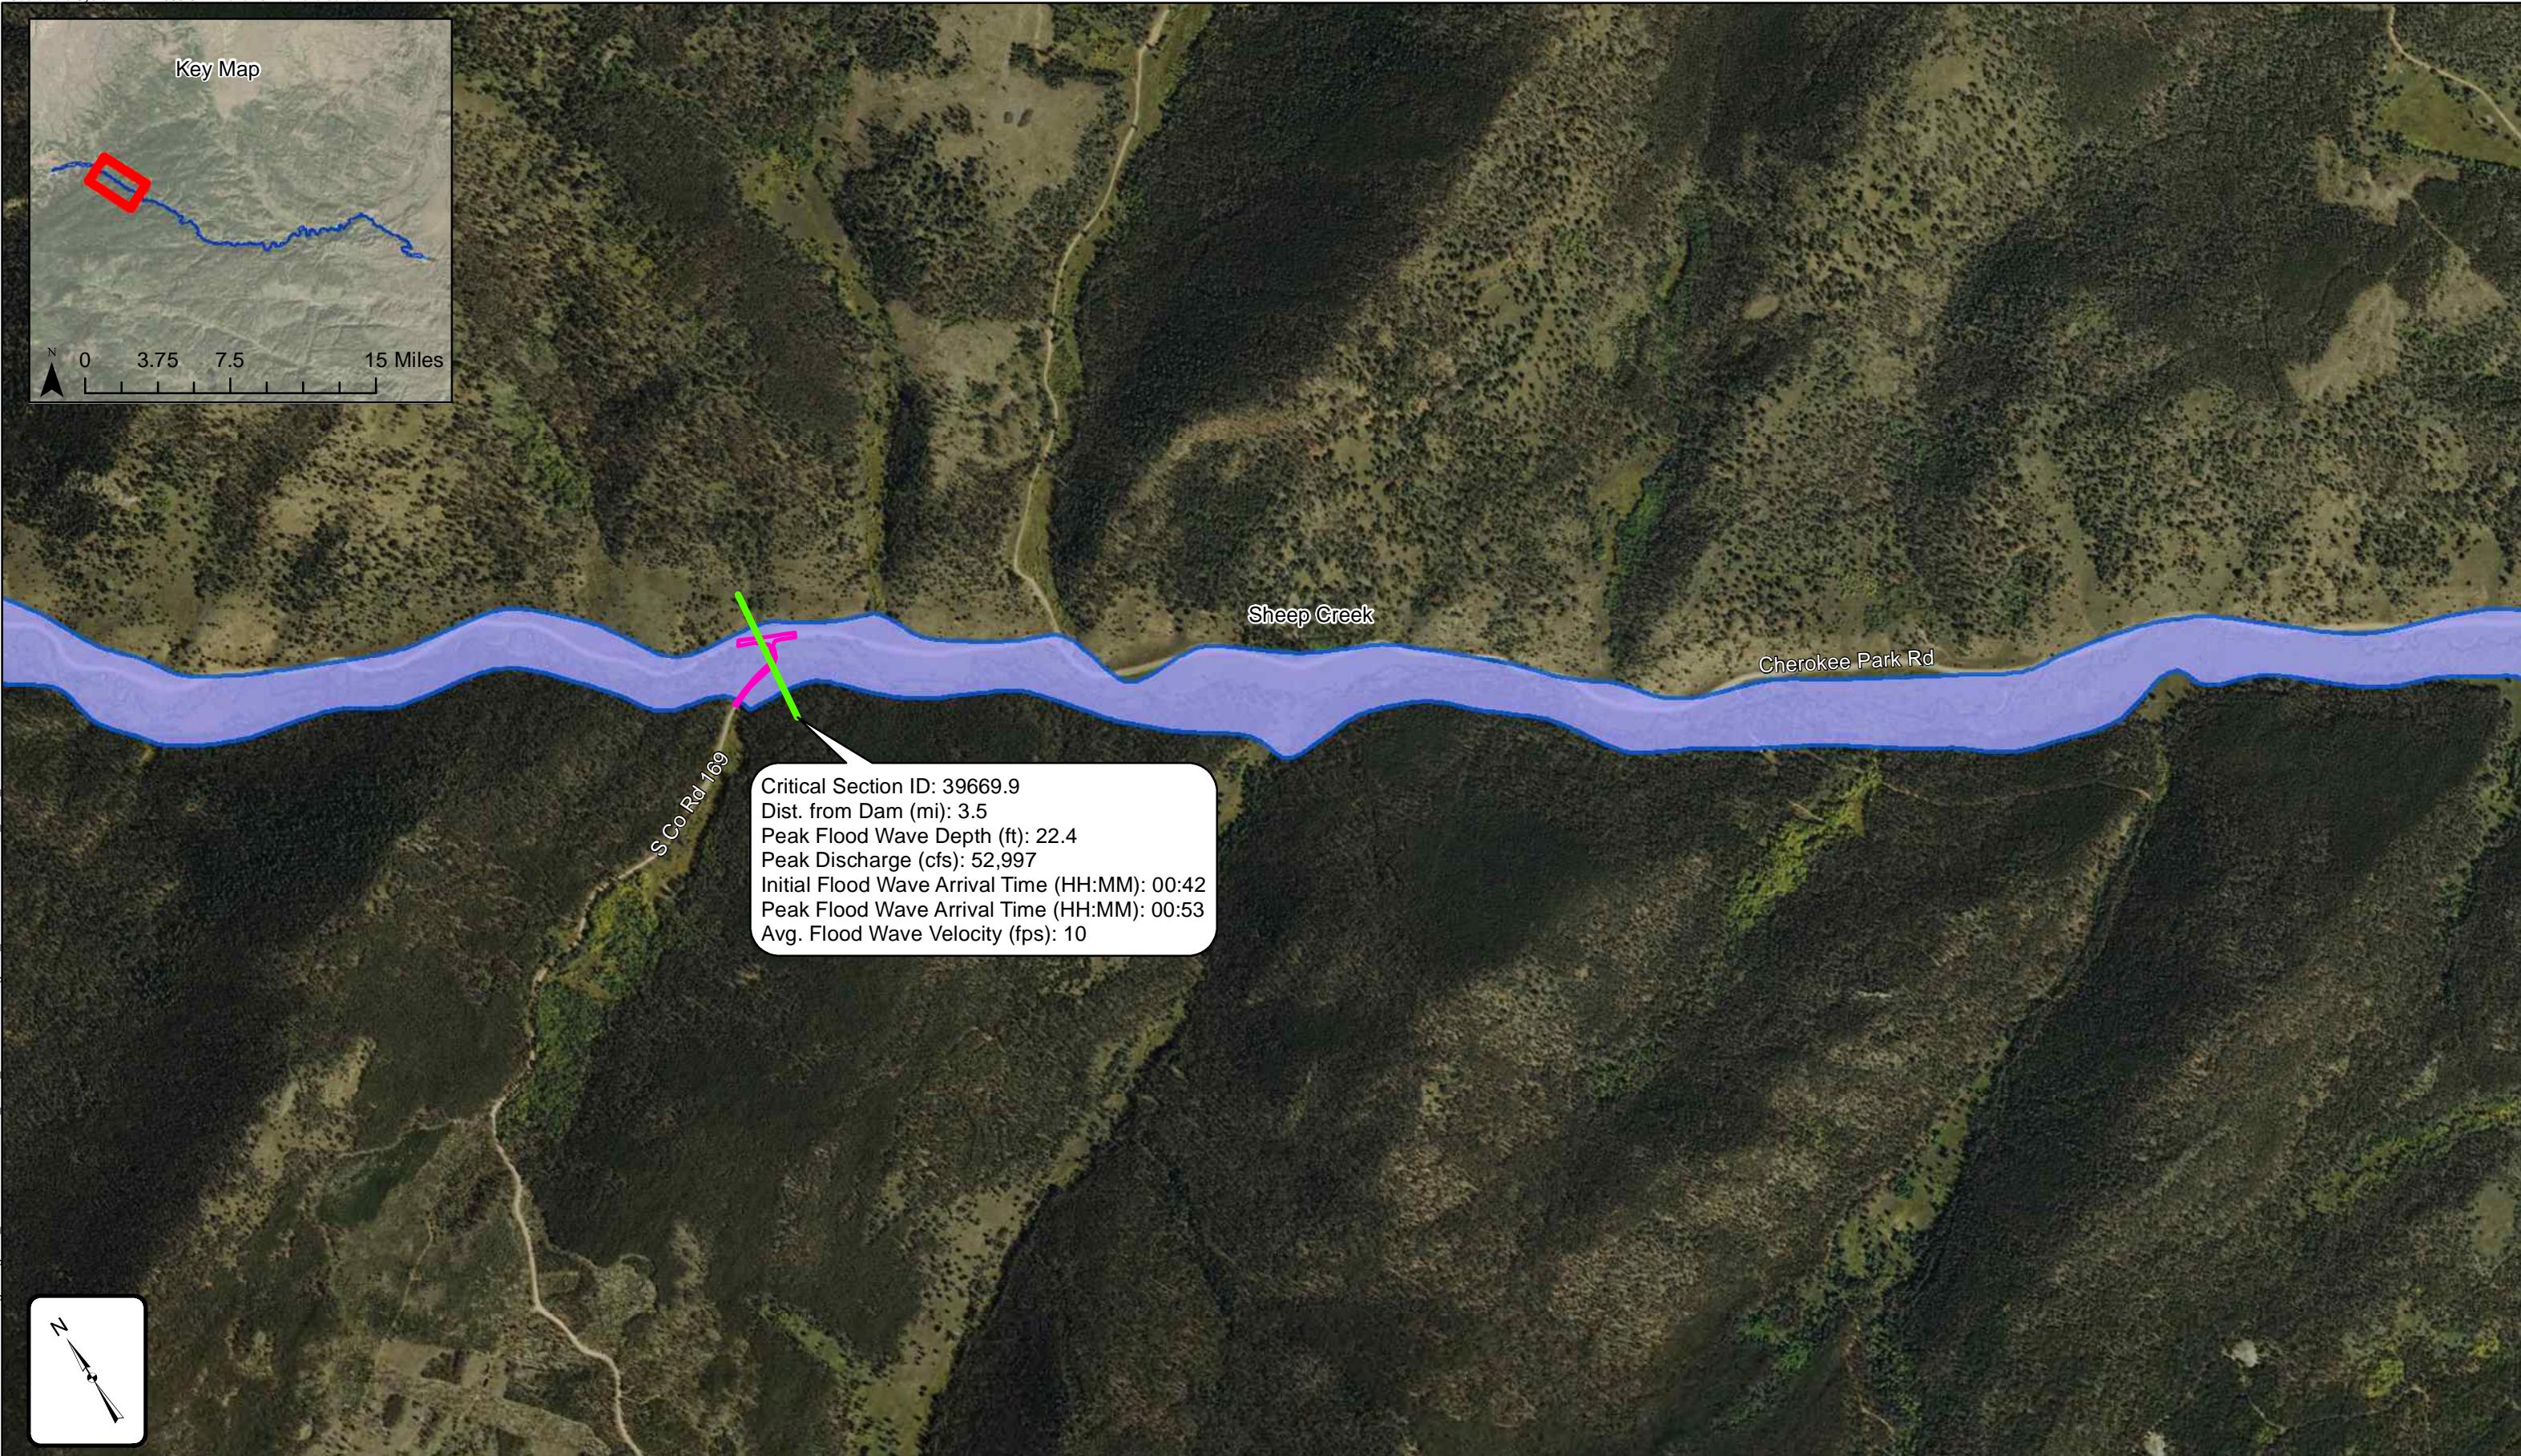
Figure 3

- Flood Inundation Area
- Structure
- Critical Cross Section
- Potentially Inhabited Structure
- Road Crossing

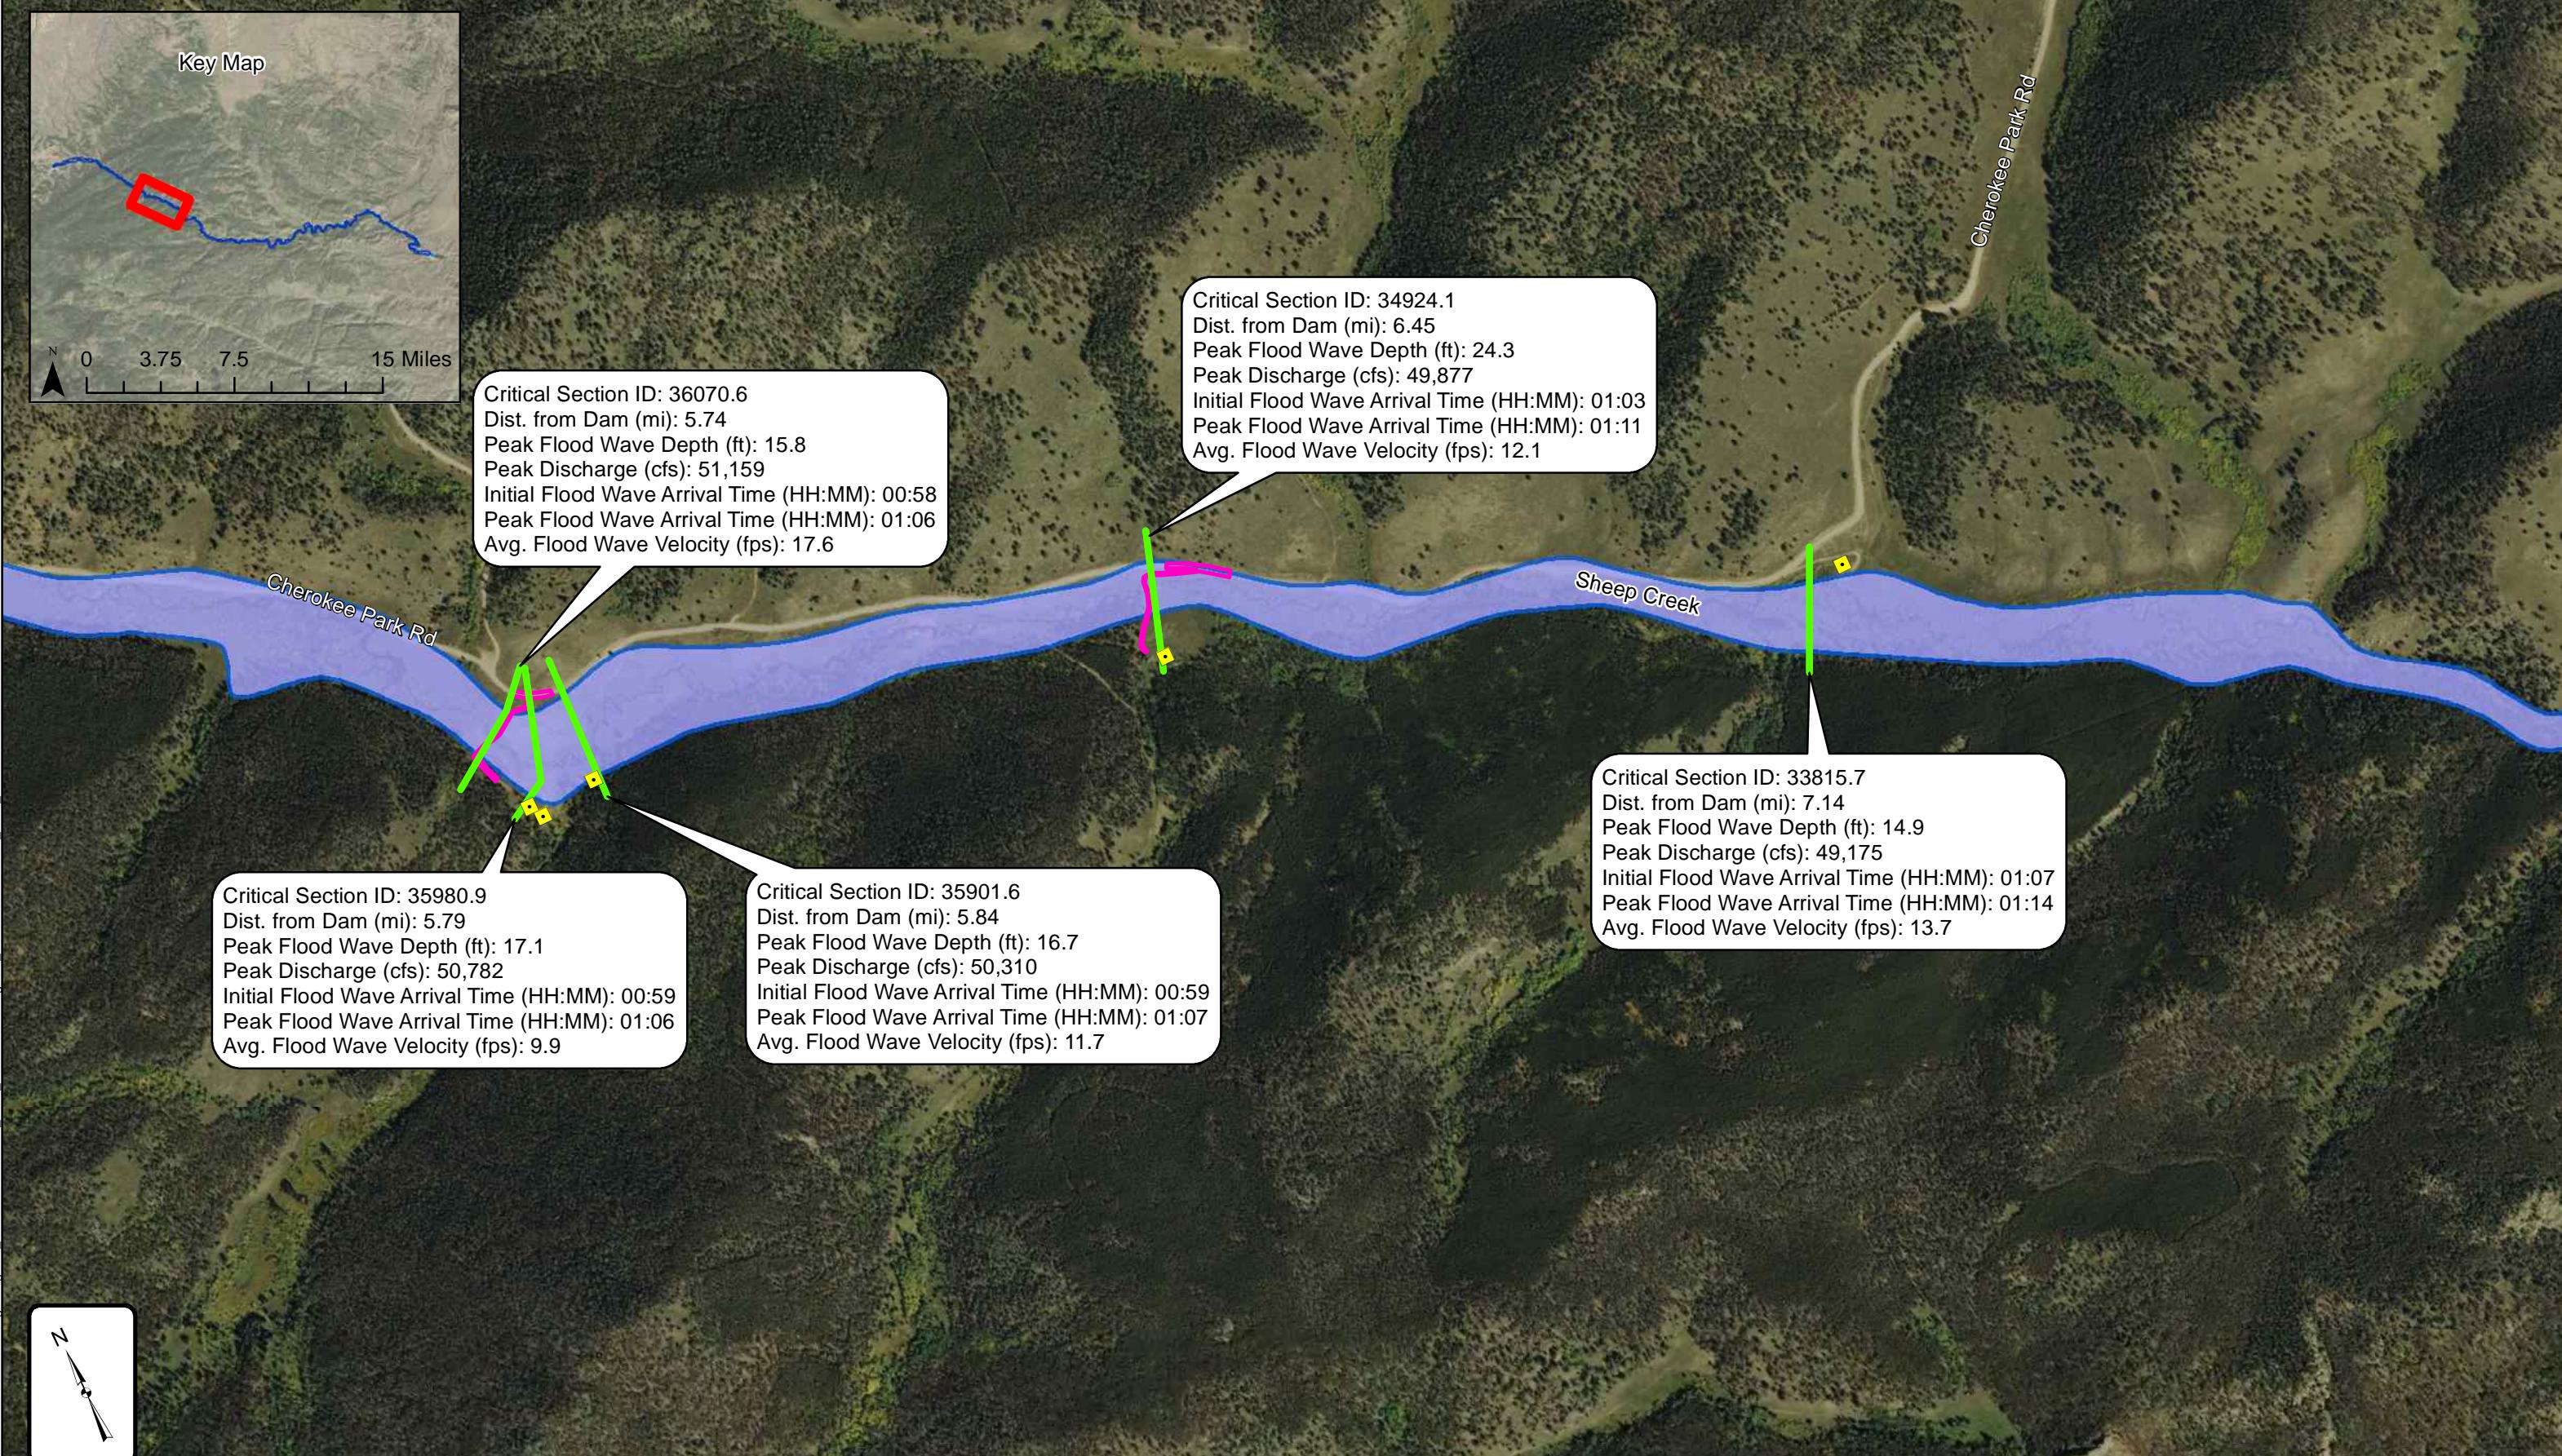
Figure 4

- Flood Inundation Area
- Structure
- Potentially Inhabited Structure
- Critical Cross Section
- Road Crossing

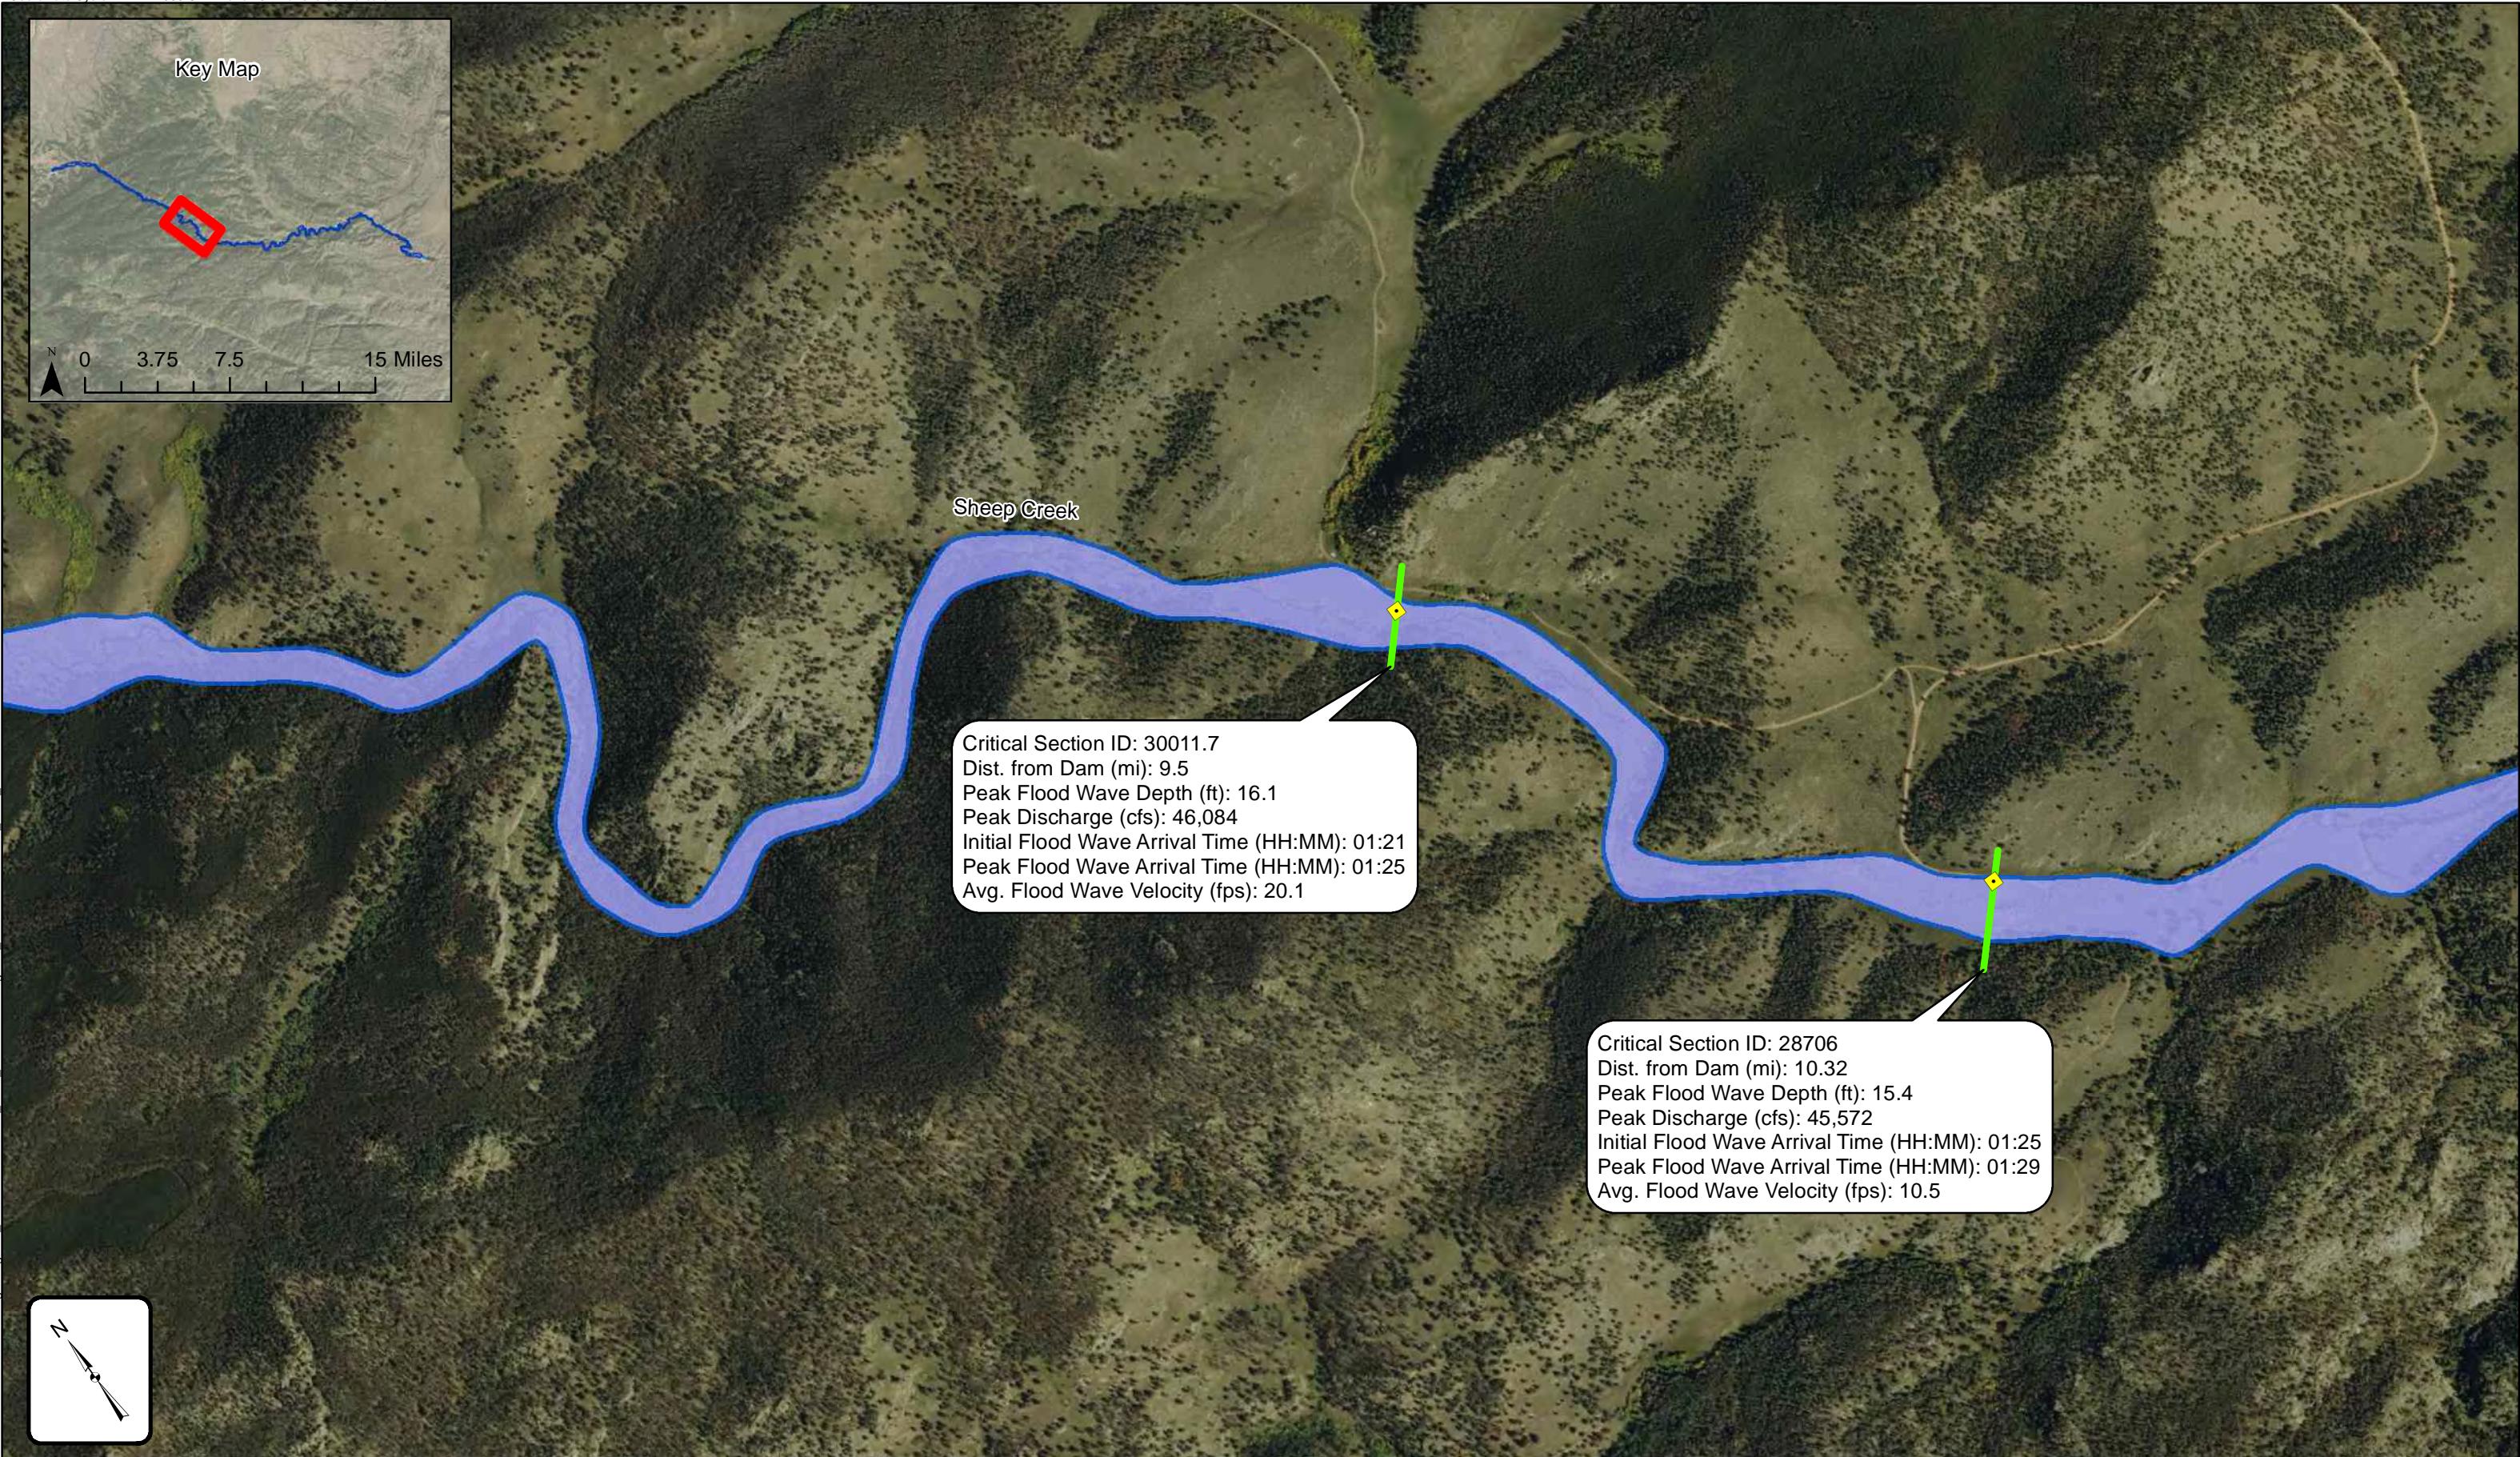
Figure 5

- Flood Inundation Area
- Critical Cross Section
- Road Crossing

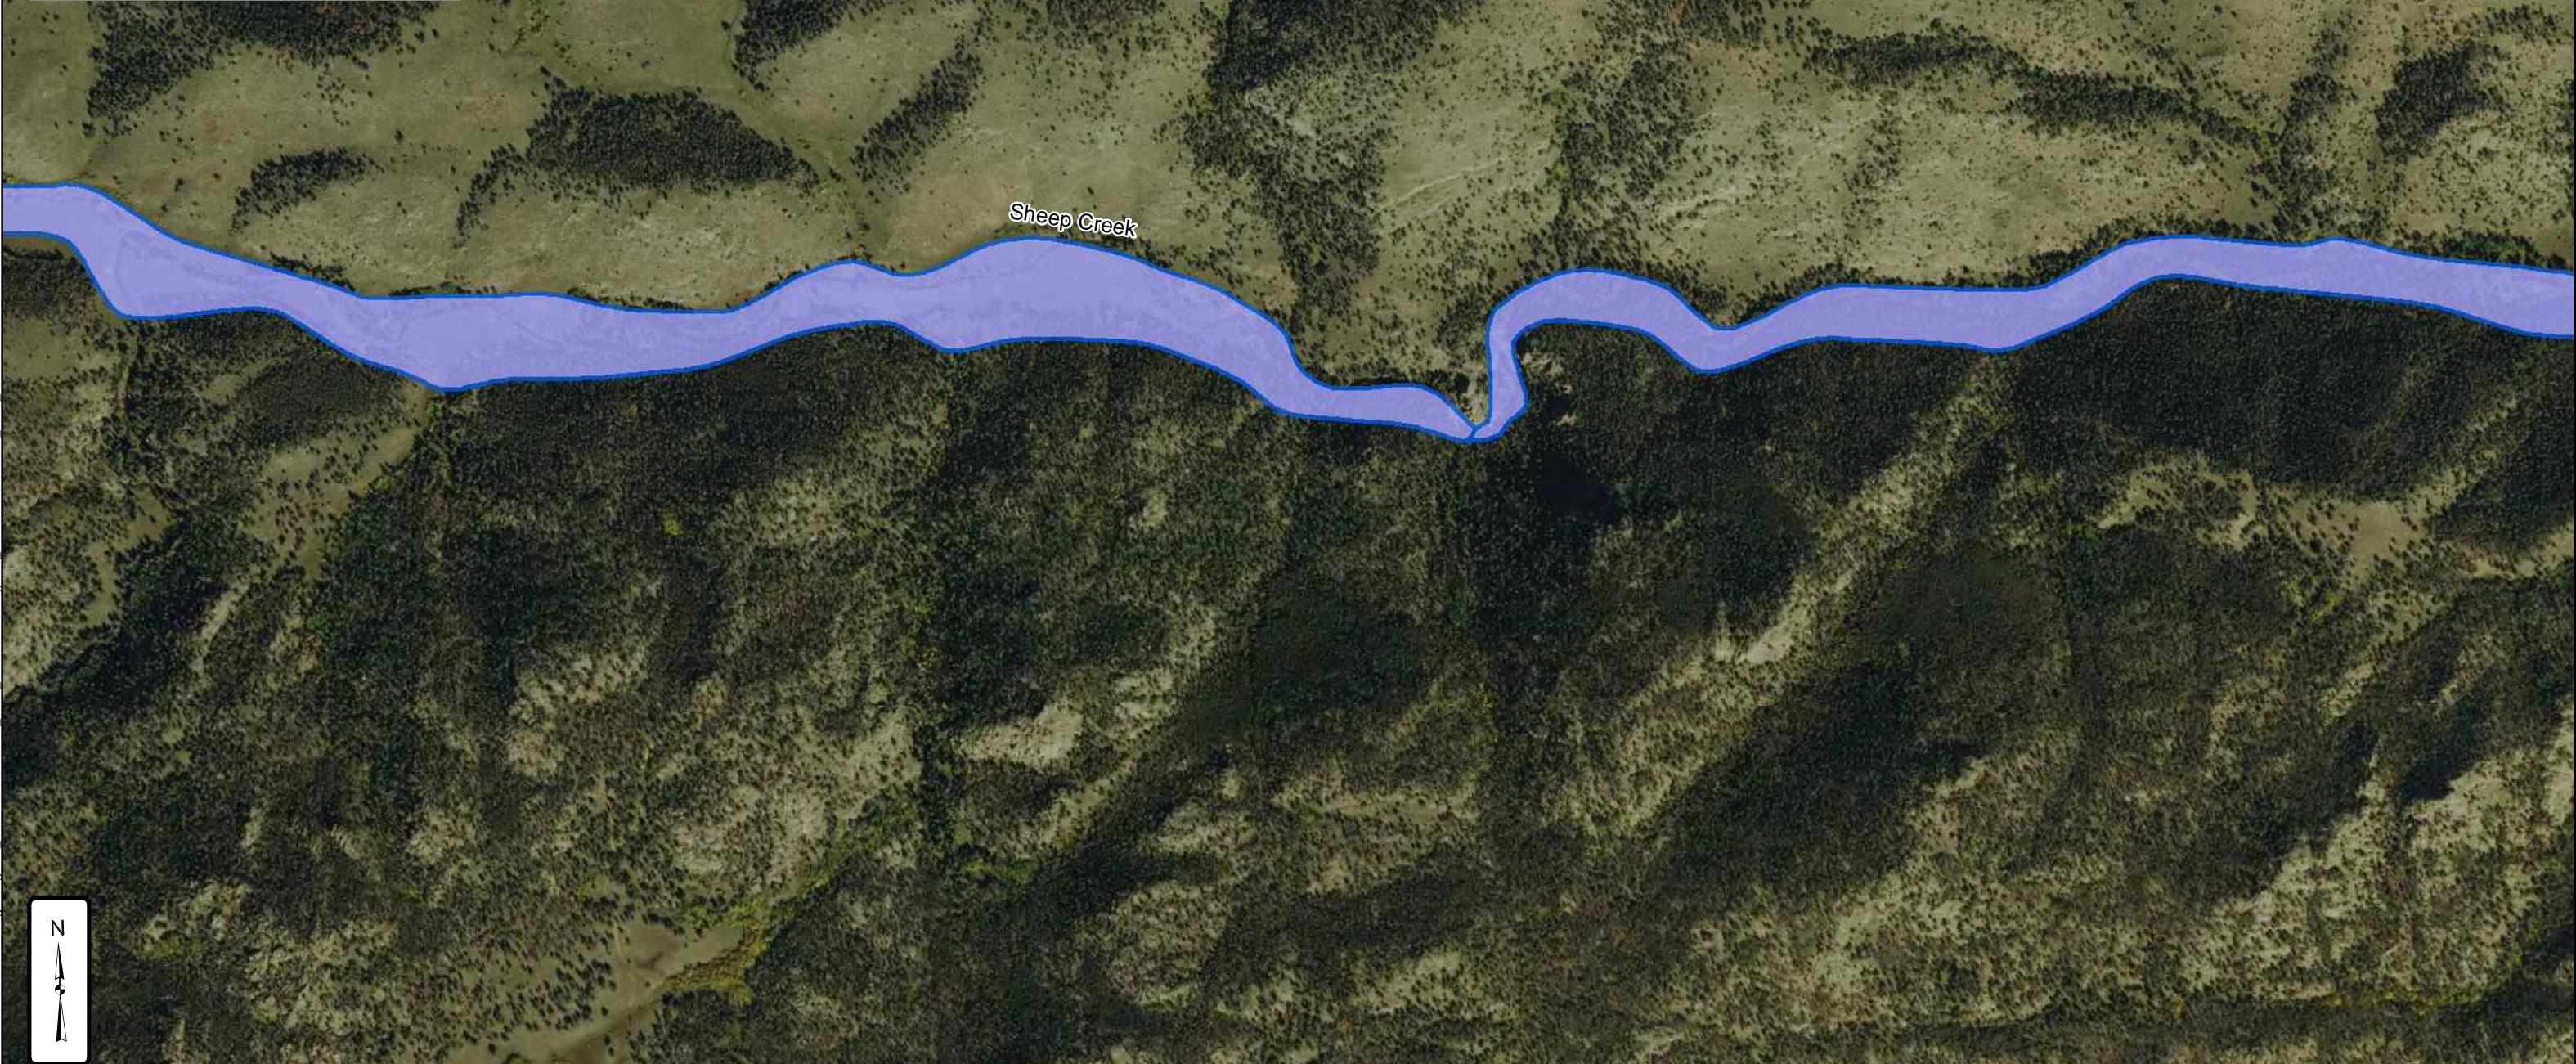
Figure 6

- Flood Inundation Area
- Structure
- Critical Cross Section
- Potentially Inhabited Structure
- Road Crossing

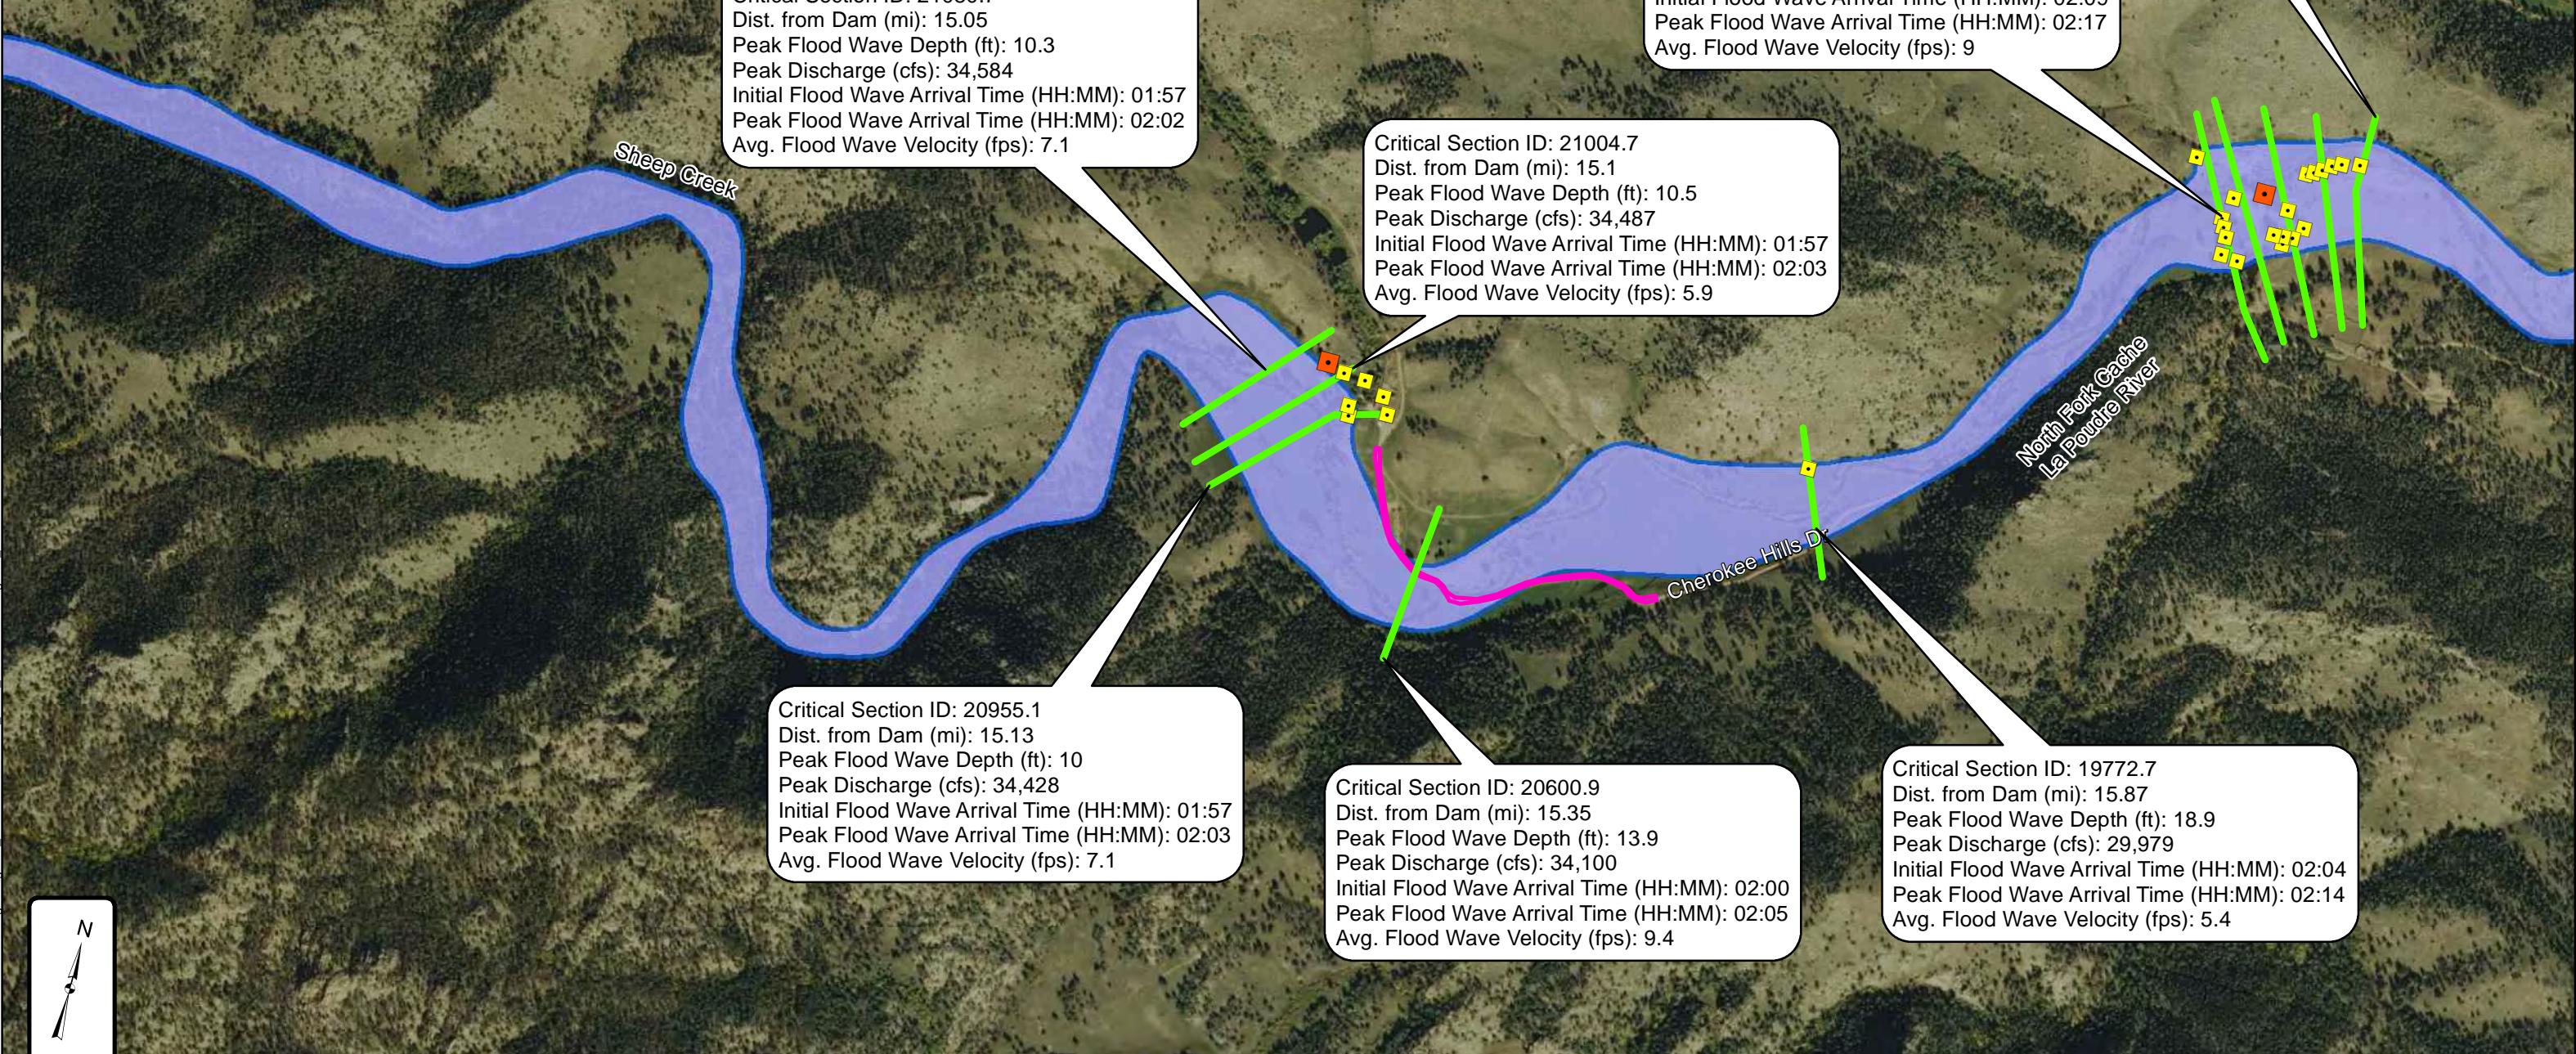
Figure 7

- Flood Inundation Area
- Structure
- Critical Cross Section
- Potentially Inhabited Structure
- Road Crossing

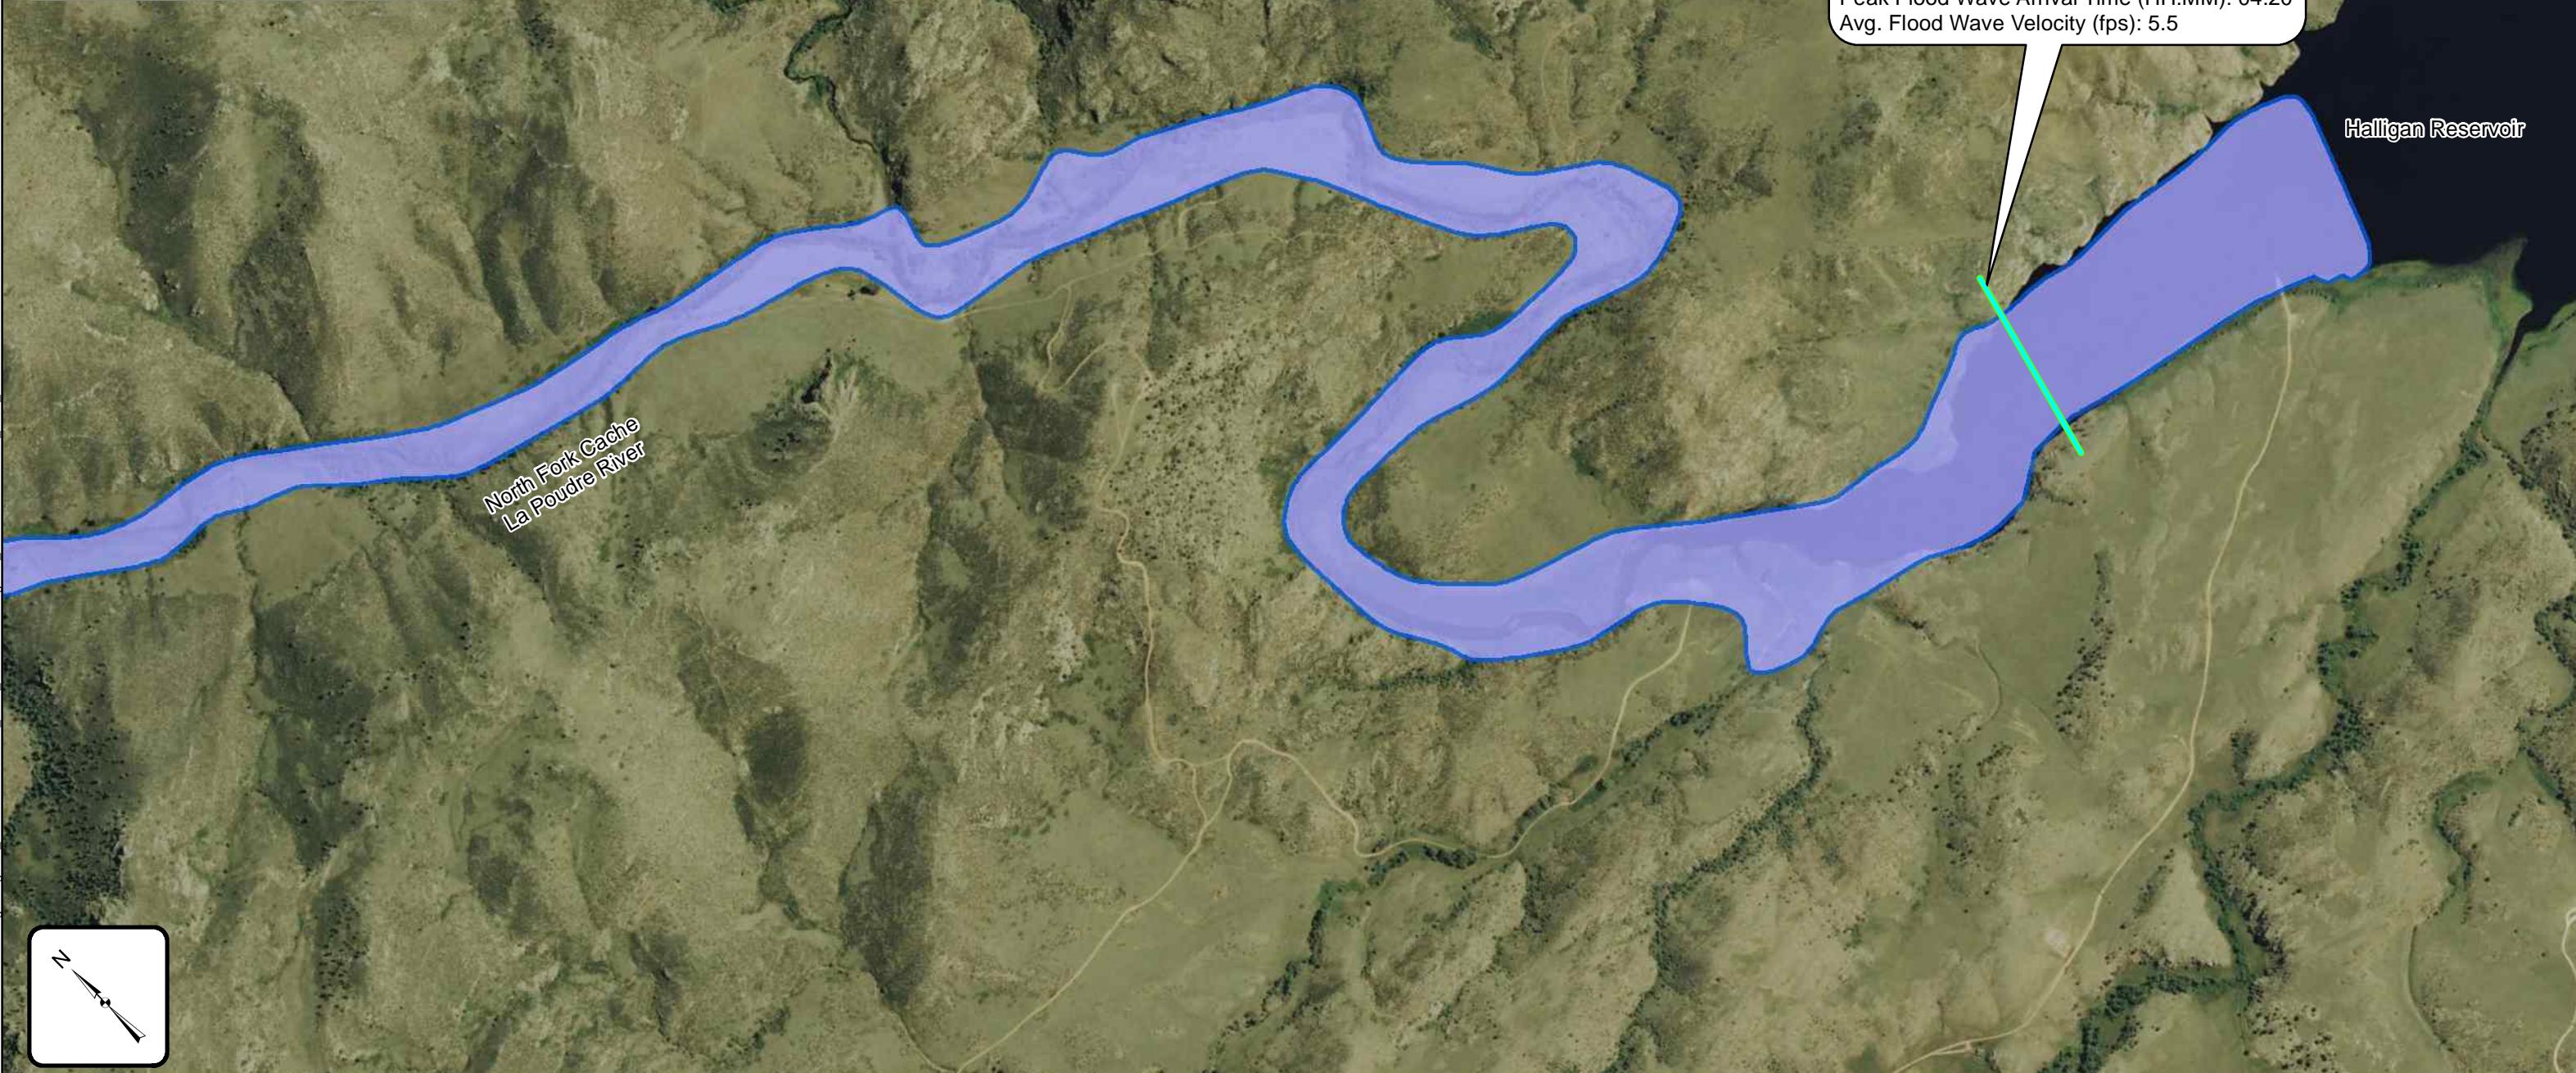
Figure 9

- Flood Inundation Area
- Structure
- Critical Cross Section
- Potentially Inhabited Structure
- Road Crossing

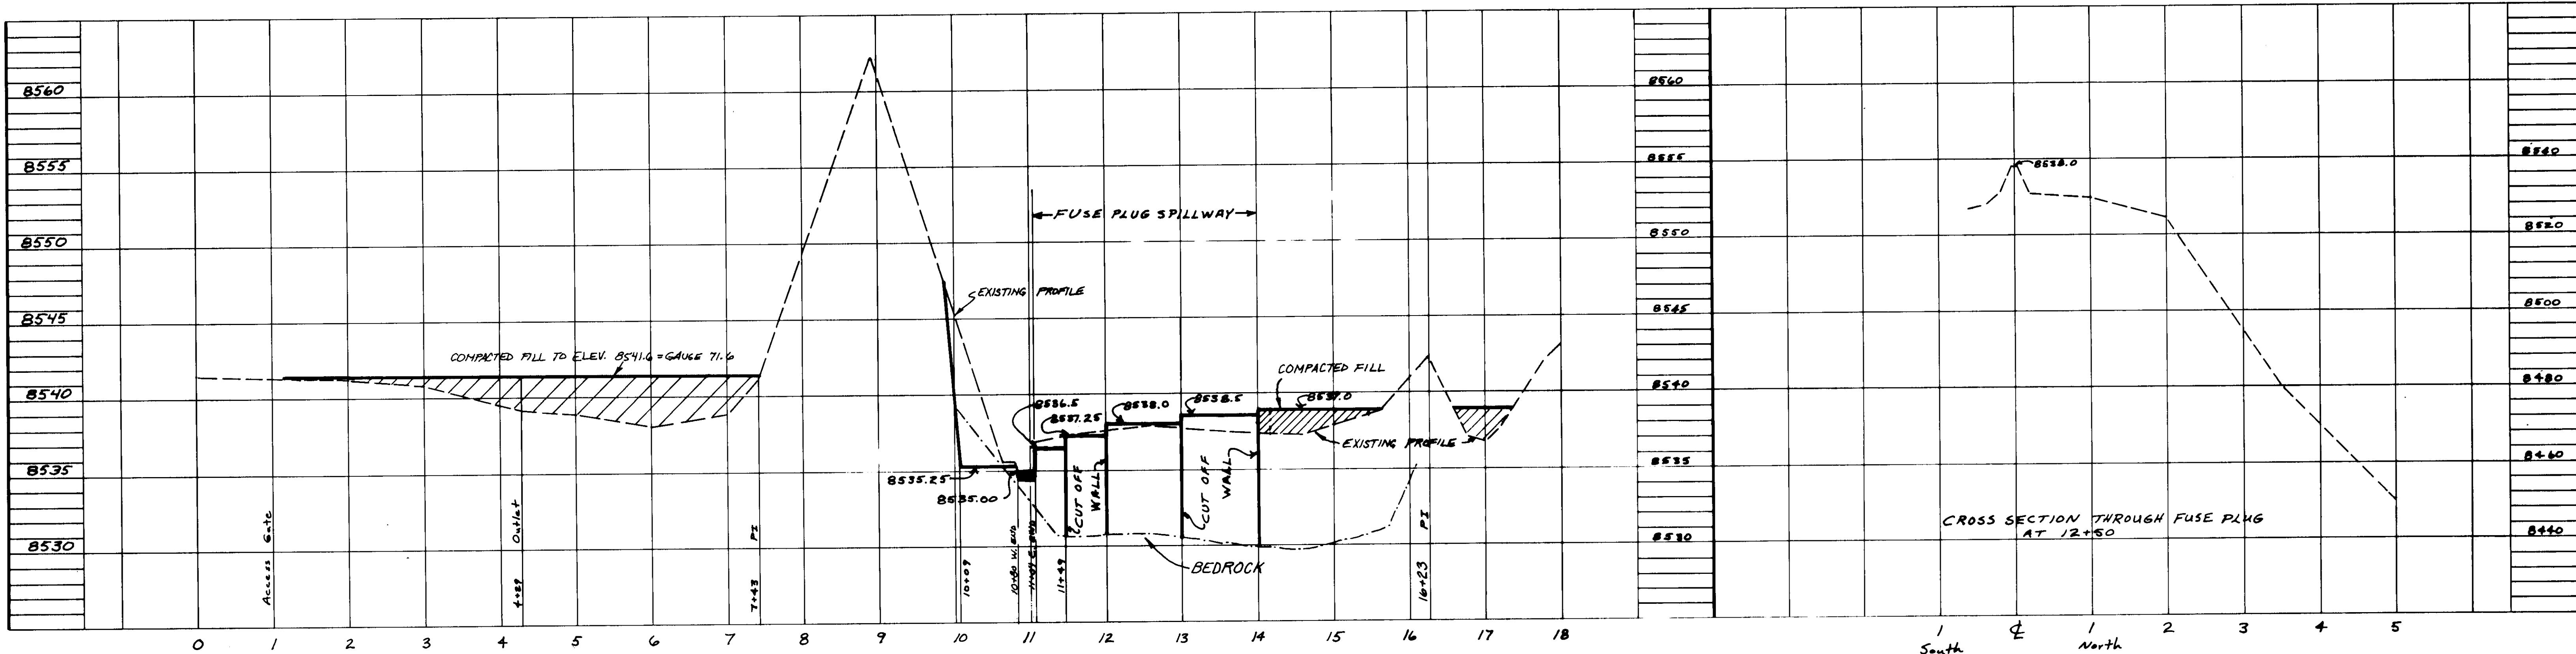
WORSTER RESERVOIR
WATER DIVISION 1 , DISTRICT 3 **C-56A**
DAM I.D. # 030401
DIVIDE CANAL AND RESERVOIR CO.

NOTE: From approx. sta. 0+50 to sta. 3+50 the upstream face of the dam was reconstructed at a slope of 3:1. From sta. 0+50 to 7+50 and from sta. 14+00 to 16+00 a 12" gravel blanket and an 18" layer of rock riprap was placed from the dam crest down to USGS Elevation 8528.

Control Points are steel pipe set in concrete with chisel marks on the caps.

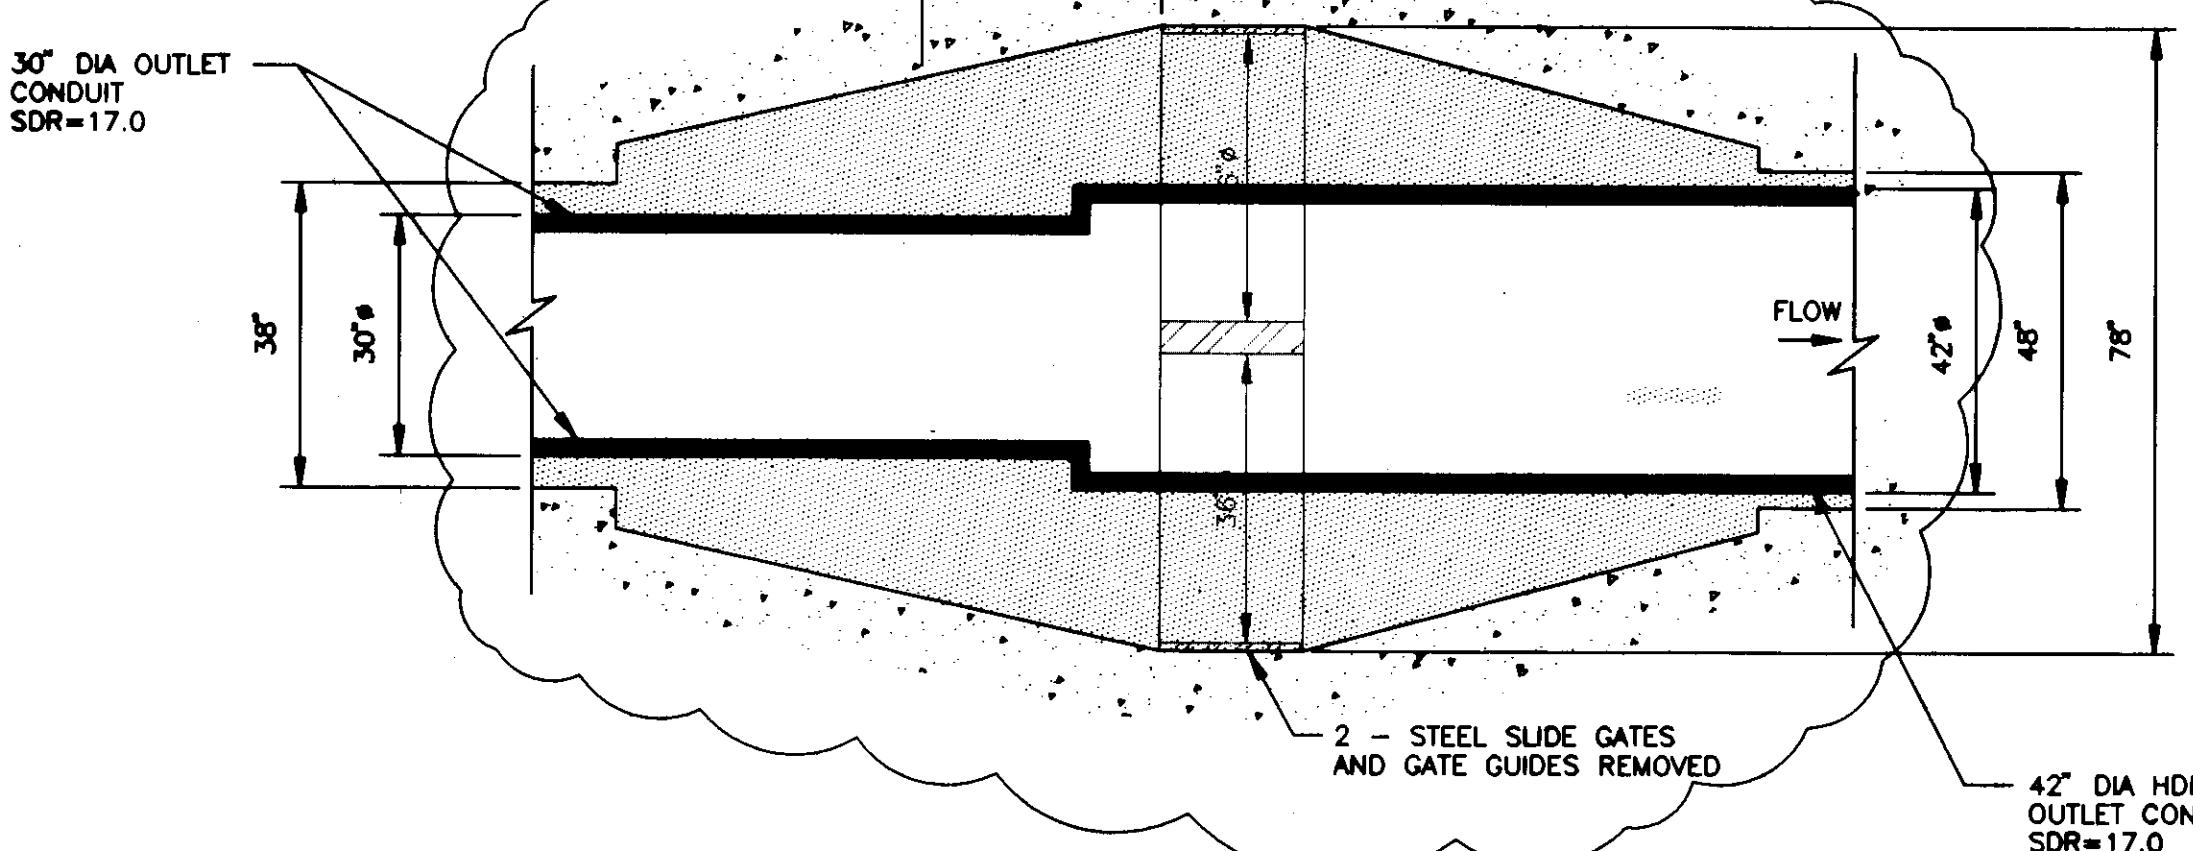
VALVE CHAMBER PLAN VIEW

NOT TO SCALE
