Worster Dam – DAM I.D. # 030401

Dam Breach Analysis and Flood Inundation Mapping

TETRA TECH PROJECT No. 114-910349

MAY 23, 2016

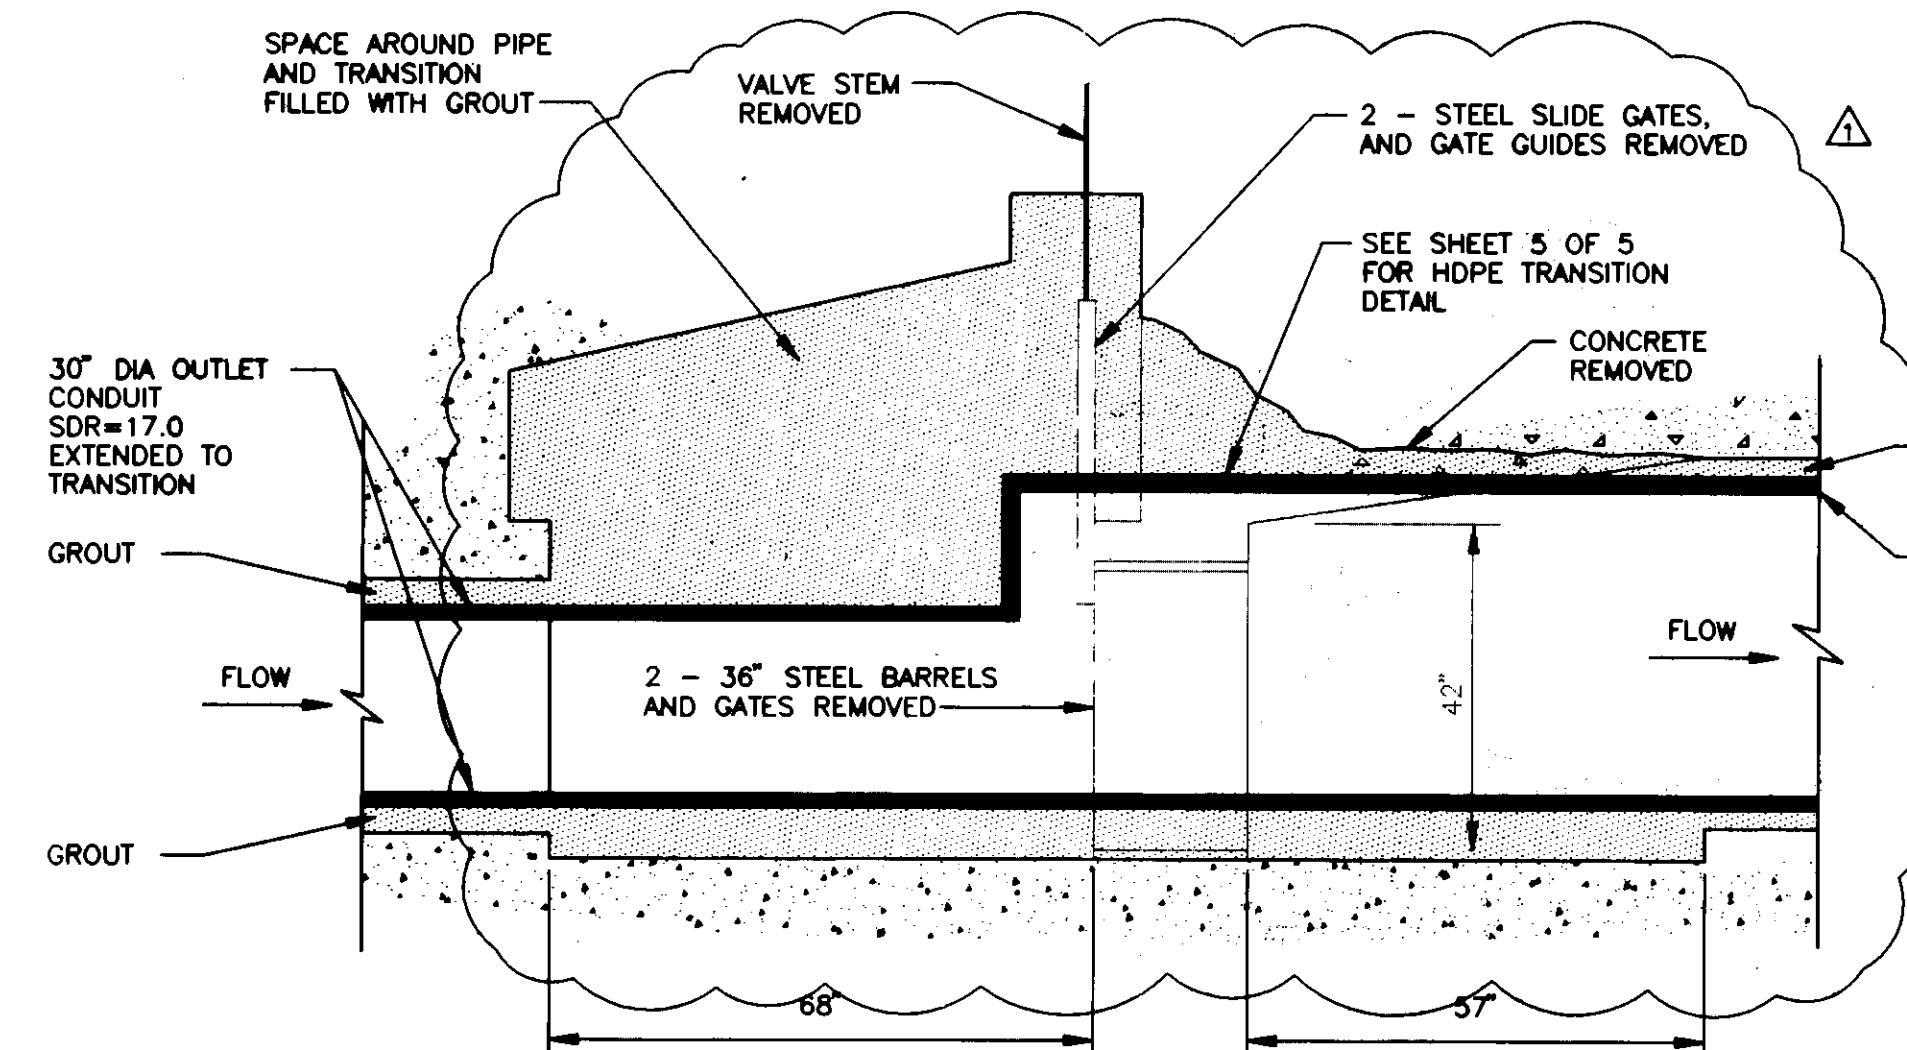
VALVE CHAMBER PROFILE

NOT TO SCALE

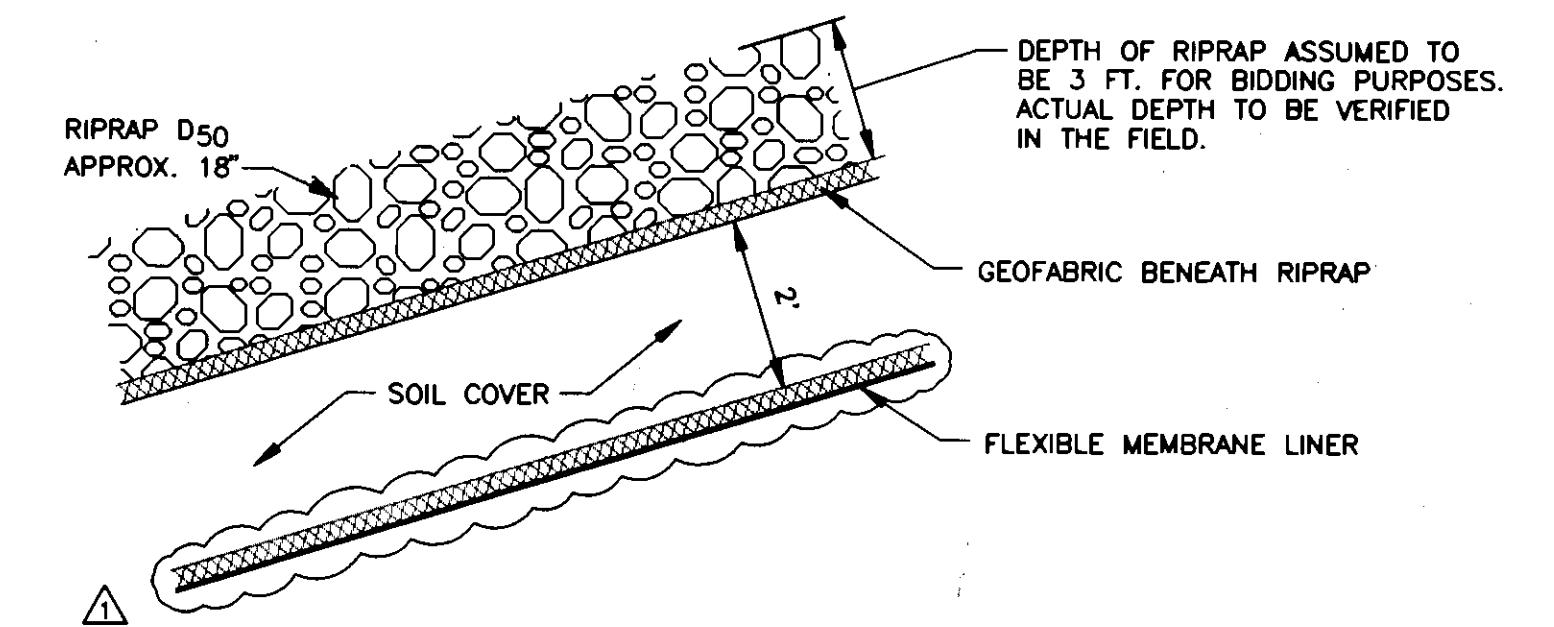
TYPICAL RIPRAP DETAIL

NOT TO SCALE

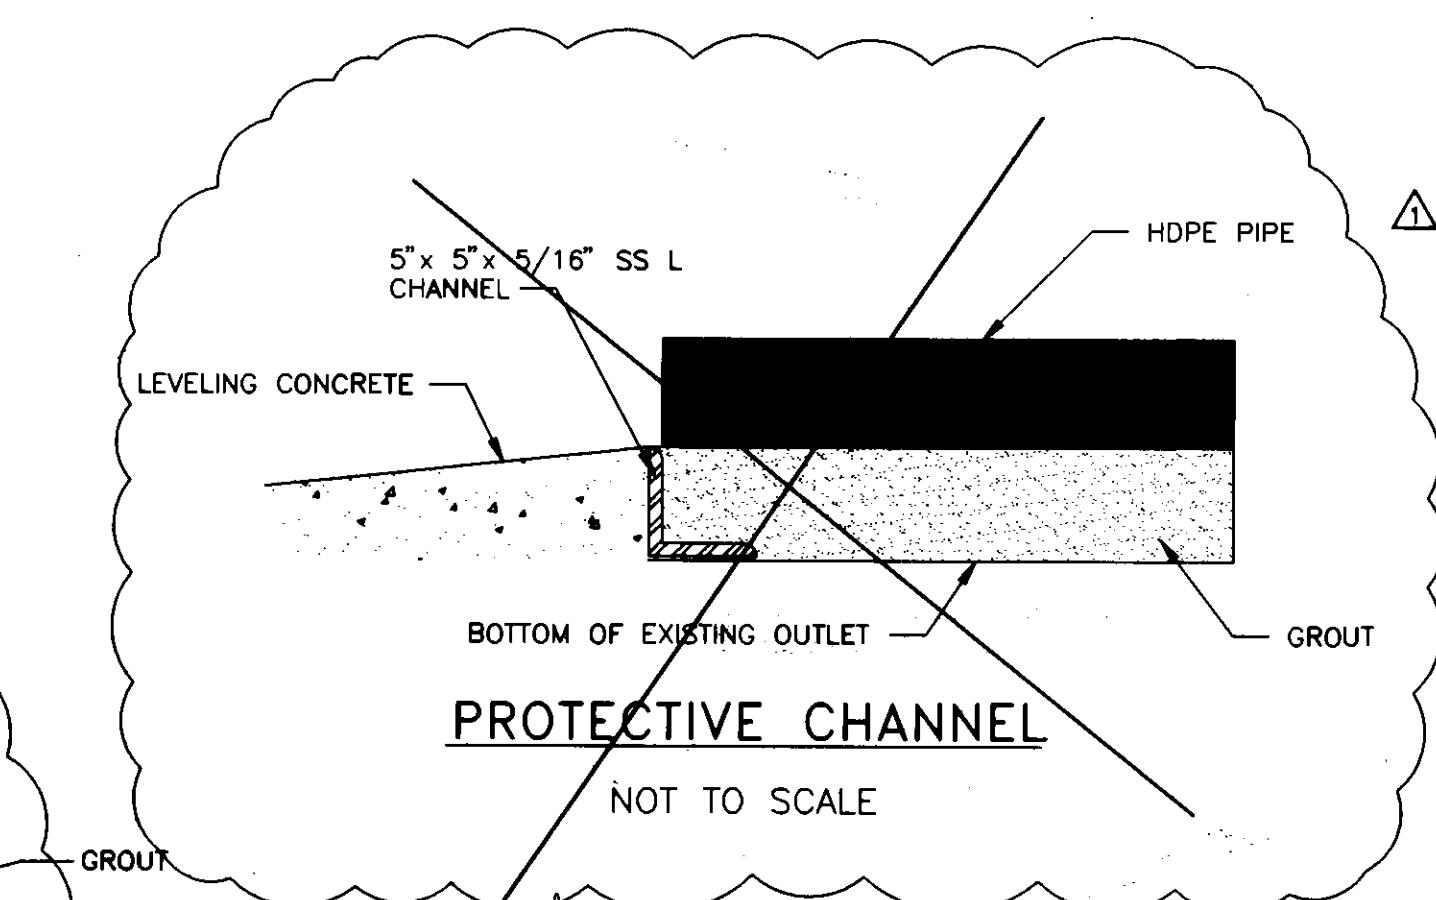
PROTECTIVE CHANNEL

NOT TO SCALE

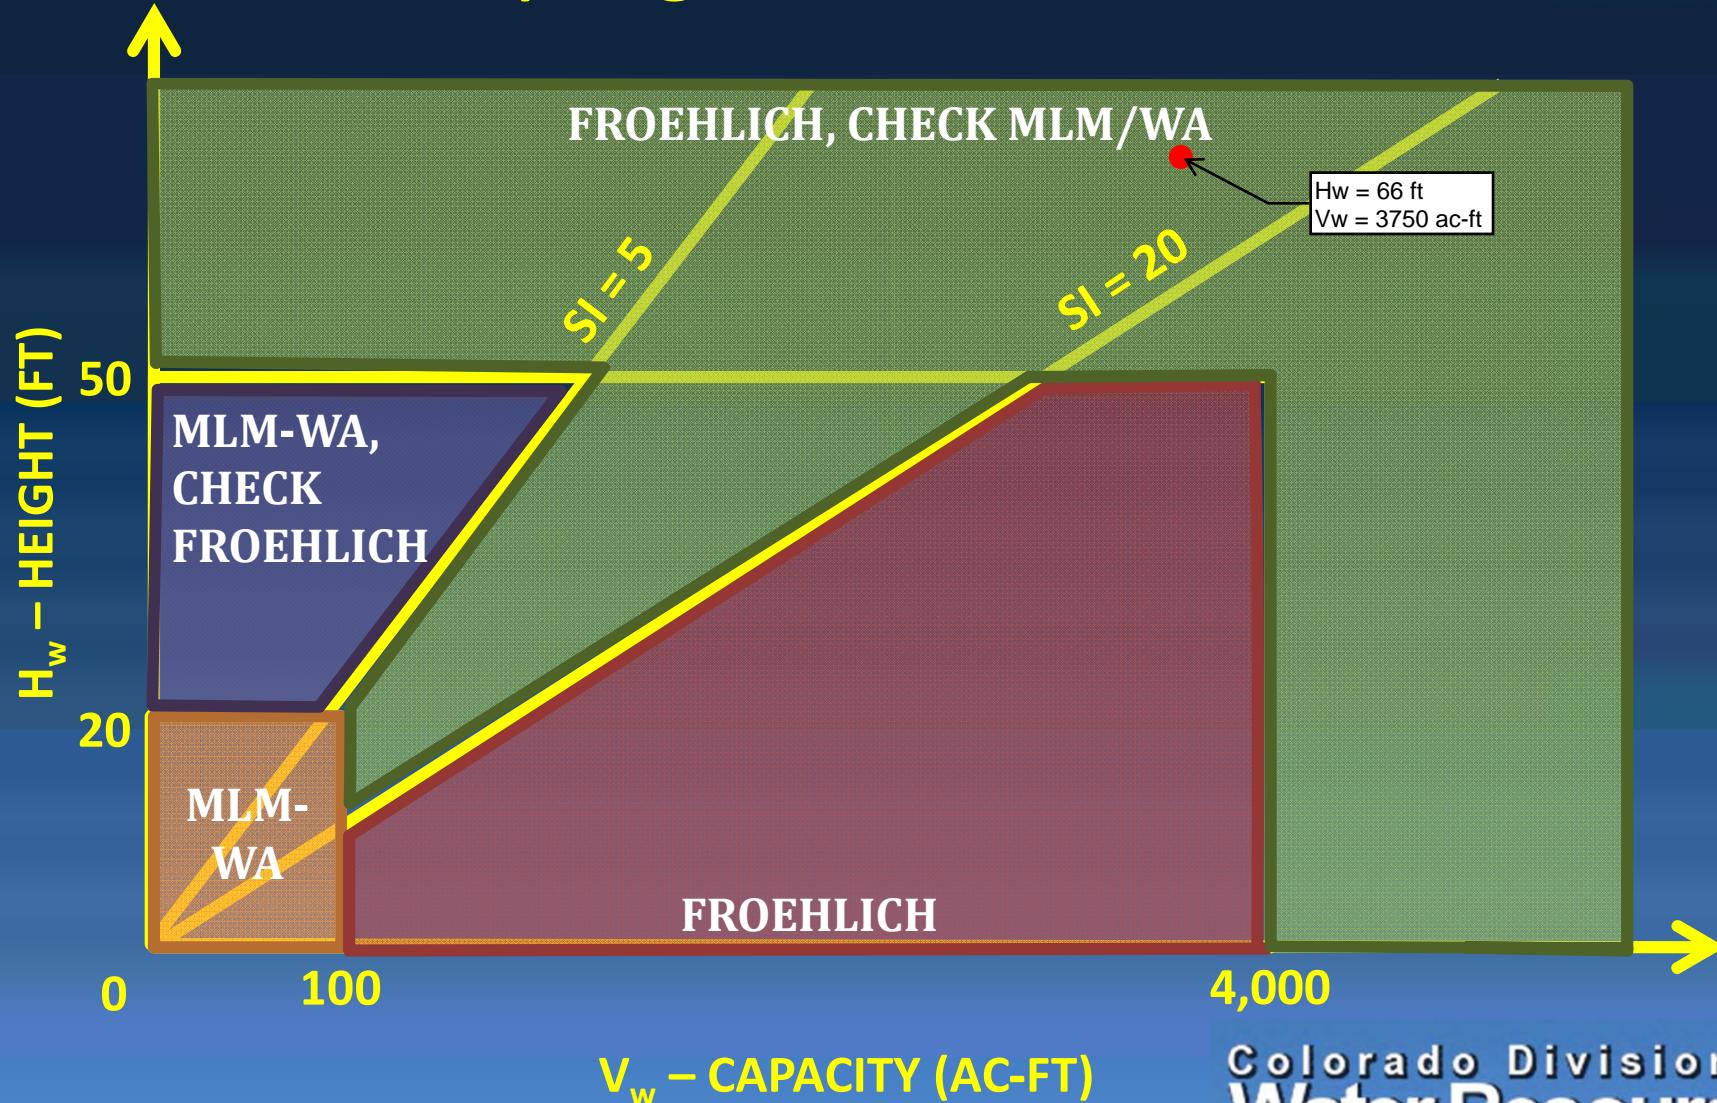
Piping Failure Mode

$$SI = \frac{V_w}{H_w}$$

Adapted from Colorado Rules and Regulations for Dam Safety and Dam Construction, 2007

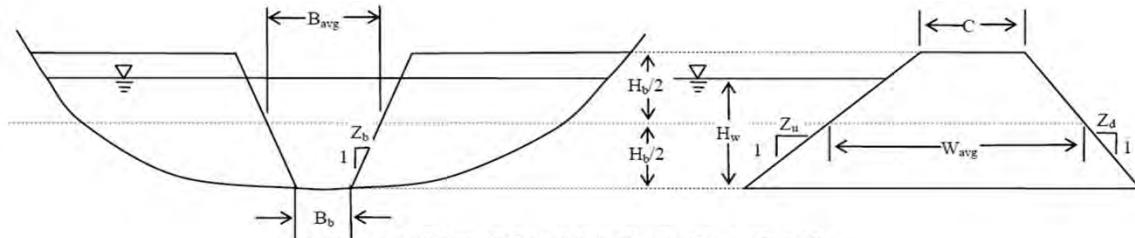
Figure 1- Breach Variable Definition Sketch

ESTIMATION OF DAM BREACH PARAMETERS
USING THE FROEHLICH 2008 METHOD

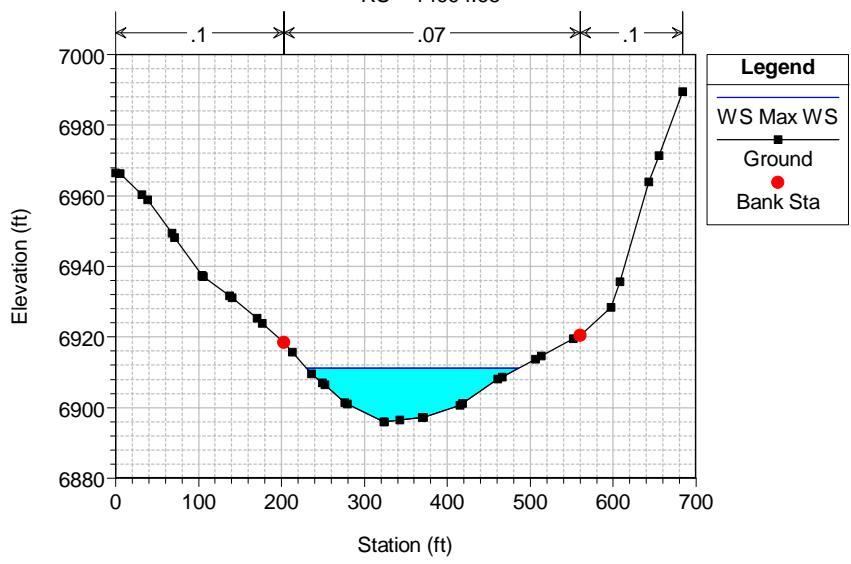
Worster Dam Breach Model

Plan: Worster Dam Breach Unsteady Flow 5/14/2016

RS = 14994.68

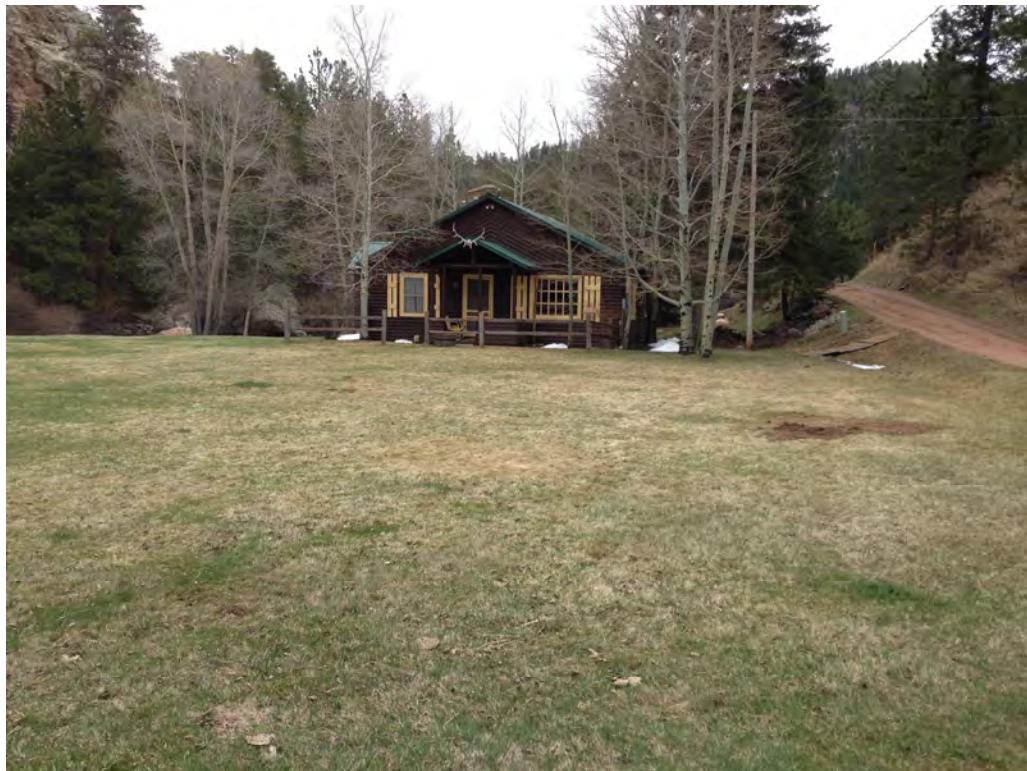
Photo 1 – Structure near Critical Section 16697.8

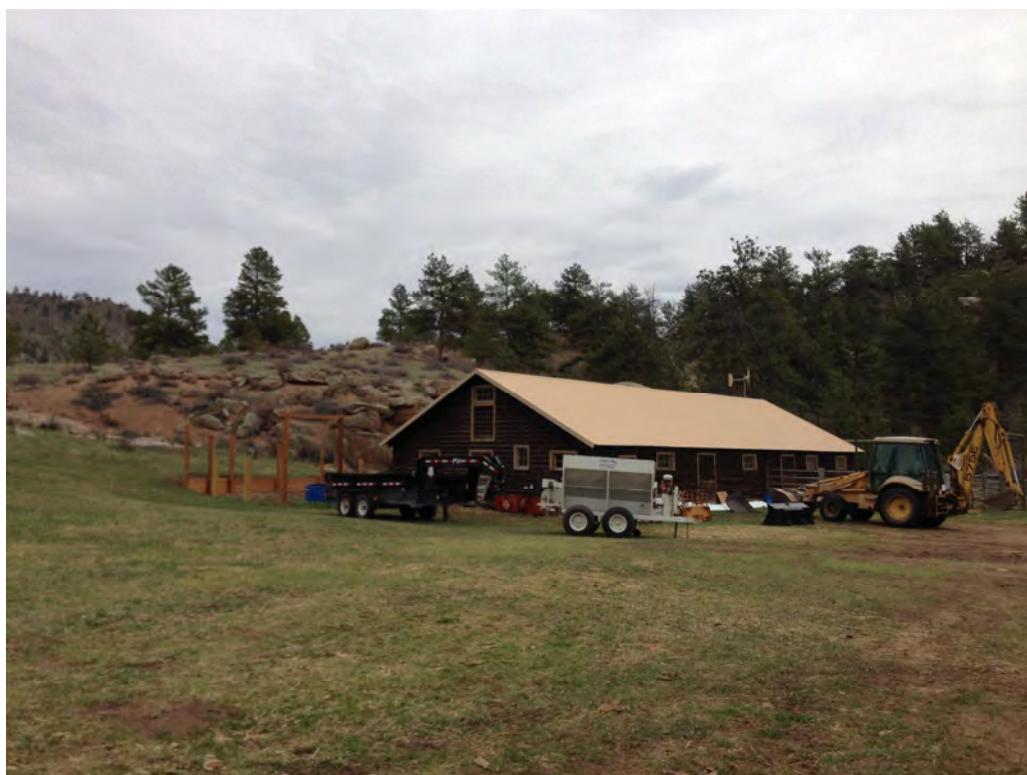
Photo 2 – Structure at Critical Section 16937.9

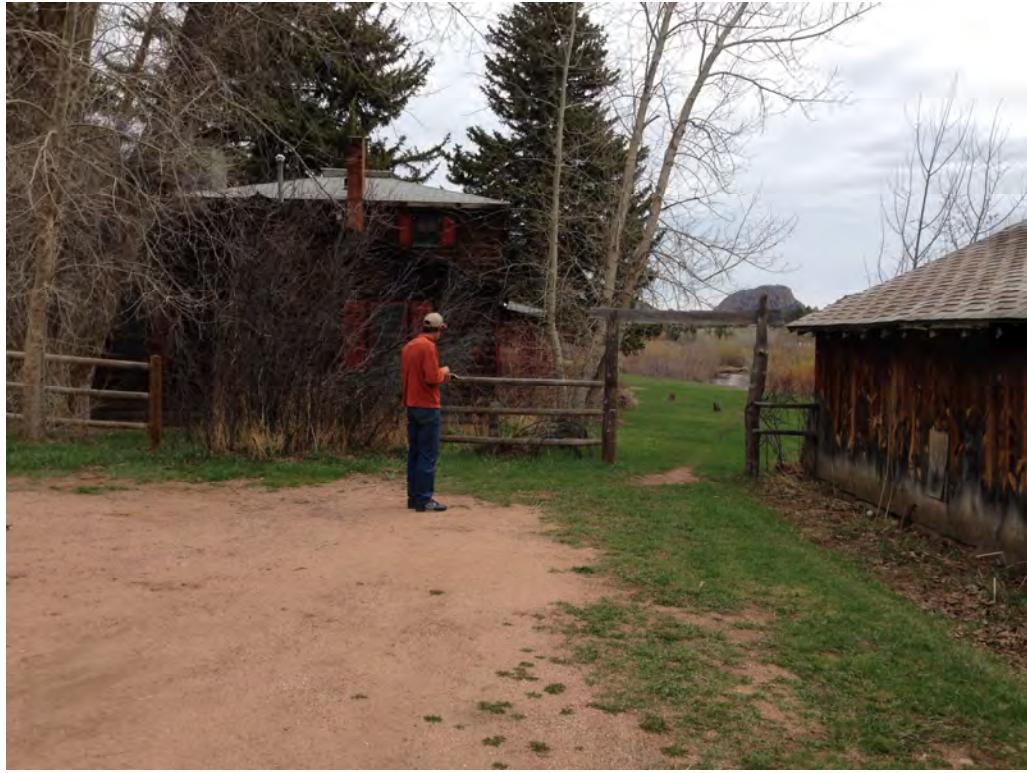
Photo 3 – Structures at Critical Section 17627.5
