# Final Report

## Assessment of Geomorphic Impacts of Vegetation Removal on the Colorado River 2013/14 Grant

Gigi Richard, Colorado Mesa University  
Shannon Hatch, Tamarisk Coalition

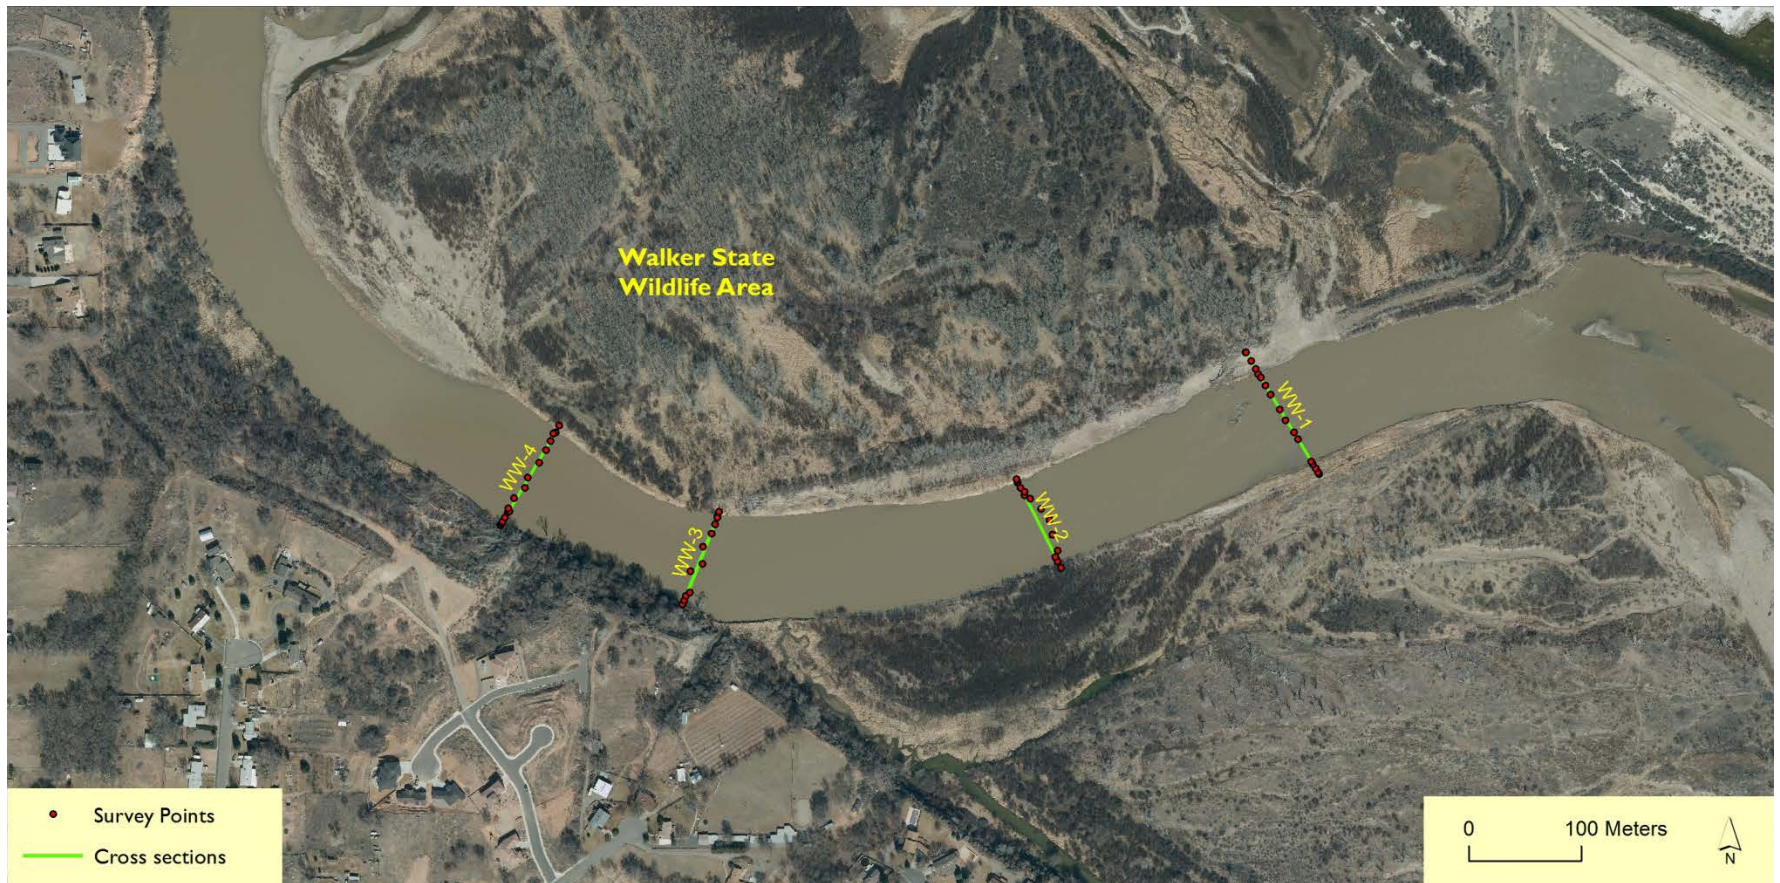
Figure 2 – Walker SWA study site with locations of August 2013 survey points (Background image Mesa County 2012 aerial photo).

At the Walker SWA site four cross-section (WW-1 through WW-4, WW = Walter Walker) locations were established (Figure 2). Locations were selected to include areas where tamarisk removal would occur close to the river channel and bank. Also, downstream location was constrained by private property on the left bank. The last section is just upstream of private property. At both sites, the endpoint locations were mapped with a mapping-grade (< one meter accuracy) GPS. T-posts were installed to note the location of the endpoints.

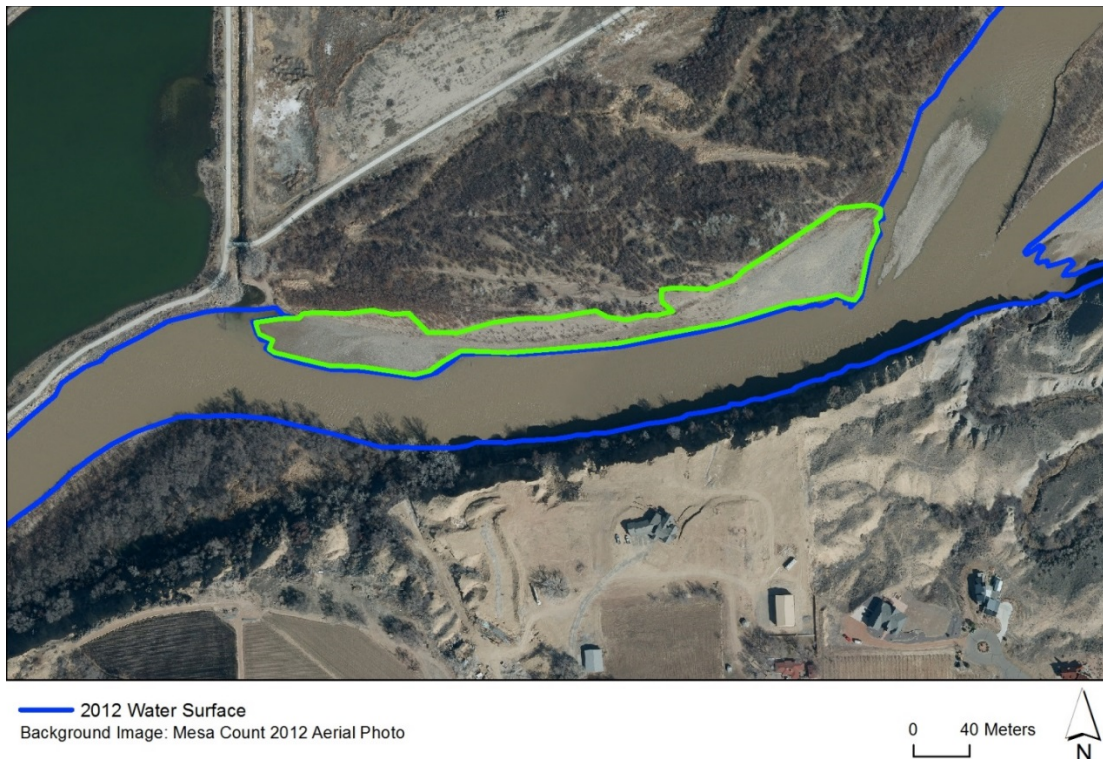
**Figure 7 – Example comparison of water surface outline versus the non-vegetated active channel. The polygon outlined in green would be considered active channel, but would not be included if just the water surface were outlined.**

TetraTech previously digitized the channel centerline and water surface from 1937 and 2007 aerial photos. While comparison of the digitized water surfaces does illustrate dramatic channel changes, the outlined area will vary as discharge varies. As a result, unless the aerial photos were taken at about the same discharge, a quantitative analysis of channel change cannot be accomplished using water surface polygons. An example of the difference between outlining the water surface versus the active channel is shown in Figure 8 where the green polygon shows an example of area that would be included in the active channel, but is not included in the water surface outline.
