RE: C-2014, LEDE Dam, Request for Conditional Fill with Fill Restriction.

L.E.D.E. DAM/RESERVOIR ENLARGEMENT

DAMID 370105

INITIAL FILL AND MONITORING PLAN

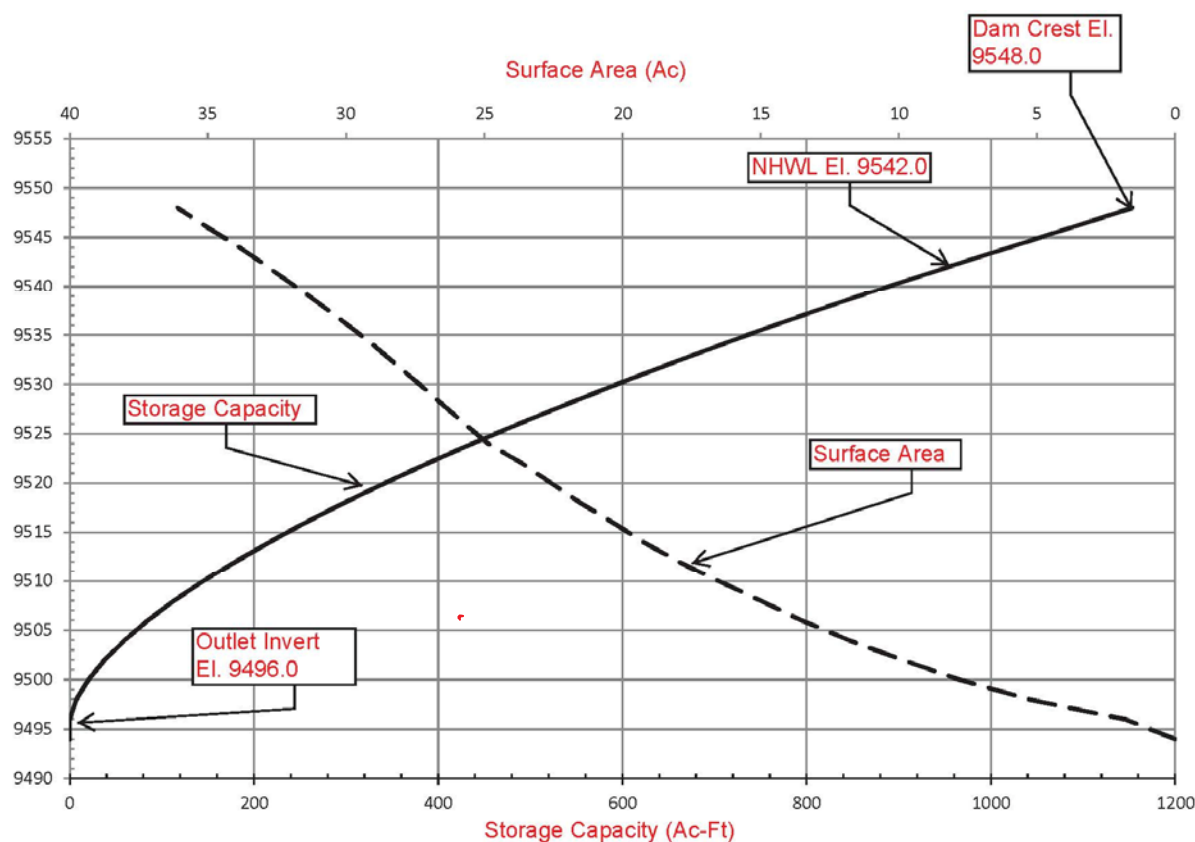
Figure 1.3 - Reservoir Area Capacity Curve

The area-capacity data for the reservoir was generated using the average end area method from two-foot contour data in the AutoCAD drawings used for design. The final storage capacity of the reservoir will depend on the volume of material that was excavated from within the reservoir area. The project plans called for the removal of material from within the reservoir to use in construction of the dam. The storage capacity data presented in this report is based on the excavation contours shown on the Construction Plans. The final stage storage table will be developed as part of the As Built drawings and Final Construction Report. See Figure 1.3 for the design Stage-Storage Capacity Curve
