## FEASIBILITY EVALUATION

### WALSENBURG CITY LAKE DAM REHABILITATION AND ENLARGEMENT

HUERFANO COUNTY, COLORADO  
DAMID: 10327

Project 14120  
March 2017

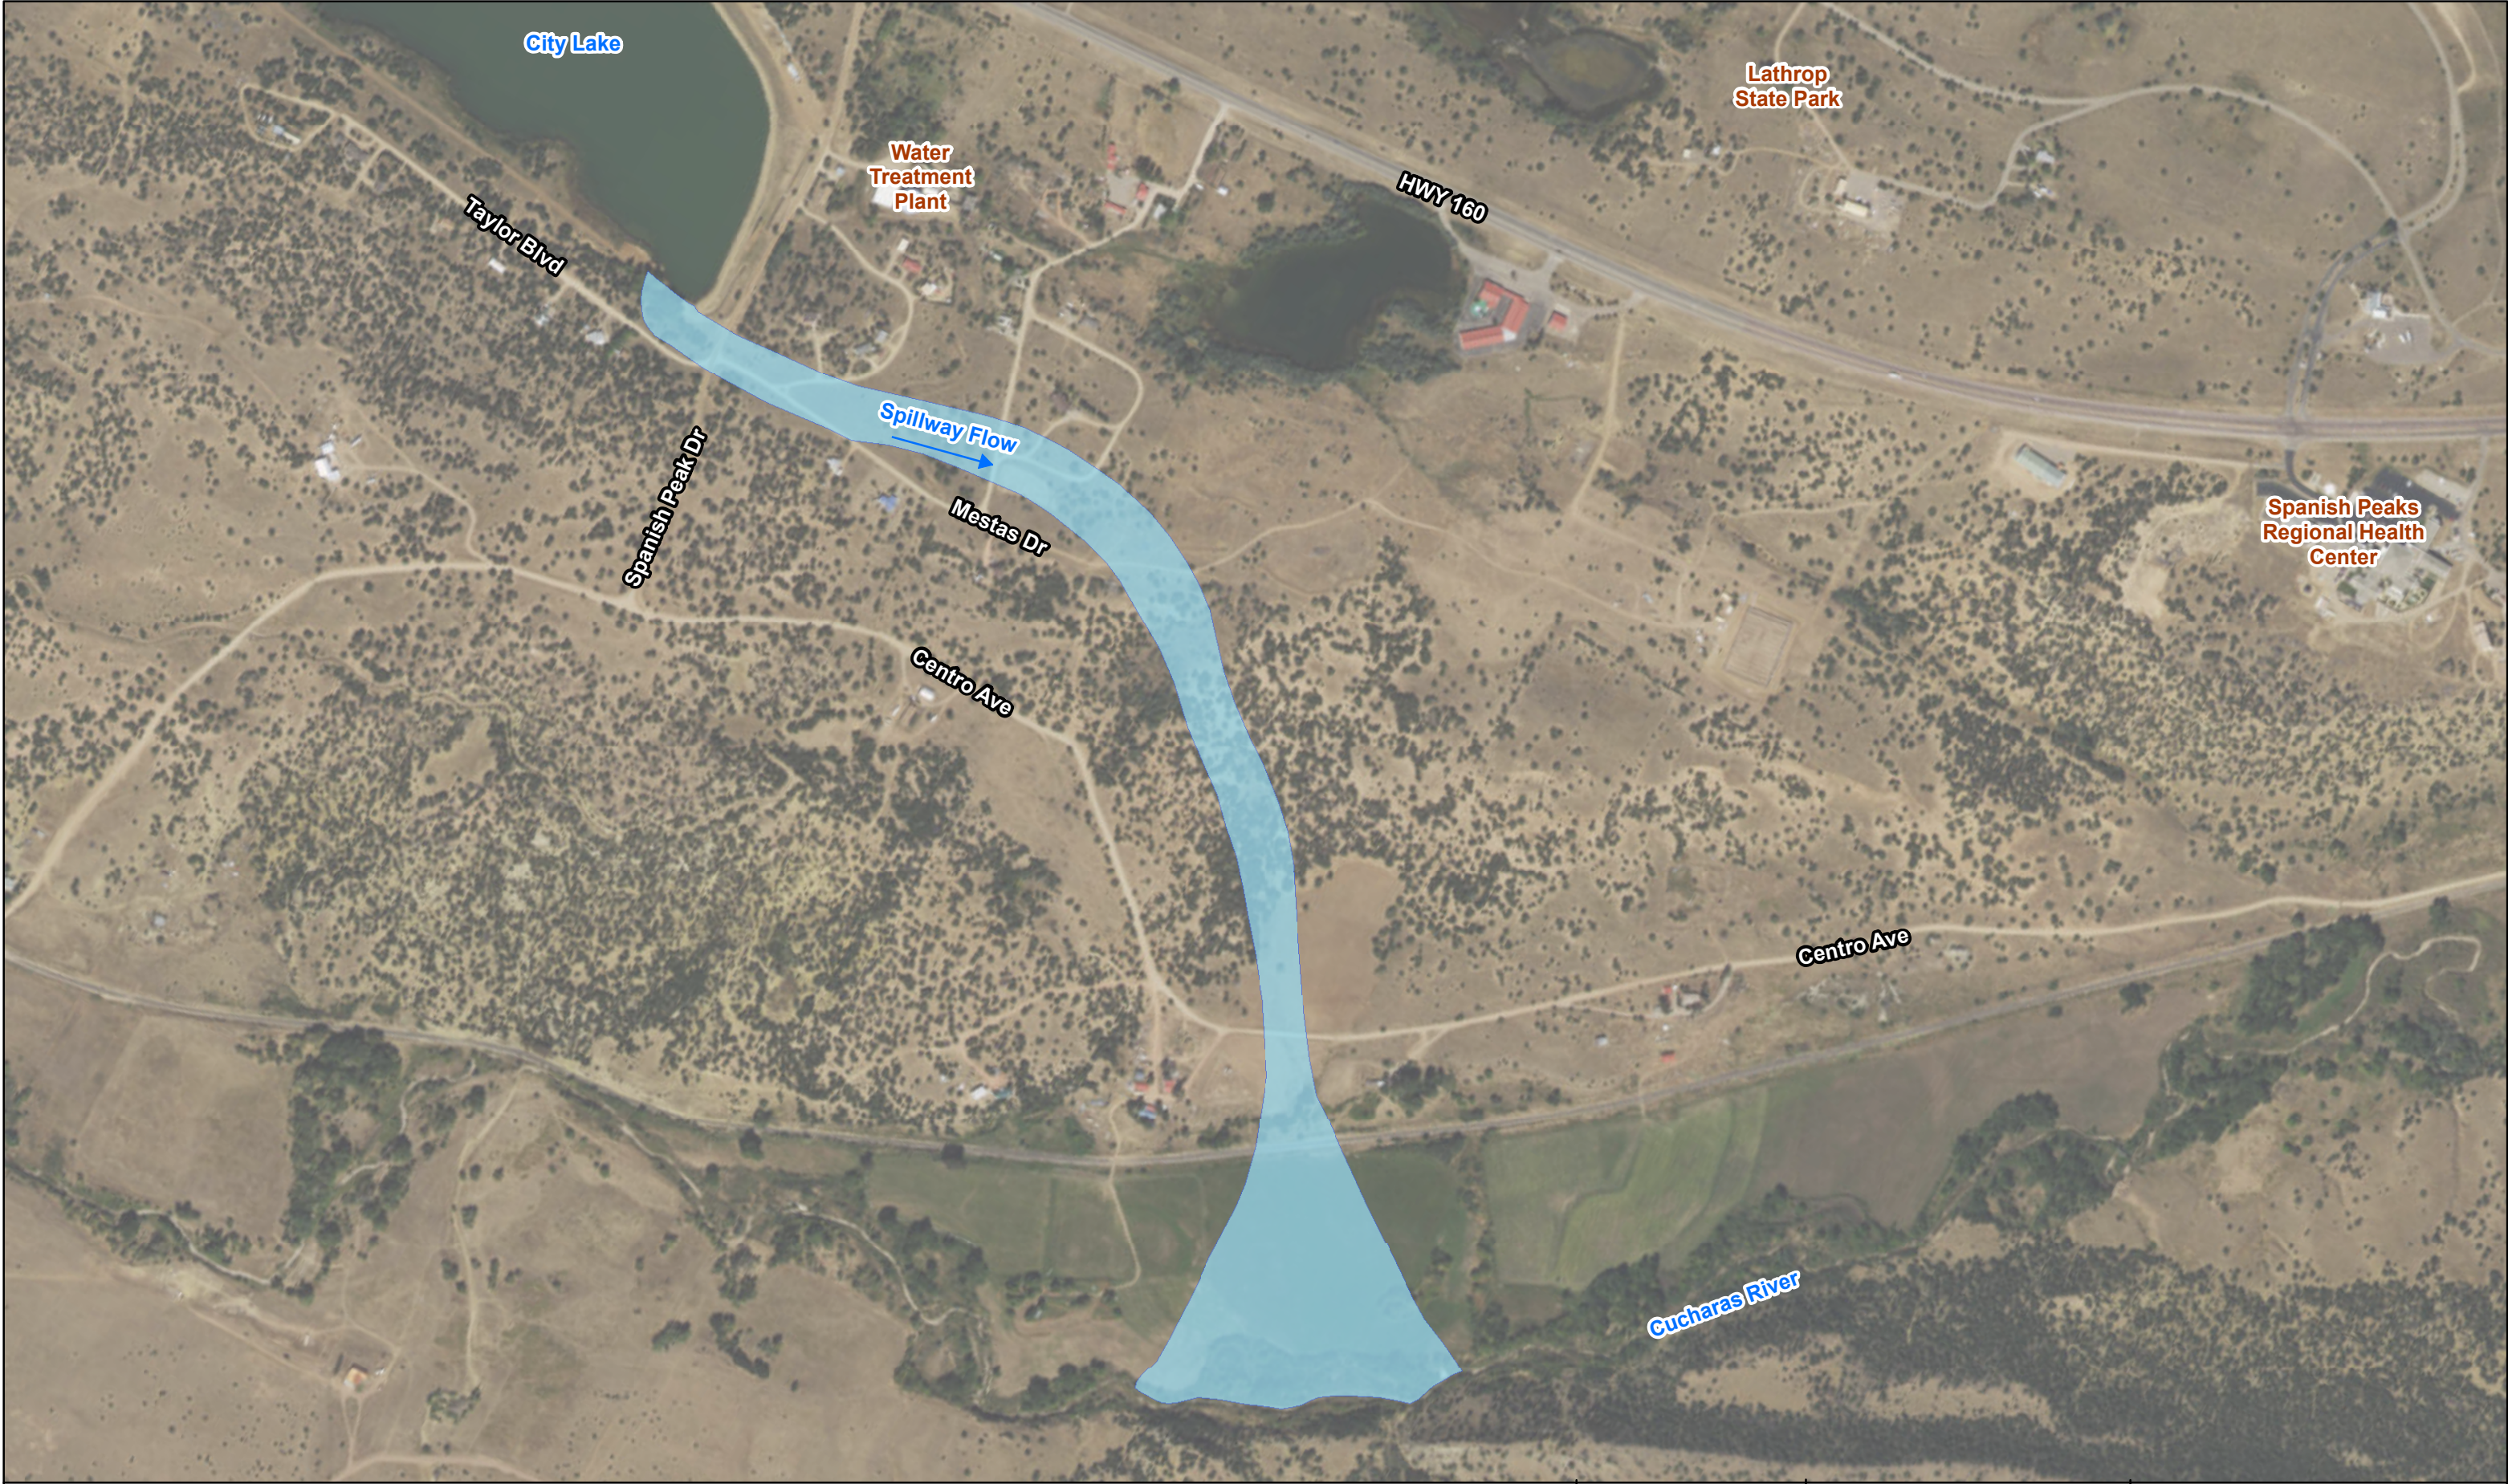
**Figure 5.1**

| Figure 5.1 | City Lake Dam Spillway Inundation Plan |

A new 50-foot-wide open channel emergency spillway will be constructed at the southeast corner of the reservoir. The new emergency spillway will have a concrete wall control section with a flowline at Elevation (El.) 6523.0, which is 6 inches above the service spillway flowline, grouted riprap-lined channel on the embankment downstream slope, and a riprap-lined discharge channel. The spillway will discharge across a county road and into an arroyo that drains southeastward back to the Cucharas River. The flow path for the new emergency spillway generally matches the existing emergency spillway flow path. The extent of a maximum emergency spillway discharge inundation flow path is shown on Figure 5.1.

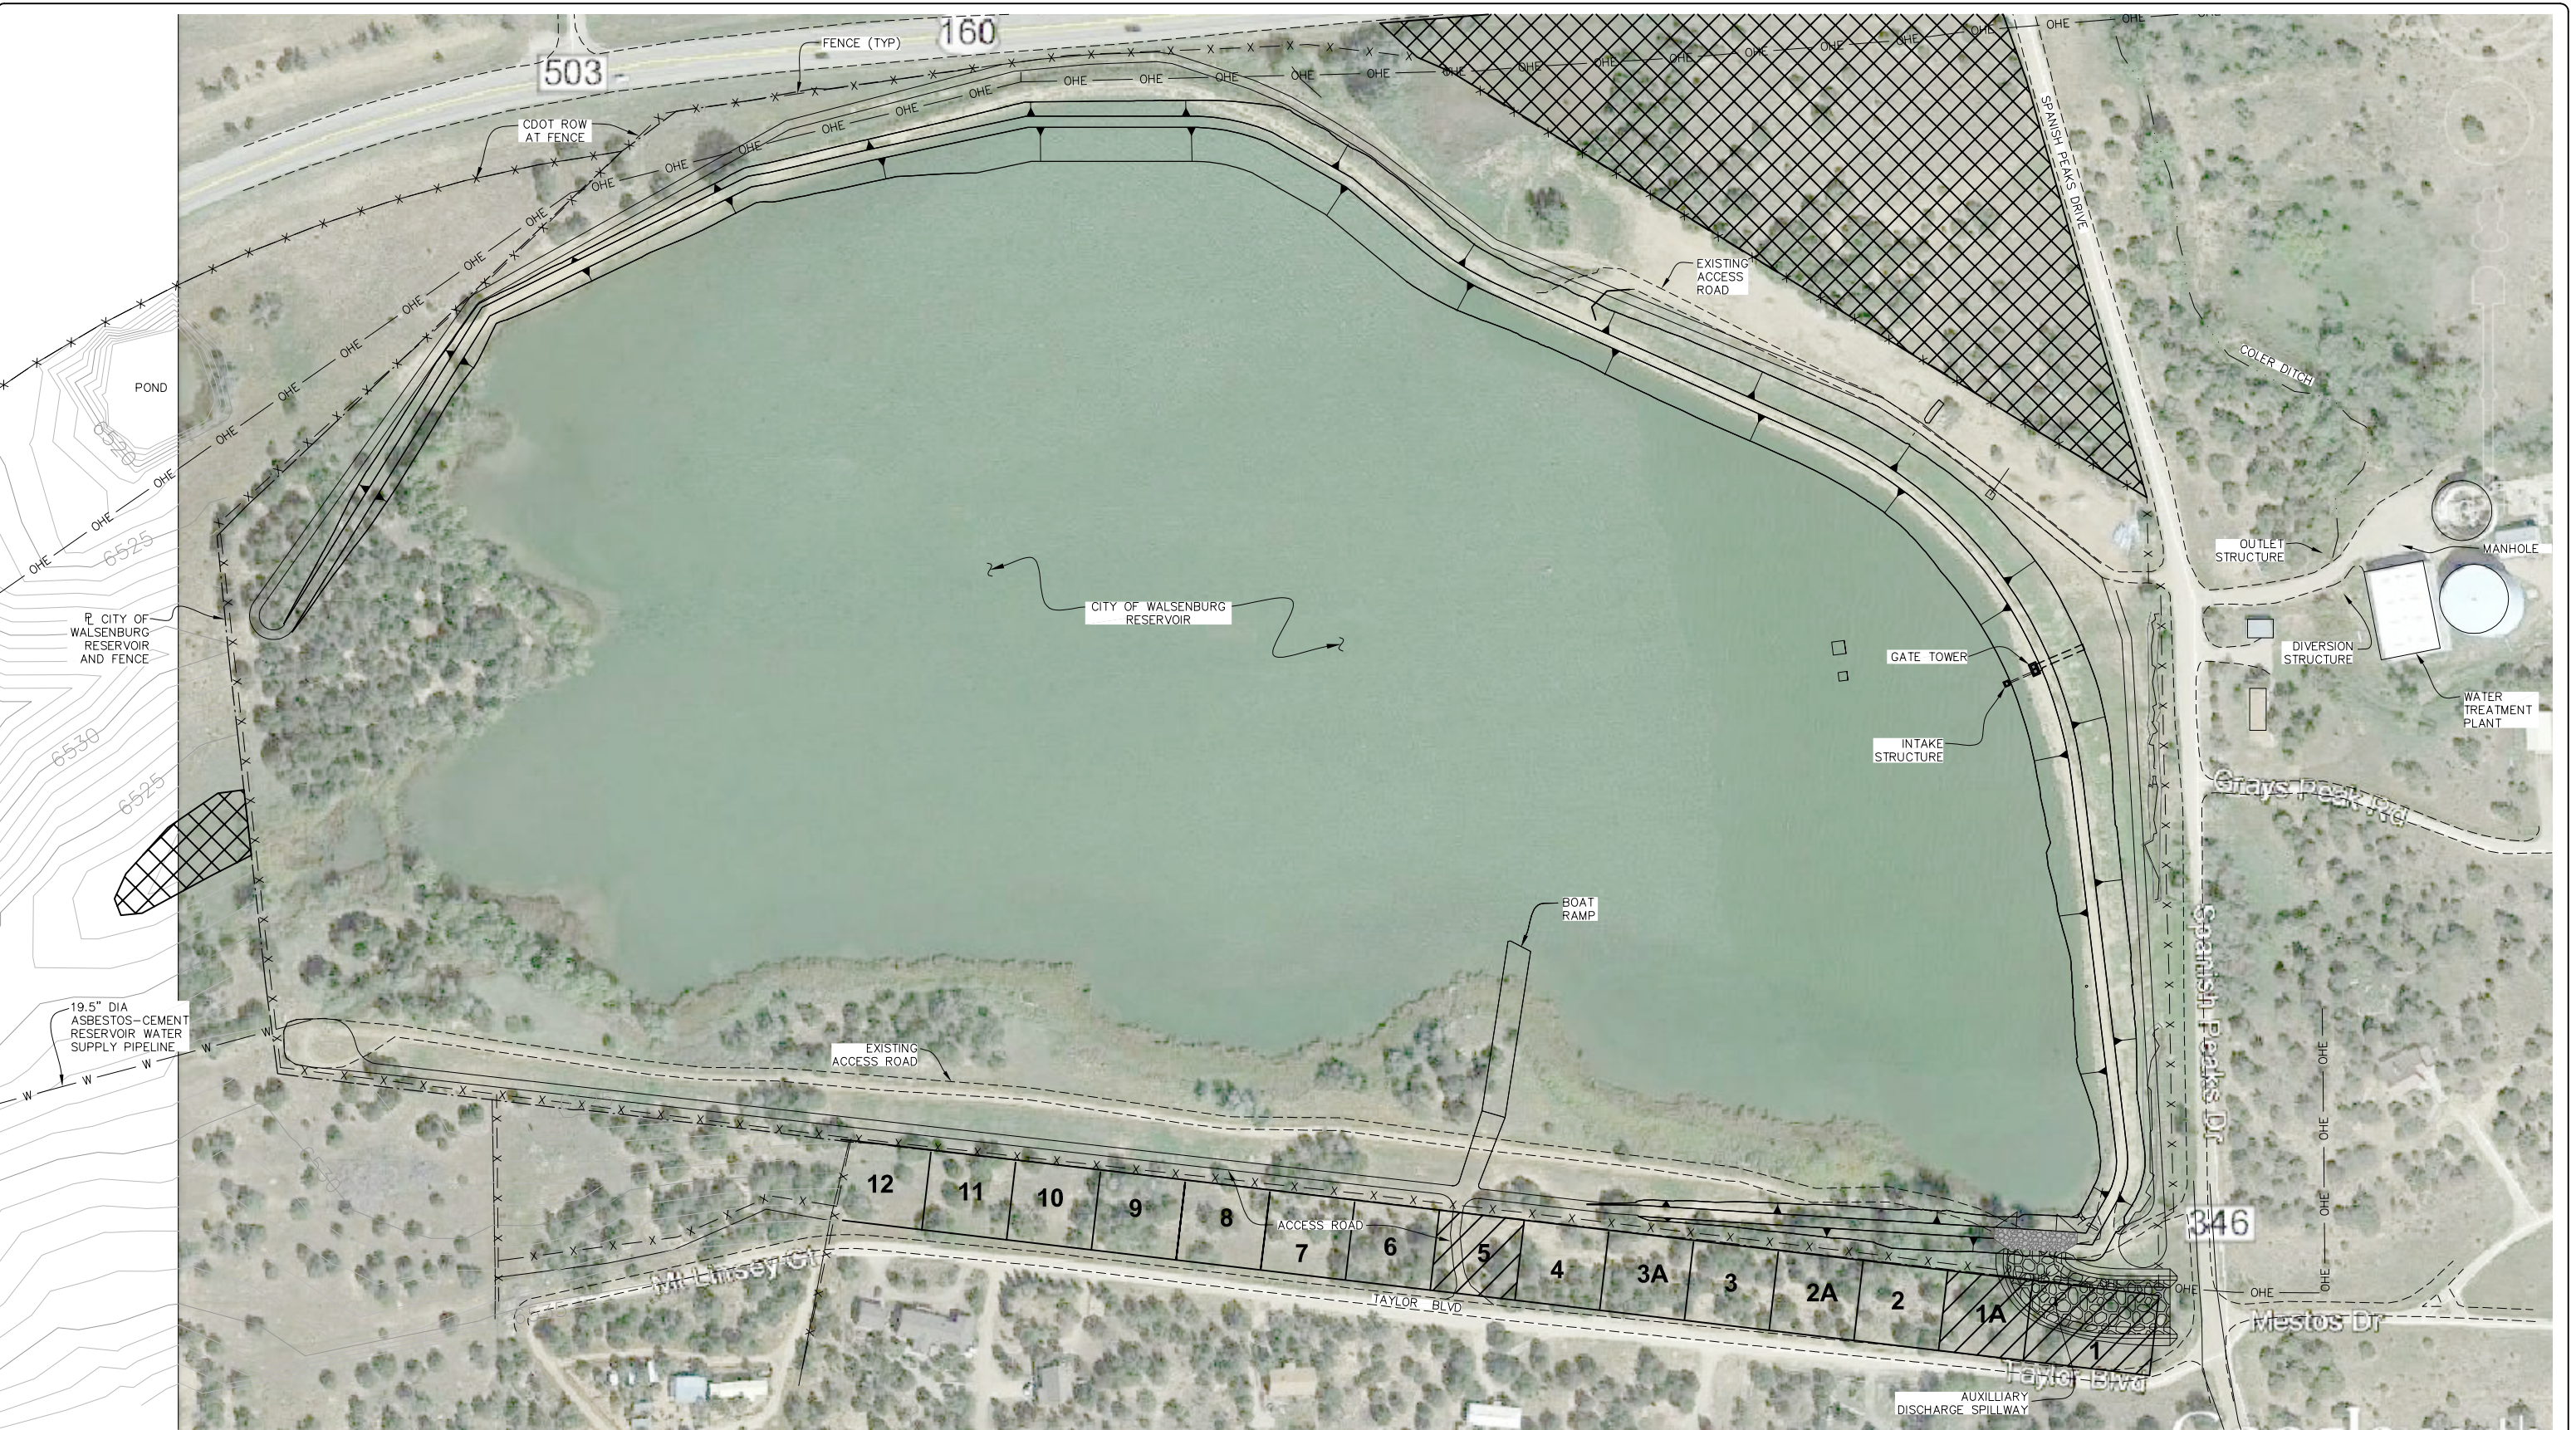
ADJACENT PROPERTY  
TO BE ACQUIRED  
March 2017  
Figure 5.2

| Figure 5.2 | Adjacent Property to be Acquired |

PROPERTY TO BE ACQUIRED  
EASEMENT TO BE ACQUIRED

The current emergency spillway has an access road to the west side of the reservoir where the supply pipeline delivers water to the reservoir. The new auxiliary emergency spillway will prevent vehicle access from the dam crest across the spillway and will not allow continuation of the existing access road to the west side of the reservoir. There are a number of undeveloped subdivision lots located on the south reservoir boundary and west of the spillway, one of which could be used to construct a new access road to the west side of the reservoir. A purchase of one of these lots is an anticipated requirement for a new access road. The subdivision lots on shown on Figure 5.2.

An easement or purchase of the privately owned land adjoining the reservoir property on the northeast side, south of US Highway 160 and west of Spanish Peaks Drive will be required to stockpile removed embankment material and for processing and blending imported embankment material. The City has discussed an easement for this purpose
