Cultural Resource Inventory of the Proposed Lined Ditch Reach of the Florida Farmers Ditch on Private Lands in La Plata County, Colorado

State of Colorado Archaeological Permits 2010-72/2011-58
SEAS Project No. 11-001
March 2011

The project area is located approximately four miles east of Durango in La Plata County, Colorado (Figures 2.1, 2.2, and 2.3; Table 2.1). The project crosses portions of Sections 19, 30, and 31 in Township 35 North, Range 8 West, NMPM and portions of Sections 24 and 25, Township 35 North, Range 9 West, NMPM, entirely on private lands. The purpose of the project is water conservation along the Florida Farmers Ditch. The Florida Farmers Ditch is an earthen structure and much water loss occurs through seepage. To minimize water loss during conveyance, Wright Water Engineers, Inc. proposes to line the canal with shotcrete placed over 30 mil PVC synthetic liner sandwiched between two layers of 8-ounce non-woven geotextile fabric. Prior to lining the ditch, the ditch profile will be restored to an optimal trapezoidal flow path, versus the existing eroded U-shaped flow path. Only two of the lateral gates may be replaced and most of the existing gates and feature

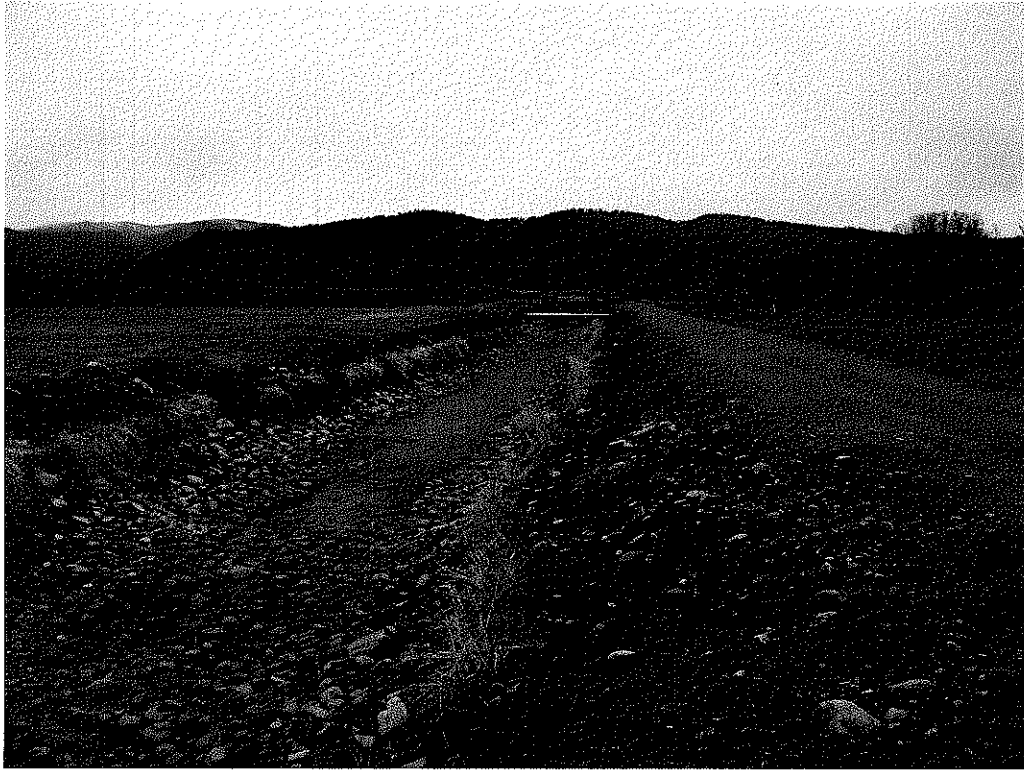
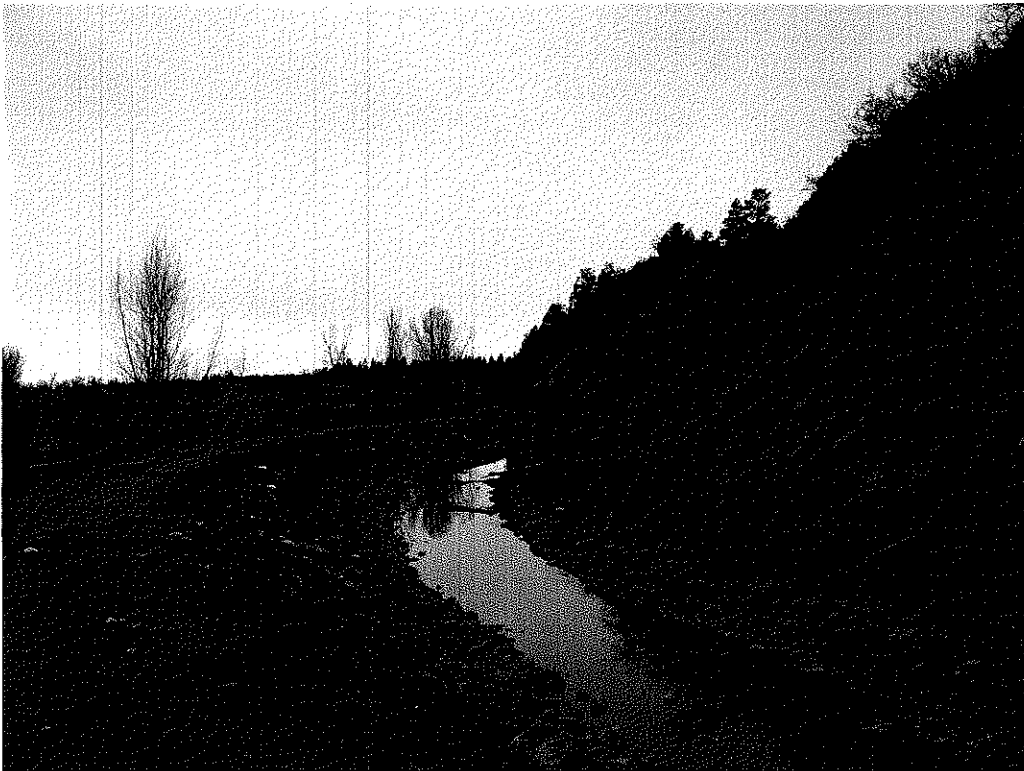
Figure 2.3 View North of Florida Farmers Ditch from South End of Project (Top) and View Southwest from North End of Project (Bottom)

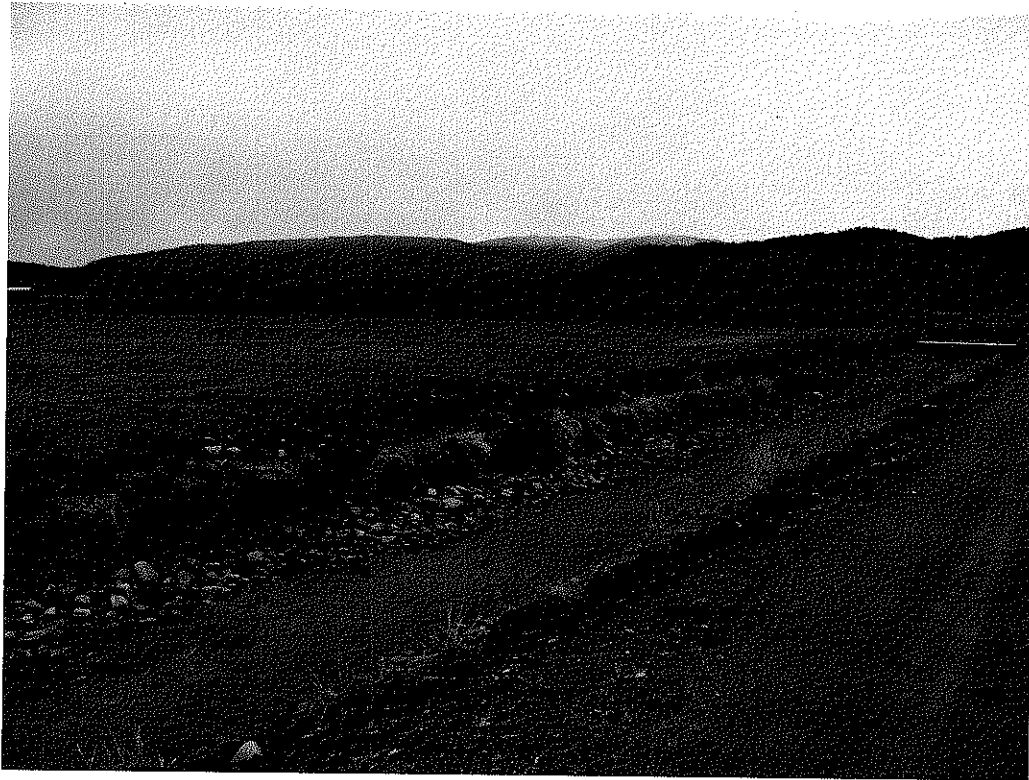
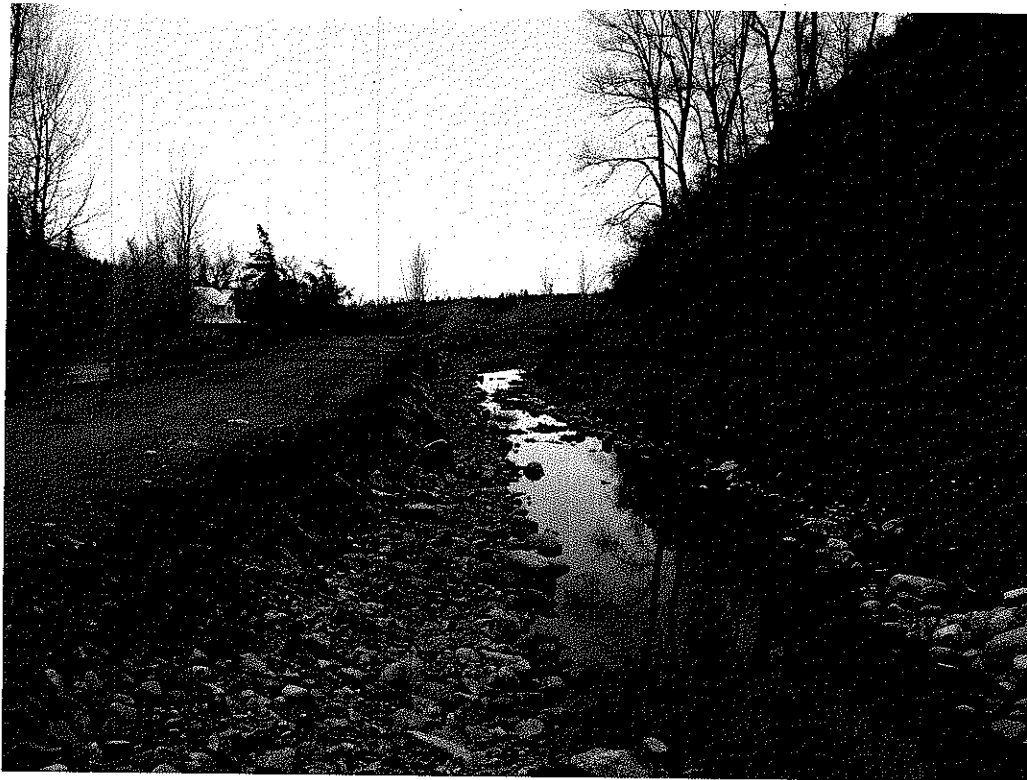
Figure 5.2 Overviews of Site Segment 5LP5661.6 Facing North Near South End (Top) and View South Near North End (Bottom)

Site segment 5LP 5661.6 is on the northern portion of the historic Florida Farmers Ditch (Figures 5.1 to 5.7). The northern end of site segment 5LP 5661.6 lies 900 ft west of the Farmers Ditch Diversion Dam on the Florida River, which is not within the current project area. The Florida Farmers Ditch was first adjudicated in November of 1923 (Case No. CA1751) for 71 cfs. The water rights were enlarged 110 cfs (Case No. B-1751) in 1966, following the construction of Lemon Reservoir in 1963 and an enlargement of the canal system that occurred between 1962 to 1964. Currently, the absolute water rights for the Florida Farmers Ditch is 184.99 cfs. The Florida Farmers Ditch provides irrigation water for farms and ranches on the east side of Florida Mesa. Florida Mesa as a landform has exceptionally fertile soils, being covered with a thick mantle of loess. Prior to the construction of Lemon Reservoir, irrigation water was available following spring runoff when river levels were high and farmers often ran out of irrigation water by the middle of the growing season (FDC 2011). The Florida Project, which resulted in the construction of Lemon Reservoir and enlargement and refurbishing of the canal system, sought to provide late season irrigation water to area farms and ranches, including the Southern Ute Indian Tribe.

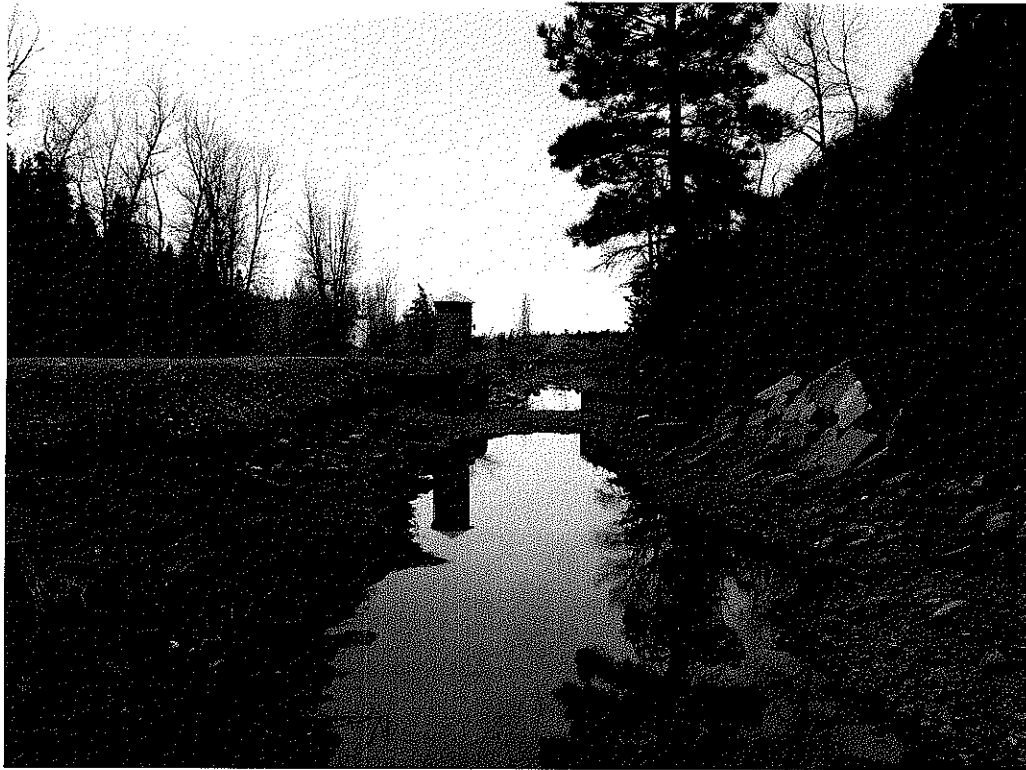
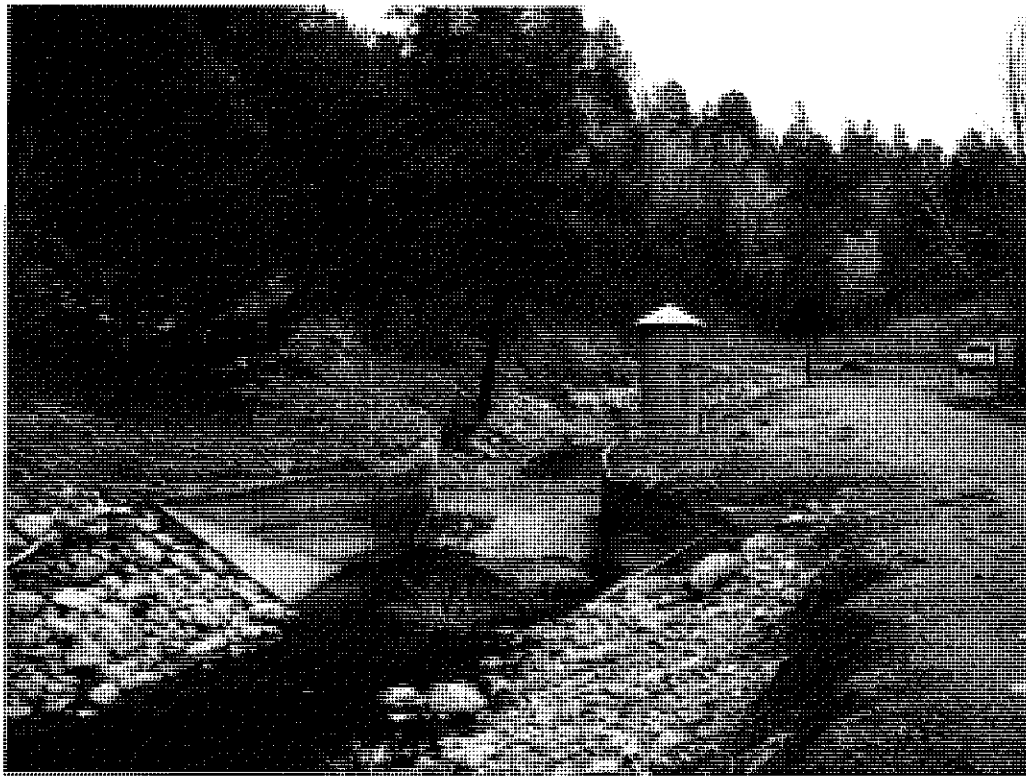
Figure 5.4 View of Feature 3 Drop Structure and Feature 4 Flow Gauge Housing Facing South (Top) and North (Bottom), Site 5LP 5661.6

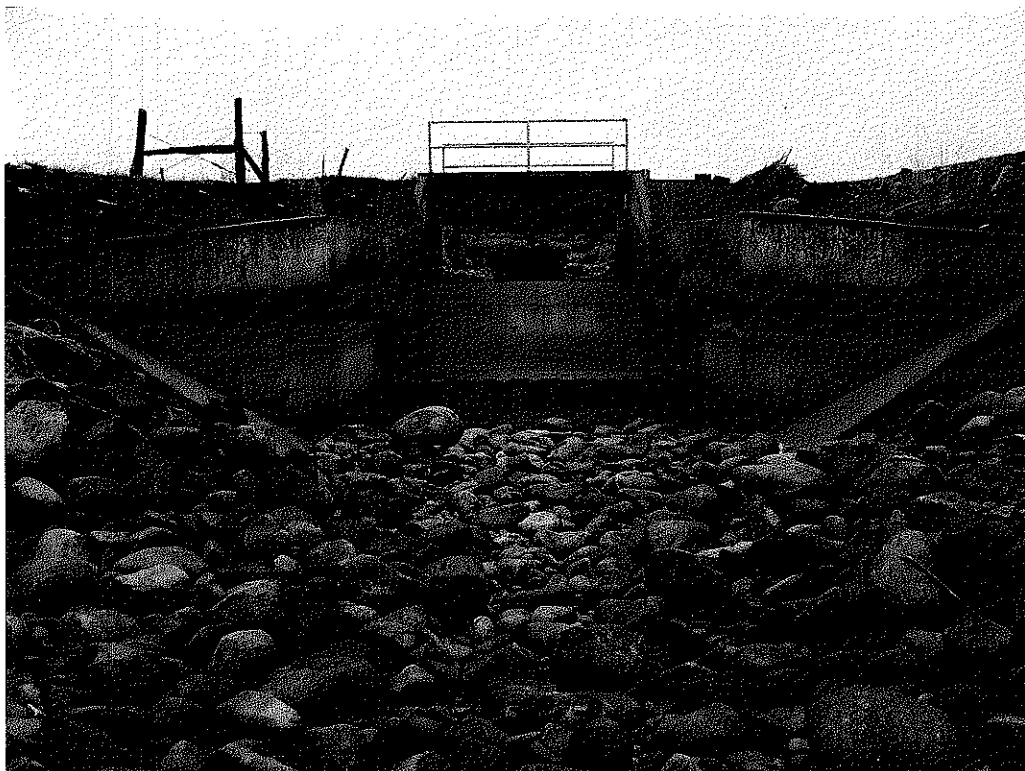
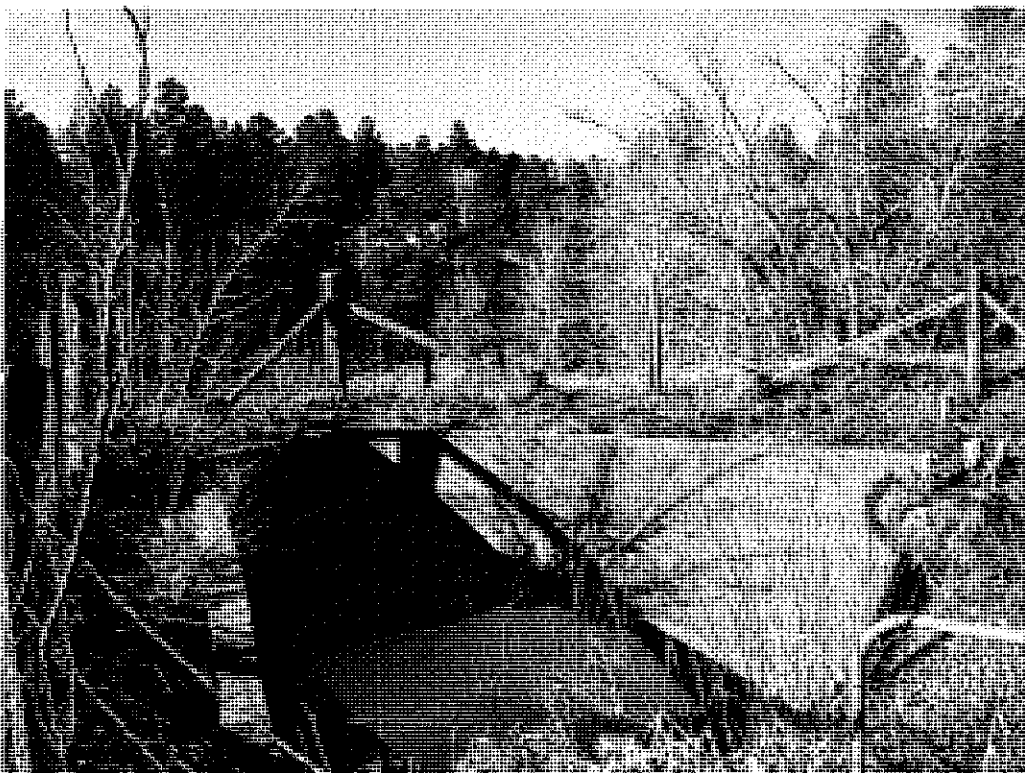
Figure 5.7 View North of Feature 17 Drop Structure (Top) and View Southwest of Feature 24 Siphon Crossing Under CR 234 (Bottom), Site 5LP 5661.6

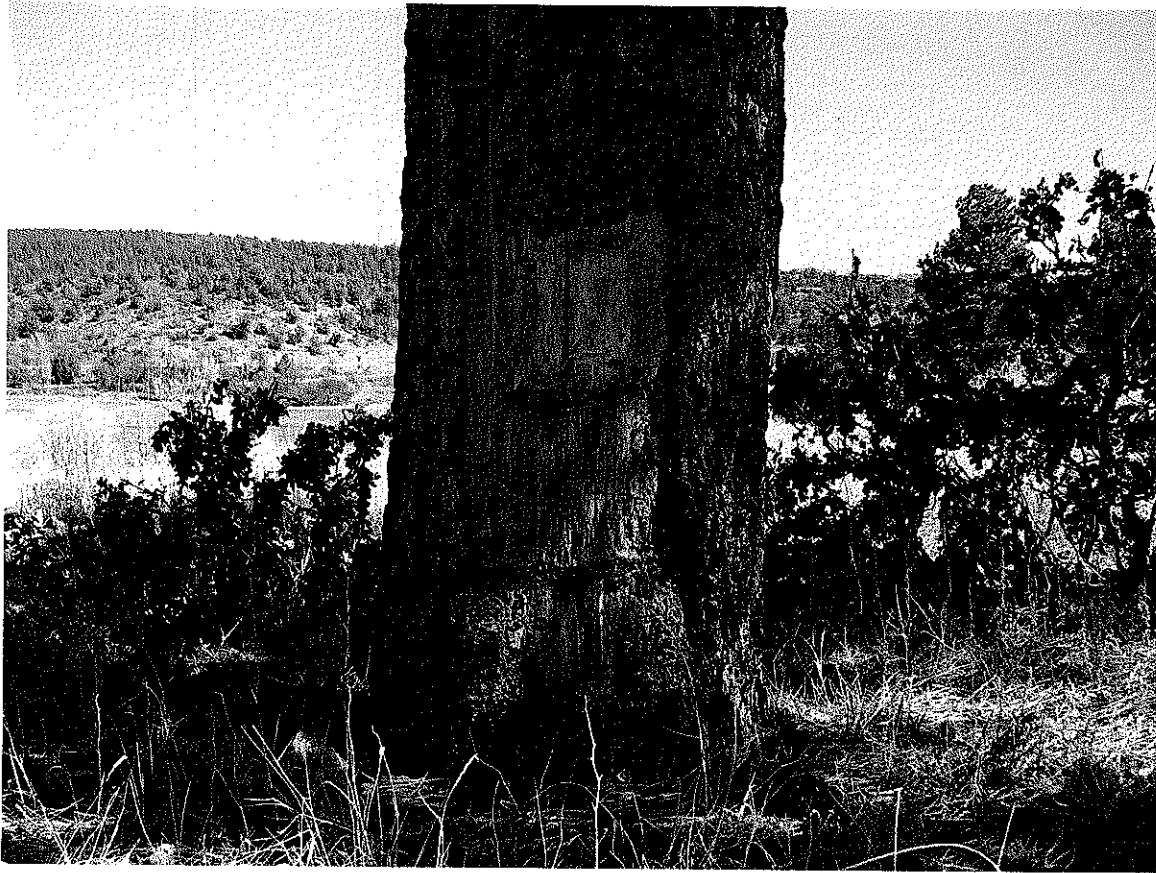
Figure 5.11 View Facing East of Culturally Modified Tree, Site 5LP 9766

The site consists of a single ponderosa pine tree measuring 90 cm in diameter at chest height that has been culturally modified (Figures 5.10 and 5.11). The cultural modification consists of a rectangular scar measuring 40 cm wide by 90 cm high on the west side of the tree. Three horizontal cut marks are visible on the exposed wood. The tree continued to grow after it was peeled, and the bark now bulges approximately 7 cm beyond the exposed wood inside the scar. The bottom of the scar is currently approximately 20 cm above the modern ground surface, but soil was deposited around the tree during either the original canal construction project, or the reconstruction project, burying the ground surface to an estimated depth of 40-50 cm. The head of a metal nail or spike is visible protruding from the wood at the base of the scar. It is unknown if there is any association between the scarring of the tree and the spike, but the spike must have been driven into the tree after the tree was peeled, as the head is flush with the peeled wood. The barren scar may represent aboriginal bark peeling to access inner bark used as a starvation food, a seasonal delicacy, a medicinal tea, or a poultice. In addition, the sap was used to waterproof objects and the outer bark used for construction of cradleboards, trays, and other purposes (Martorano 1981). The cultural scarring of this tree, unusually rectangular in outline, may not have been for the cambium as a food source, but probably as a cradleboard or tray. However, given the presence of the spike within the scar, the modification may not represent aboriginal use and it may be of historic European American origin. The site has good research potential and dating potential through incremental tree boring.
