### **Cucharas Collaborative Storage Geotechnical Investigation Project**

## PRELIMINARY GEOTECHNICAL EVALUATION

Cucharas Basin Collaborative Storage  
Huerfano County, Colorado

**Project No. 18.117**  
**November 27, 2018**

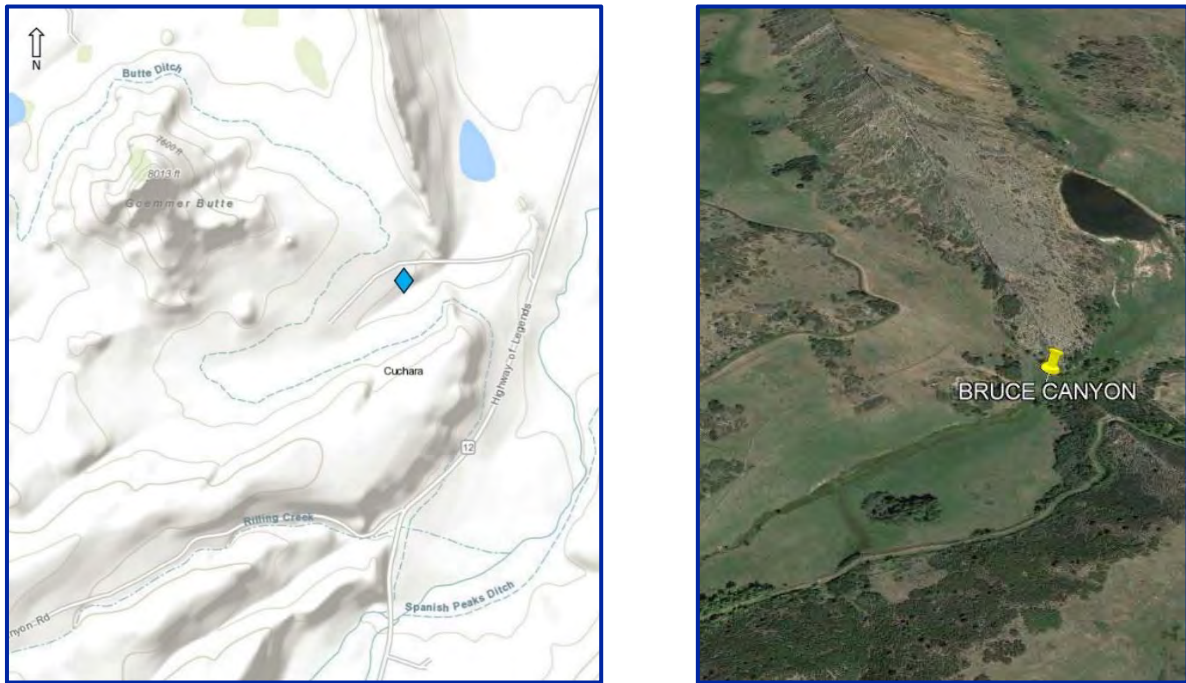
**FIGURE 5. Bruce Canyon project site (topographic and Google Earth images) is located southwest of the Town of La Veta, west of County Road 12 (CR12). Bruce Canyon is an east-west valley cut through by a north-south trending intrusive dike. There is an ephemeral spring and an irrigation ditch in the project area. Goemmer Butte is a prominent volcanic feature west of the project site.**

The Bruce Canyon site is located southwest of the Town of La Veta off State Highway 12 (SH12). The potential dam site is upstream of an intrusive dike that strikes northwest to southeast, cutting through the Cuchara Formation that comprises the valley rock (Figure 5). The low valley drains an ephemeral creek through the dike and Butte Ditch runs around the periphery at an elevation of 7,420 feet. Goemmer Butte is west of the valley. Goemmer Butte is a volcanic plug intruded into the Cuchara Formation and exhibits the only evidence in the immediate vicinity of Spanish Peaks for magma venting to the surface. A crescent shaped body of eruptive breccia is well exposed on the south and west sides of the butte. The Eocene aged Cuchara Formation exposed here represents its lowermost part. Typically, the formation is arkosic, conglomeratic, and cross bedded, found in fining upward alluvial cycles. The mudstones are drab brown to red. There are prominent pebbles and cobbles in the sandstone and red mudstone helps distinguish the unit in this area (Penn, 1996<sup>6</sup>).

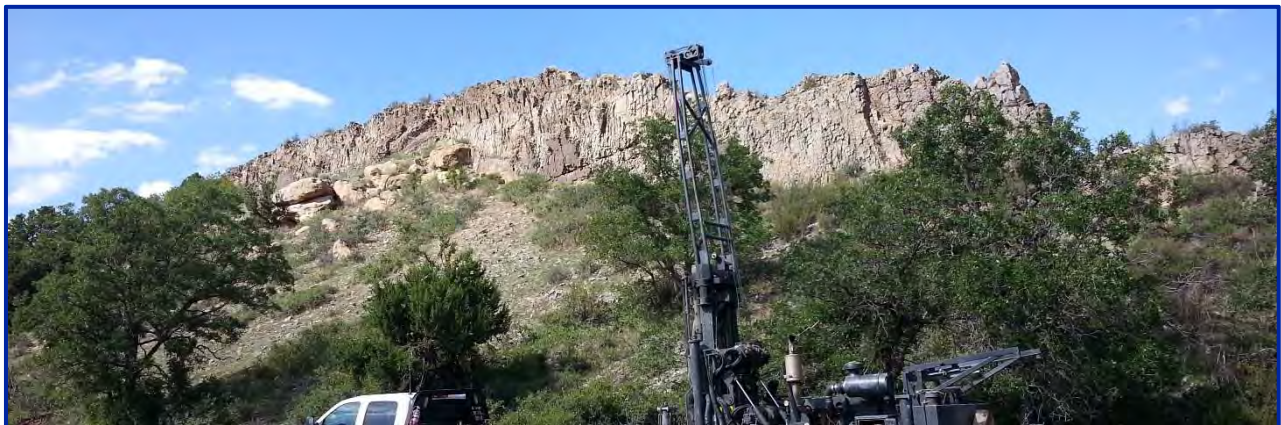
**FIGURE 6. Intrusive dike on the northeast side of the site. A potential source for rockfall into the project area.**

Geologic hazards at Bruce Canyon are rockfall and landslides. The vertical face of the intrusive dike is a source area for rockfall into the project area (Figure 6). Even so, rockfall is not expected to affect the project adversely, as there is little evidence of rockfall near the proposed abutment locations, the evidence indicates rocks that have fallen are not large, and rocks would likely fall into the reservoir, as opposed to on the embankment. The slopes on either side of the valley have the potential for downslope movement (Figure 7). Because the interbedded and fractured nature of the sedimentary rock units in this area, the slope stability could be affected by the infiltration and movement of water along fractures and bedding planes, increasing weathering, and reducing strength along discontinuities.

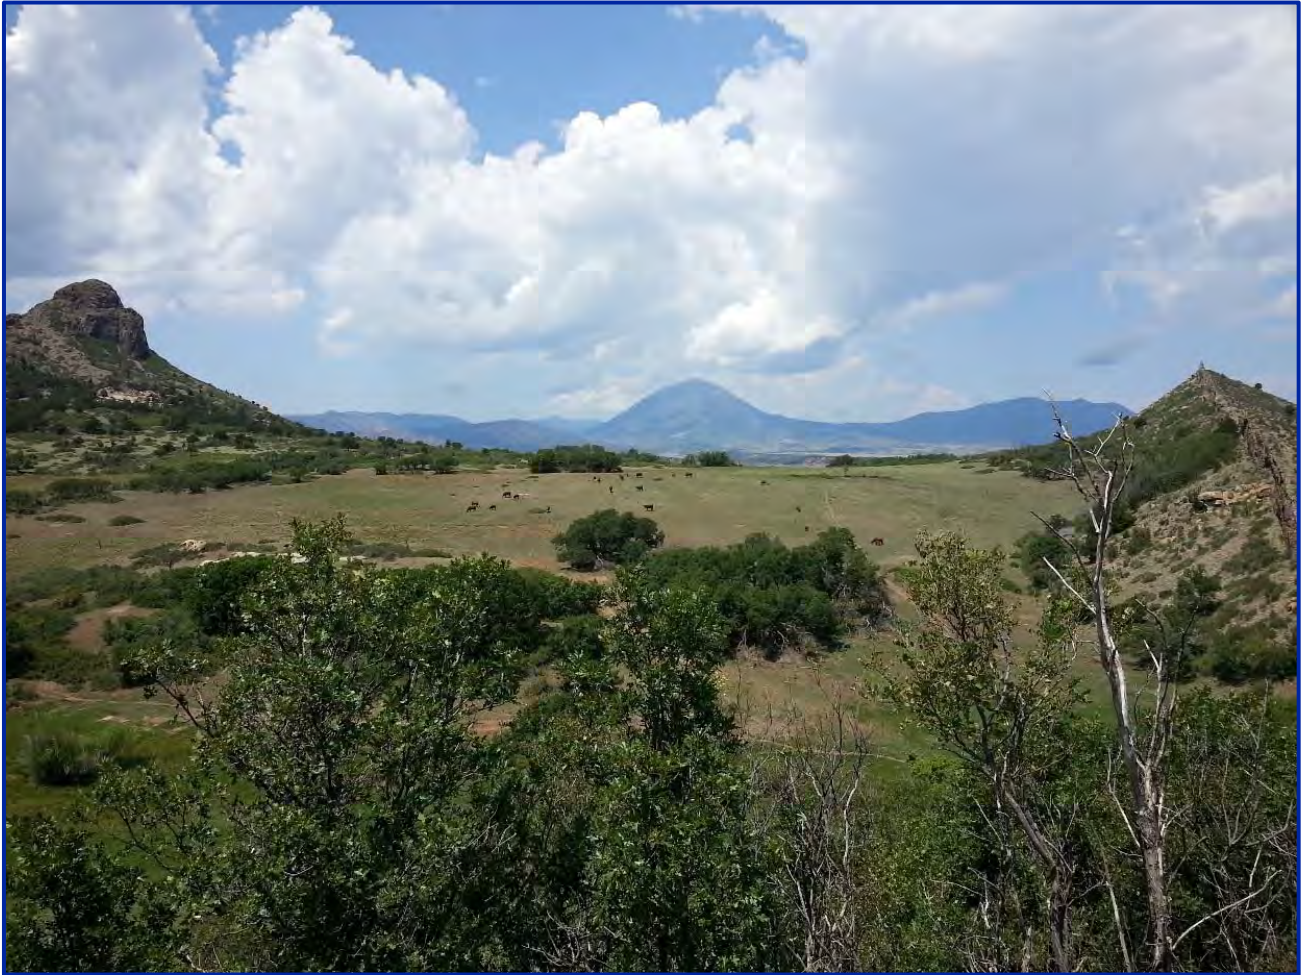
**FIGURE 7. Bruce Canyon project site. View is looking north from the south side of the project area. Steep hill slopes on either side of the valley have the potential for downslope movement due to the fractured and interbedded nature of the sedimentary rock units.**

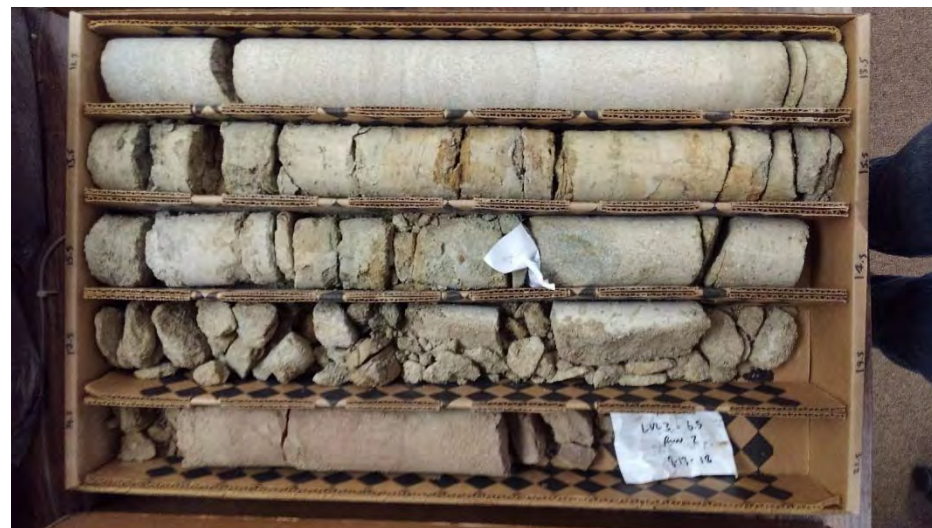
**Photo 16. LVL-3 from 11.5 to 21.5 feet.**

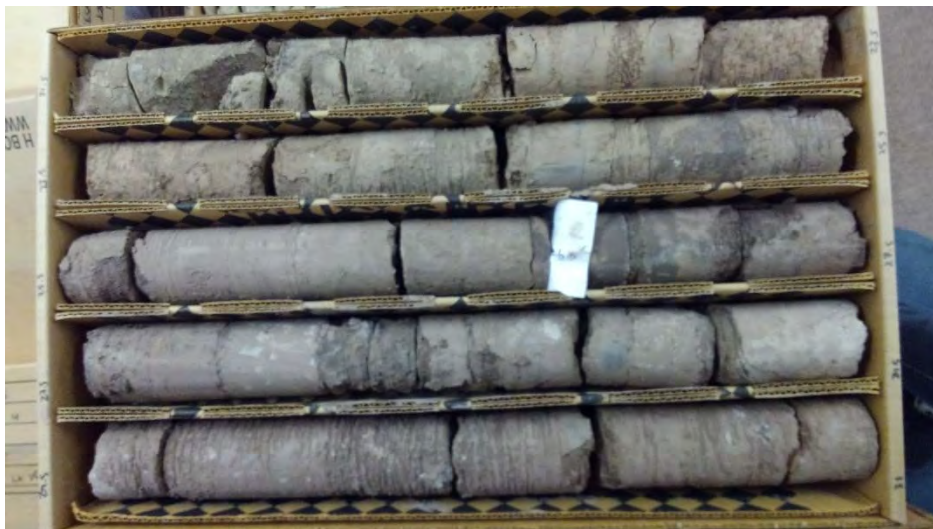
**Photo 17. LVL-3 from 21.5 to 31 feet.**

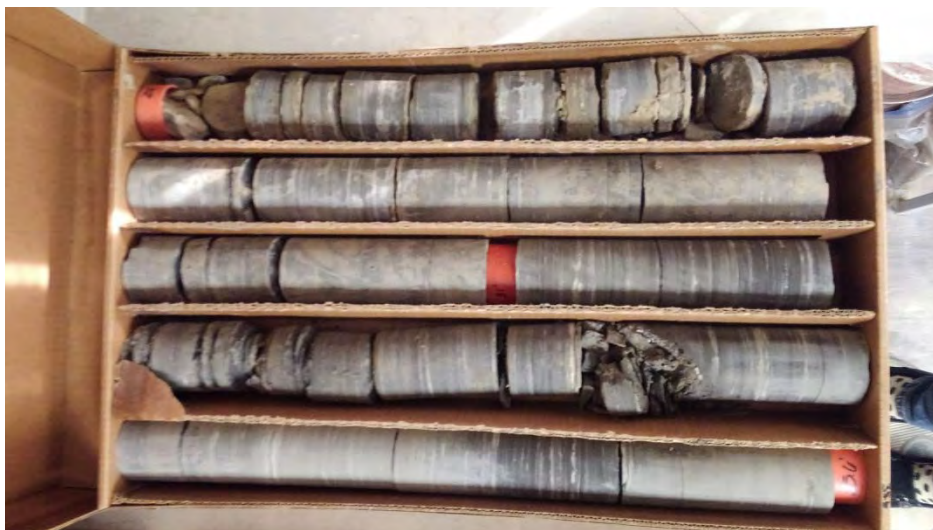
**Photo 19. MS-3 from 26 to 35.6 feet.**

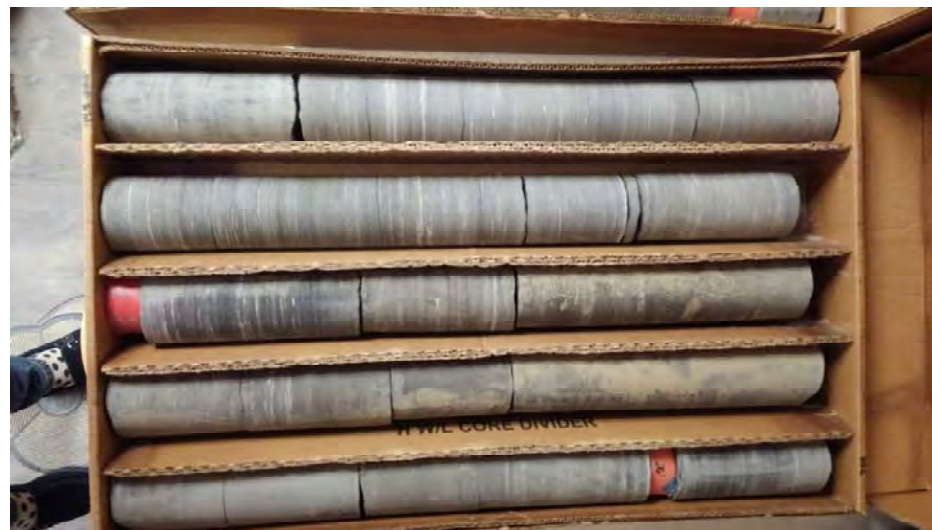
**Photo 20. MS-3 from 35.6 to 44.5 feet.**

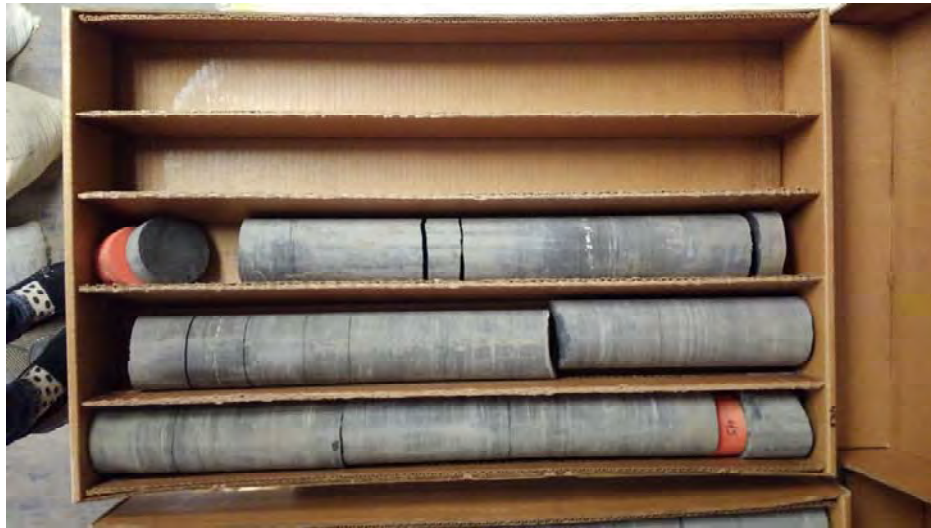
**Photo 21. MS-3 from 44.5 to 50 feet.**

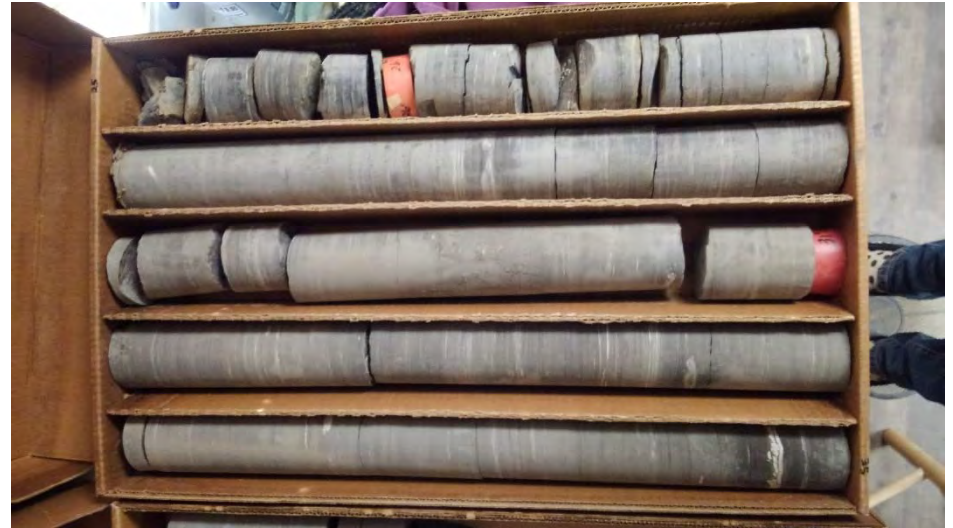
**Photo 22. MS-5 from 25 to 35 feet.**

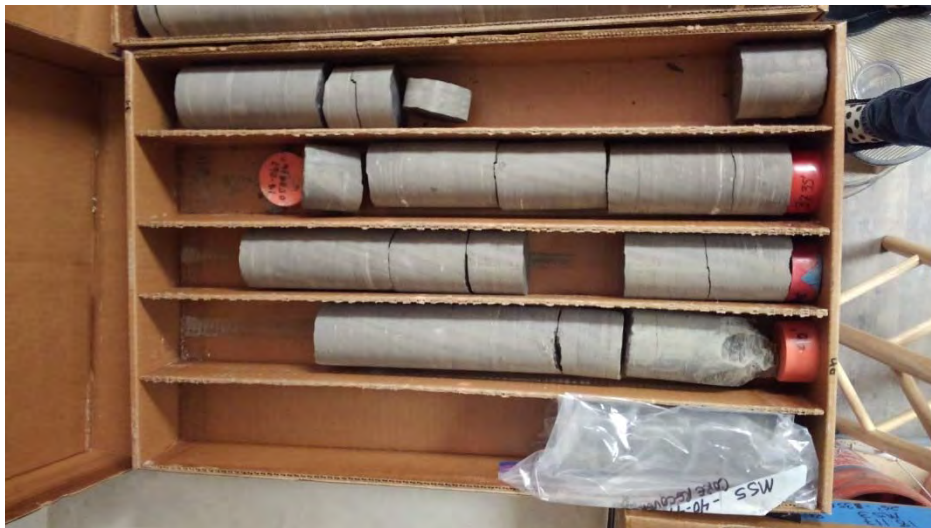
**Photo 23. MS-5 from 35 to 40 feet.**

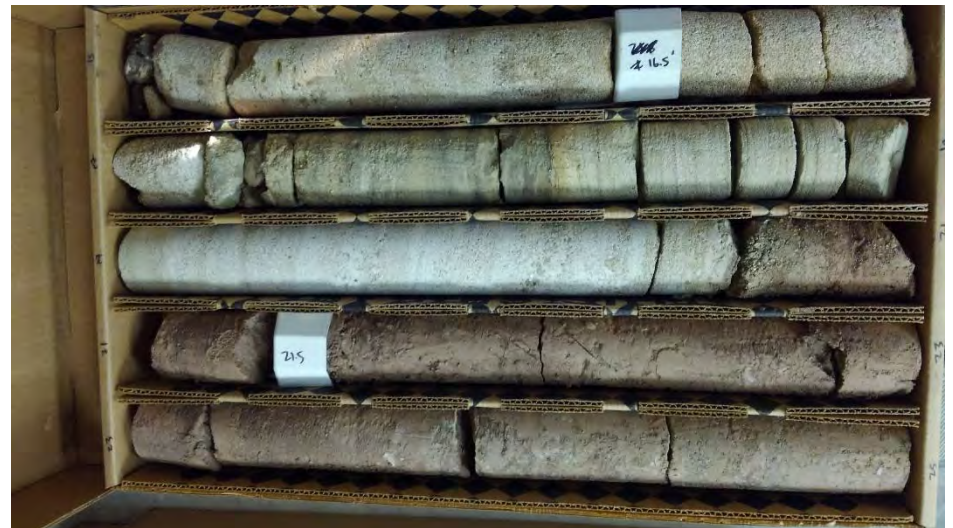
**Photo 24. LVL-1 from 15 to 25 feet.**

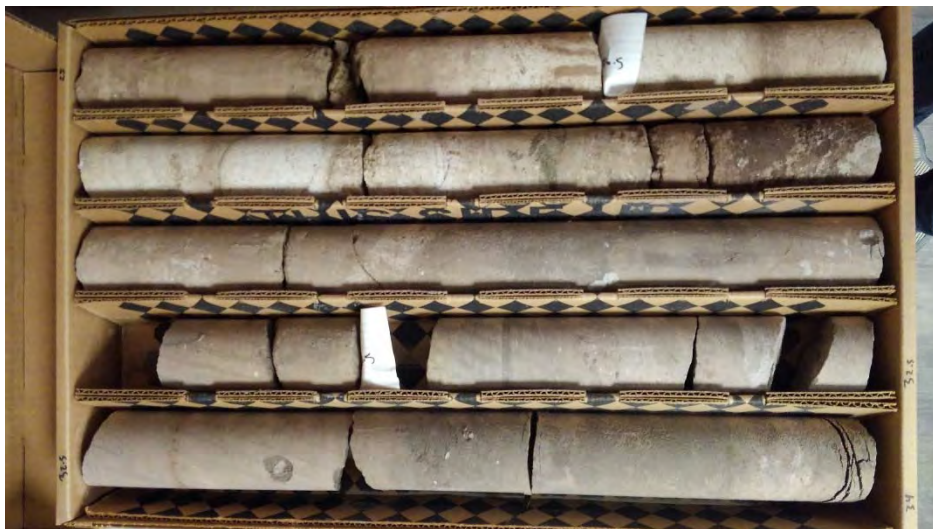
**Photo 25. LVL-1 from 25 to 34 feet.**

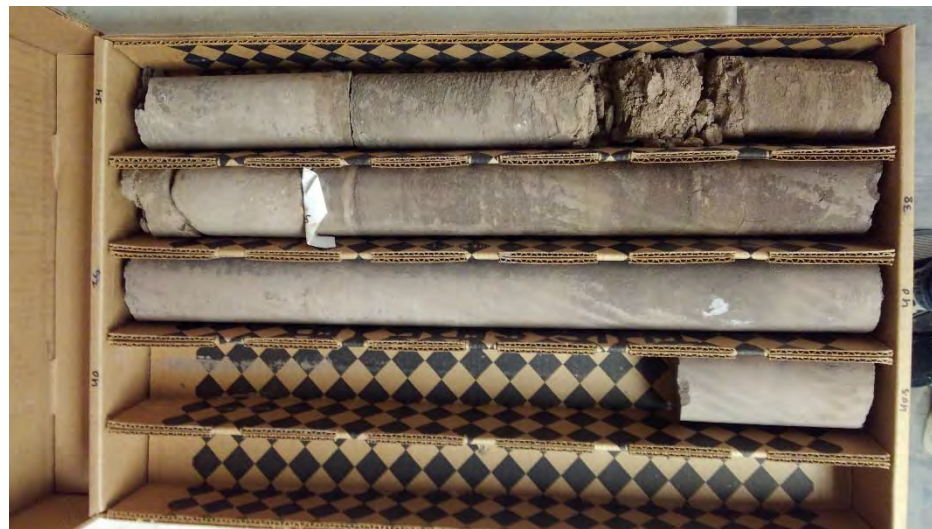
**Photo 26. LVL-1 from 34 to 40.5 feet.**

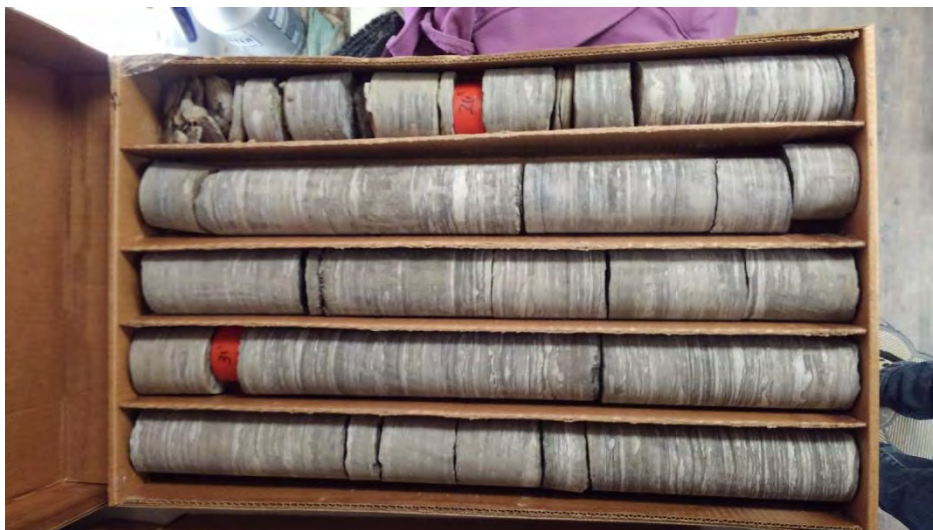
**Photo 27. MS-1 from 25 to 34.6 feet.**

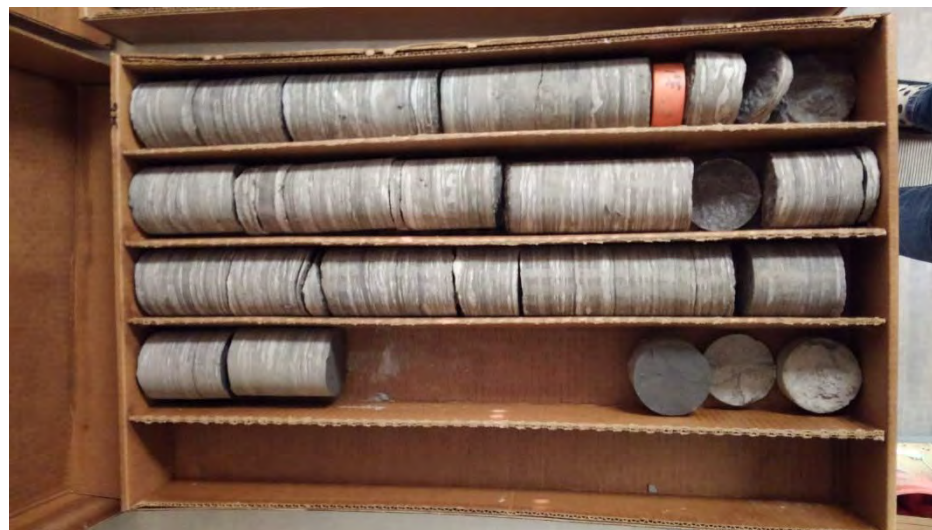
**Photo 28. MS-1 from 34.6 to 41 feet.**
