South Baker Creek Dam

30% Design Report

Huerfano County Water Conservancy District

PRELIMINARY GEOTECHNICAL EVALUATION

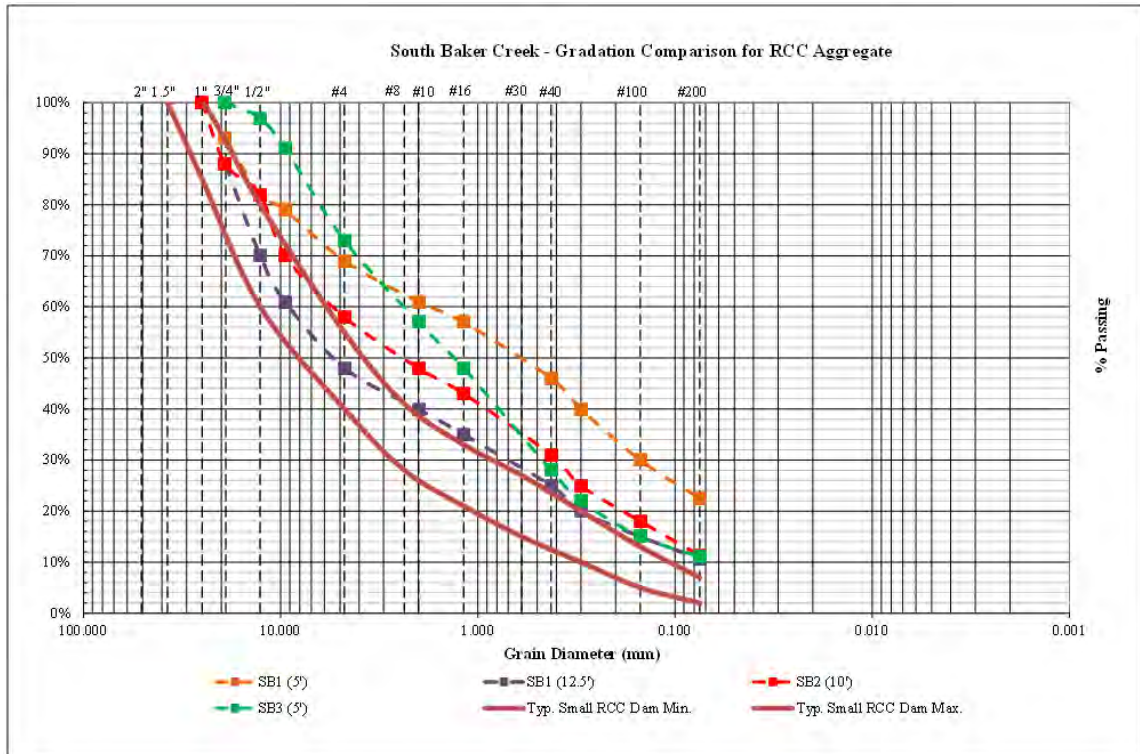
Figure 3. S. Baker Creek Gradation Comparison

One benefit of RCC dams is that it typically permits the use of lower quality aggregate as opposed to conventional concrete gravity dams. Applegate reviewed results of lab testing performed by Cesare on samples collected from borings and test pits to evaluate the suitability of native materials for RCC dam construction. Gradation plots for sampled materials were compared to a typical aggregate gradation band for small RCC dams¹. Figure 3 compares gradation plots for soil samples collected from borings SB-1 through SB-3 to the typical gradation band referenced above. These samples were determined to be most compatible with the recommended gradation band. The comparison indicates that coarse aggregate would need to be imported (either purchased commercially or from another borrow site) to achieve a gradation within the typical band. It is possible that a 3:1 blend of native sands encountered in borings SB-1 through SB-3 and a coarse aggregate similar to AASHTO #467 stone would meet the recommended gradation band. Figure 4 shows the proposed 3:1 aggregate blend utilizing #467 stone. Estimated additional costs associated with importing aggregate for the RCC mix have been incorporated in the updated Opinion of Probable Cost. Note that additional geotechnical investigation should be completed to identify other potential borrow sources, confirm the suitability of native materials for use as RCC aggregate, and estimate required quantities.

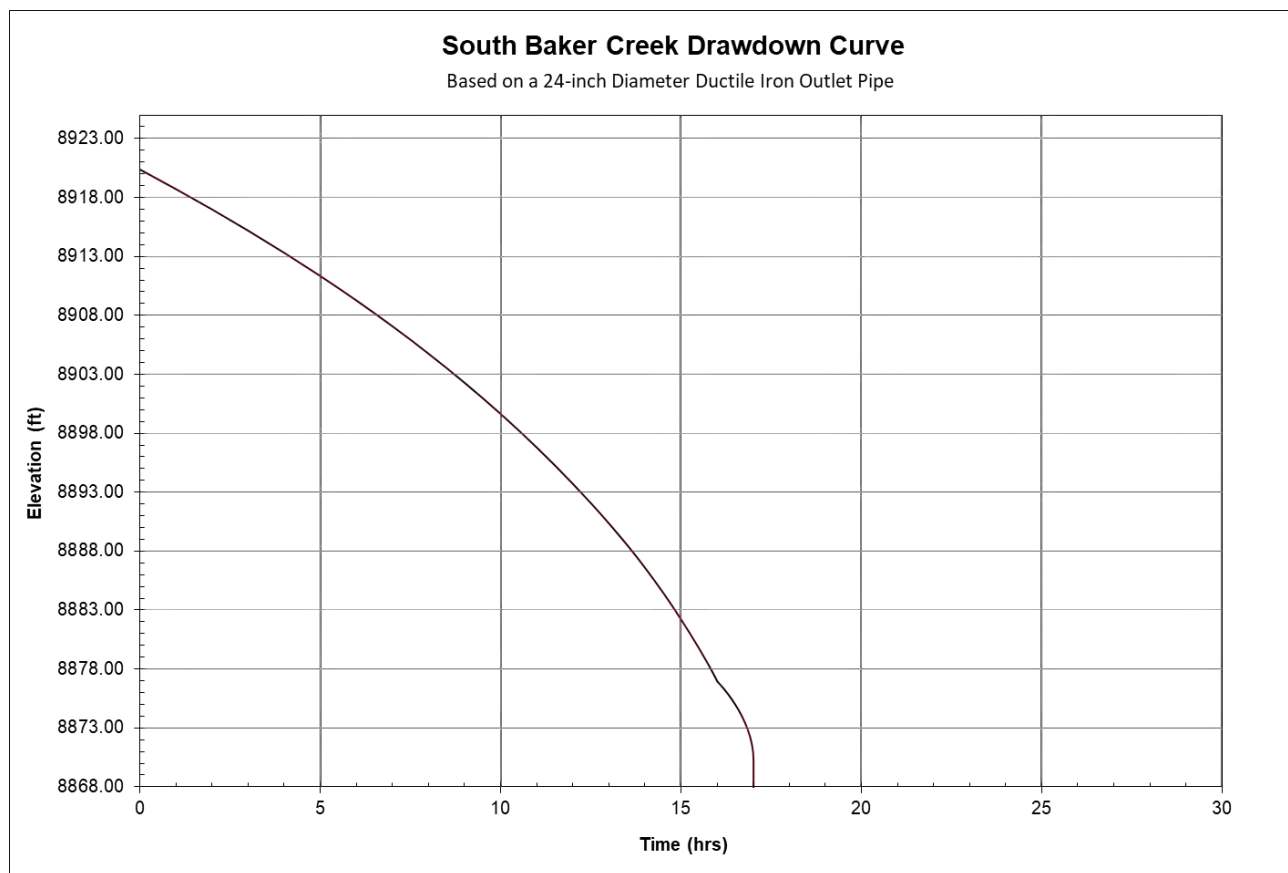
Figure 5. South Baker Creek Drawdown Curve

The outlet works will consist of a 24-inch ductile iron concrete encased outlet pipe. The outlet will regulate low-level releases through a 24-inch sluice gate which will be operated from the dam crest. The gate stem will be enclosed in a carrier pipe running along the upstream face of the dam and encased in concrete. Applegate completed stage-discharge calculations to confirm that the 24-inch outlet pipe is capable of drawing down the reservoir 5 feet in 5 days. Calculations indicate that the 24-inch pipe will be capable of drawing down the reservoir 5 feet in only 2 hours. Figure 5 shows the drawdown curve for the proposed outlet configuration. The maximum discharge is estimated to be approximately 90 cfs at full storage. Baffle blocks will be constructed in the stilling basin for energy dissipation during rapid drawdown of the reservoir. Construction details for concrete encasement of the outlet pipe and gate stem, as well as trash rack and stilling basin baffle blocks will be developed during later stages of design.

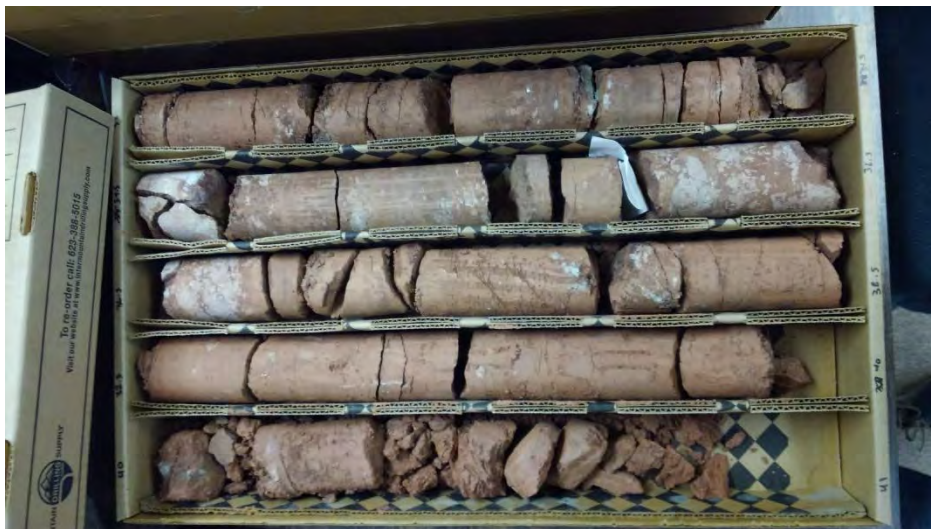
Photo 9. SB-2 from 33 to 41 feet.

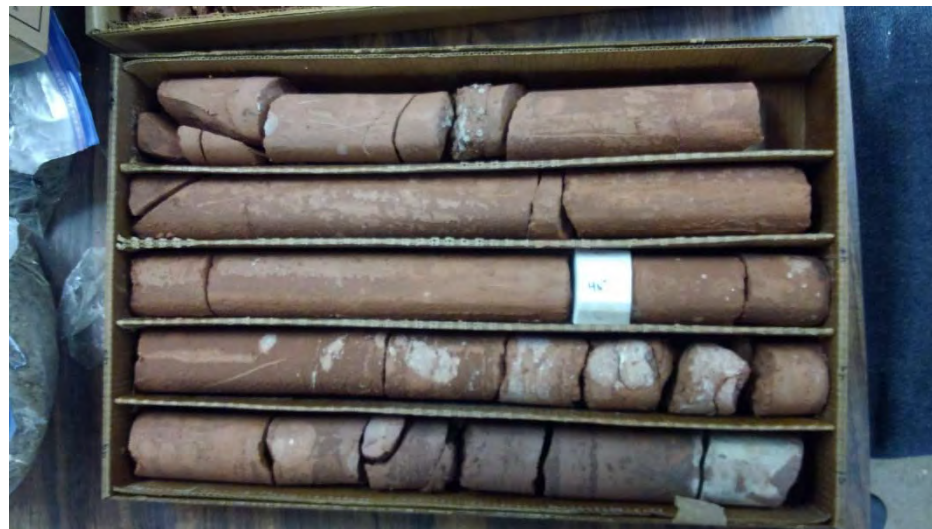
Photo 10. SB-2 from 41 to 51 feet.

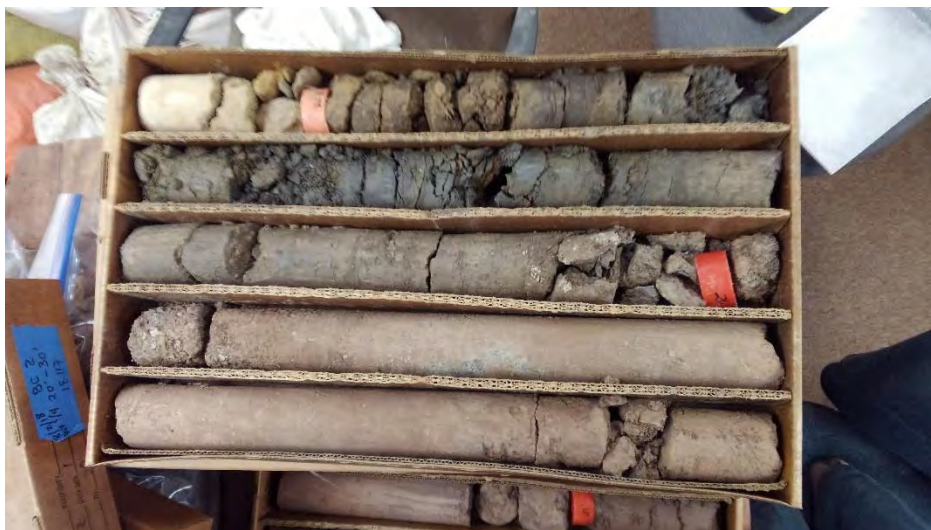
Photo 11. BC-2 from 20 to 30 feet.

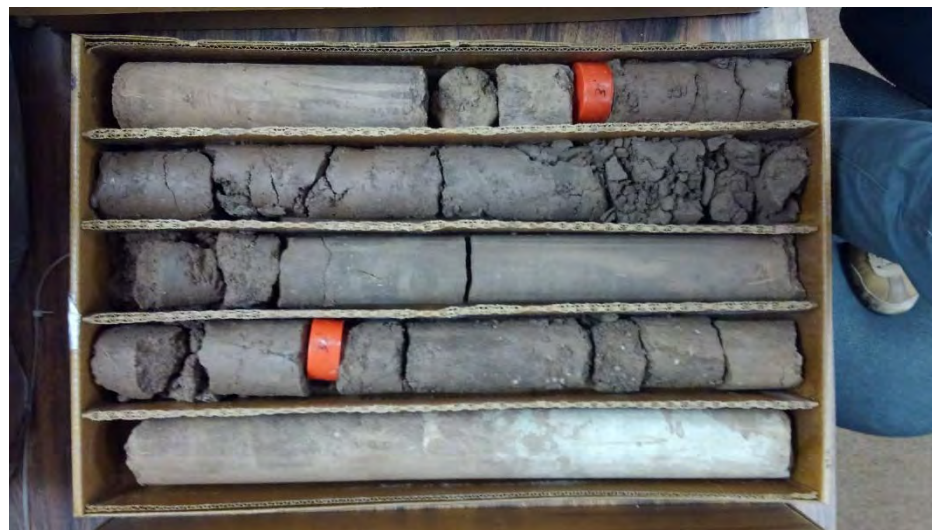
Photo 12. BC-2 from 30 to 37.2 feet.

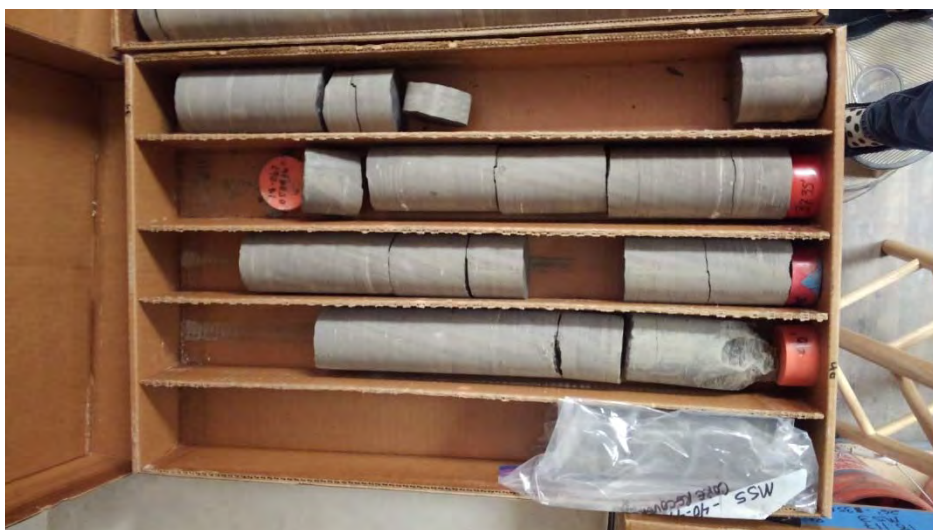
Photo 23. MS-5 from 35 to 40 feet.

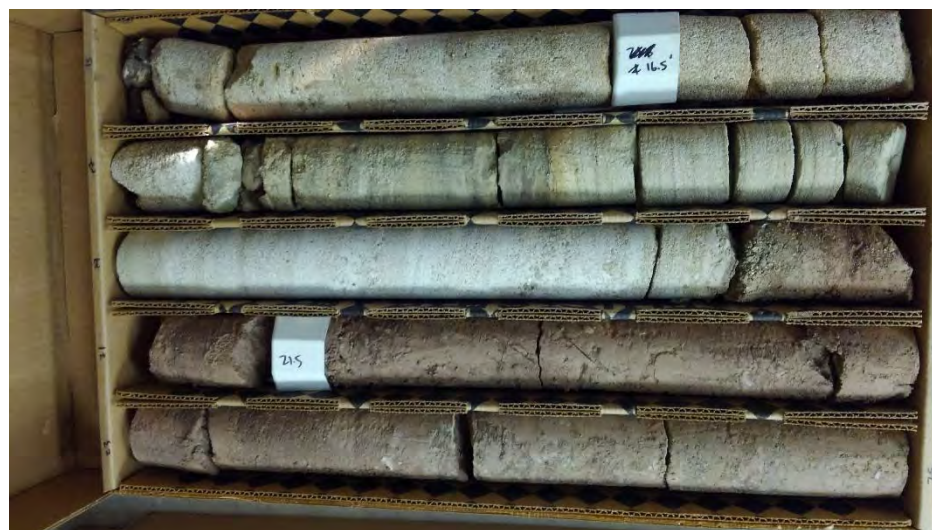
Photo 24. LVL-1 from 15 to 25 feet.

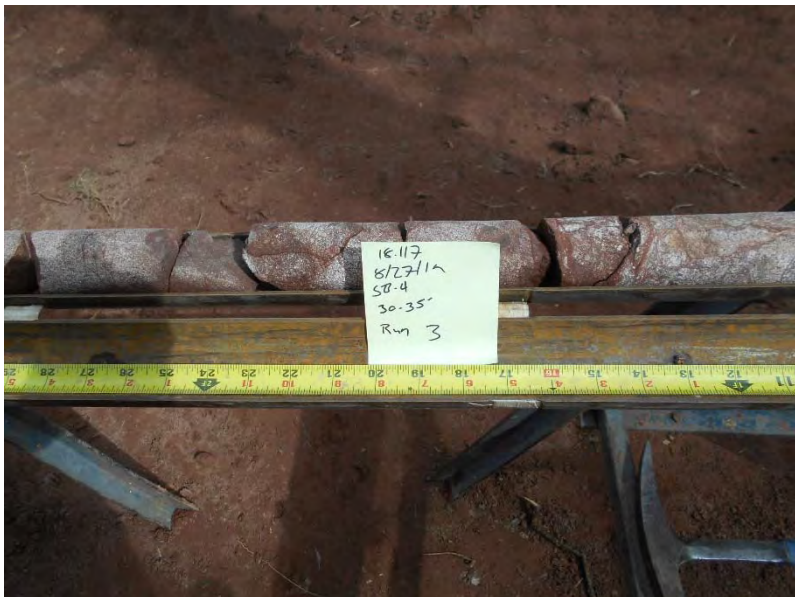
Photo 33. SB-4 from 31.5 to 33 feet.

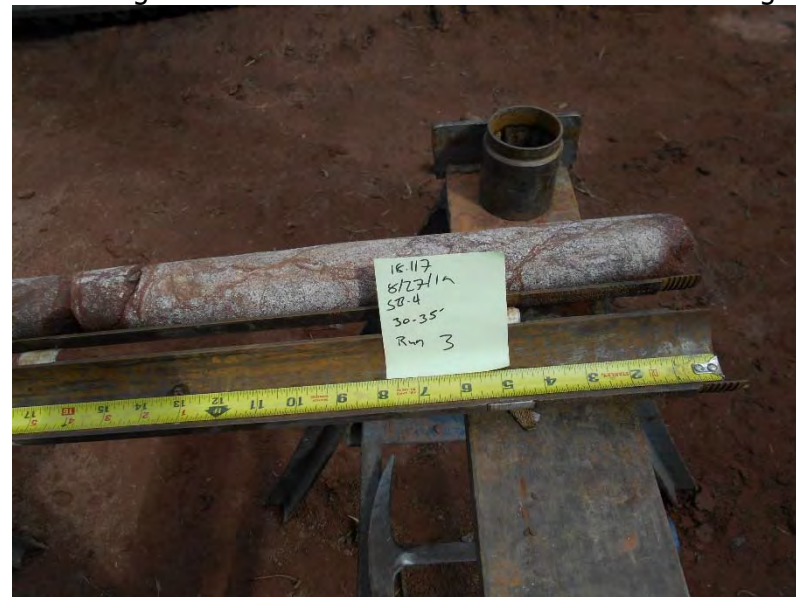
Photo 34. SB-4 from 33 to 35 feet.

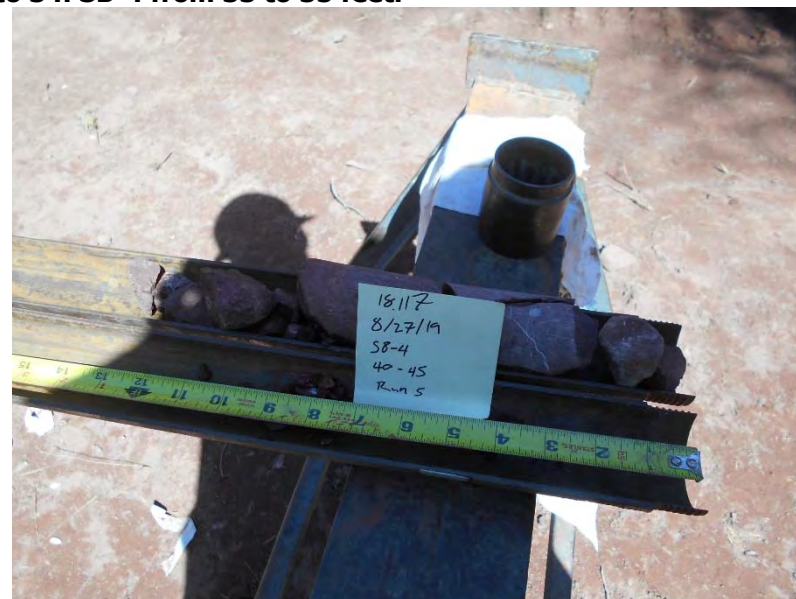
Photo 36. SB-4 from 40 to 45 feet.

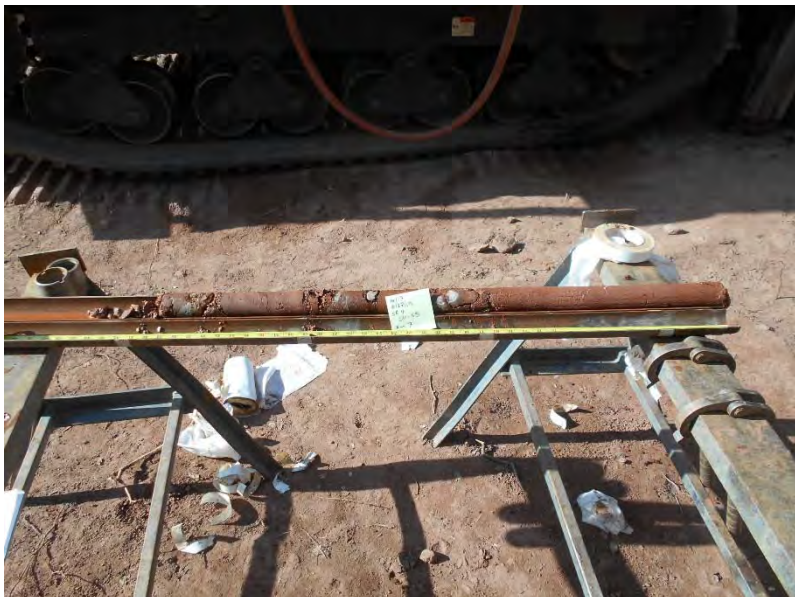
Photo 37. SB-4 from 50 to 55 feet.

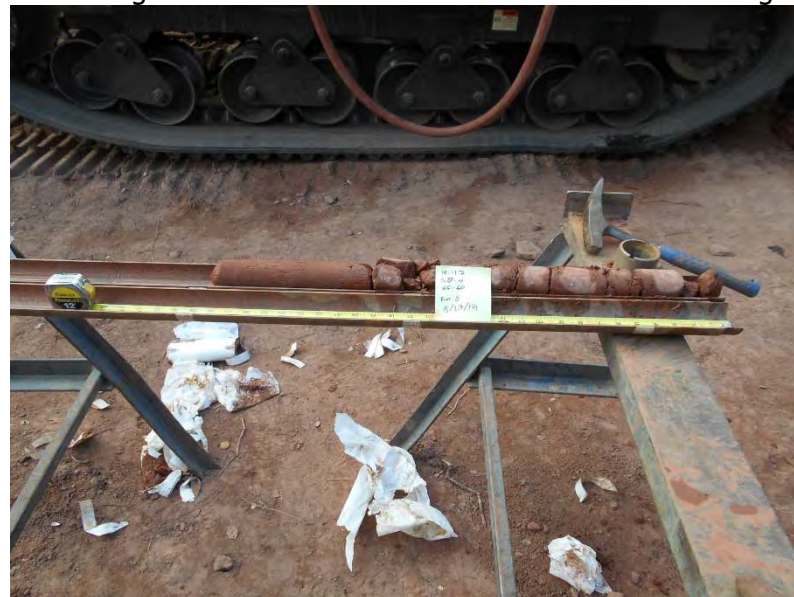
Photo 38. SB-4 from 55 to 60 feet.

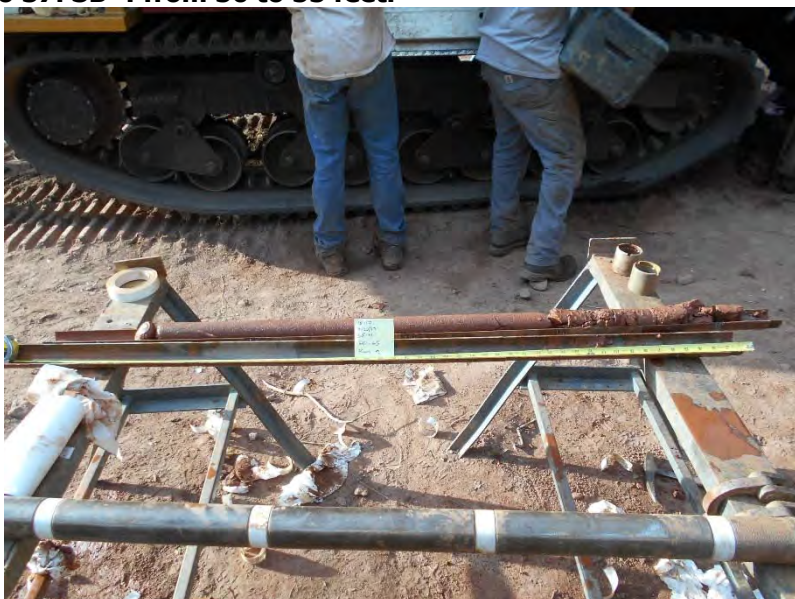
Photo 39. SB-4 from 60 to 65 feet.

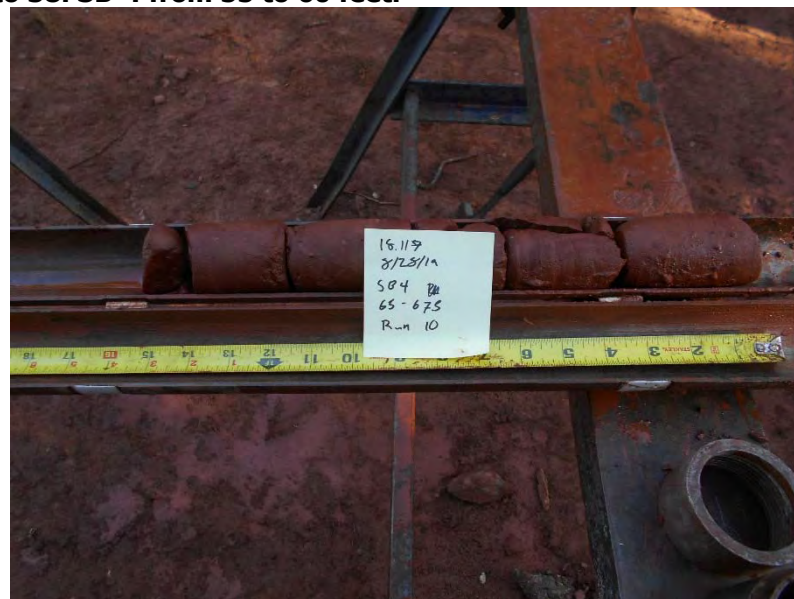
Photo 40. SB-4 from 65 to 67.5 feet.

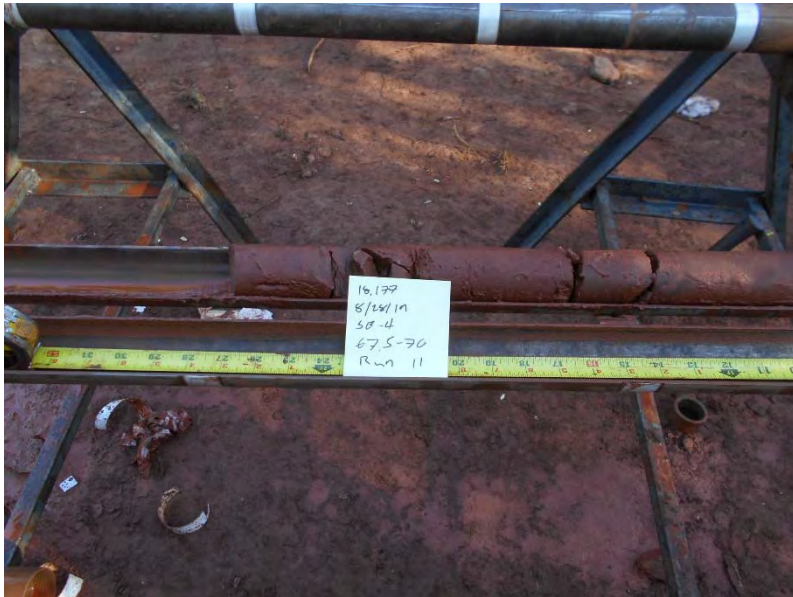
Photo 41. SB-4 from 67.5 to 69 feet.

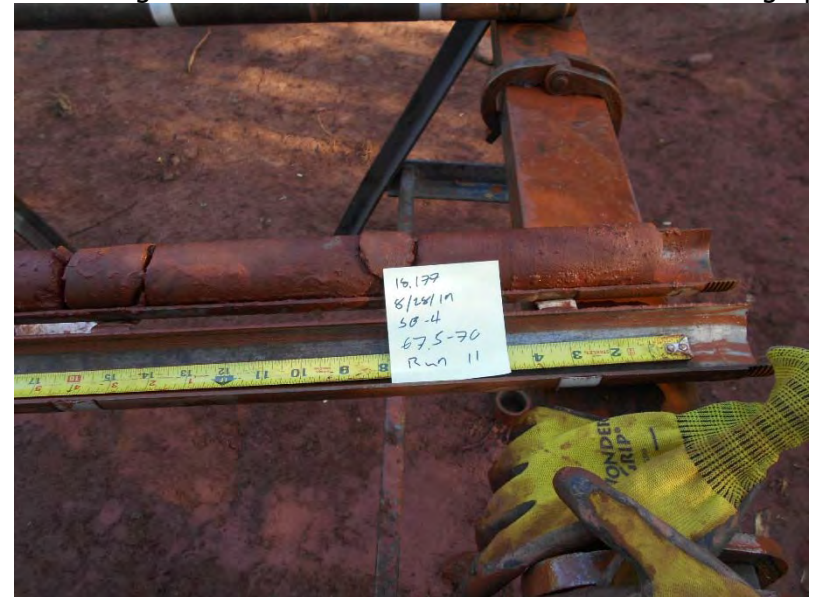
Photo 42. SB-4 from 69 to 70 feet.

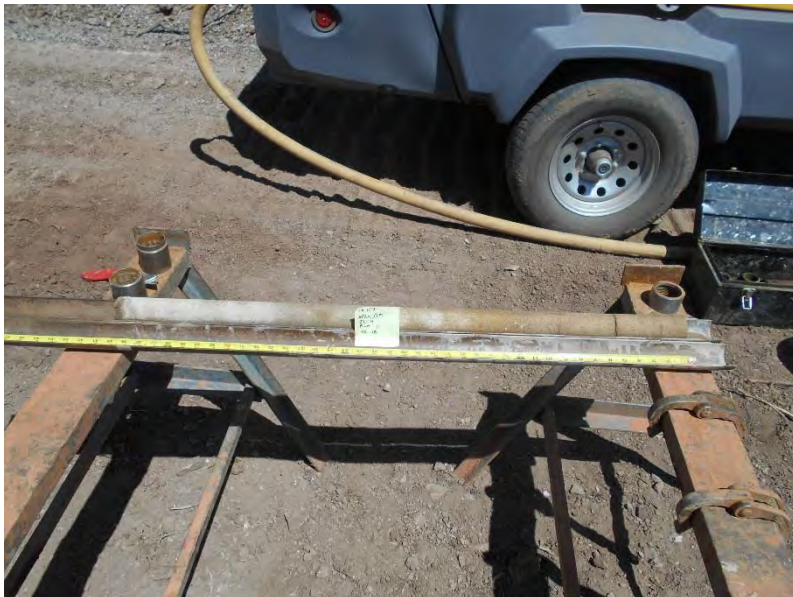
Photo 43. BC-4 from 10 to 15 feet.

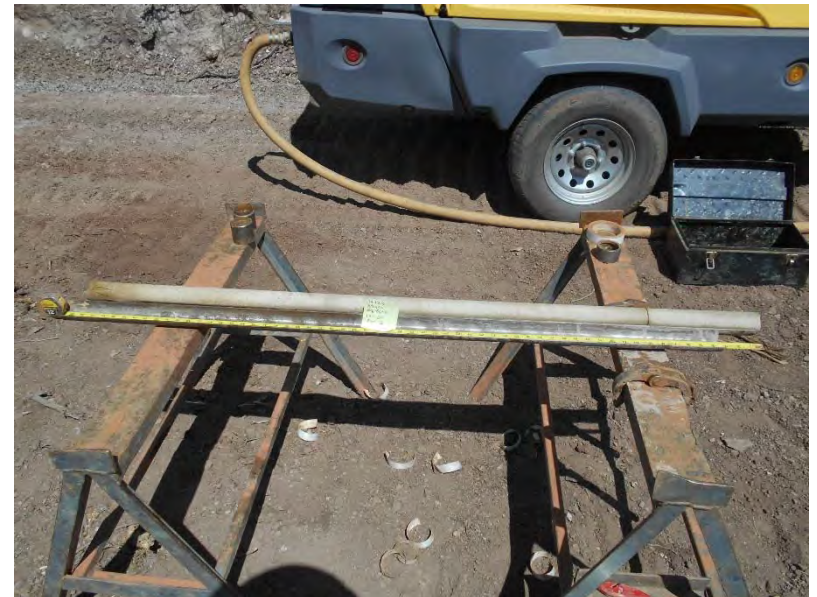
Photo 44. BC-4 from 15 to 20 feet.
