Bruce Canyon Reservoir

30% Design Report

Huerfano County Water Conservancy District

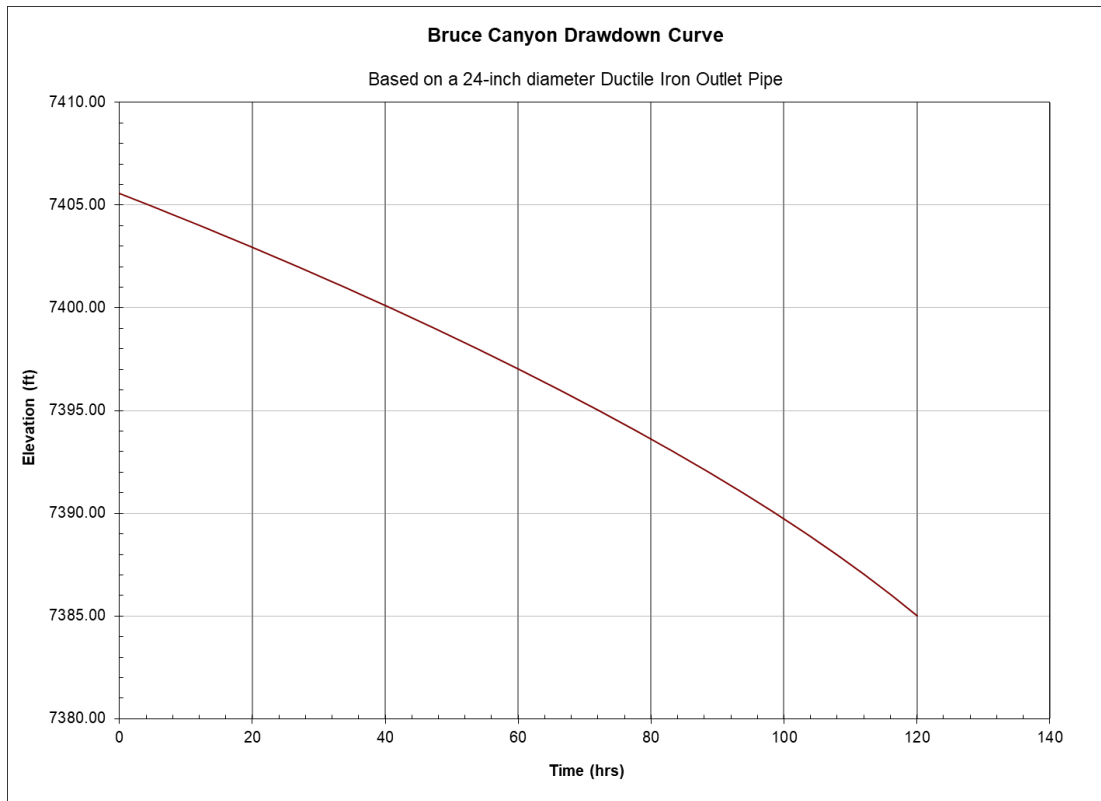
Figure 3. Draw Down Curve for Bruce Canyon Dam

The outlet works will consist of a 24-inch concrete encased ductile iron pipe (DIP). The outlet would be operated by low-level sluice gate operated from the dam crest. Applegate completed stage-discharge calculations to confirm that the 24-inch outlet pipe is capable of drawing down the reservoir 5 feet in 5 days. Calculations showed that the 24-inch pipe will be capable of drawing down the reservoir 5 feet in approximately 17 hours. A 24-inch concrete encased DIP standpipe will regulate normal pool of the reservoir at elevation 7402.90, providing approximately 2 feet of freeboard between normal water surface elevation (WSEL) and the emergency spillway crest. At normal pool, the maximum discharge is calculated to be approximately 80 cfs. Construction details for concrete encasement of the outlet pipe (and standpipe), a trash rack at the upstream invert, and the proposed USBR stilling basin will be completed for the 50% design. Figure 3 on the following page shows the drawdown curve for the dam and Figure 4 provides the stage-discharge relationship for the proposed outlet pipe.

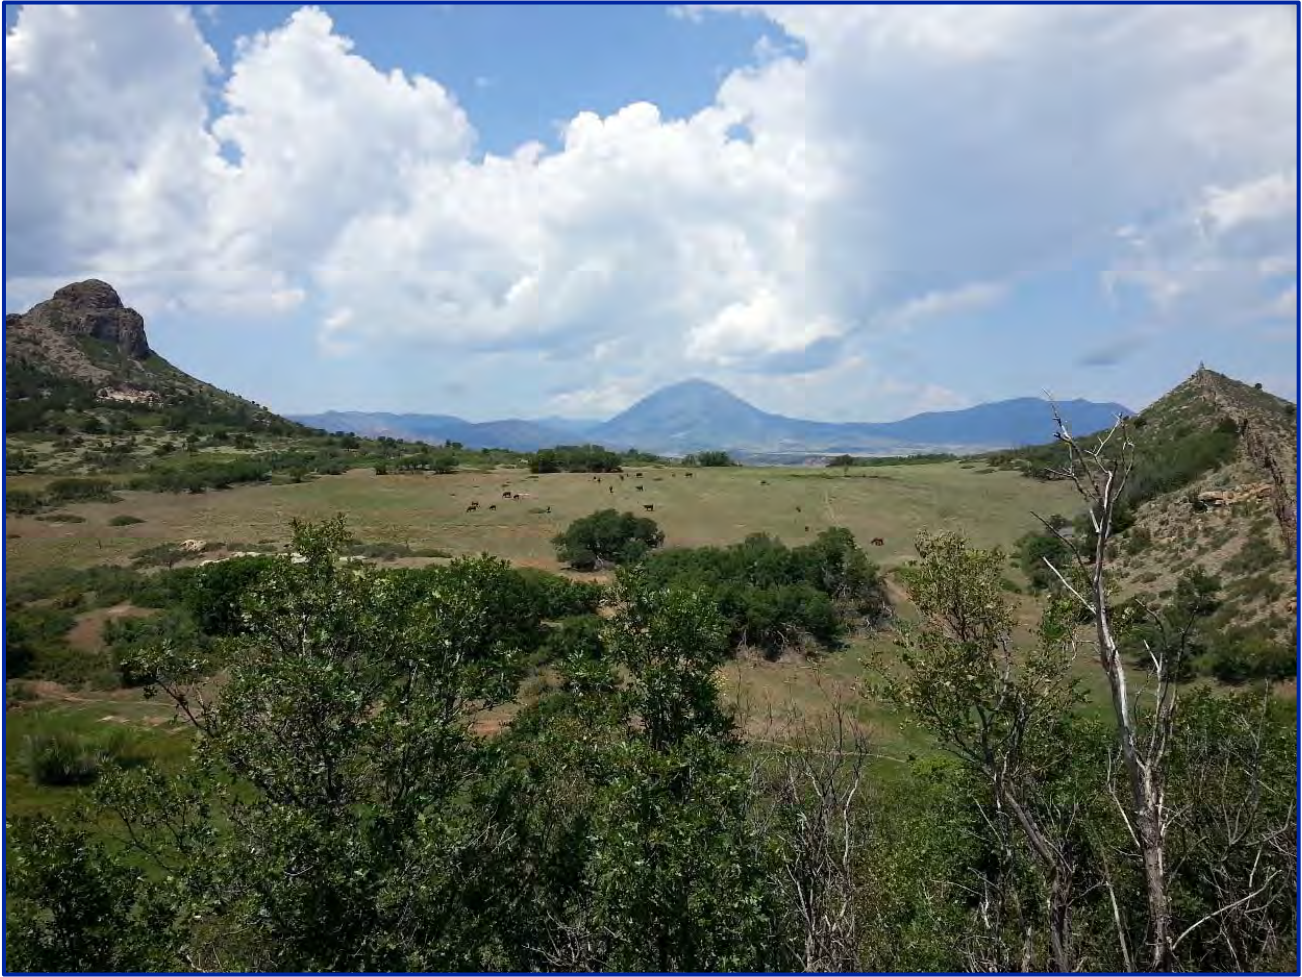
FIGURE 7. Bruce Canyon project site. View looking north from the south side of the project area. Steep hill slopes on either side of the valley have the potential for downslope movement due to the fractured and interbedded nature of the sedimentary rock units.

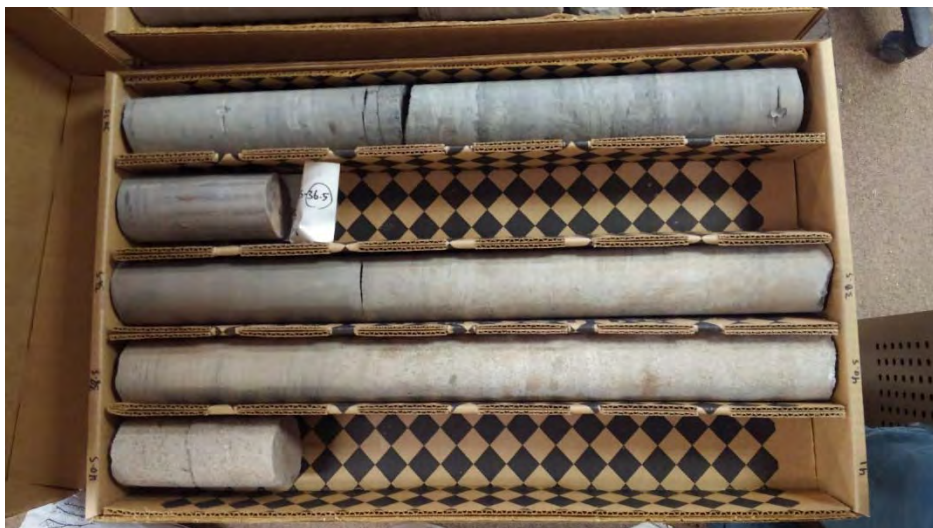
Photo 3. LVL-5 from 34.5 to 41 feet.

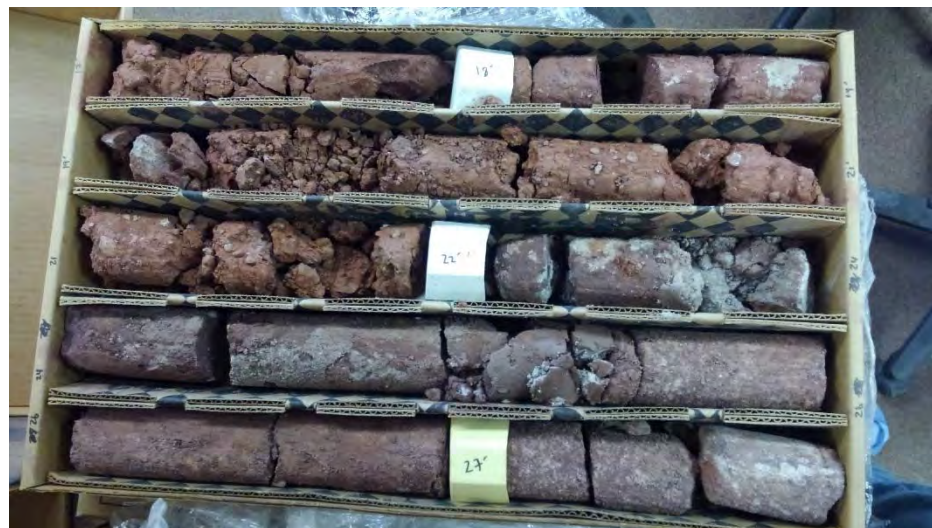
Photo 4. B-2 from 17 to 28 feet.
