# *Maria Stevens Reservoir*

## **30% Design Report**

### **Huerfano County Water Conservancy District**

AG JOB No. 18-117

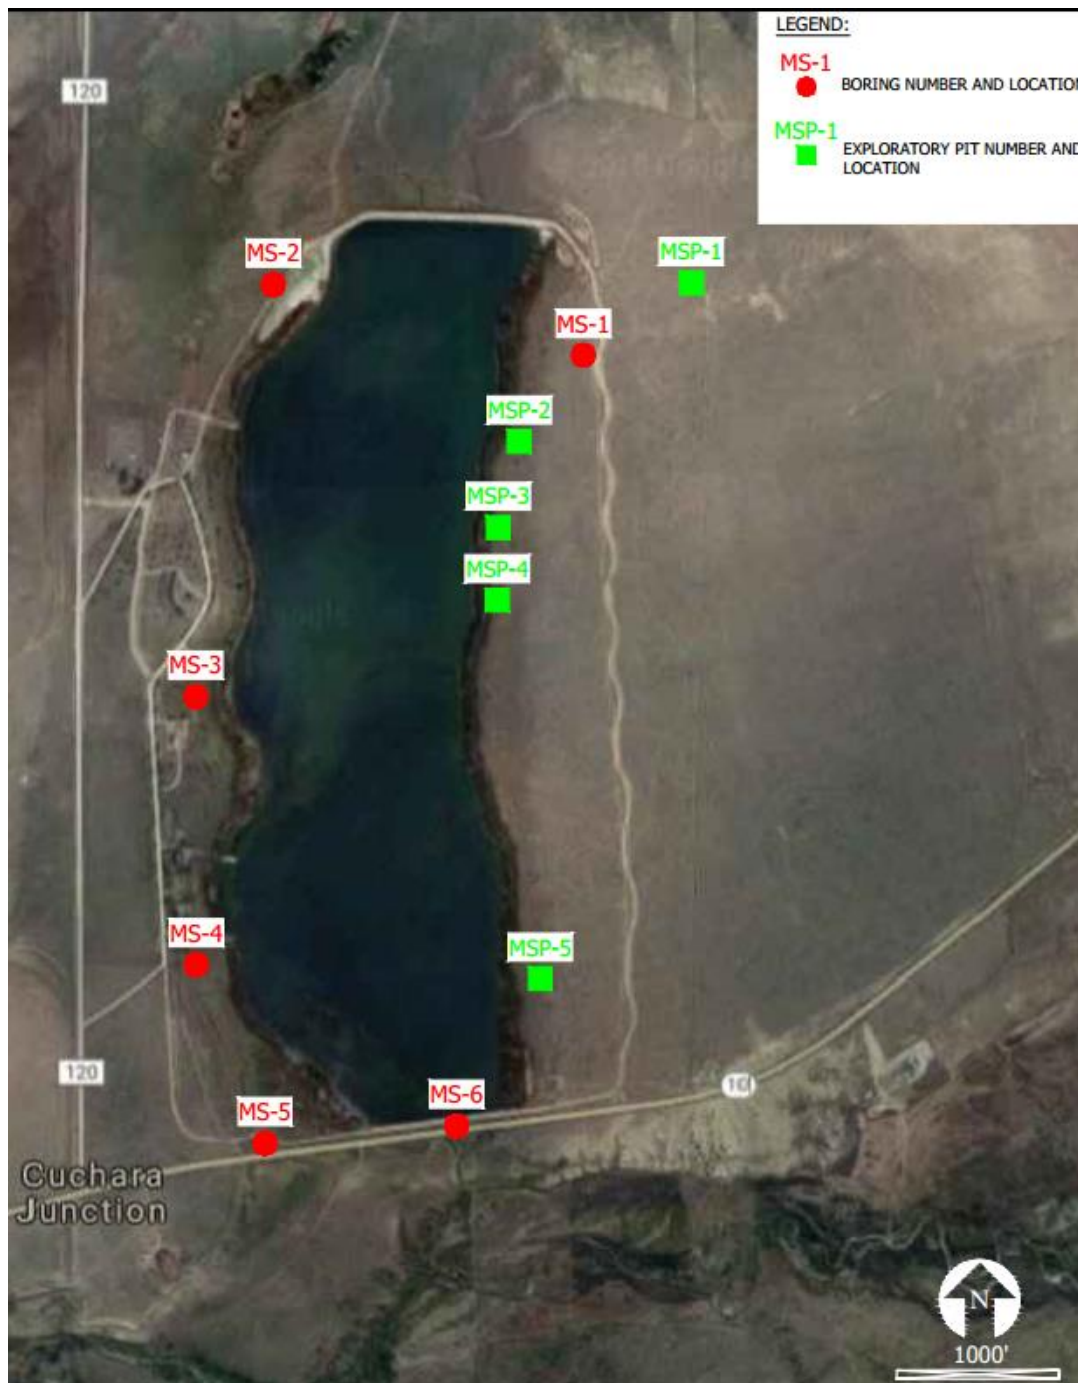
FIGURE 1. BORING AND EXPLORATORY PIT LOCATIONS FOR MARIA STEVENS RESERVOIR

Cesare explored subsurface conditions at Maria Stevens in August 2018 by drilling six borings around the north, west, and south sides of the lake, and excavating five shallow test pits along the east side of the lake (Figure 1).

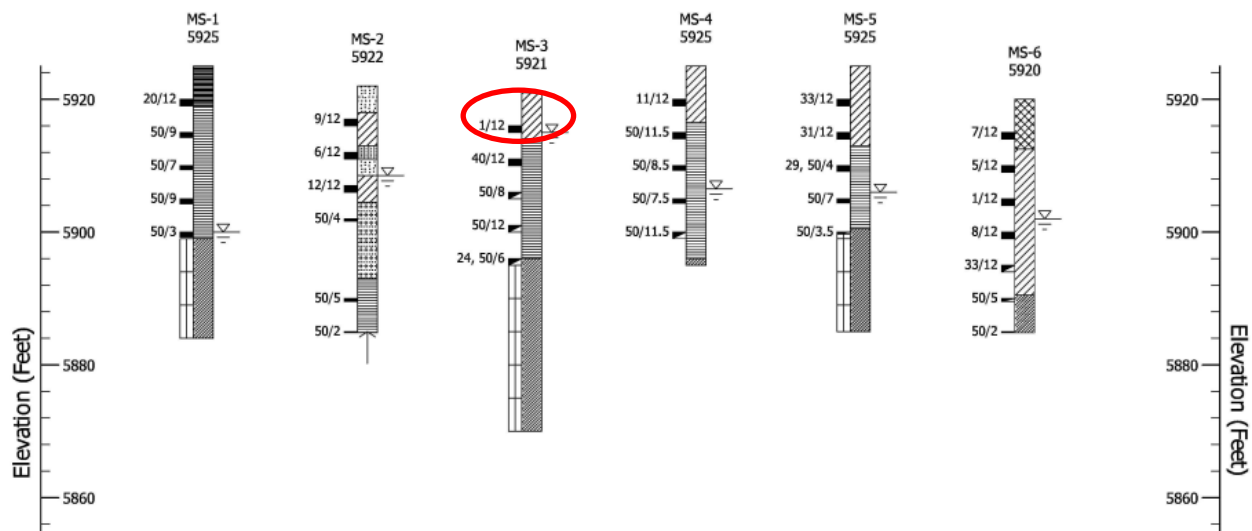
FIGURE 2: MARIA STEVENS BORING LOGS

Soils were characterized down to bedrock based on the borings, and a standard penetration test was performed on each sample. The standard penetration test is a simple and inexpensive in-situ test to estimate the relative density of soils and approximate shear strength parameters. A 140-pound

hammer is used to drive a 2-inch diameter steel sample tube a distance of 30 inches. The number of hammer blows, “blow counts”, are used as an empirical estimation of soil density. The density at each location was used to determine the horizontal and vertical extent of excavation needed to remove soft soils that would be unsuitable for the foundation of the enlarged Maria Stevens Reservoir dams. Soft soils could differentially settle beneath an enlarged dam, which could lead to embankment cracking and preferential seepage pathways that could result in geotechnical instabilities and possible dam failure. The extent of required excavation to remove soft soils that would differentially settle was based on a rule of thumb of soil with a blow count of less than 10 over a 12-inch interval. Figure 2 summarizes the lithology and standard penetration test results. For example, the material at the surface in boring “MS-3”, located along the west embankment, was a very soft clay with 1 standard blow count over a 12-inch interval (Figure 2). More detail regarding soft soils is provided in Appendix B.

The borings indicate the soil underlying the site consisted primarily of sandy clay to depths of about 6.5 to 28 feet below the ground surface. Exceptions were in Borings MS-1, MS-2, and MS-6, in which weathered claystone was encountered to a depth of 5 feet, interbedded sands and clays to a depth of 16.5 feet, and fill to a depth of 7 feet, respectively. Claystone was encountered below the soil in all borings except MS-2 and MS-6, in which sandstone and shale were encountered, respectively. Where encountered, the claystone extended to 22.5 to 27 feet in Borings MS-1, MS-3, MS-4, and MS-5, and to the depth explored of 34.5 feet in MS-2. The shale extended to the remaining depths explored in the remainder of the borings.

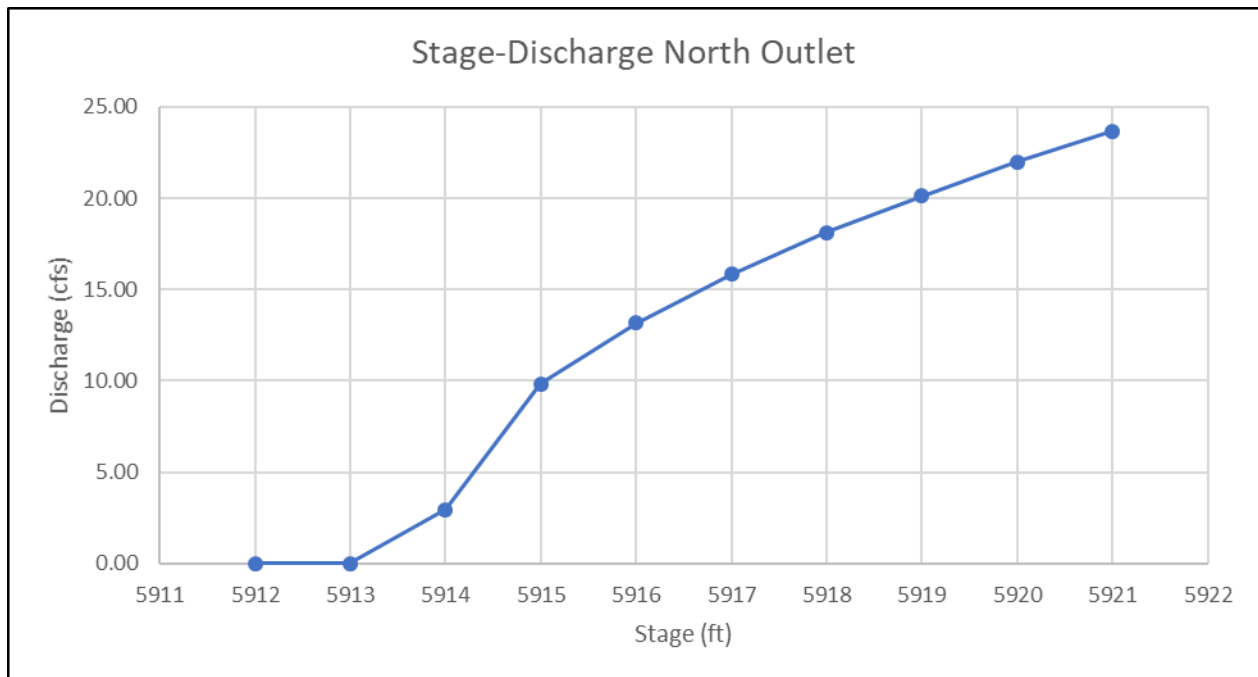
FIGURE 4. STAGE DISCHARGE CURVE FOR REPLACEMENT NORTHERN OUTLET

There is an existing above-grade pumped siphon outlet at the north embankment that consists of a 12-inch diameter HDPE pipe with an approximate design flow of 20 cfs<sup>1</sup>. The existing north outlet structure would be removed when the north embankment is excavated to remove soft soils and subsequently rebuilt with higher density foundation soils. The northern outlet would be replaced with a non-pressurized gravity driven pipe. The 30 percent design includes an 18-inch diameter HDPE pipe that will be concrete encased and discharge at an elevation of 5911 feet, with an inlet invert elevation 5913 feet. The northern outlet would be operated via a new sluiceway installed on a concrete headwall on the upstream face of the dam, with would be controlled from a pedestal on the dam crest and a gate stem buried in a concrete grade beam on the upstream face of the dam. The northern outlet pipe will provide the ability to continue to irrigate the lands north of Maria Stevens Reservoir, and also will provide some of the capacity to draw down the reservoir in emergency conditions. The stage-discharge relationship for the proposed replacement northern outlet is provided in Figure 4.

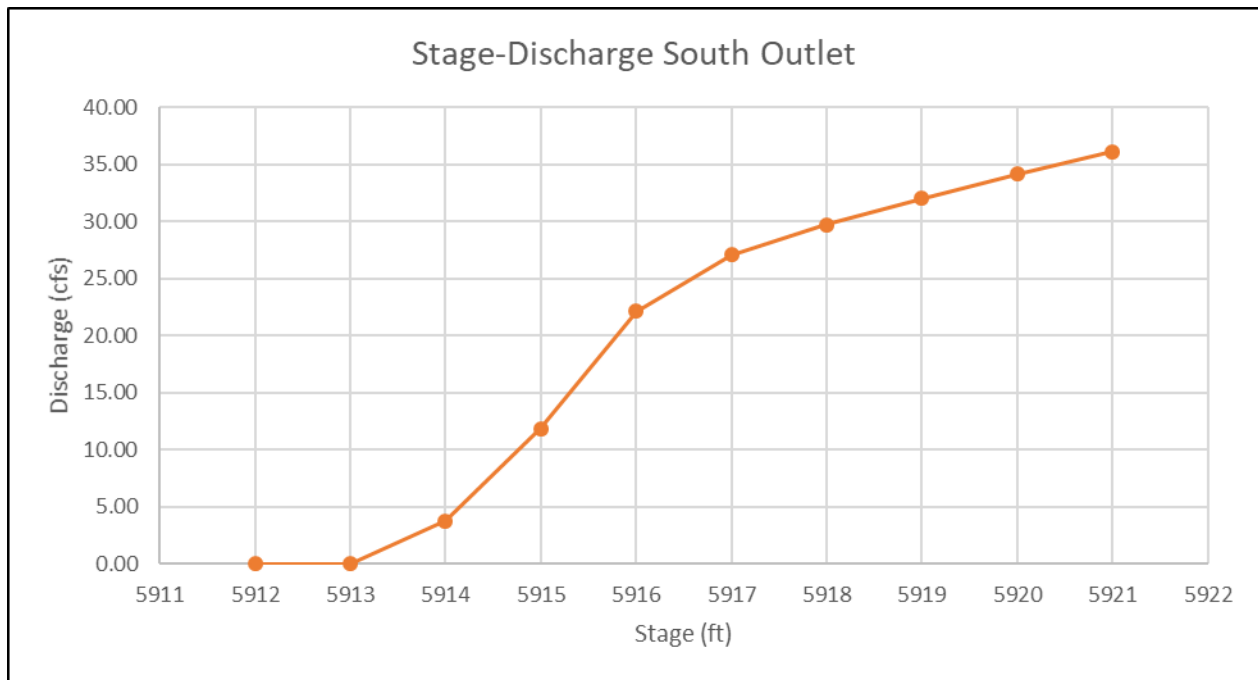
FIGURE 5. STAGE DISCHARGE CURVE FOR SOUTH DAM OUTLET

A proposed new southern outlet will be installed in the south dam, and will facilitate releases from the enlarged Maria Stevens Reservoir for exchanges to upstream reservoirs. The south dam outlet will be operated via a new sluiceway installed on a concrete headwall on the upstream face of the dam. The outlet will be a 24-inch diameter concrete encased PVC outlet pipe and will be 383 feet long. The inlet invert elevation would be 5013 feet and the outlet elevation would be 5911 feet. The outlet would be encased in structurally reinforced concrete to minimize the potential for piping along the outlet. The stage-discharge relationship for the proposed outlet pipe at the south dam is provided in Figure 5.

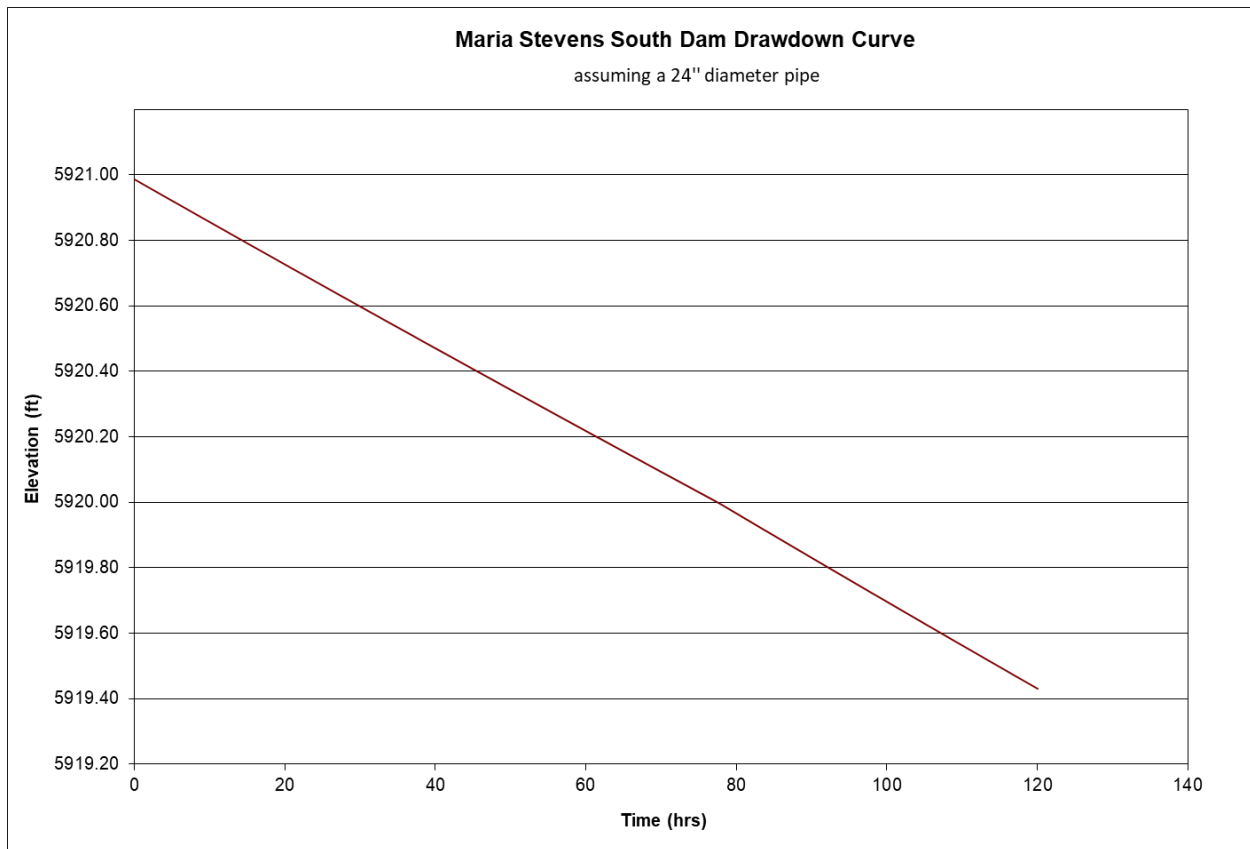
FIGURE 6. DRAWDOWN CURVE FOR SOUTH EMBANKMENT OUTLET ONLY

The outlet would be designed with the emergency drawdown capability of lowering the reservoir to a safe storage level within five days. The safe storage level for Maria Stevens Reservoir was estimated to be 5918 feet, equal to the approximate elevation of Highway 10 where the downstream risk exists. The State Engineer's Office general rule of thumb for emergency drawdown (i.e., five feet of drawdown in five days) should not apply for Maria Stevens Reservoir because of the below grade nature of the reservoir. Applegate Group has consulted with the State Engineer's Office regarding the potential waiver for the standard 5 feet of drawdown in 5 days for emergency drawdown. The drawdown curve for the proposed south outlet only (Figure 6) indicates that 1.5 feet of drawdown to an elevation of 5019.5 feet (i.e., 18 inches above Highway 10) could be achieved in five days using only the proposed southern outlet. Figure 7 indicates that drawdown of 3.5 feet to an elevation of 5917.5 feet (i.e., 6 inches below Highway 10) could be achieved in five days using a combination of the proposed southern outlet and the proposed replacement of the existing north outlet. In addition, ACER Technical Memorandum No. 3 – "Criteria and Guidelines for Evacuating Storage Reservoirs and Sizing Low-Level Outlet Works" indicates that low hazard, low risk dams such as Maria Stevens Reservoir, need to be able to be able to reduce the water surface elevation to 75% of its maximum height in 60-90 days. Figure 7 indicates that this stage will be reached in 11 days, well before the 60 to 90-day requirement.

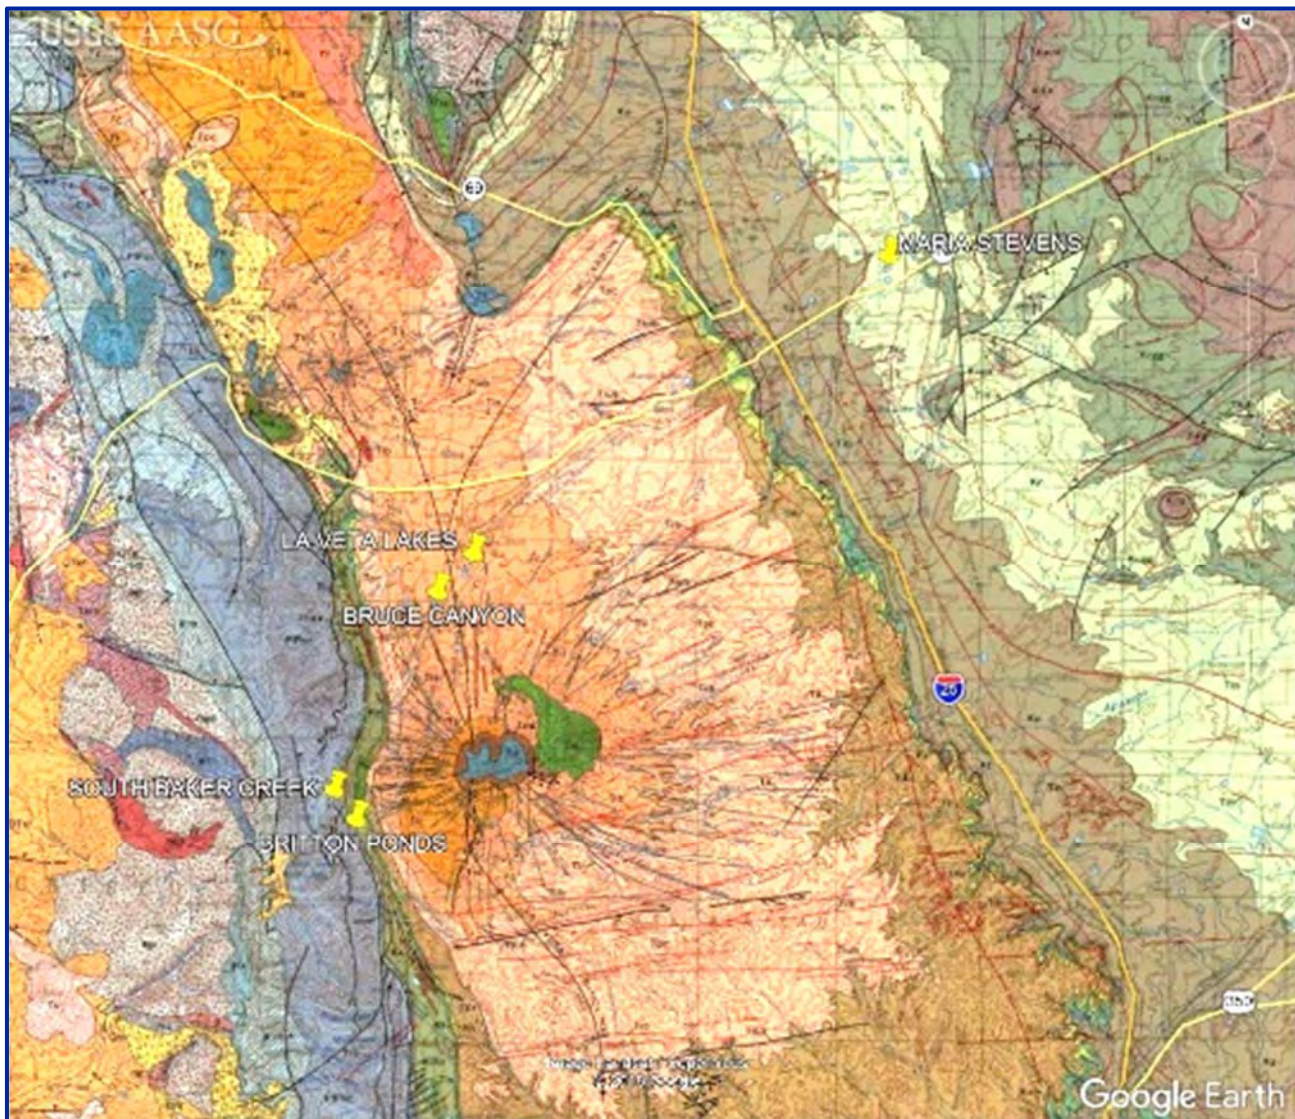
A portion of the Trinidad geologic quadrangle map<sup>1</sup> in Figure 1 shows the locations of the five project sites. Four of the five study sites are located in the central and western portions of the La Veta syncline fold and Spanish Peaks intrusions. Maria Stevens is the only site located on the gently dipping eastern side of the fold on the plains.

**FIGURE 1. Geologic map showing the five study site locations. The La Veta syncline axis trends southeast to northwest and along the fold axis are the East and West Spanish peak intrusions and radiating dikes. The Maria Stevens site is north and east of the Cucharas area on the gently dipping east limb of the fold.**

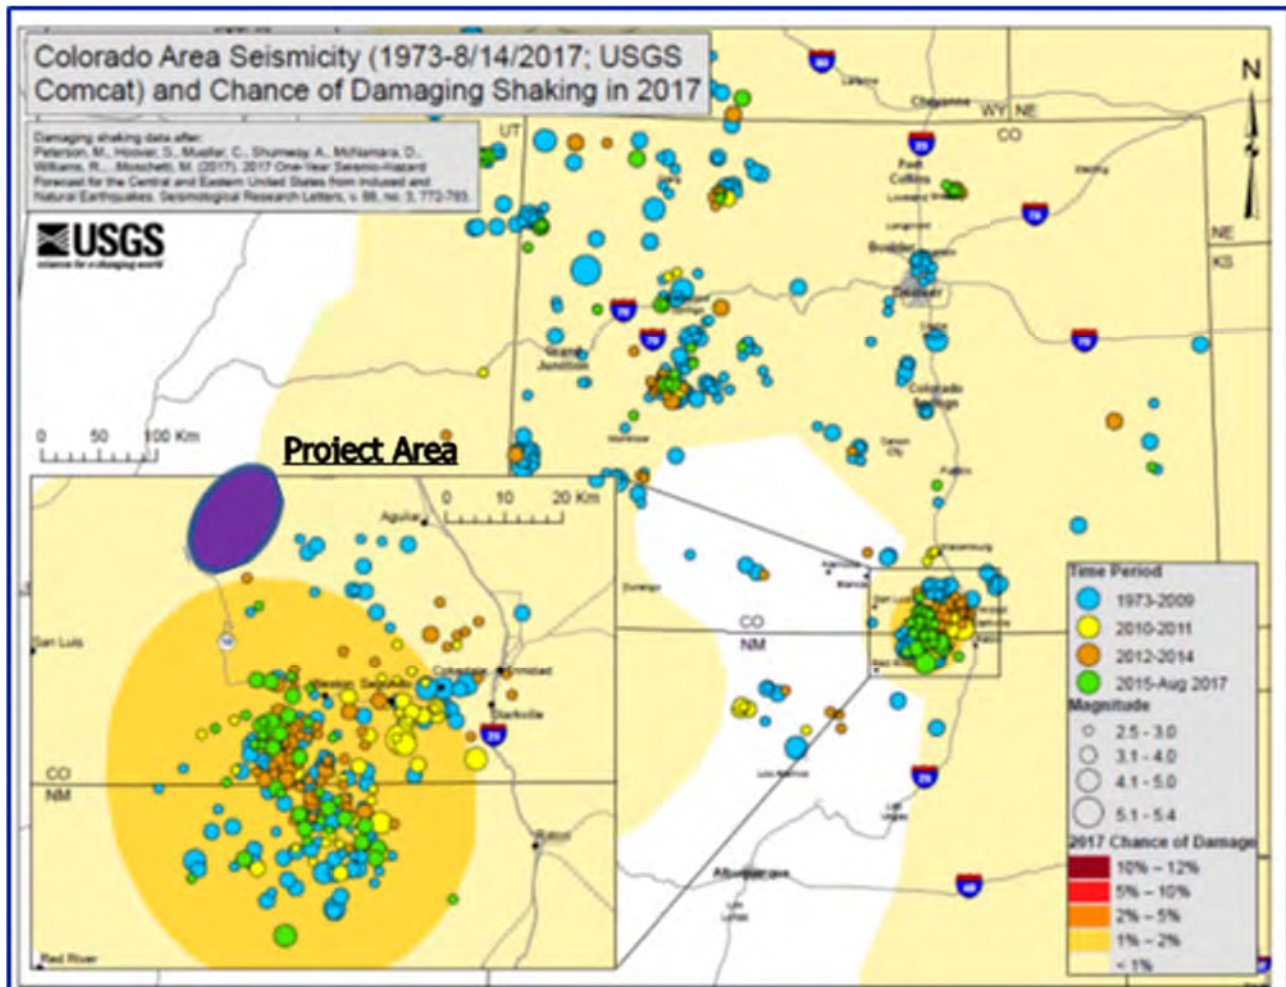
Seismic hazards are low in the project area; however, earthquakes have occurred in the region, mainly south of the project area. Mapped earthquakes and percent chance of damage are shown on the USGS<sup>5</sup> (Figure 3). The project sites fall into the less than 1% chance of damage area mapped by the USGS. This indicates, should an earthquake occur, there is a very low risk of damage from an event that will affect any of the project sites.

**FIGURE 3. Colorado seismicity from the USGS earthquakes hazards program. There is very low seismic risk for the project area.**

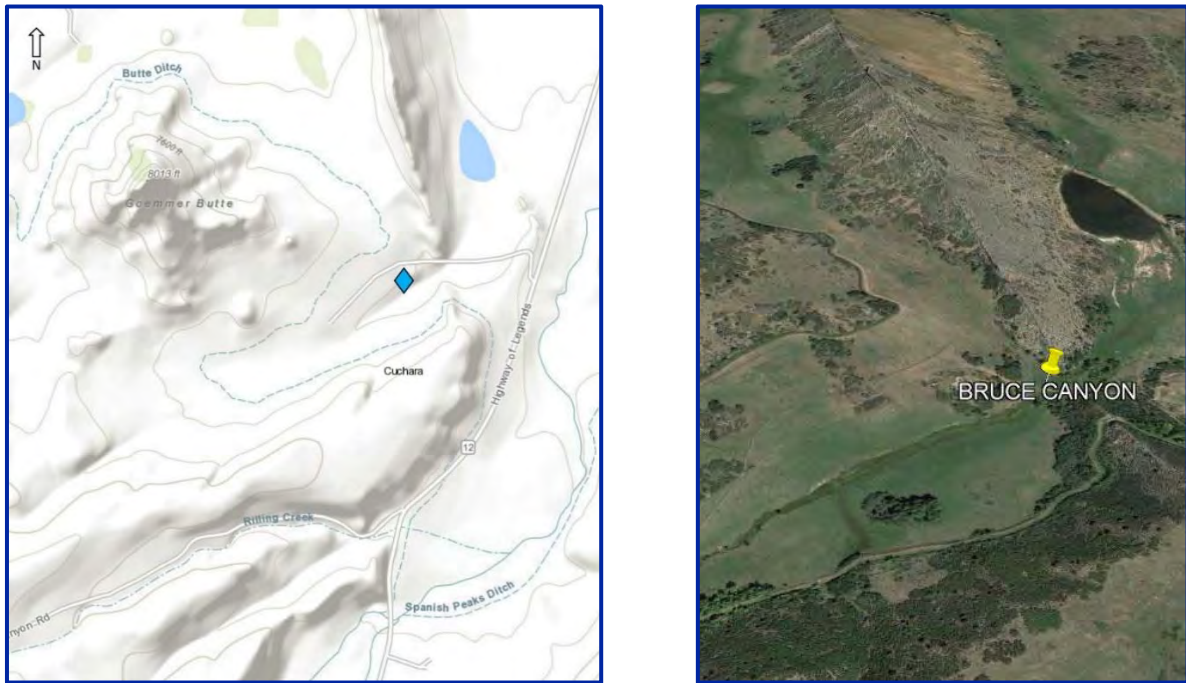
The Bruce Canyon site is located southwest of the Town of La Veta off SH12. The potential dam site is upstream of an intrusive dike that strikes northwest to southeast, cutting through the Cuchara Formation that comprises the valley rock (Figure 5). The low valley drains an ephemeral creek through the dike and Butte Ditch runs around the periphery at an elevation of 7,420 feet. Goemmer Butte is west of the valley. Goemmer Butte is a volcanic plug intruded into the Cuchara Formation and exhibits the only evidence in the immediate vicinity of Spanish Peaks for magma venting to the surface. A crescent shaped body of eruptive breccia is well exposed on the south and west sides of the butte. The Eocene aged Cuchara Formation exposed here represents its lowermost part. Typically, the formation is arkosic, conglomeratic, and cross bedded, found in fining upward alluvial cycles. The mudstones are drab brown to red. There are prominent pebbles and cobbles in the sandstone and red mudstone helps distinguish the unit in this area (Penn, 1996<sup>6</sup>).

**FIGURE 5. Bruce Canyon project site (topographic and Google Earth images) is located southwest of the Town of La Veta, west of CR12. Bruce Canyon is an east-west valley cut through by a north-south trending intrusive dike. There is an ephemeral spring and an irrigation ditch in the project area. Goemmer Butte is a prominent volcanic feature west of the project site.**

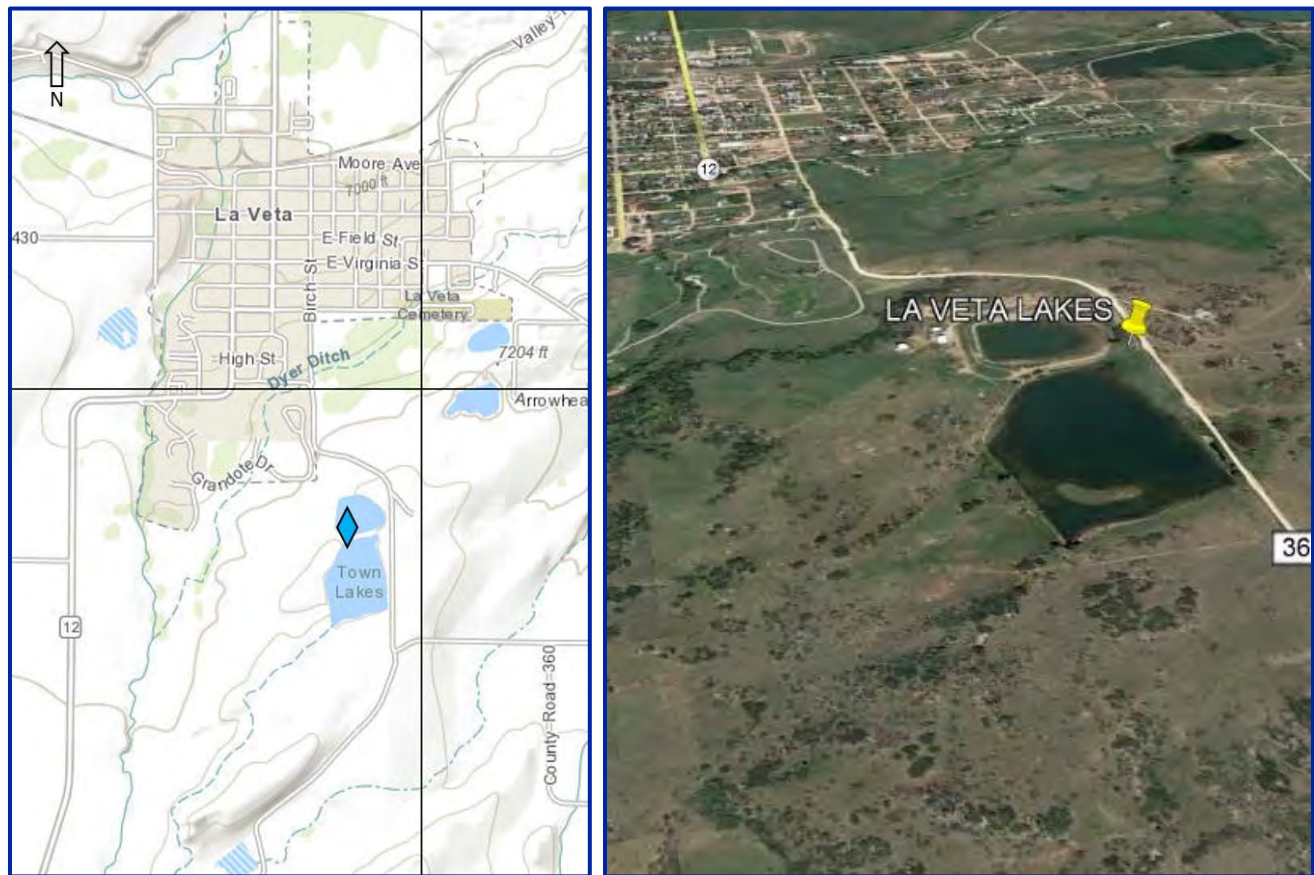
**FIGURE 8. La Veta Lakes project site (topographic and Google Earth images) is located just south of the Town of La Veta and about 100 feet above the valley in elevation. La Veta Lakes is a water storage area that is fed by a piped diversion from the Cucharas River. The site is in the middle of the La Veta syncline and is underlain by the Tertiary Cuchara Formation.**

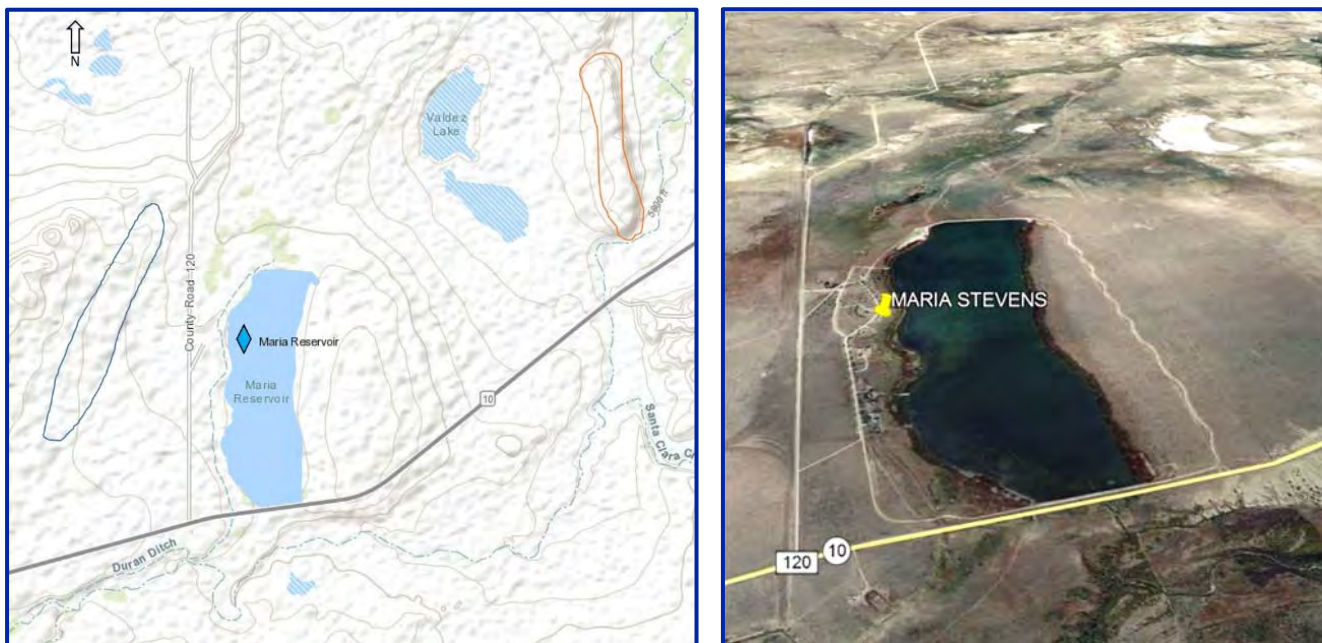
Located east of Walsenburg on the north side of SH10, Maria Stevens Reservoir occupies a low point between two low ridges to the west and east (Figure 9). Geologically, the units in this area are the Niobrara Formation and the Pierre Shale. The Niobrara is Cretaceous age limestone with chalk layers. The Pierre Shale is Cretaceous age dark gray fissile siltstone and shale. Because of the location of Maria Stevens in the small topographic swale, it is interpreted that the Niobrara has been eroded in this area and the bedrock below the topsoil is the Pierre shale. Notably, on the ridge northwest of the site, there are several sand and gravel quarries indicating that fluvial erosion and deposition likely stripped the Niobrara from the surface as rivers crossed the area. A geologic hazard that may impact the project is possible sinkholes that may develop in buried limestone units.

**FIGURE 9. Location and topography of Maria Stevens Reservoir (topographic and Google Earth images). Walsenburg is west, via SH10. The circled area on the left of the topographic map is a gravel ridge. The circled area on the right of this map is a ridge of Cretaceous Carlile shale, Greenhorn limestone, and Graneros Shale consisting of dark gray shale, gray limestone, and gray shale. The reservoir sits in a low point underlain by Pierre shale.**

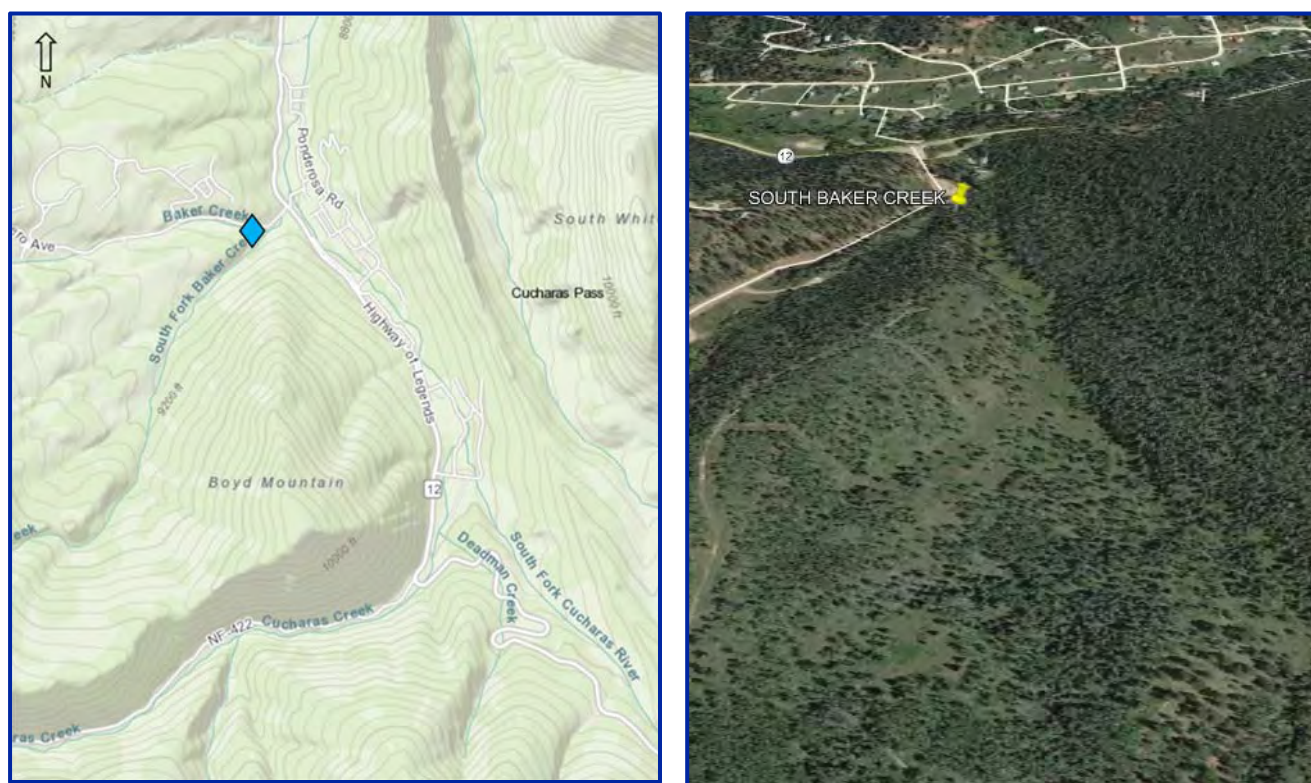
The South Baker project site is located southwest of the Bruce Canyon site, west of CR12, north of Cucharas Pass (Figure 10). South Baker Creek is in a southwest–northeast trending valley with South Baker Creek and is a tributary of the South Fork of the Cucharas River. The South Baker Creek drainage is bounded on the north side by a small ridge and to the south by Boyd Mountain. The sedimentary units of this area are the Pennsylvanian Permian Sangre de Cristo Formation. Characterized by red and gray conglomerate, arkose, sandstone, siltstone, shale, and gray limestone. The variety of units in this formation suggests that there are variable weathering and erosion patterns in the steeply dipping unit. Boyd Mountain is well vegetated. Slope instability of the flank of Boyd Mountain is a potential hazard.

**FIGURE 10. South Baker Creek project site (topographic and Google Earth images) is located southwest of the Bruce Canyon site, west of SH12, north of Cucharas Pass. South Baker Creek is a southwest–northeast trending valley with South Baker Creek becoming a tributary of the South Fork of the Cucharas River at the mouth of the valley. Google Earth image is an oblique image looking east down the creek drainage.**

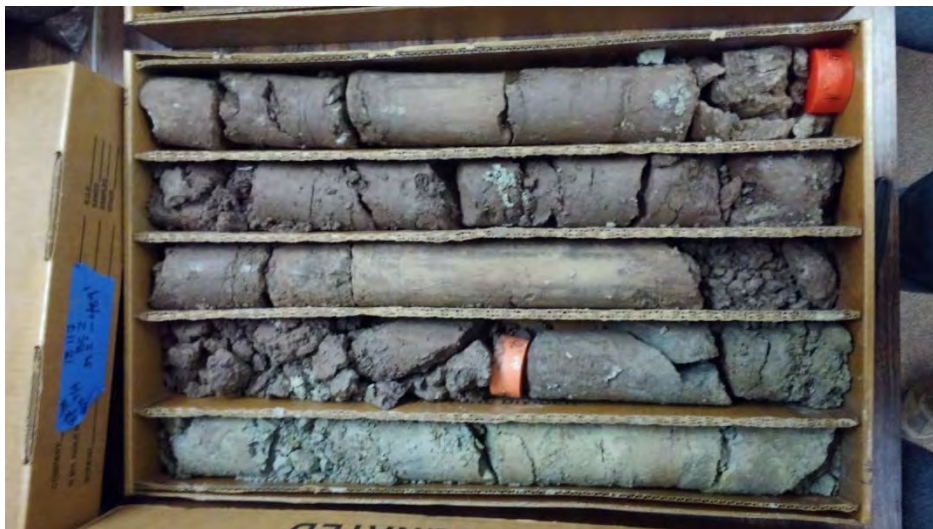
**Photo 13. BC-2 from 37.2 to 48.9 feet.**

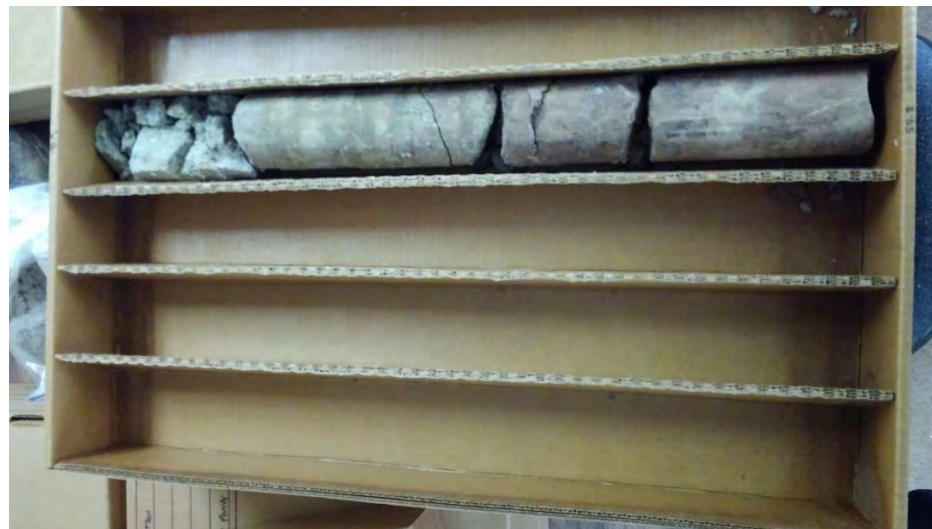
**Photo 14. BC-2 from 48.9 to 50.8 feet.**

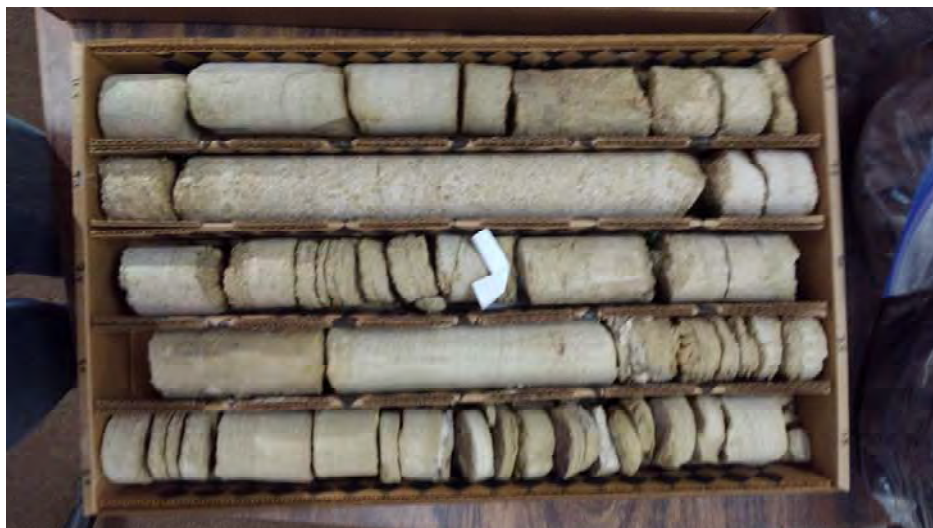
**Photo 15. LVL-3 from 1.5 to 11.5 feet.**

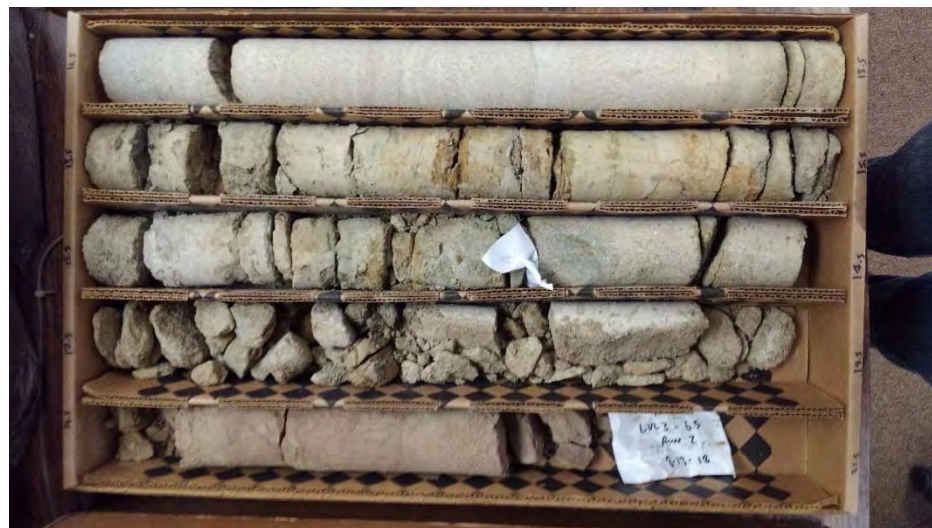
**Photo 16. LVL-3 from 11.5 to 21.5 feet.**

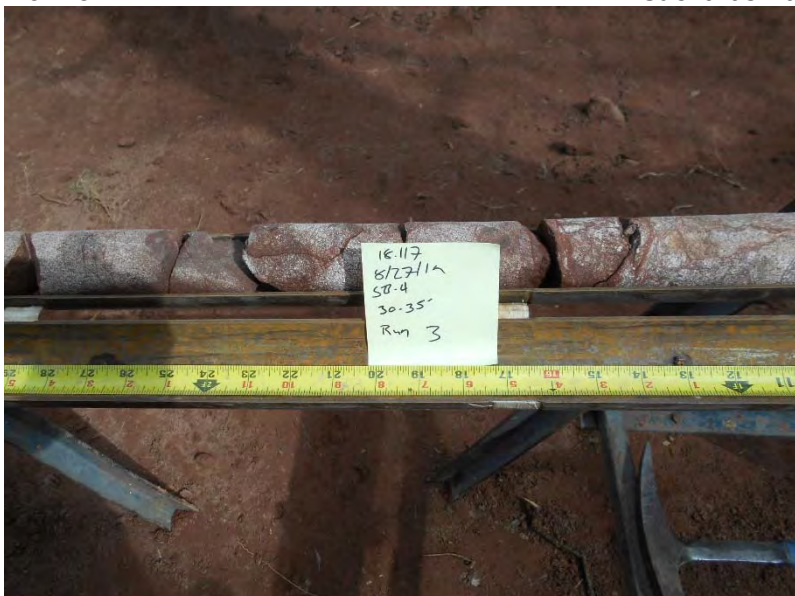
**Photo 33. SB-4 from 31.5 to 33 feet.**

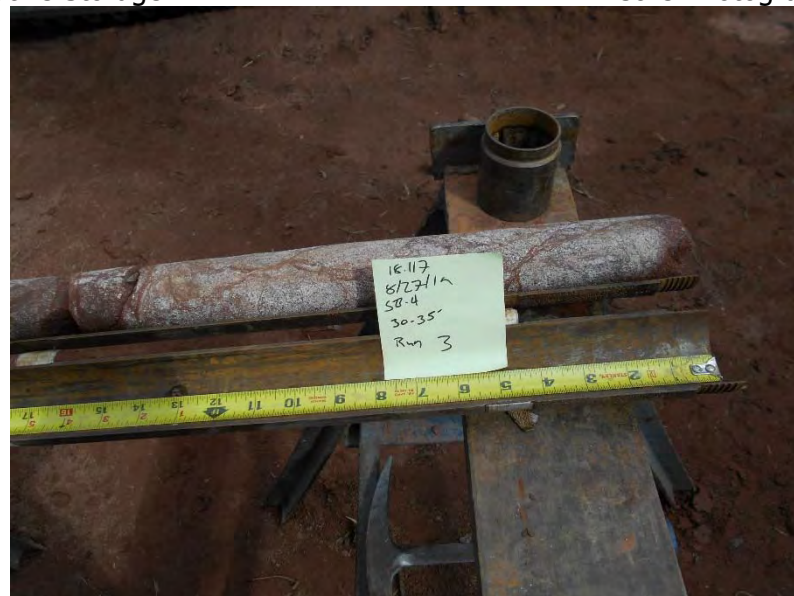
**Photo 34. SB-4 from 33 to 35 feet.**

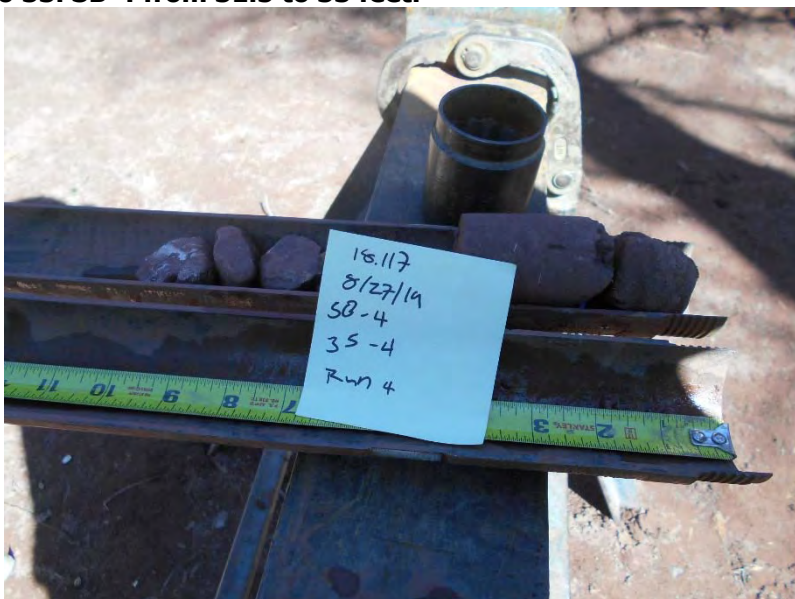
**Photo 35. SB-4 from 35 to 40 feet.**

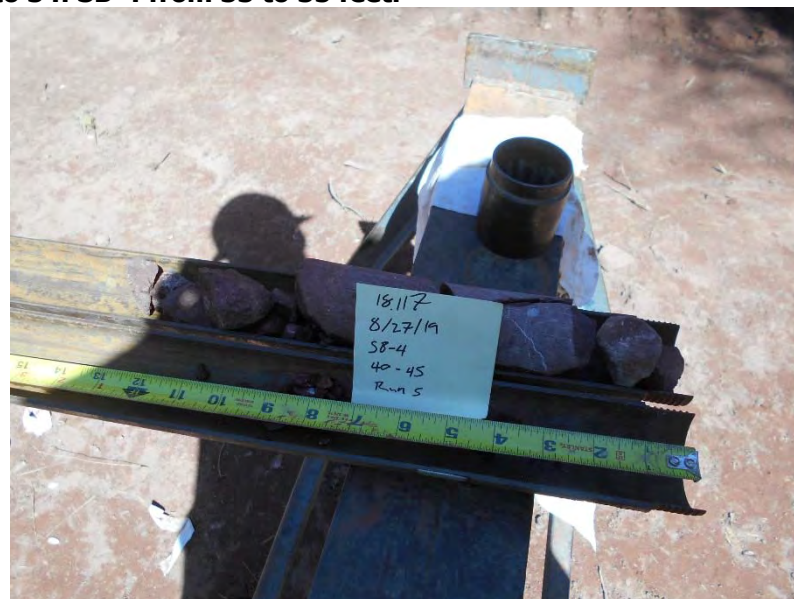
**Photo 36. SB-4 from 40 to 45 feet.**

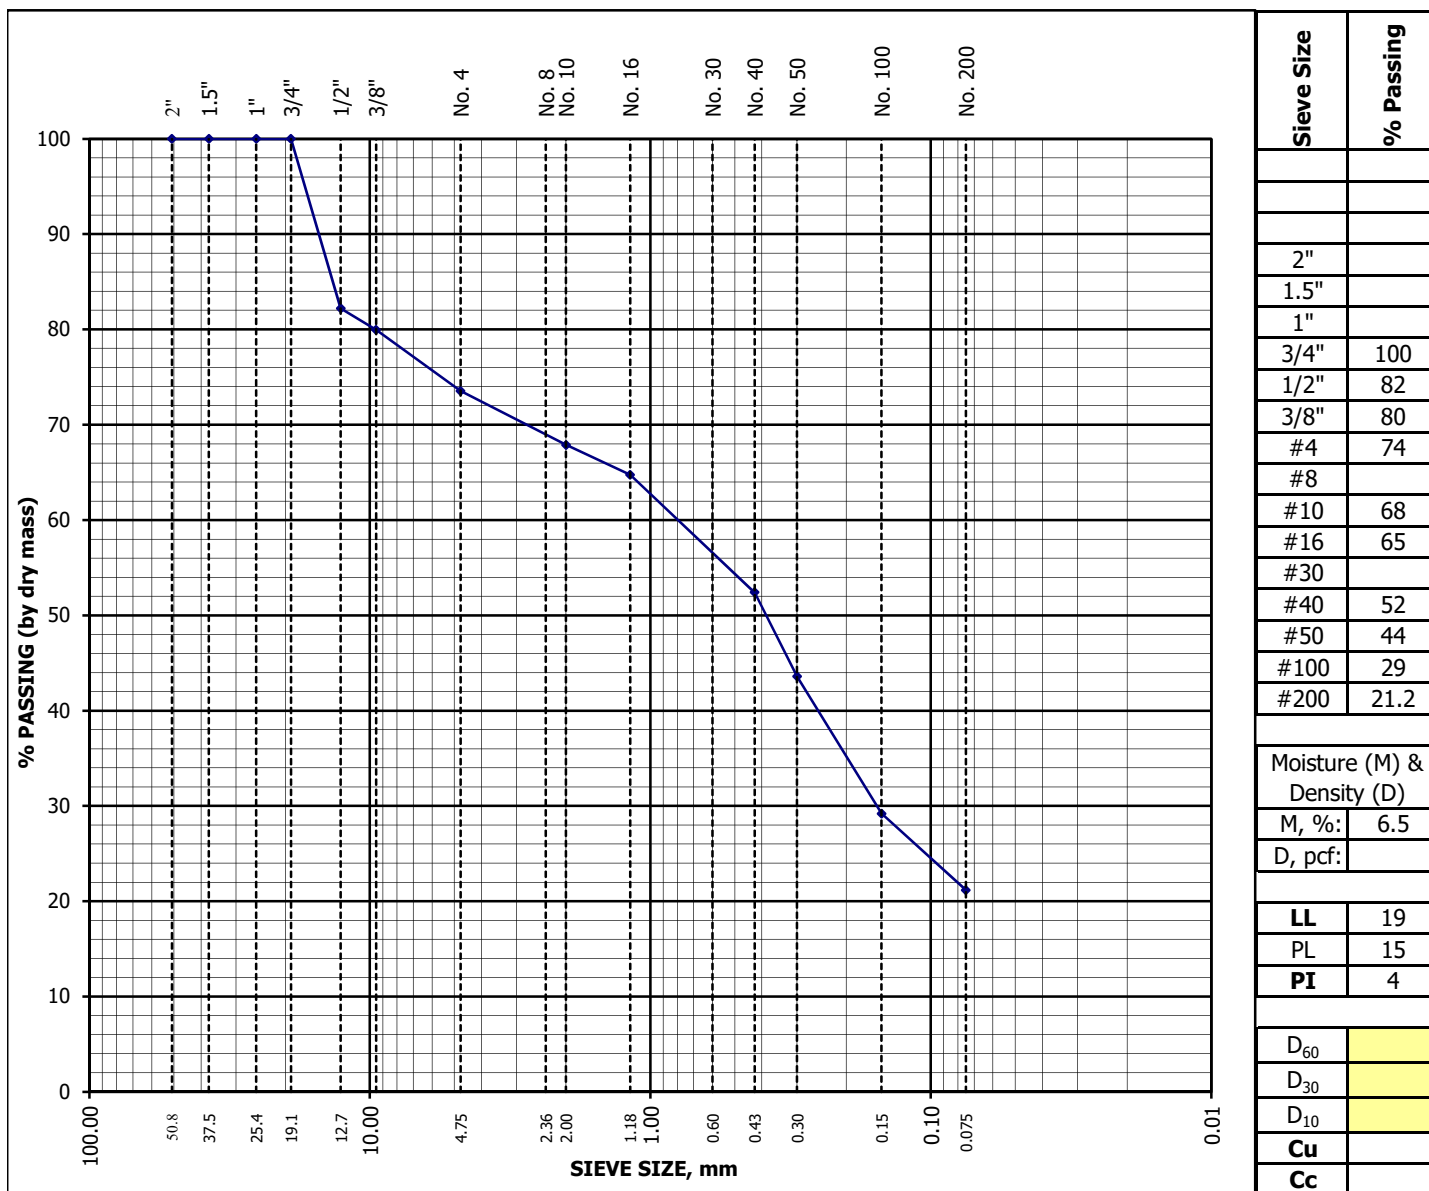
Project Number: 18.117, Applegate Group Date: 8-Sep-18  
Project Name: Cucharas Basin Collaborative Storage Technician: J. Holiman  
Lab ID Number: 1822891 Reviewer: J. Crystal  
Sample Location: B-1 at 7'  
Visual Description: SAND, silty, clayey, reddish brown

**AASHTO M 145 Classification:** A-2-4 **Group Index:** (0)  
**Unified Soil Classification System**  
**(ASTM D 2487):** (SC-SM) Silty, clayey sand

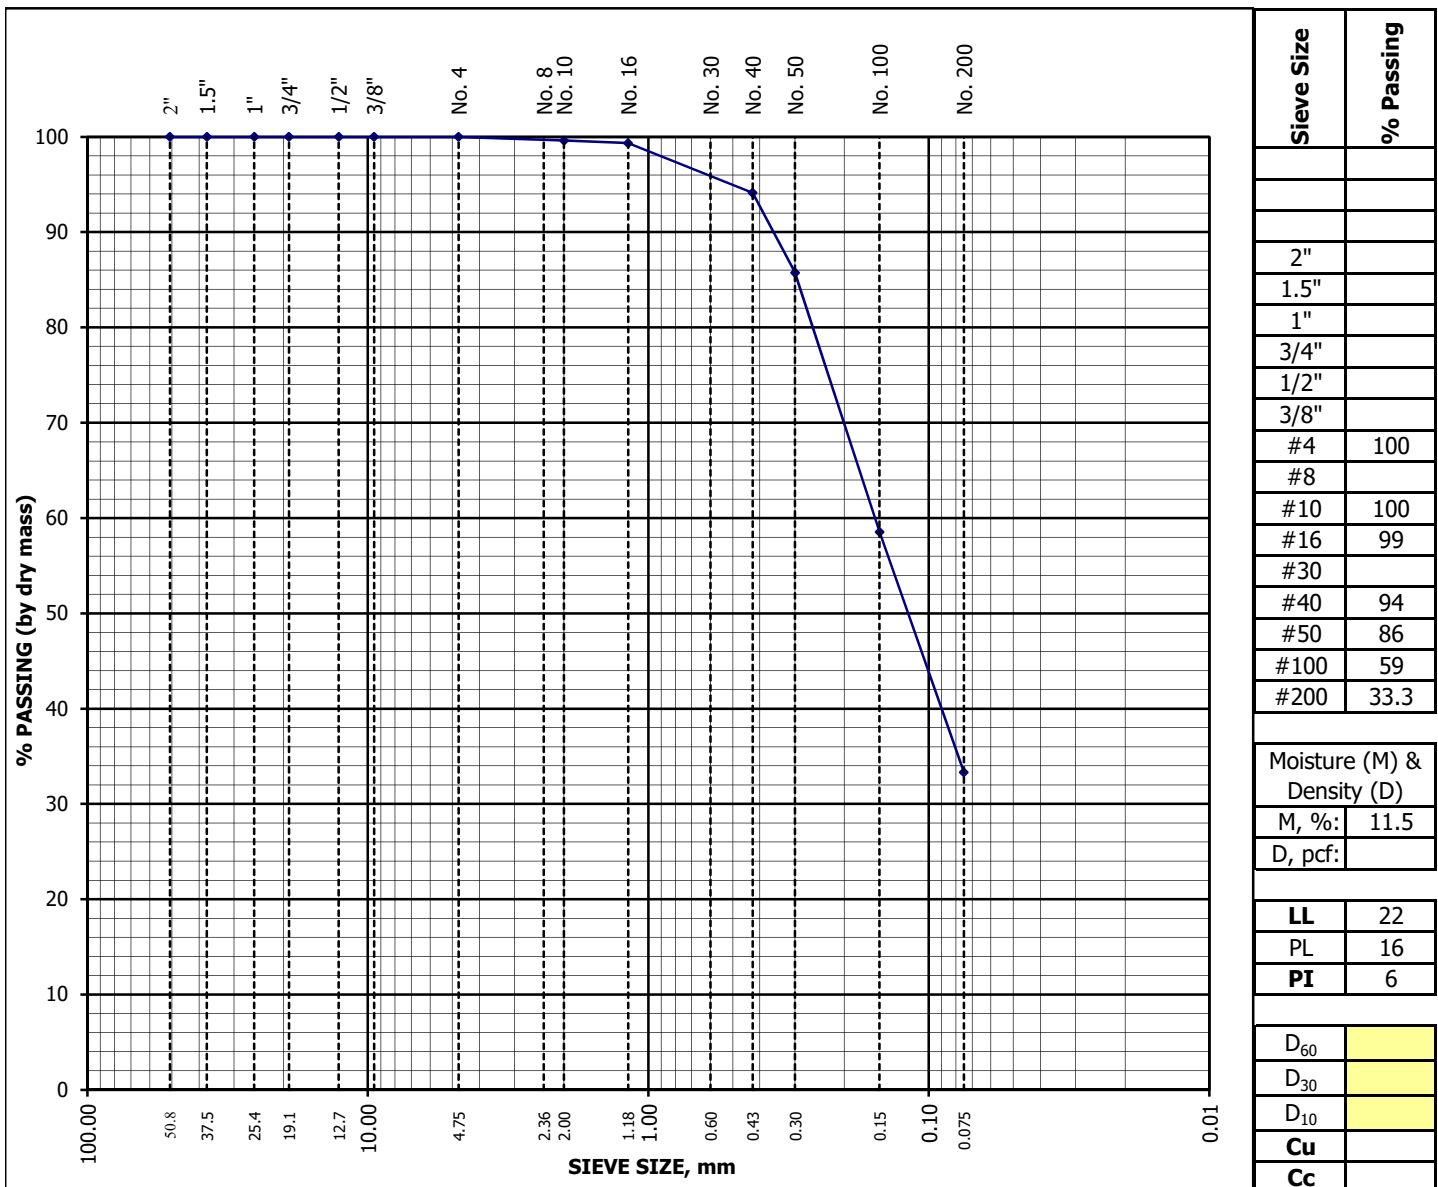
Project Number: 18.117, Applegate Group Date: 5-Sep-18  
Project Name: Cucharas Basin Collaborative Storage Technician: J. Weinerth  
Lab ID Number: 1822871 Reviewer: J. Crystal  
Sample Location: BC-1 at 5'  
Visual Description: SAND, clayey, brown

**AASHTO M 145 Classification:** A-2-4 **Group Index:** (0)  
**Unified Soil Classification System**  
**(ASTM D 2487):** (SC) **Clayey sand**
