# *Maria Stevens Reservoir*

## **30% Design Report**

### **Huerfano County Water Conservancy District**

AG JOB No. 18-117

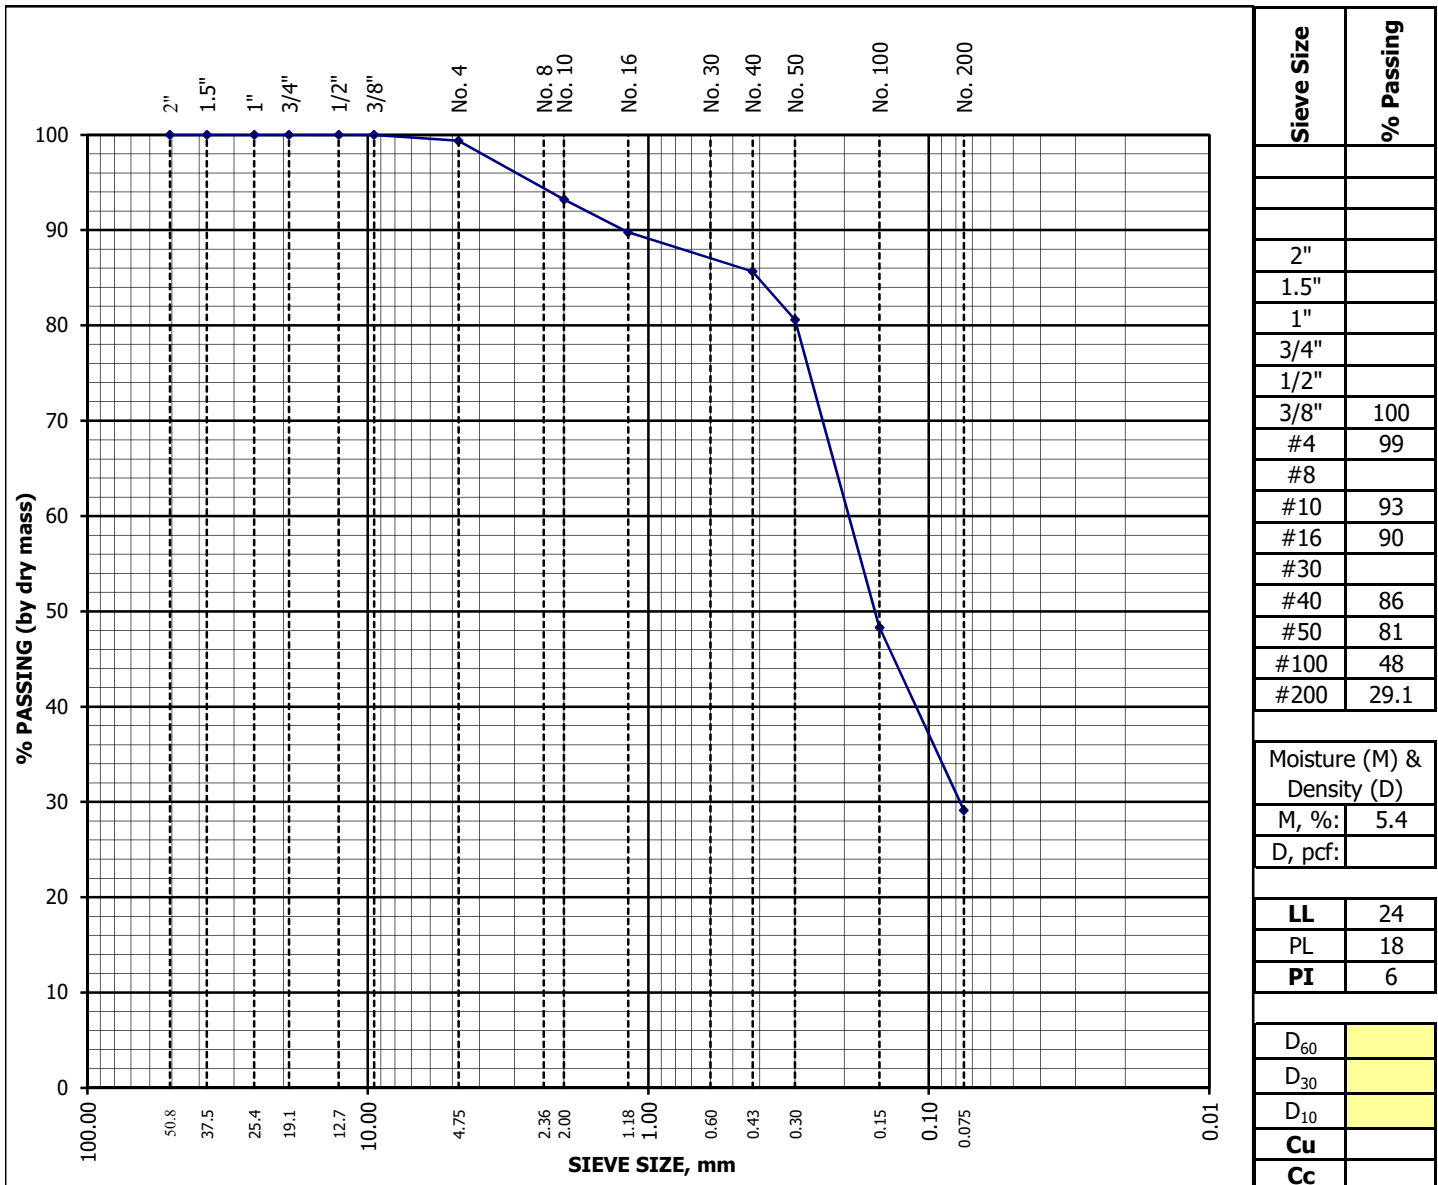
Project Number: 18.117, Applegate Group Date: 5-Sep-18  
 Project Name: Cucharas Basin Collaborative Storage Technician: J. Weinerth  
 Lab ID Number: 1822875 Reviewer: J. Crystal  
 Sample Location: BC-3 at 5'  
 Visual Description: SAND, silty, clayey, brown

**AASHTO M 145 Classification:** A-2-4 **Group Index:** (0)  
**Unified Soil Classification System**  
**(ASTM D 2487):** (SC-SM) Silty, clayey sand

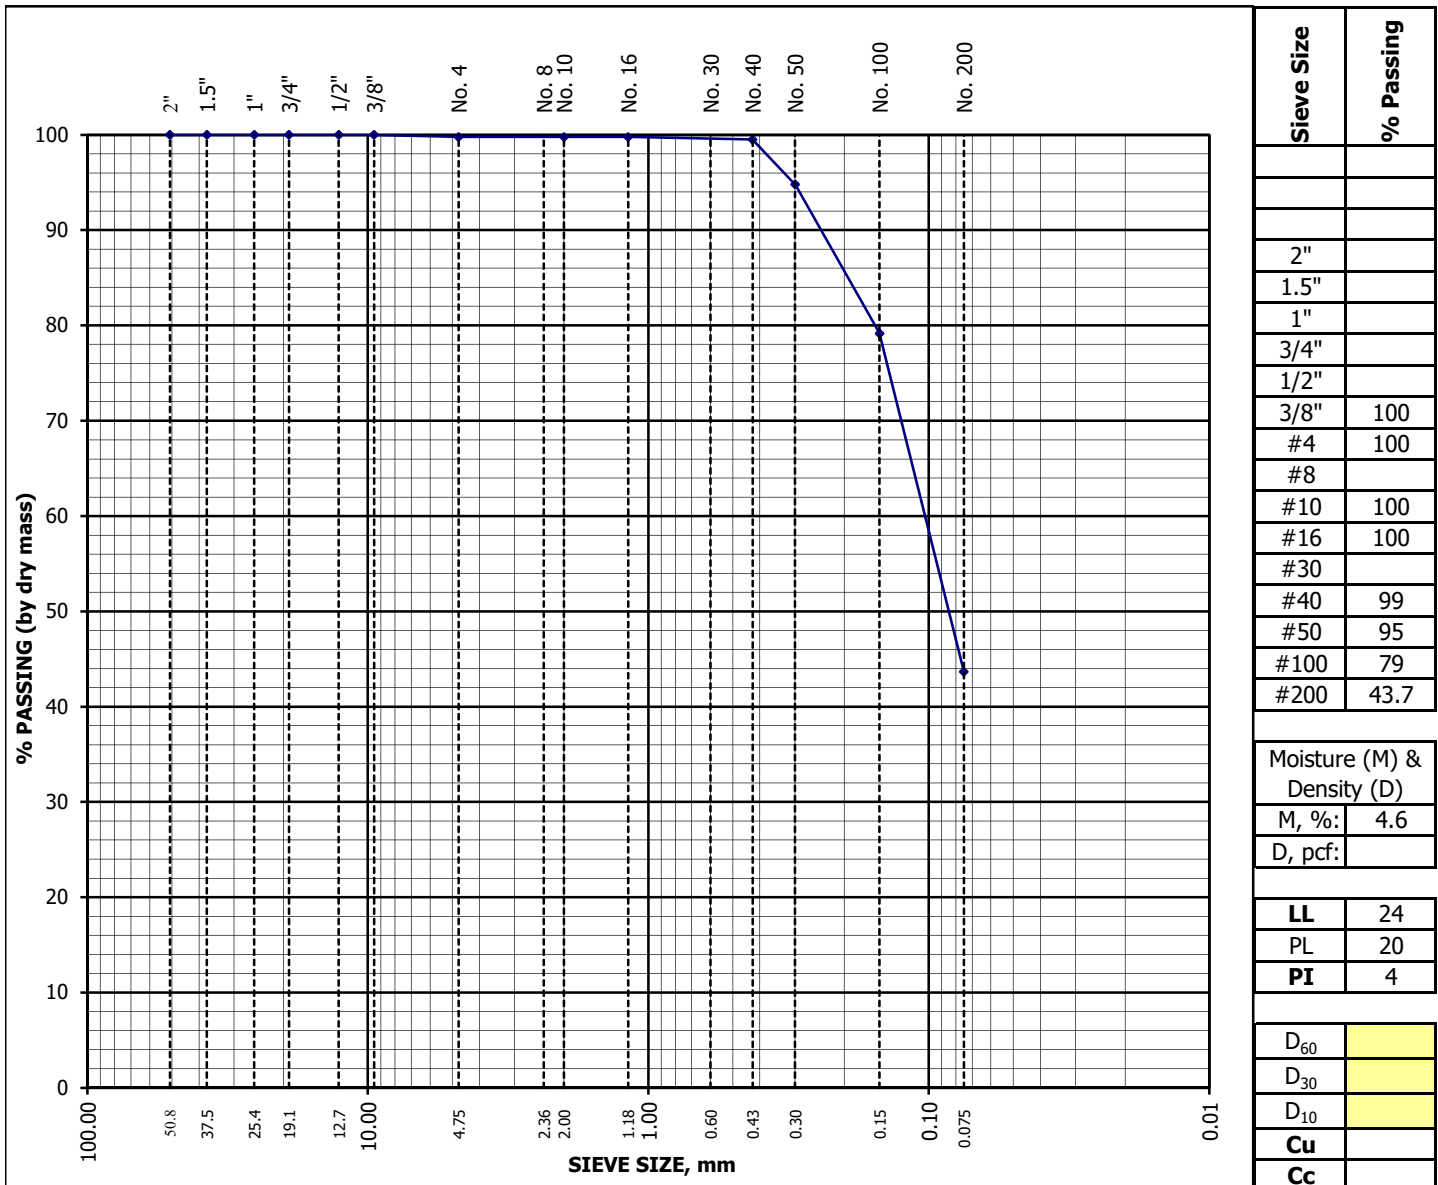
Project Number: 18.117, Applegate Group	Date: 5-Sep-18
Project Name: Cucharas Basin Collaborative Storage	Technician: J. Weinerth
Lab ID Number: 1822876	Reviewer: J. Crystal
Sample Location: BC-3 at 15'	
Visual Description: SANDSTONE, silty, clayey, brown

**AASHTO M 145 Classification:** A-4 **Group Index:** (0)  
**Unified Soil Classification System**  
**(ASTM D 2487):** (SC-SM) Silty, clayey sand

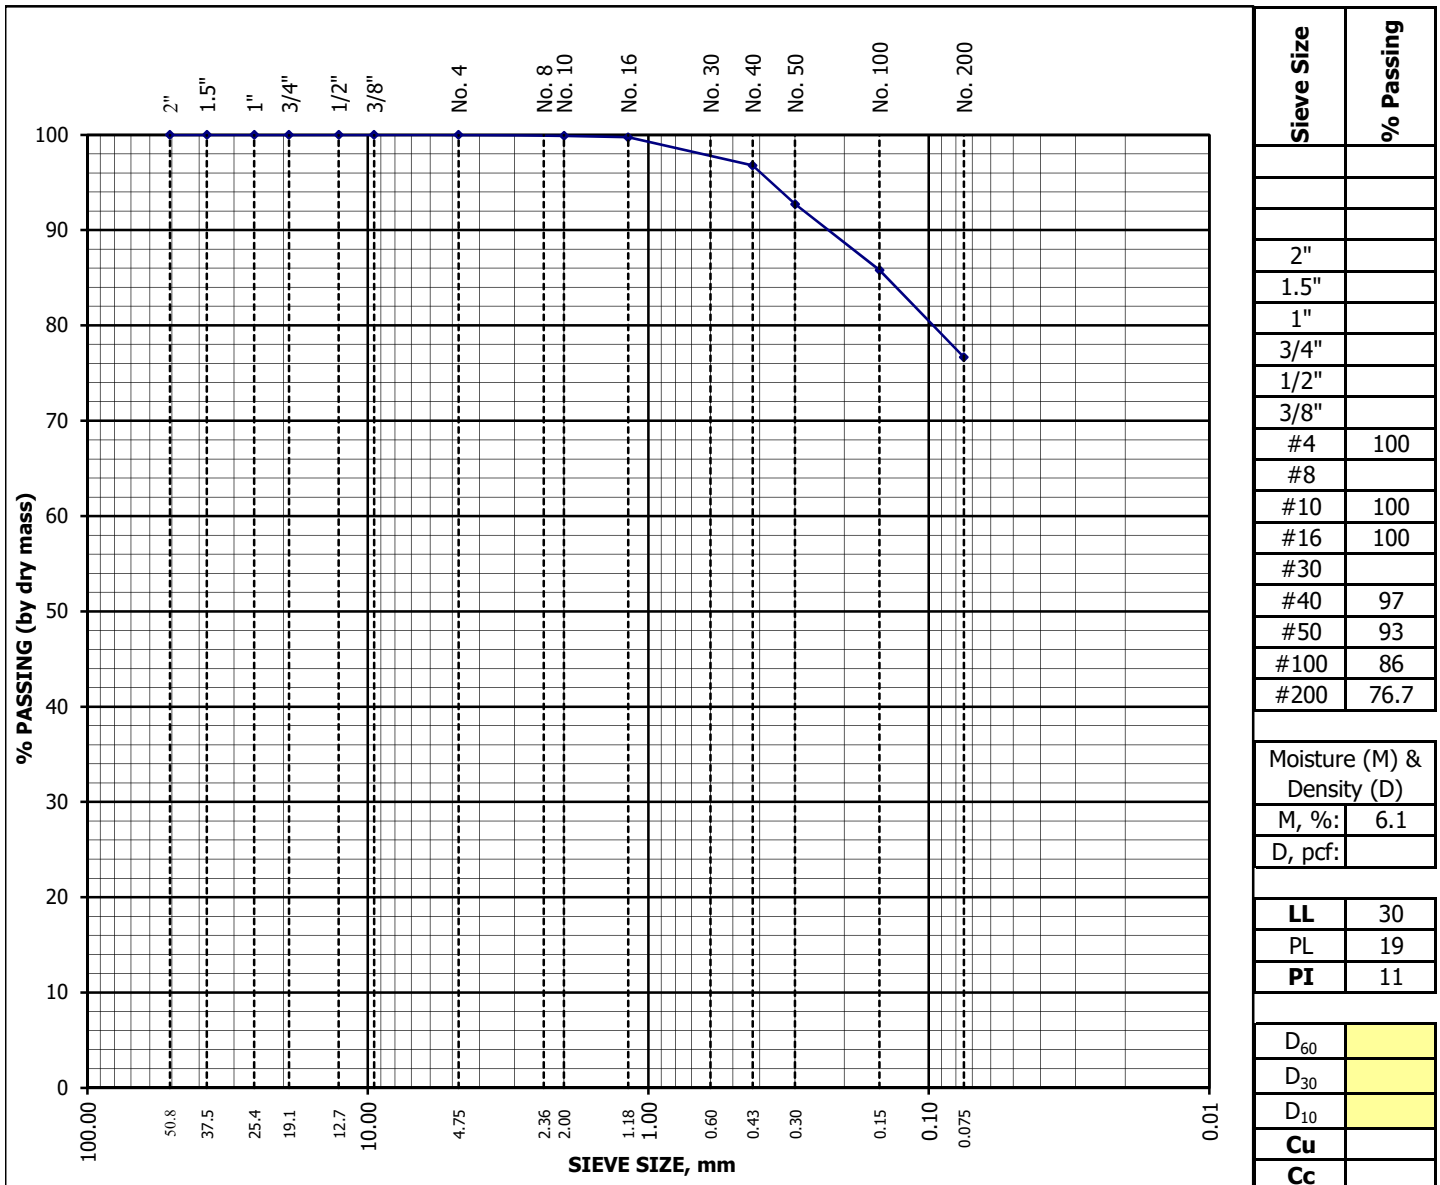
Project Number: 18.117, Applegate Group Date: 9-Sep-19  
Project Name: Cucharas Basin Collaborative Storage Technician: C. Zoetewey  
Lab ID Number: 1921469 Reviewer: J. Crystal  
Sample Location: BC-4 at 10'  
Visual Description: CLAY, with sand, brown

**AASHTO M 145 Classification:** A-6 **Group Index:** 7  
**Unified Soil Classification System**  
**(ASTM D 2487):** (CL) **Lean clay with sand**

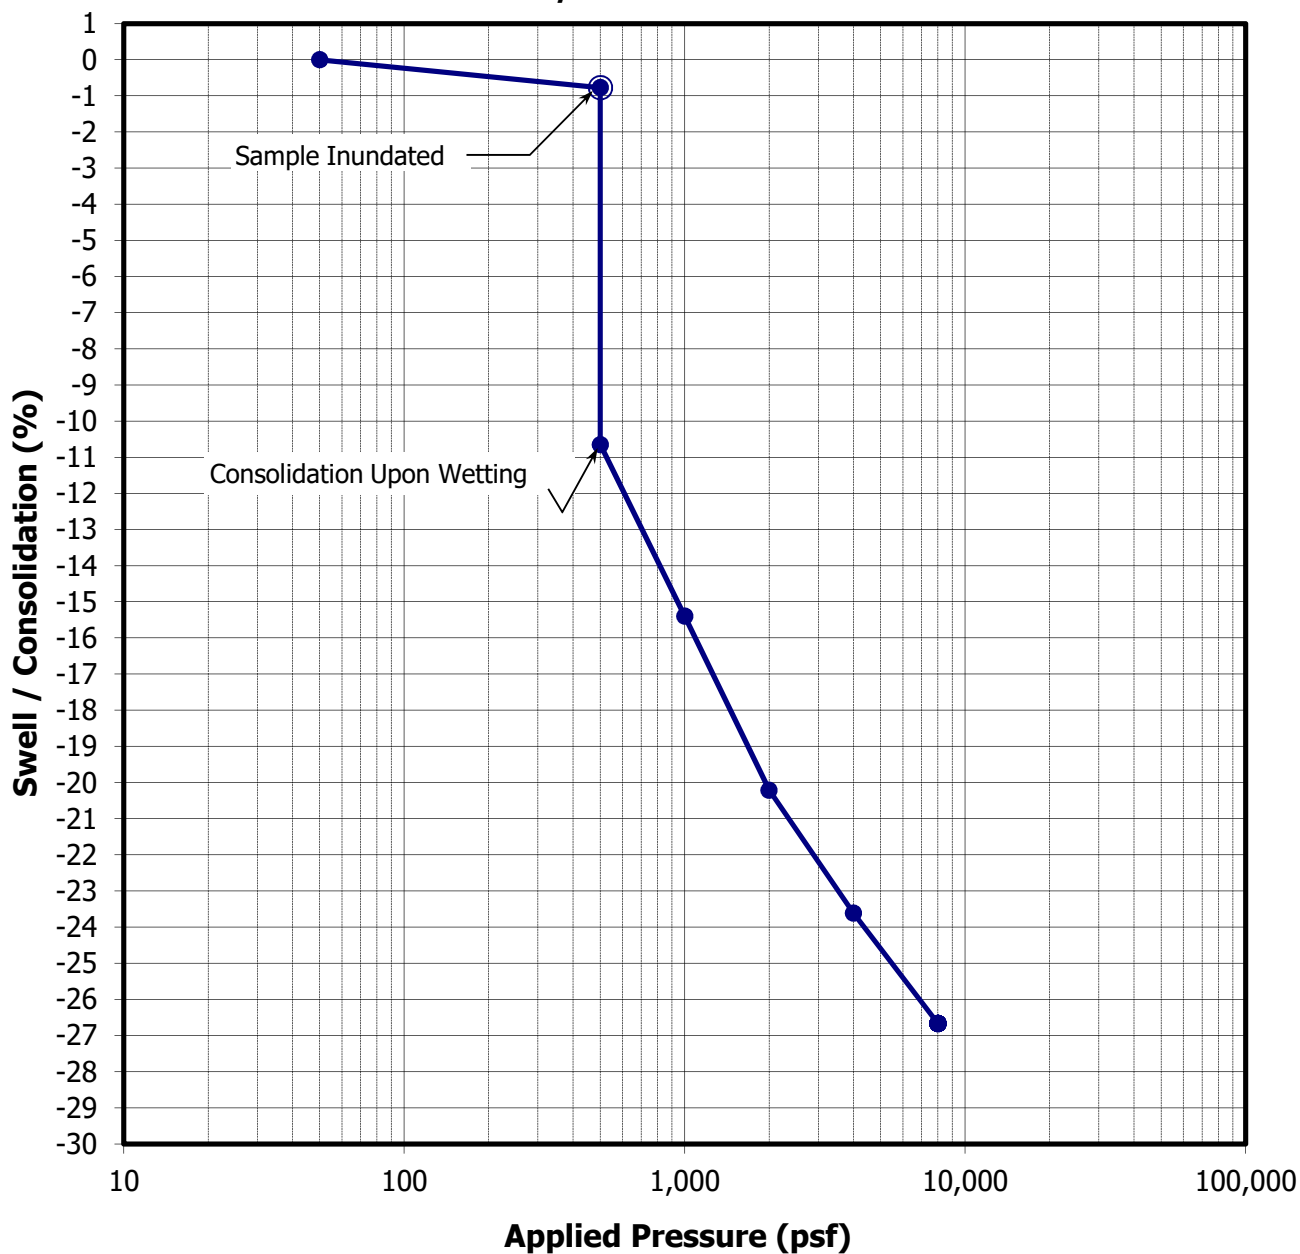
### SWELL/CONSOLIDATION PLOT

Sample Location	Sample Depth (feet)	Lab ID Number: 1822500	Dry Density (pcf)	Moisture Content (%)	Inundation Pressure (psf)	Volume Change (%)	Swell Pressure (psf)
		Visual Description of Sample					
BCP-5	0 to 8	CLAY, sandy, brown	82.8	5.1	500	-9.9	N/A
Client:		Applegate Group			Project No.:	18.117	
Project:		Cucharas Basin Collaborative Storage			Figure:	1822500

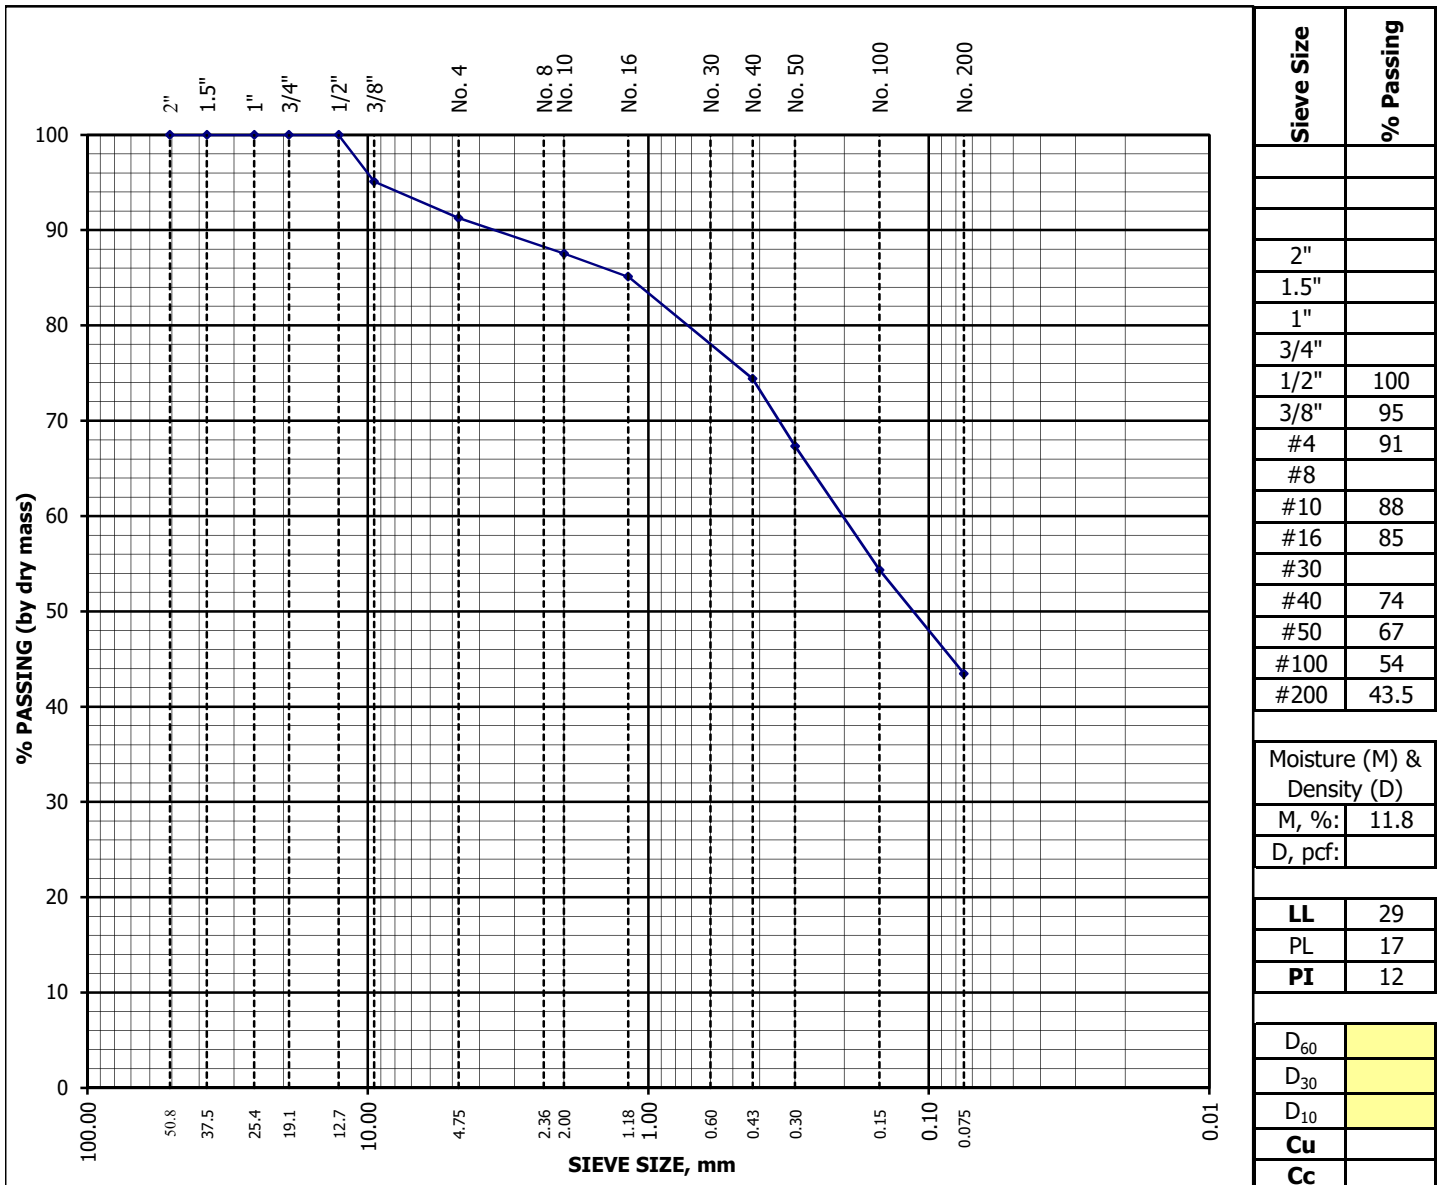
Project Number: 18.117, Applegate Group Date: 7-Oct-18  
Project Name: Cucharas Basin Collaborative Storage Technician: G. Hoyos  
Lab ID Number: 1822655 Reviewer: J. Crystal  
Sample Location: BCP-5 at 2' to 8'  
Visual Description: SAND, clayey, reddish brown

**AASHTO M 145 Classification:** A-6 **Group Index:** 2  
**Unified Soil Classification System**  
**(ASTM D 2487):** (SC) Clayey Sand

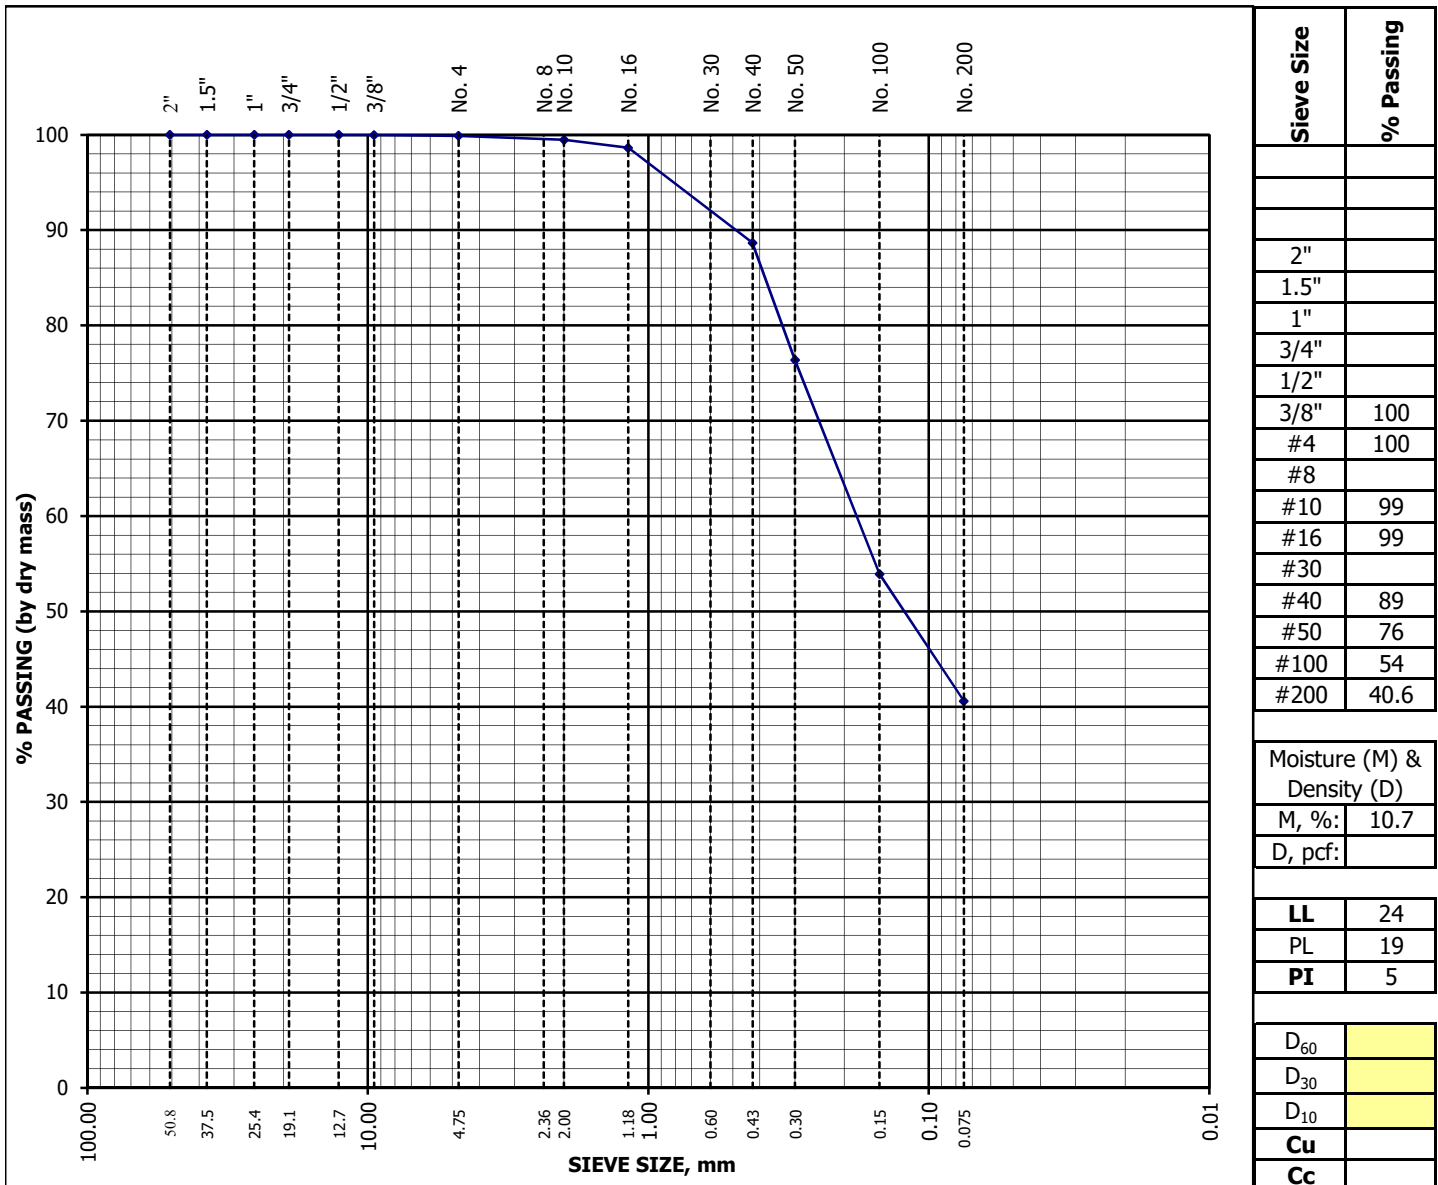
Project Number: 18.117, Applegate Group Date: 8-Sep-18  
Project Name: Cucharas Basin Collaborative Storage Technician: J. Holiman  
Lab ID Number: 1822895 Reviewer: J. Crystal  
Sample Location: LVL-1 at 15'  
Visual Description: SAND, silty, clayey, brown

**AASHTO M 145 Classification:** A-4 **Group Index:** (0)  
**Unified Soil Classification System**  
**(ASTM D 2487):** (SC-SM) Silty, clayey sand

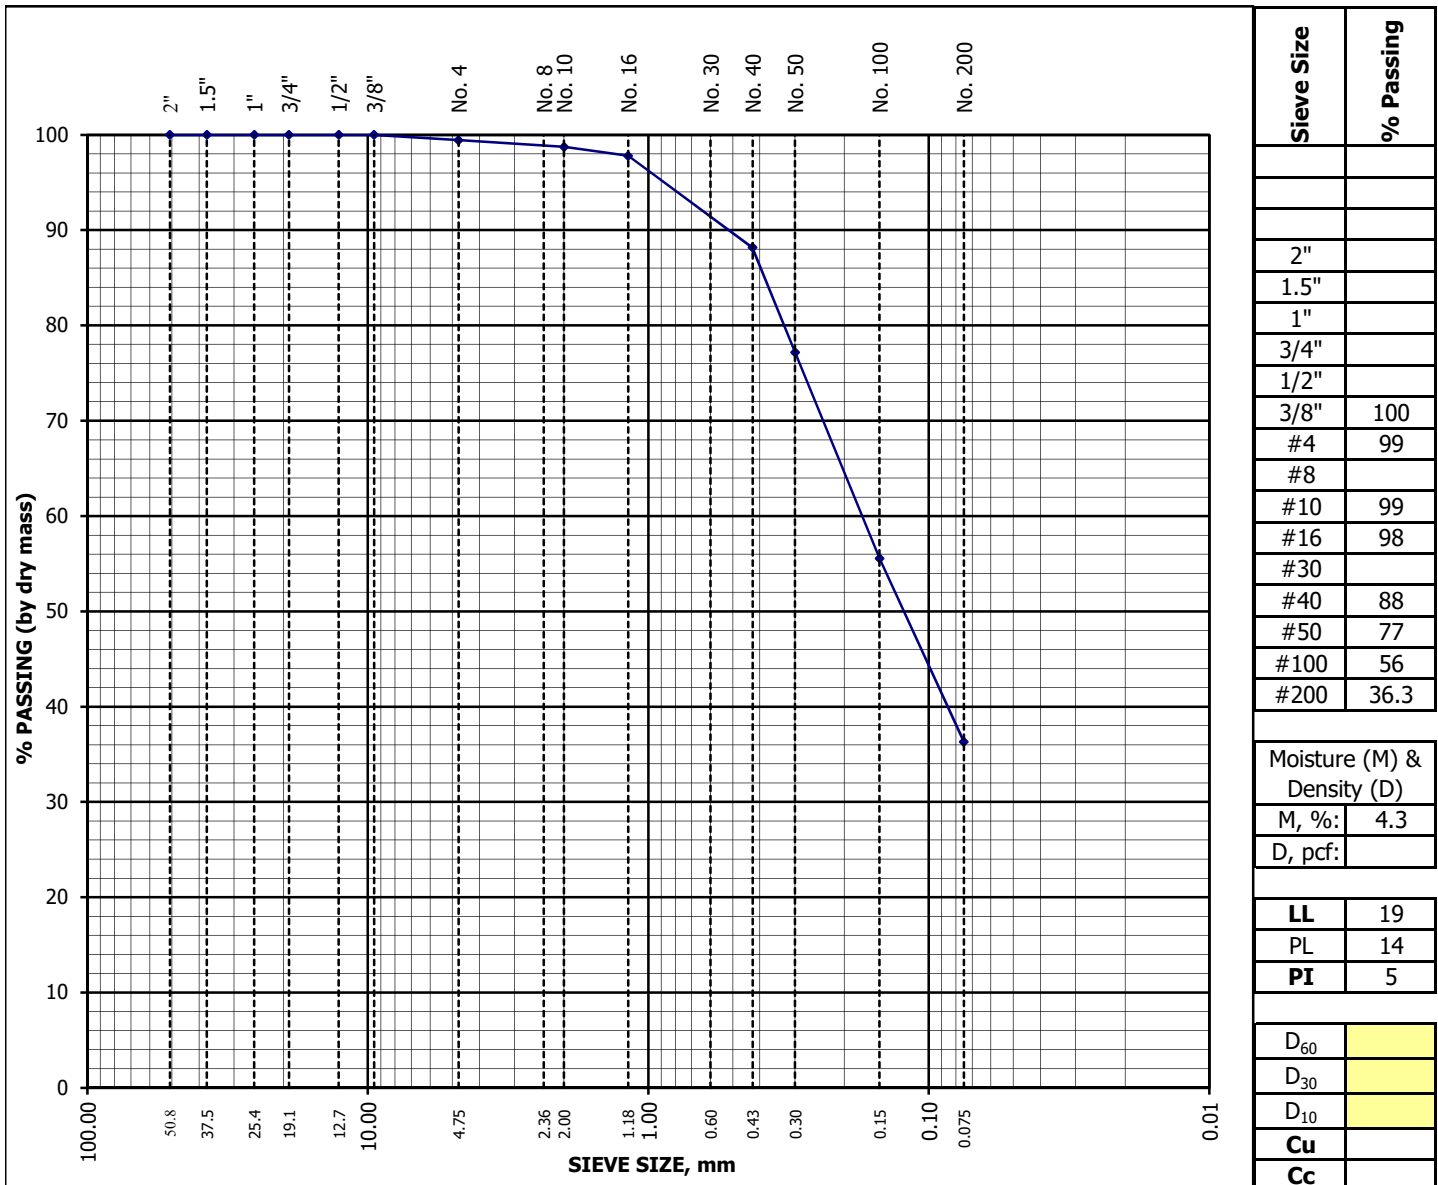
Project Number: 18.117, Applegate Group Date: 8-Sep-18  
Project Name: Cucharas Basin Collaborative Storage Technician: J. Holiman  
Lab ID Number: 1822898 Reviewer: J. Crystal  
Sample Location: LVL-7 at 4'  
Visual Description: SAND, silty, clayey, brown

**AASHTO M 145 Classification:** A-4 **Group Index:** (0)  
**Unified Soil Classification System**  
**(ASTM D 2487):** (SC-SM) Silty, clayey sand

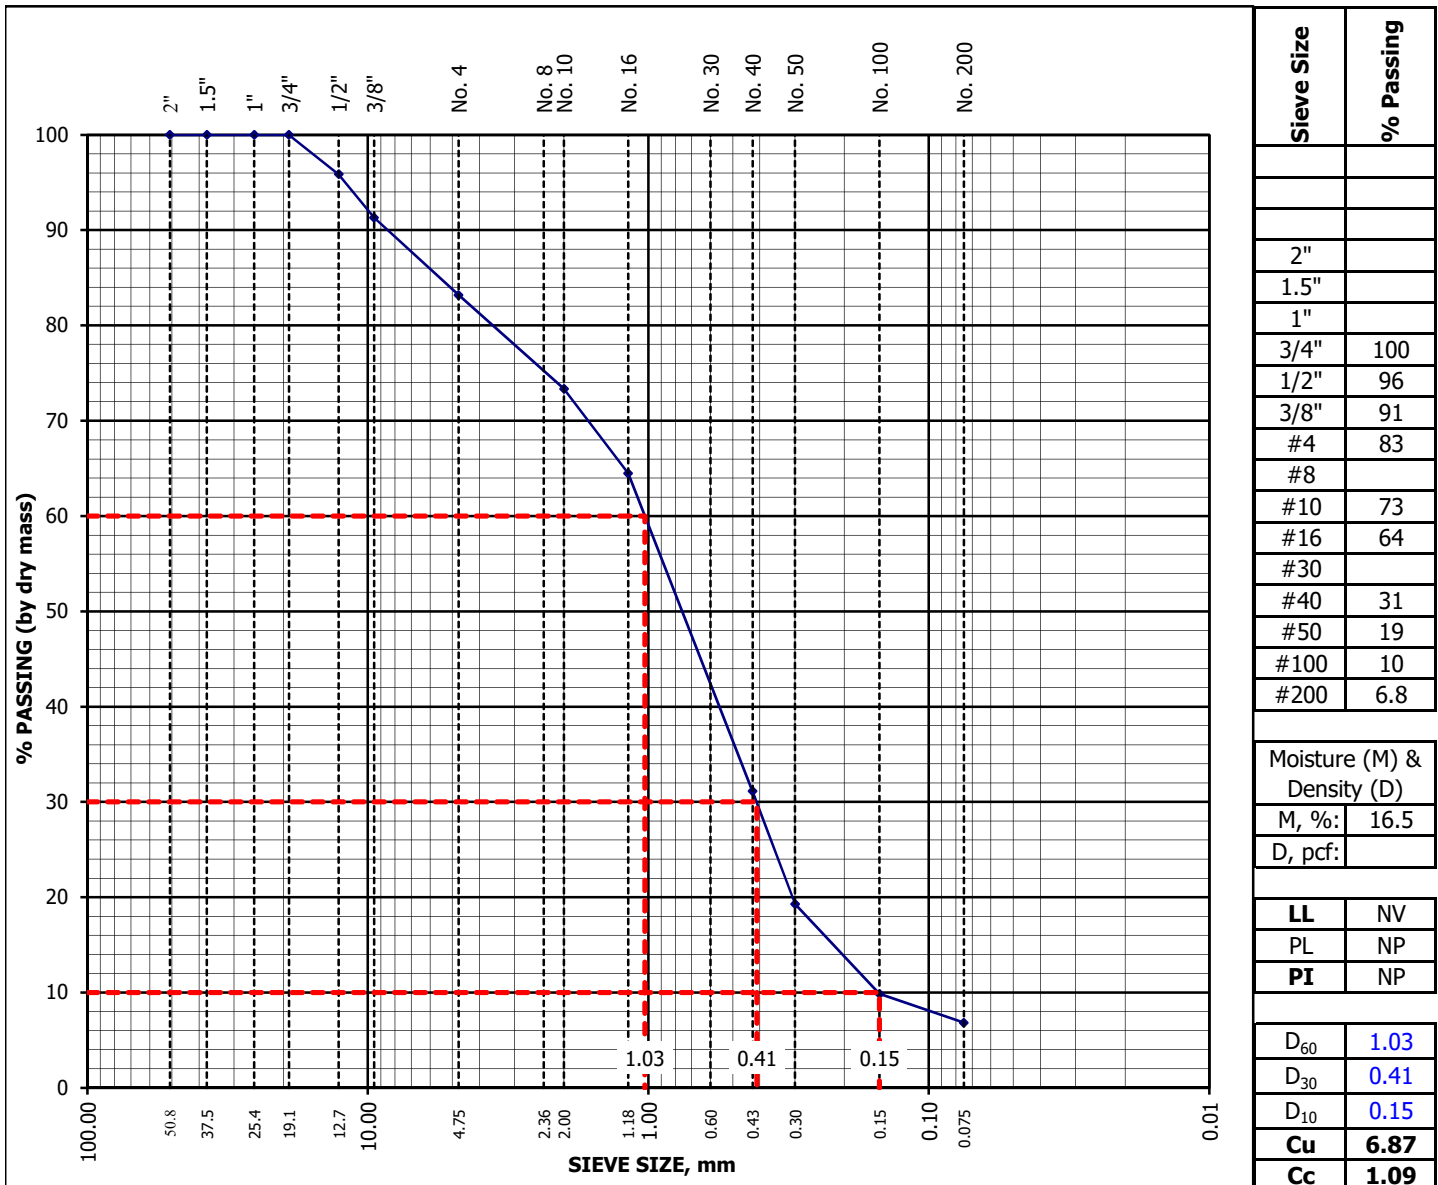
Project Number: 18.117, Applegate Group Date: 5-Sep-18  
Project Name: Cucharas Basin Collaborative Storage Technician: J. Weinerth  
Lab ID Number: 1822880 Reviewer: J. Crystal  
Sample Location: MS-2 at 20'  
Visual Description: SAND, with silt and gravel, brown

**AASHTO M 145 Classification:** A-1-b **Group Index:** 0  
**Unified Soil Classification System**  
**(ASTM D 2487):** (SW-SM) Well-graded sand with silt and gravel

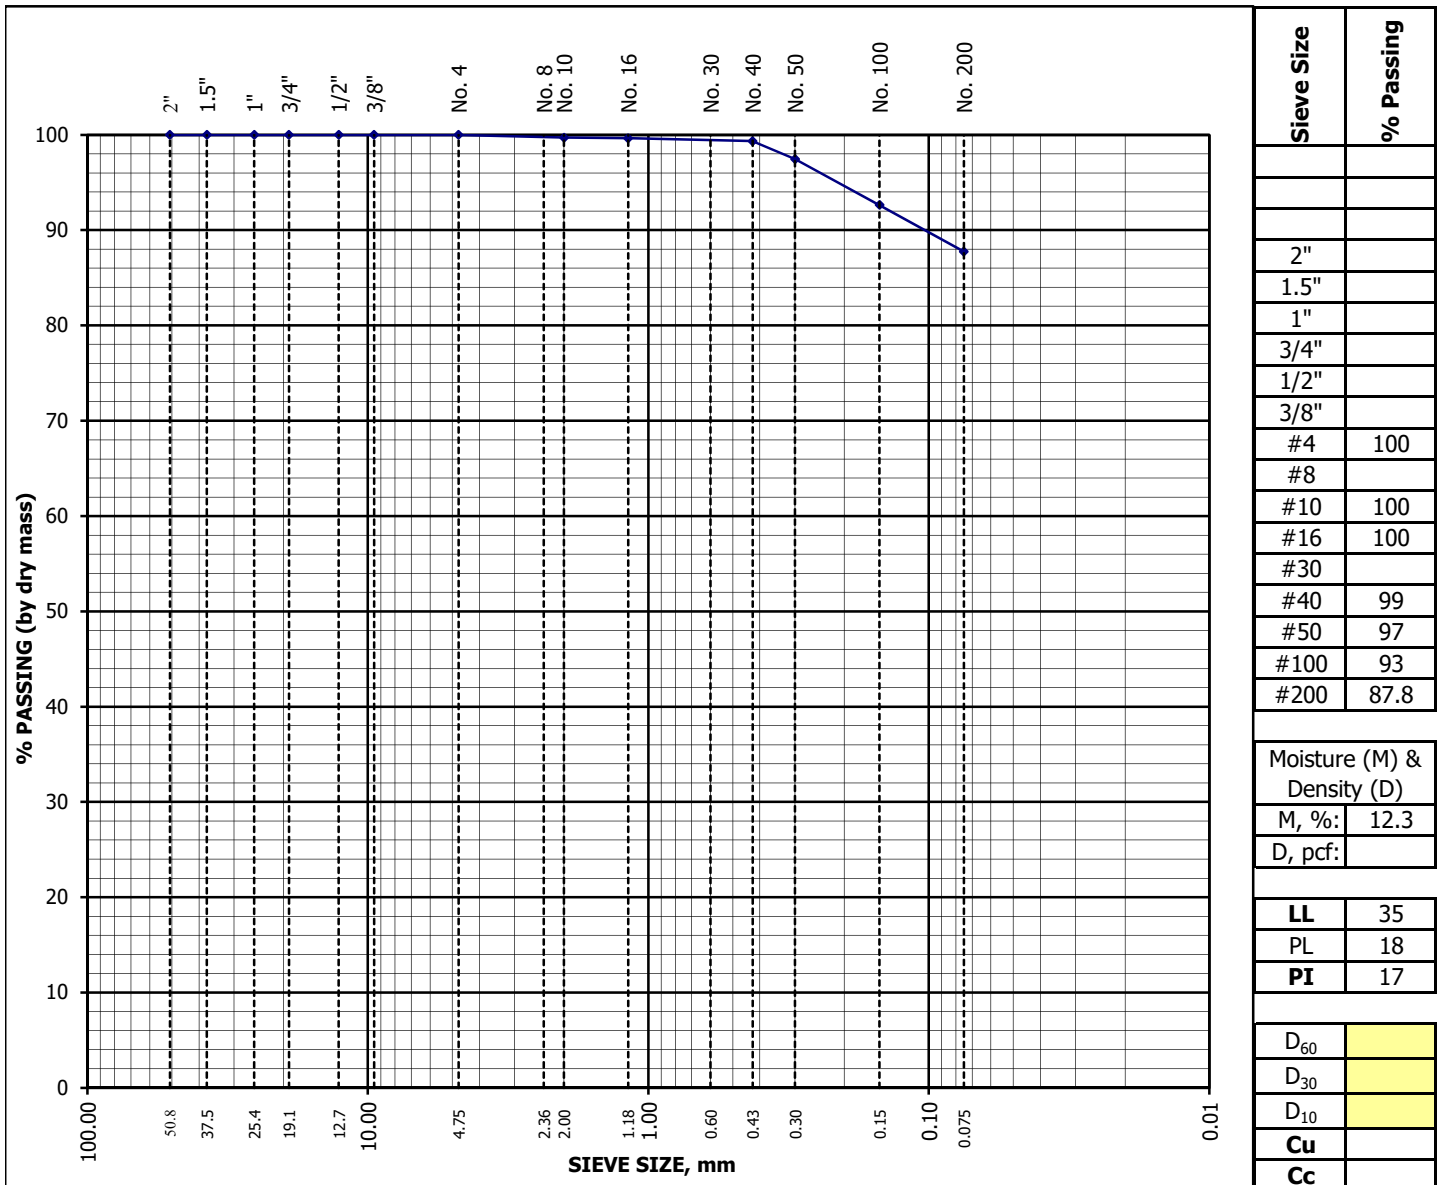
Project Number: 18.117, Applegate Group Date: 8-Sep-18  
Project Name: Cucharas Basin Collaborative Storage Technician: J. Holiman  
Lab ID Number: 1822883 Reviewer: J. Crystal  
Sample Location: MS-5 at 10'  
Visual Description: CLAY, brown

**AASHTO M 145 Classification:** A-6 **Group Index:** 14  
**Unified Soil Classification System**  
**(ASTM D 2487):** (CL) **Lean clay**

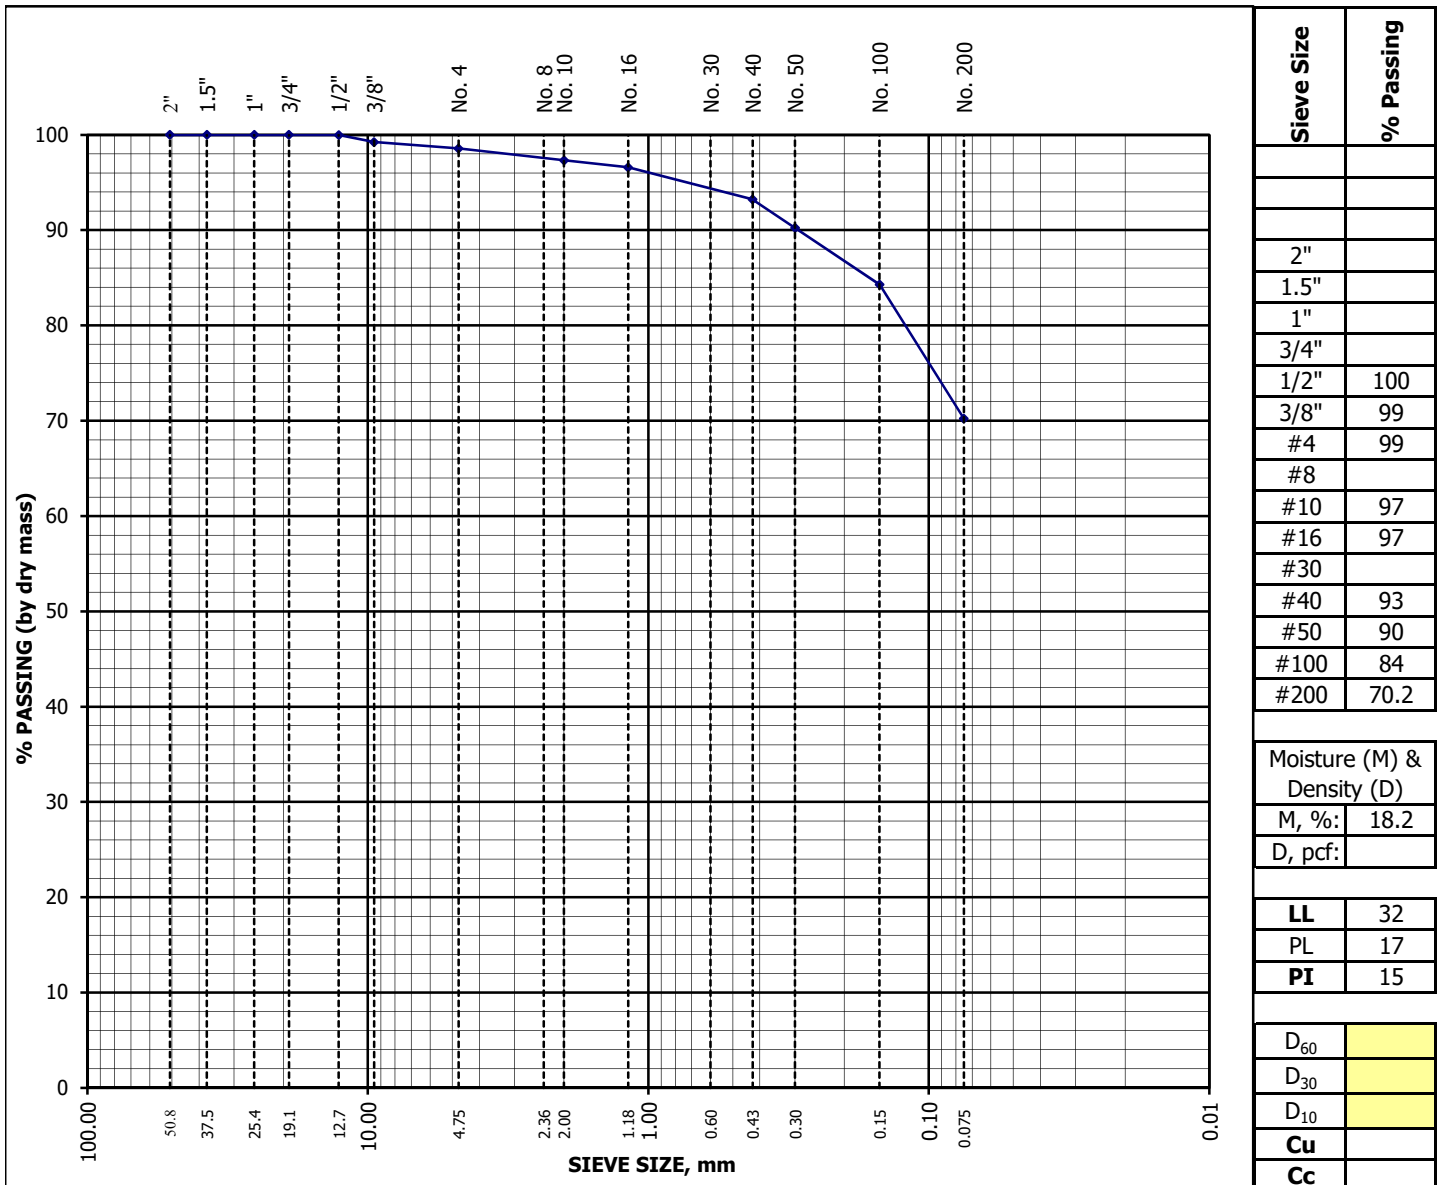
Project Number: 18.117, Applegate Group Date: 8-Sep-18  
Project Name: Cucharas Basin Collaborative Storage Technician: J. Holiman  
Lab ID Number: 1822884 Reviewer: J. Crystal  
Sample Location: MS-6 at 10'  
Visual Description: CLAY, sandy, brown

**AASHTO M 145 Classification:** A-6 **Group Index:** 8  
**Unified Soil Classification System**  
**(ASTM D 2487):** (CL) Sandy lean clay

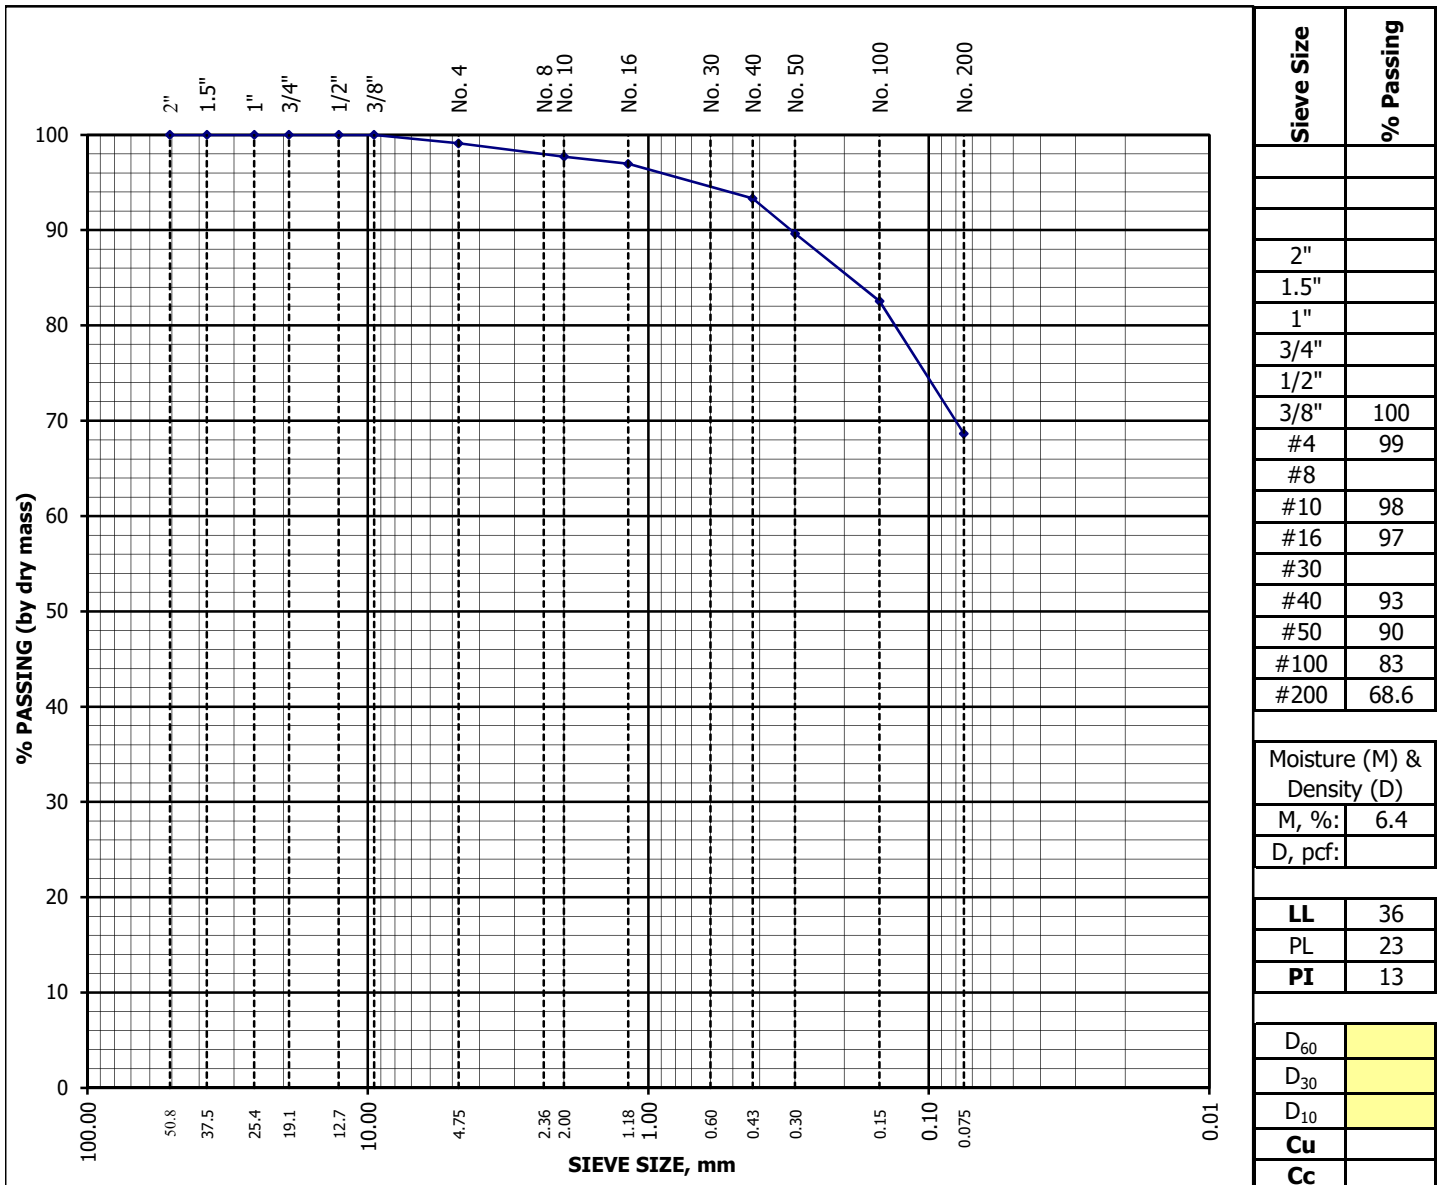
Project Number:	18.117, Applegate Group	Date:	21-Sep-18
Project Name:	Cucharas Basin Collaborative Storage	Technician:	J. Holiman
Lab ID Number:	1822641	Reviewer:	J. Crystal
Sample Location:	MSP-2 at 1' to 3'		
Visual Description:	CLAY, sandy, light brown

**AASHTO M 145 Classification:** A-6 **Group Index:** 8  
**Unified Soil Classification System**  
**(ASTM D 2487):** (CL) Sandy lean clay

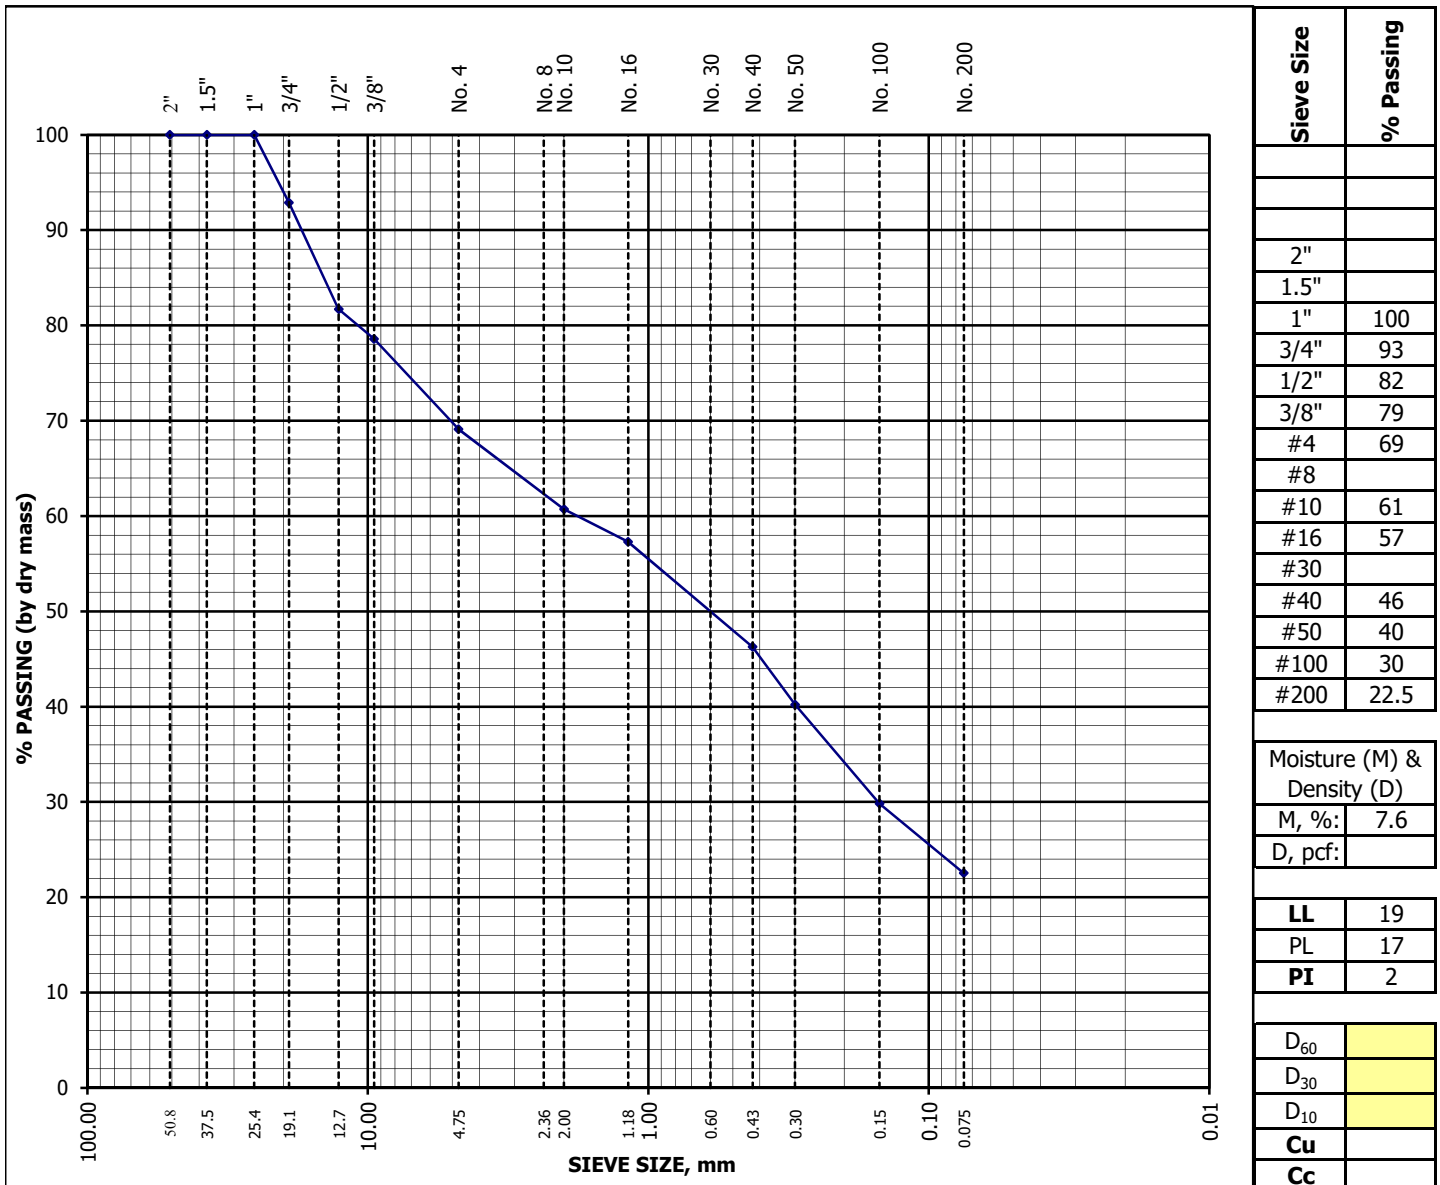
Project Number: 18.117, Applegate Group Date: 12-Sep-18  
 Project Name: Cucharas Basin Collaborative Storage Technician: G. Hoyos  
 Lab ID Number: 1822886 Reviewer: J. Crystal  
 Sample Location: SB-1 at 5'  
 Visual Description: SAND, silty, with gravel, red

**AASHTO M 145 Classification:** A-1-b **Group Index:** (0)  
**Unified Soil Classification System**  
**(ASTM D 2487):** (SM) **Silty sand with gravel**
