# *Maria Stevens Reservoir*

## **30% Design Report**

### **Huerfano County Water Conservancy District**

AG JOB No. 18-117

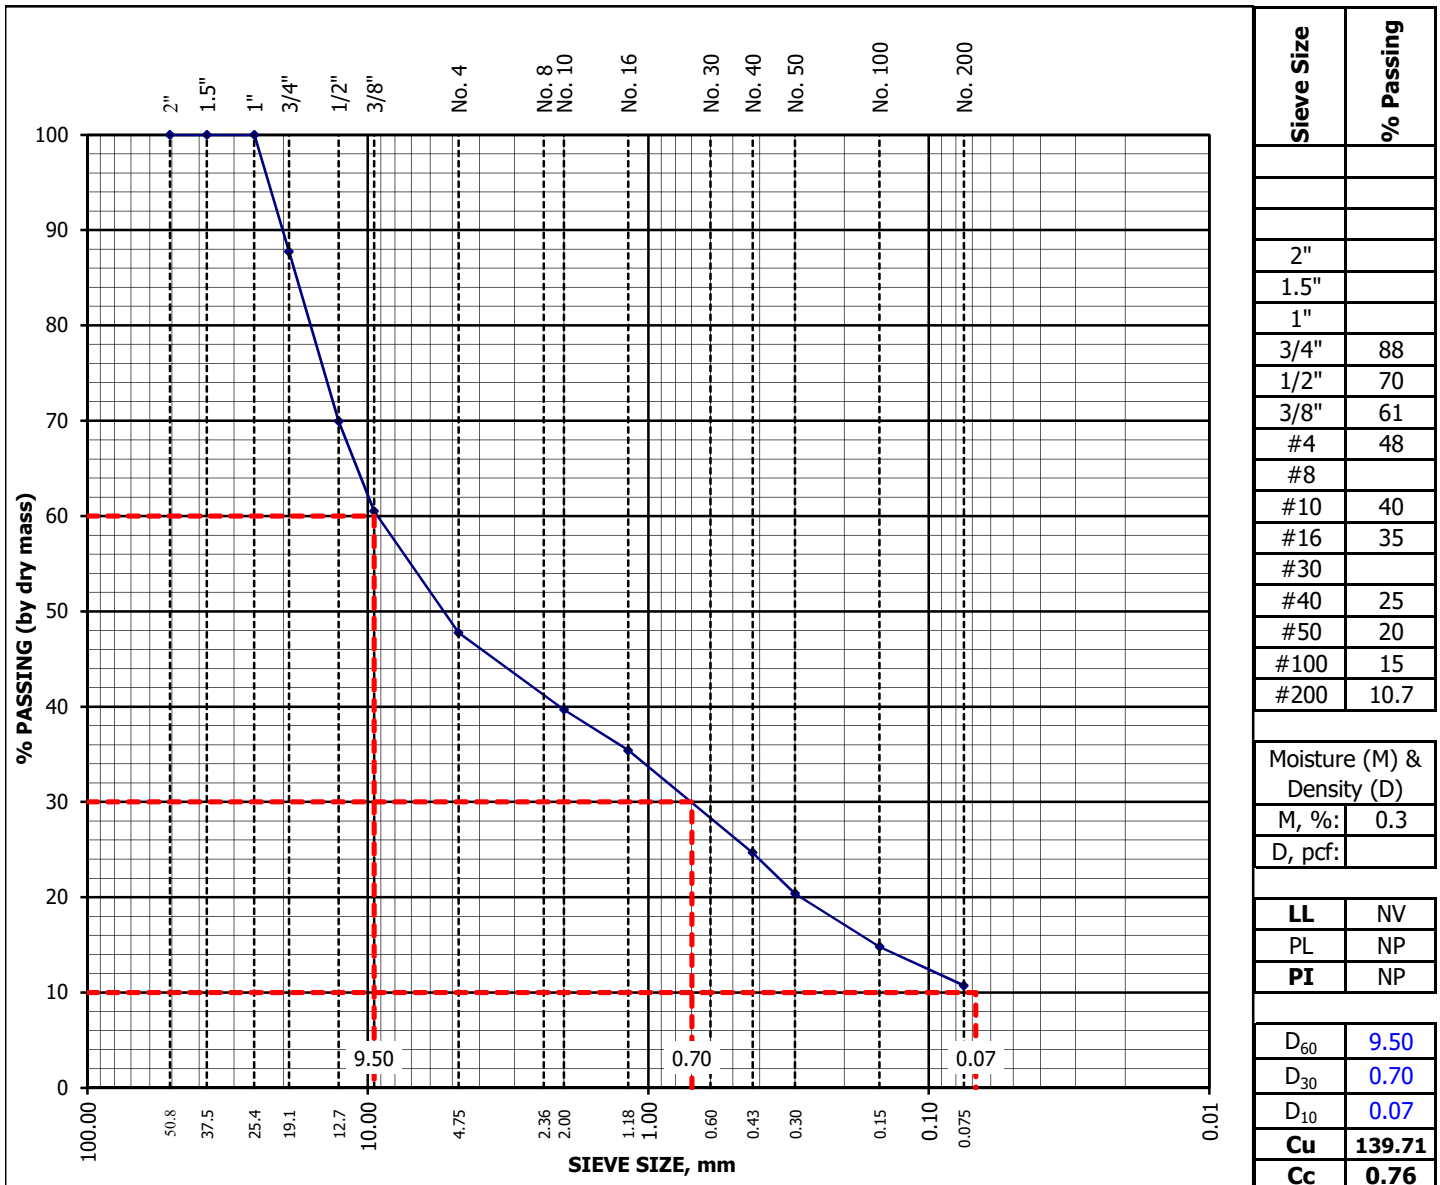
Project Number: 18.117, Applegate Group Date: 5-Sep-18  
Project Name: Cucharas Basin Collaborative Storage Technician: J. Weinerth  
Lab ID Number: 1822887 Reviewer: J. Crystal  
Sample Location: SB-1 at 12.5'  
Visual Description: Gravel, with silt, with sand, pink

**AASHTO M 145 Classification:** A-1-b **Group Index:** 0  
**Unified Soil Classification System**  
**(ASTM D 2487):** (GP-GM) Poorly graded gravel with silt and sand

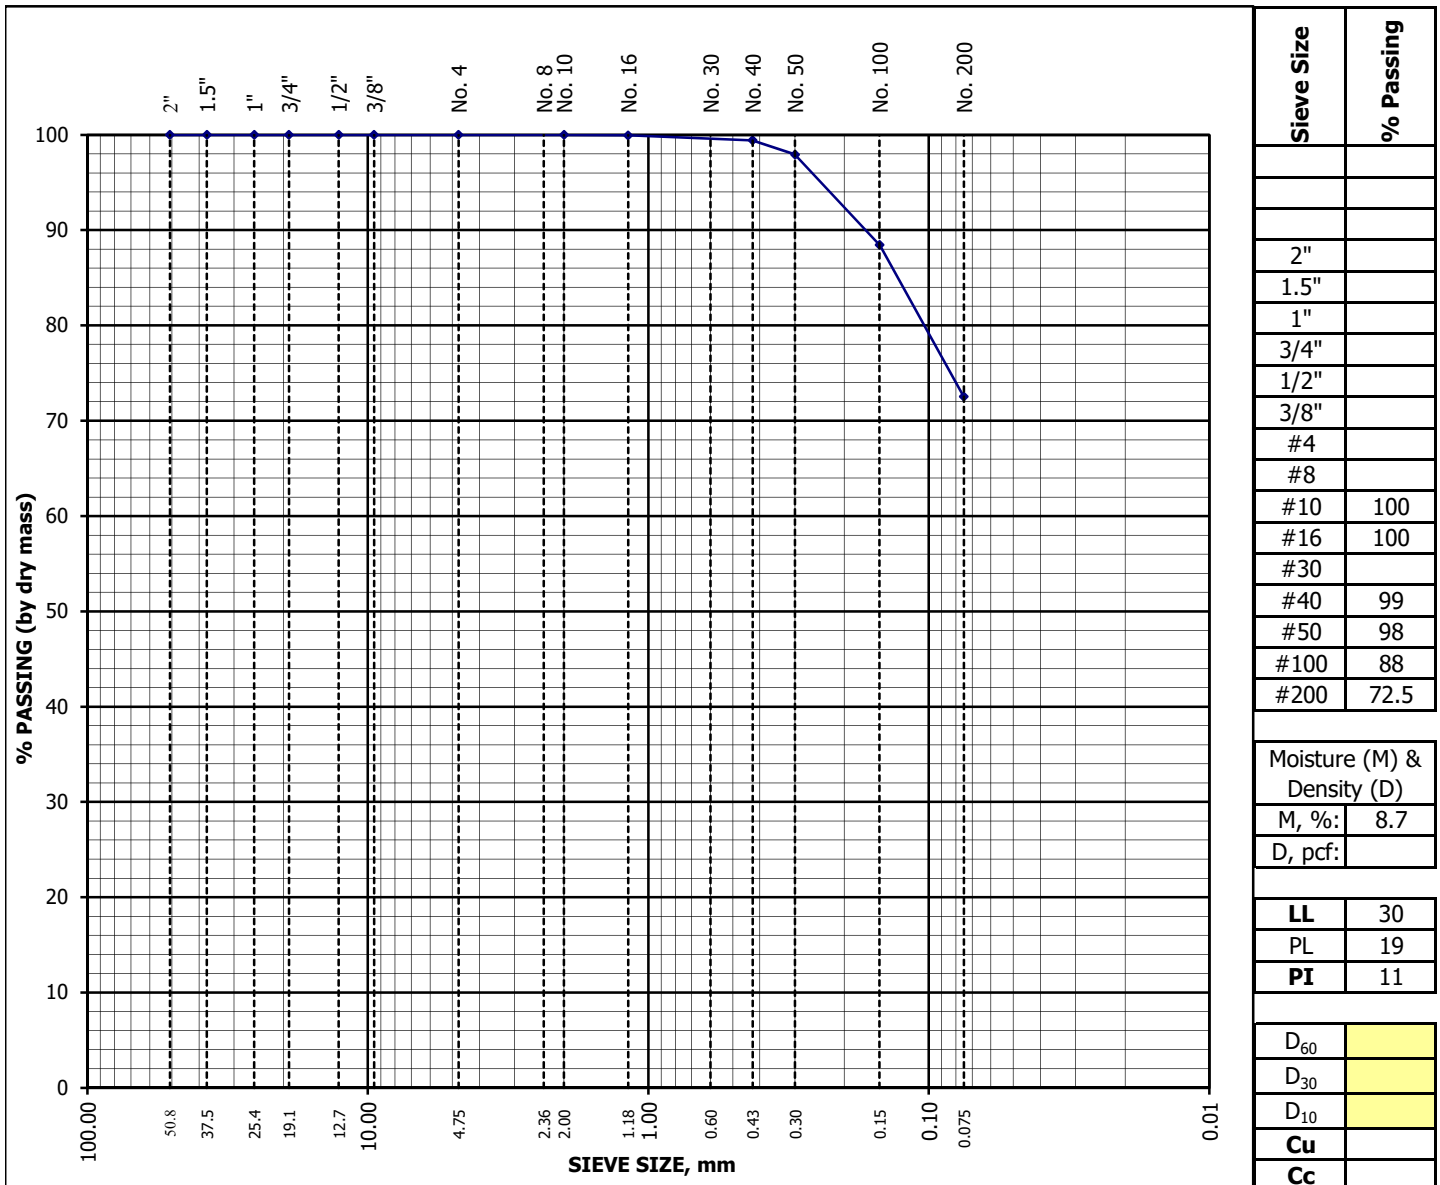
Project Number: 18.117, Applegate Group Date: 8-Sep-18  
Project Name: Cucharas Basin Collaborative Storage Technician: J. Holiman  
Lab ID Number: 1822888 Reviewer: J. Crystal  
Sample Location: SB-1 at 20'  
Visual Description: CLAY, with sand, red

**AASHTO M 145 Classification:** A-6 **Group Index:** 6  
**Unified Soil Classification System**  
**(ASTM D 2487):** (CL) **Lean clay with sand**

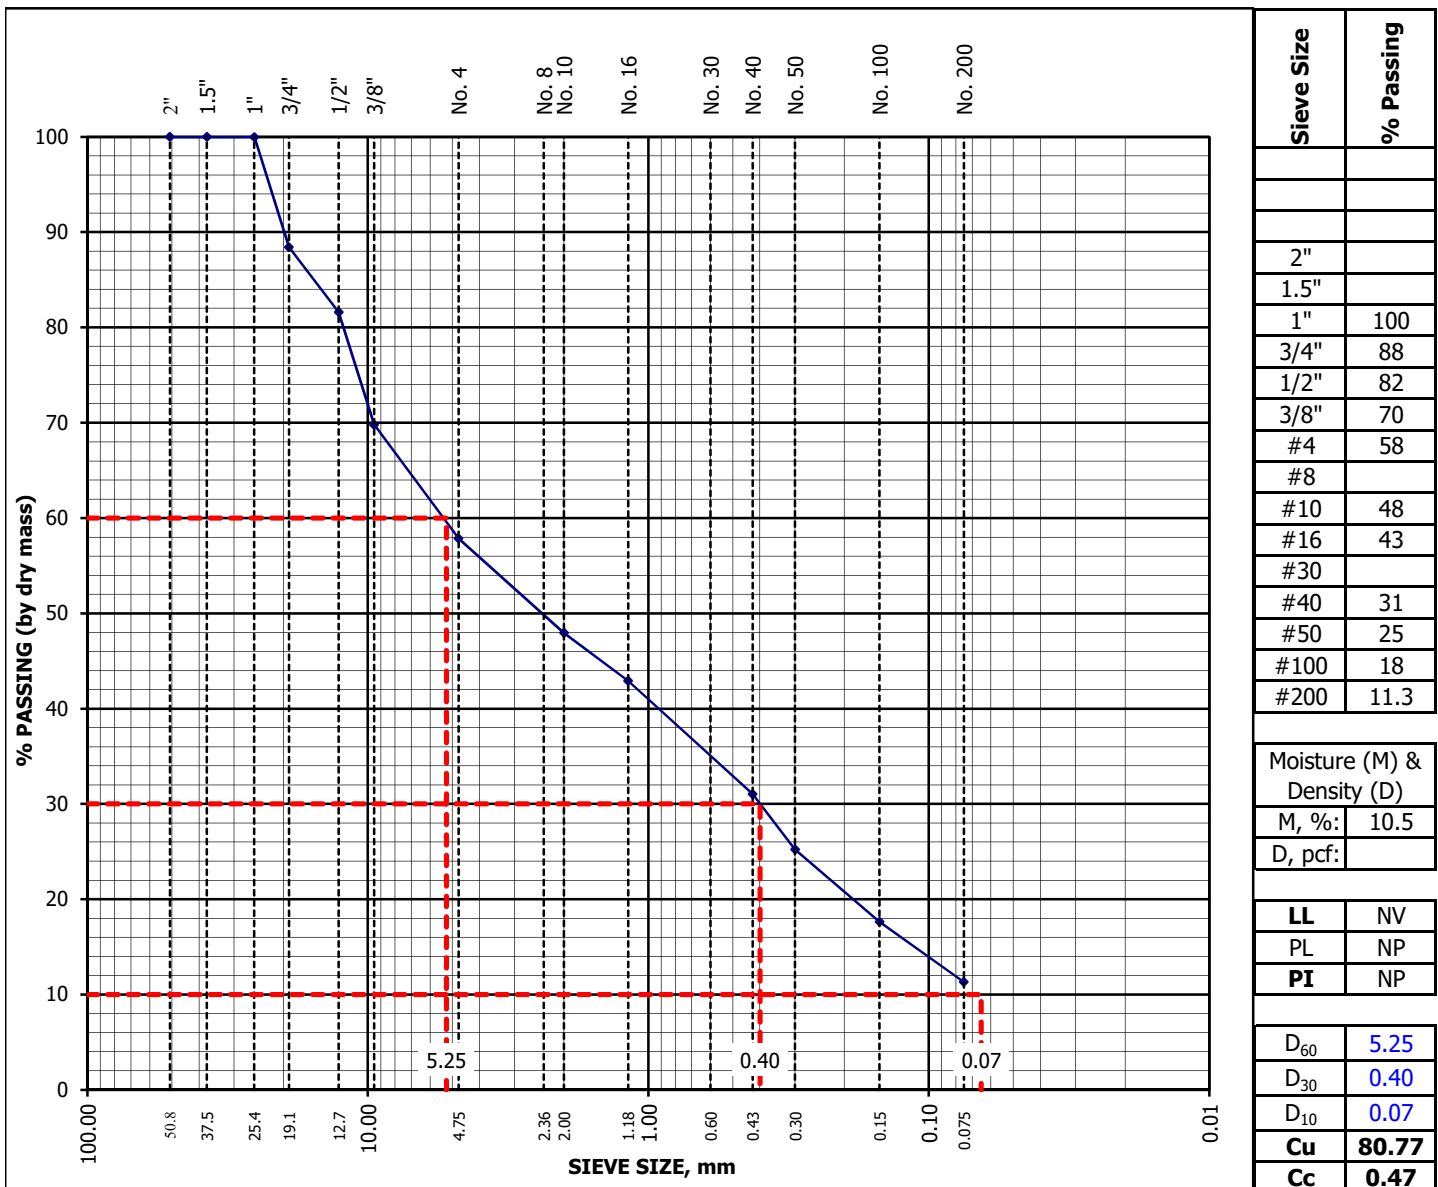
Project Number: 18.117, Applegate Group Date: 5-Sep-18  
Project Name: Cucharas Basin Collaborative Storage Technician: J. Weinerth  
Lab ID Number: 1822889 Reviewer: J. Crystal  
Sample Location: SB-2 at 10'  
Visual Description: SAND, with silt and gravel, red brown

**AASHTO M 145 Classification:** A-1-b **Group Index:** 0  
**Unified Soil Classification System**  
**(ASTM D 2487):** (SP-SM) Poorly graded sand with silt and gravel

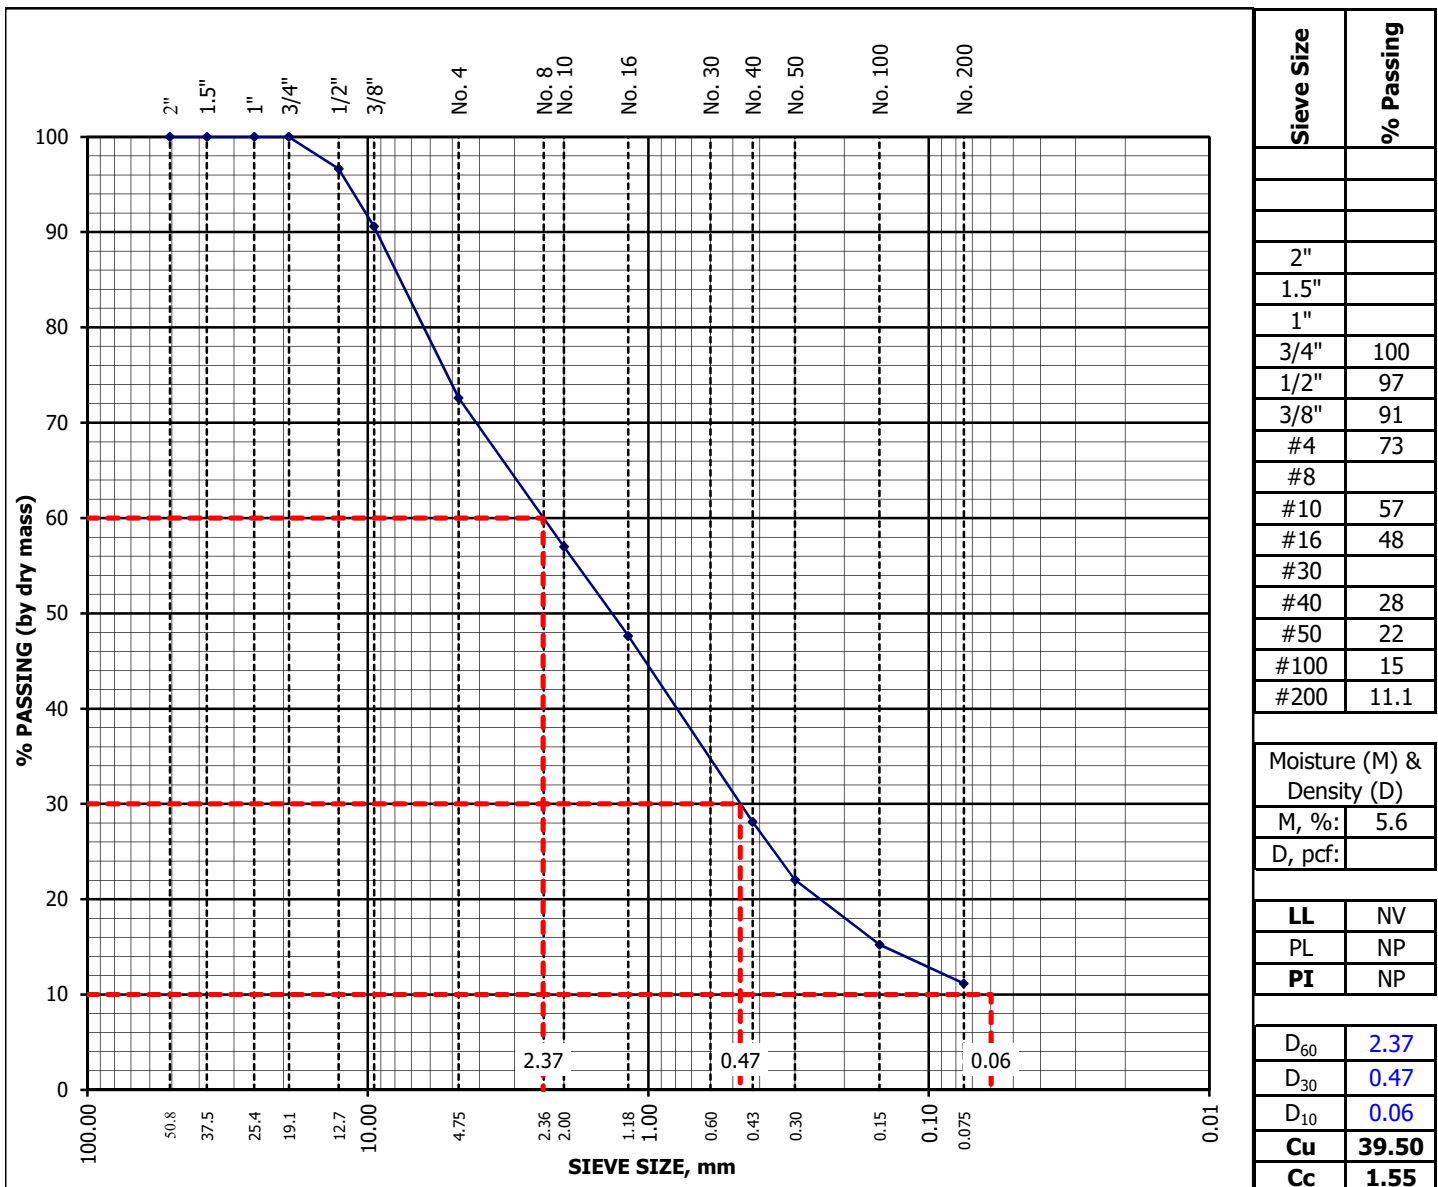
Project Number:	18.117, Applegate Group	Date:	12-Sep-18
Project Name:	Cucharas Basin Collaborative Storage	Technician:	G. Hoyos
Lab ID Number:	1822890	Reviewer:	J. Crystal
Sample Location:	SB-3 at 5'		
Visual Description:	SAND, with silt and gravel, red

**AASHTO M 145 Classification:** A-1-b **Group Index:** 0  
**Unified Soil Classification System**  
**(ASTM D 2487):** (SW-SM) Well graded sand with silt and gravel

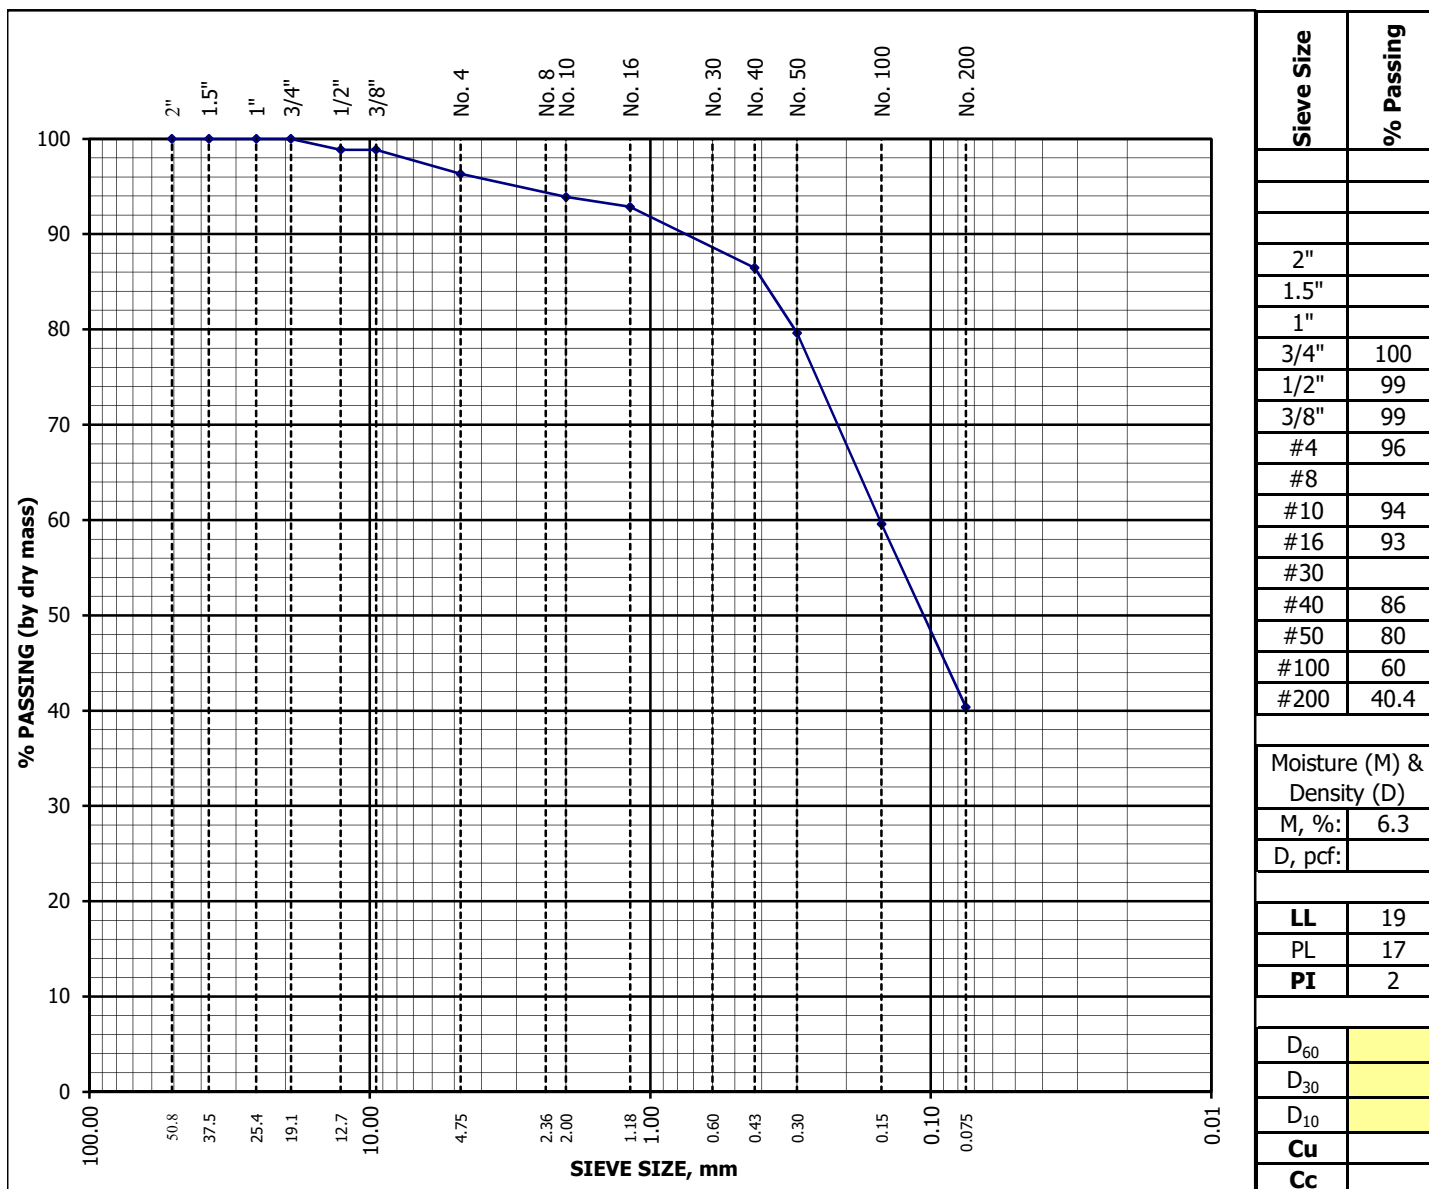
Project Number: 18.117, Applegate Group Date: 9-Sep-19  
Project Name: Cucharas Basin Collaborative Storage Technician: C. Zoetewey  
Lab ID Number: 1921468 Reviewer: J. Crystal  
Sample Location: SB-5 at 1'  
Visual Description: SAND, silty, reddish brown

**AASHTO M 145 Classification:** A-4 **Group Index:** (0)  
**Unified Soil Classification System**  
**(ASTM D 2487):** (SM) **Silty sand**

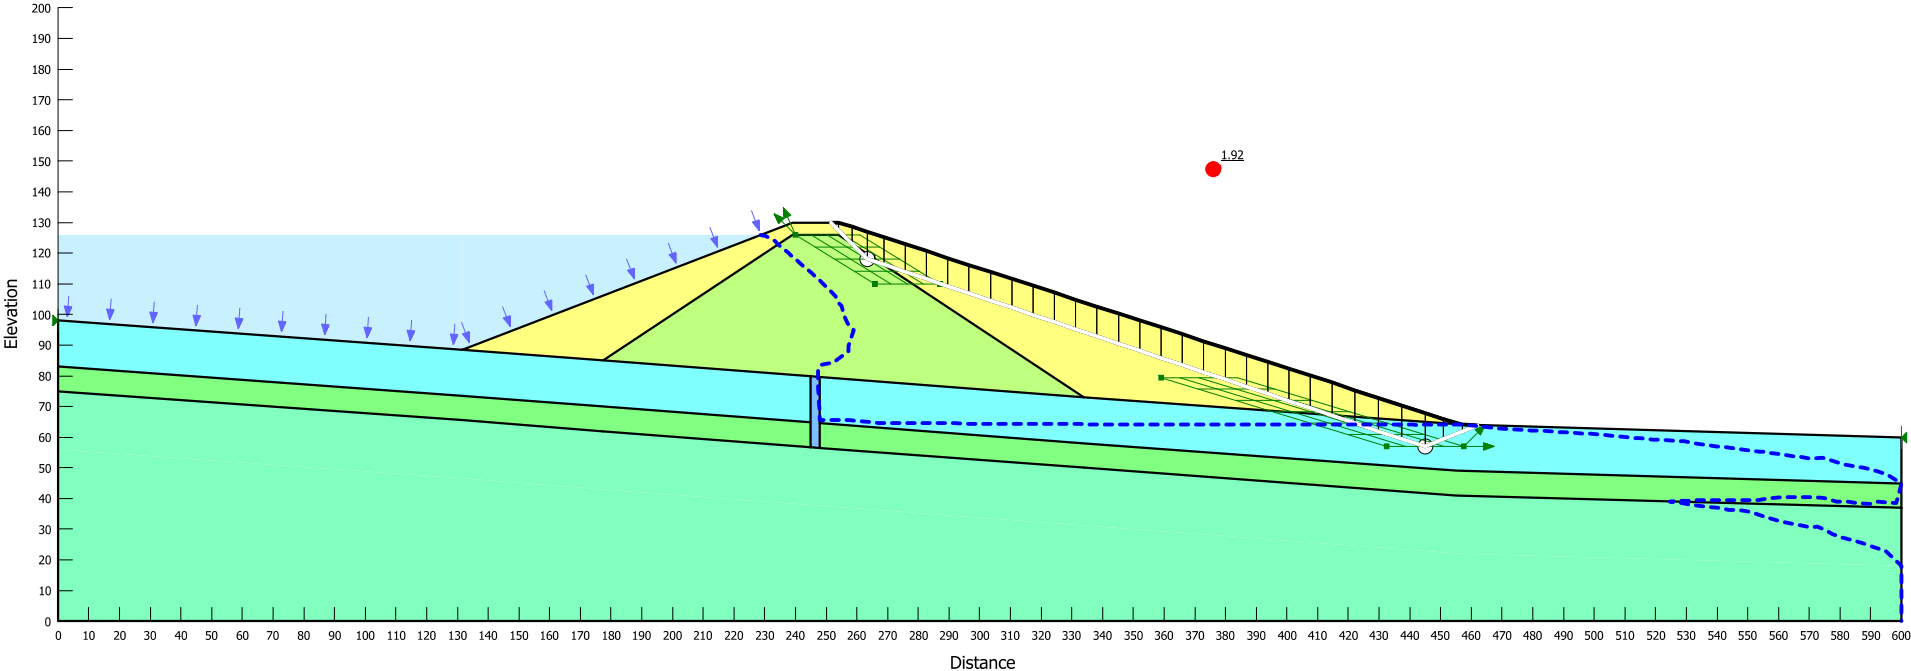
Color	Name	Model	Unit Weight (pcf)	Cohesion' (psf)	Phi' (°)	Phi-B (°)
<span style="color: green;">■</span>	Claystone	Mohr-Coulomb	135	3,000	0	0
<span style="color: yellow;">■</span>	Core	Mohr-Coulomb	125	25	30	0
<span style="color: blue;">■</span>	Cutoff	Mohr-Coulomb	125	10	11	0
<span style="color: cyan;">■</span>	Overburden	Mohr-Coulomb	130	10	30	0
<span style="color: lightgreen;">■</span>	Sandstone	Mohr-Coulomb	140	3,000	0	0
<span style="color: yellow;">■</span>	Shell	Mohr-Coulomb	132	25	30	0

Steady State Seepage Stability, Block Failure

The diagram illustrates a cross-section of a dam project. The vertical axis represents Elevation from 0 to 200 feet, and the horizontal axis represents Distance from 0 to 600 feet. The dam profile includes several distinct geological layers: Claystone at the base, followed by a Core, a Cutoff wall, Overburden, Sandstone, and a Shell layer on top. A dashed blue line shows a proposed circular failure surface passing through the core and cutoff areas. Blue arrows indicate water seepage from the left side towards the right. A red dot on the right side of the diagram marks a specific point with a value of 1.90.

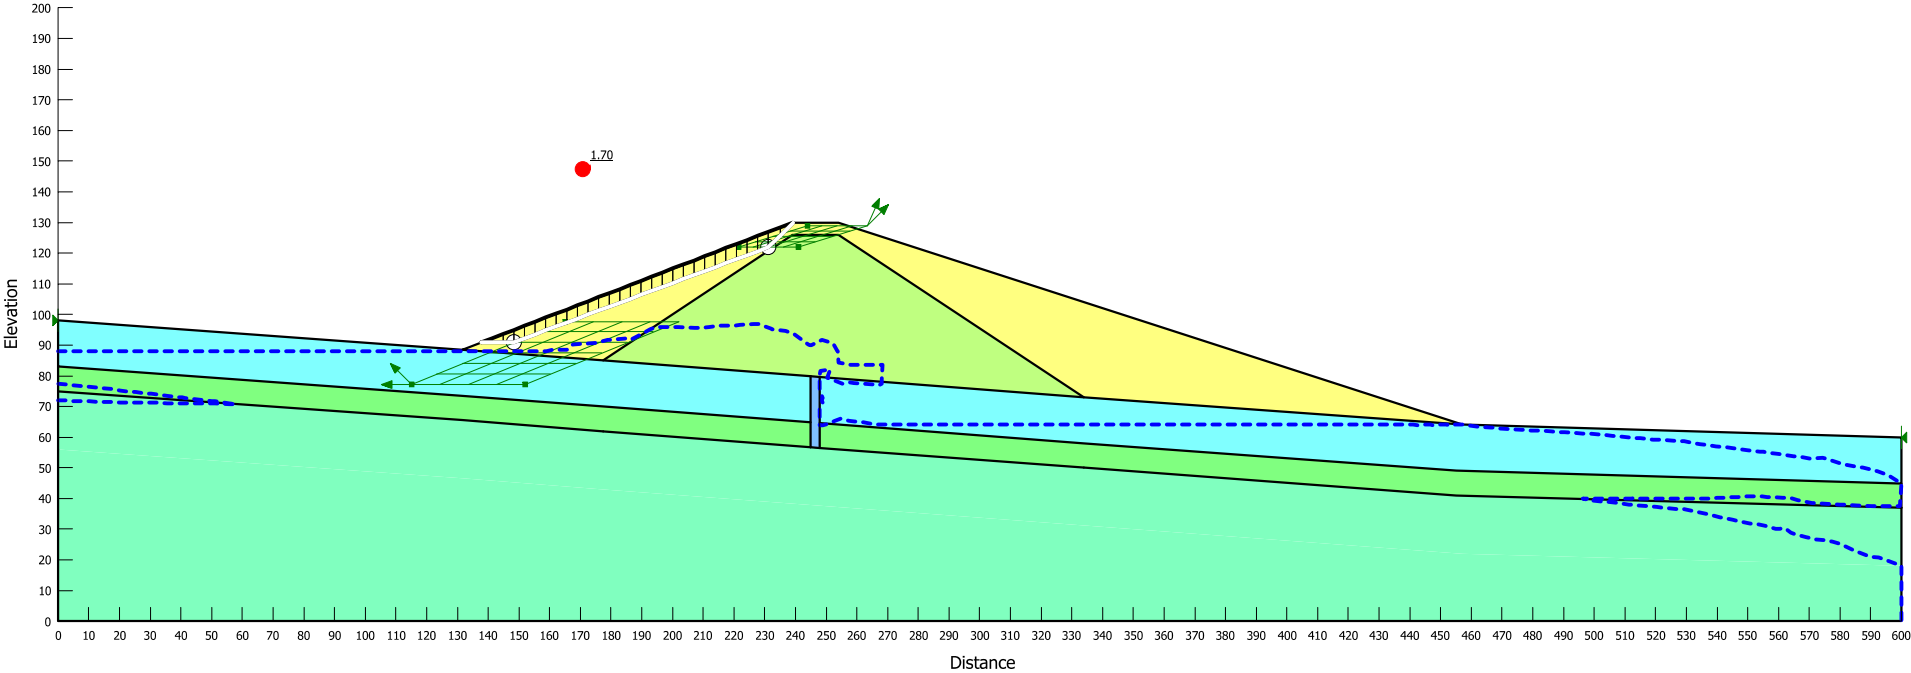
Color	Name	Model	Unit Weight (pcf)	Cohesion' (psf)	Phi' (°)	Phi-B (°)
	Claystone	Mohr-Coulomb	135	3,000	0	0
	Core	Mohr-Coulomb	125	25	30	0
	Cutoff	Mohr-Coulomb	125	10	11	0
	Overburden	Mohr-Coulomb	130	10	30	0
	Sandstone	Mohr-Coulomb	140	3,000	0	0
	Shell	Mohr-Coulomb	132	25	30	0

**Transient Seepage Stability, Block Failure, Eleventh Day**

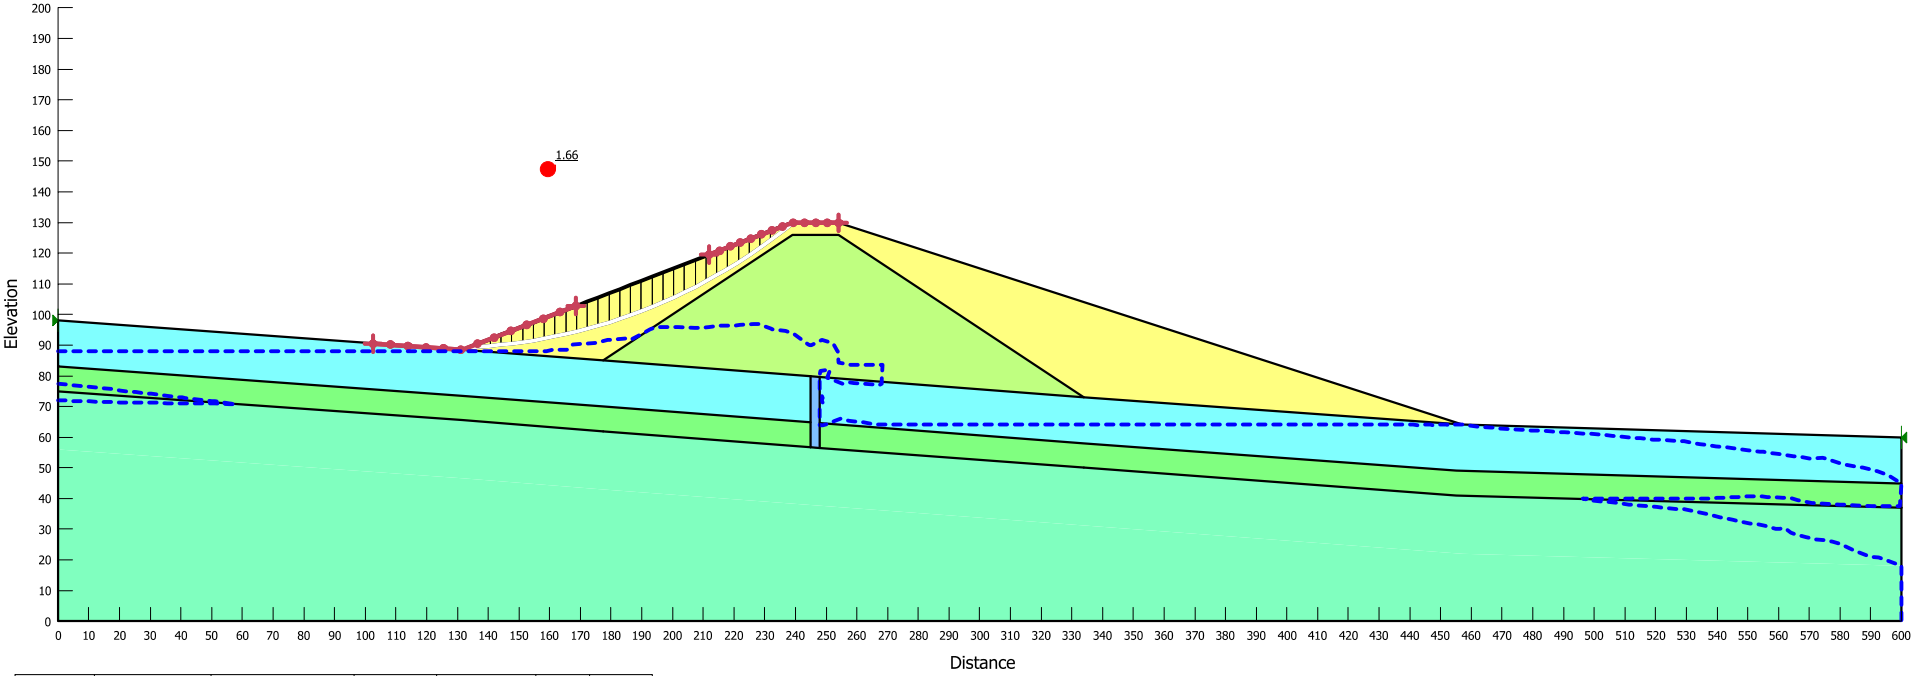
Color	Name	Model	Unit Weight (pcf)	Cohesion' (psf)	Phi' (°)	Phi-B (°)
<span style="color: green;">■</span>	Claystone	Mohr-Coulomb	135	3,000	0	0
<span style="color: yellow;">■</span>	Core	Mohr-Coulomb	125	25	30	0
<span style="color: blue;">■</span>	Cutoff	Mohr-Coulomb	125	10	11	0
<span style="color: cyan;">■</span>	Overburden	Mohr-Coulomb	130	10	30	0
<span style="color: green;">■</span>	Sandstone	Mohr-Coulomb	140	3,000	0	0
<span style="color: yellow;">■</span>	Shell	Mohr-Coulomb	132	25	30	0

**Transient Seepage Stability, Circular Failure, Twentieth Day**

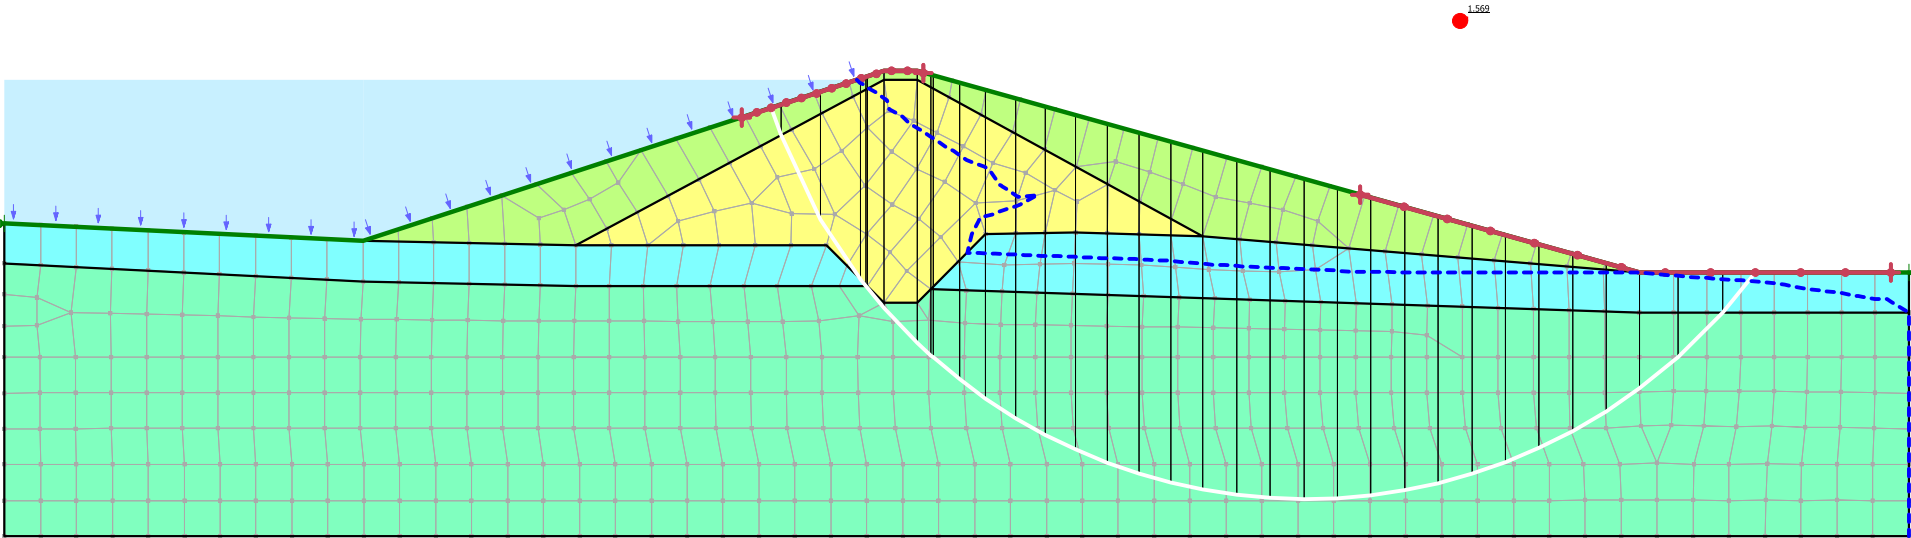
Color	Name	Model	Unit Weight (pcf)	Cohesion' (psf)	Phi' (°)	Phi-B (°)
<div></div>	Core	Mohr-Coulomb	125	25	25	0
<div></div>	Gravel	Mohr-Coulomb	132	10	35	0
<div></div>	Sandstone	Mohr-Coulomb	140	3,000	0	0
<div></div>	Shell	Mohr-Coulomb	125	25	25	0

**Steady State Seepage Stability, Circular Failure**

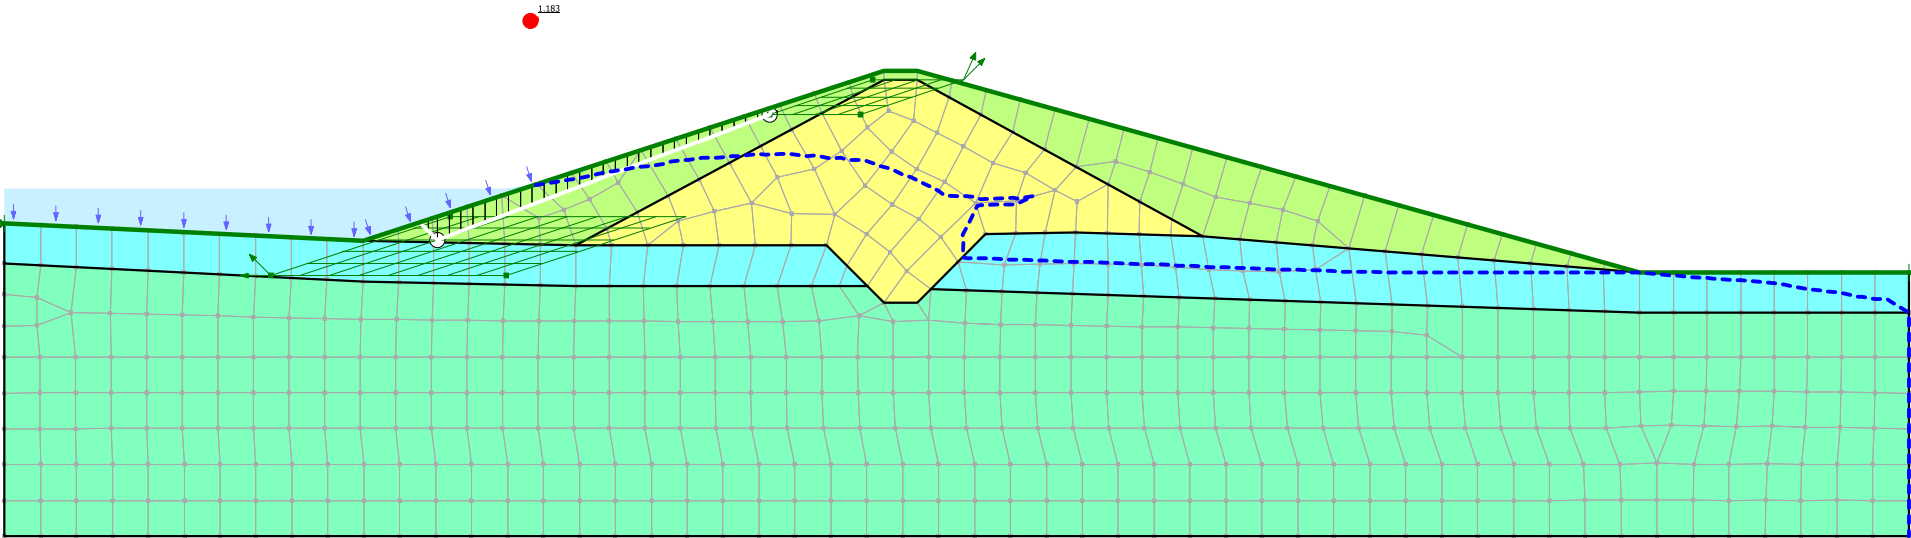
Color	Name	Model	Unit Weight (pcf)	Cohesion' (psf)	Phi' (°)	Phi-B (°)
<div></div>	Core	Mohr-Coulomb	125	25	25	0
<div></div>	Gravel	Mohr-Coulomb	132	10	35	0
<div></div>	Sandstone	Mohr-Coulomb	140	3,000	0	0
<div></div>	Shell	Mohr-Coulomb	125	25	25	0

**Transient Seepage Stability, Block Failure, 52nd Day**

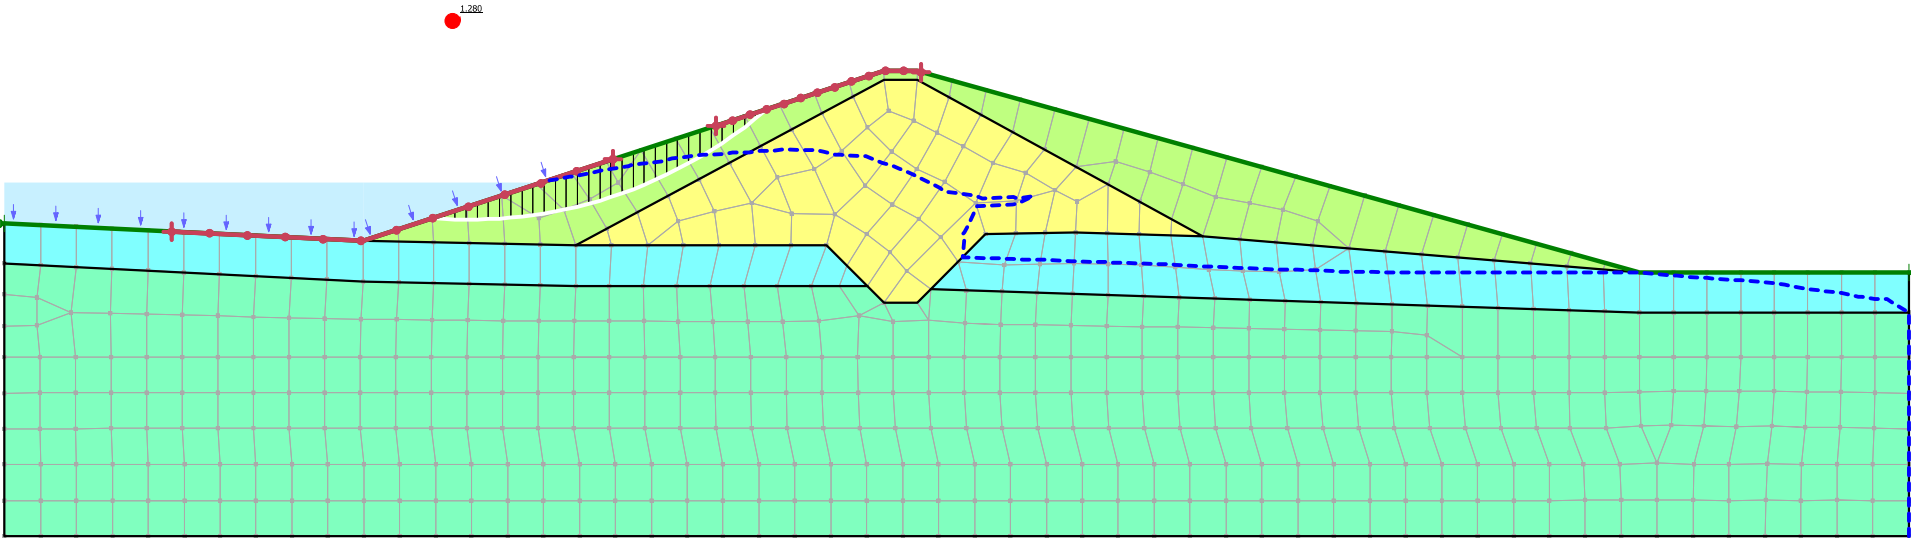
Color	Name	Model	Unit Weight (pcf)	Cohesion' (psf)	Phi' (°)	Phi-B (°)
<div></div>	Core	Mohr-Coulomb	125	25	25	0
<div></div>	Gravel	Mohr-Coulomb	132	10	35	0
<div></div>	Sandstone	Mohr-Coulomb	140	3,000	0	0
<div></div>	Shell	Mohr-Coulomb	125	25	25	0

**Transient Seepage Stability, Circular Failure, 48th Day**

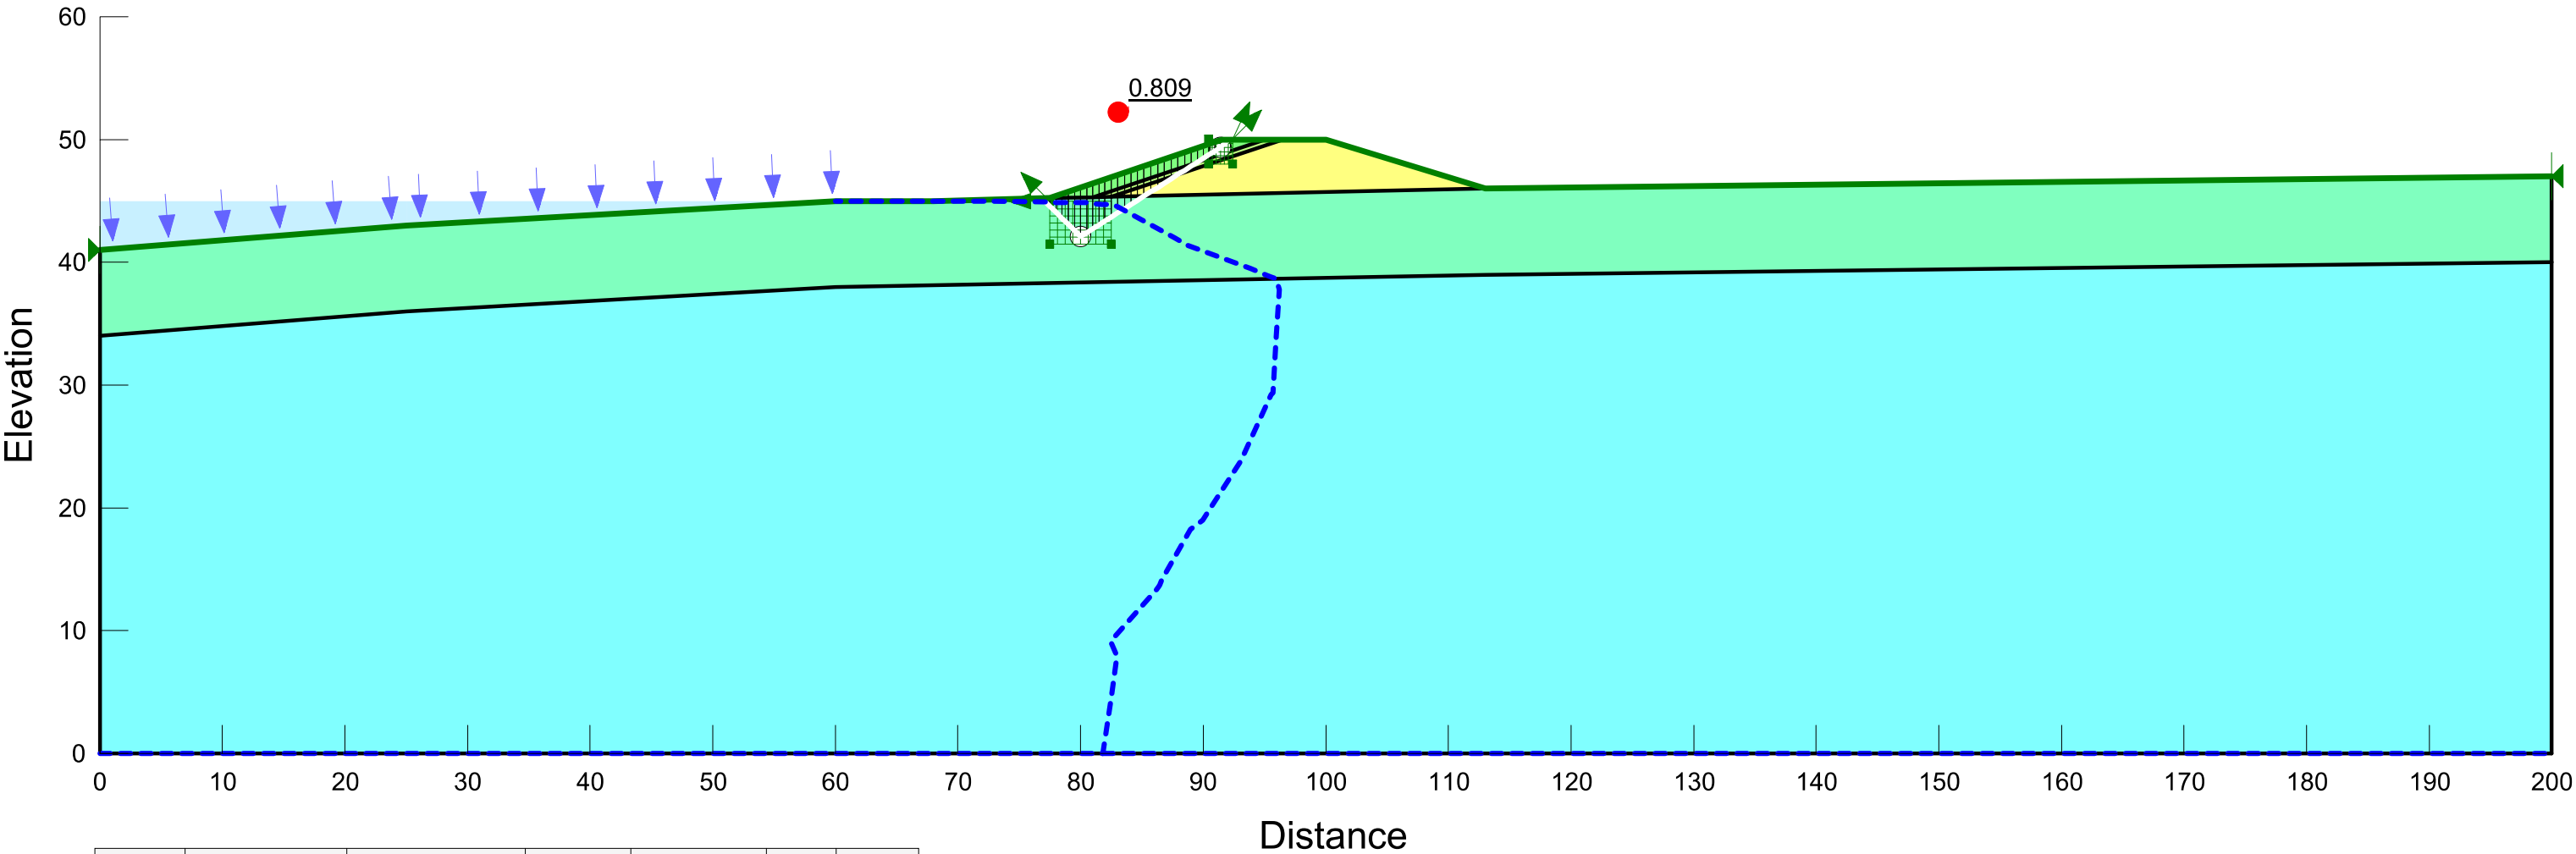
Transient Seepage, First Day Circular Failure Stability Analysis

Color	Name	Model	Unit Weight (pcf)	Cohesion' (psf)	Phi' (°)	Phi-B (°)
<div></div>	Clay Embankment	Mohr-Coulomb	125	25	25	0
<div></div>	Claystone	Mohr-Coulomb	135	3,000	0	0
<div></div>	Native Clay	Mohr-Coulomb	115	0	15	0
<div></div>	Rip Rap	Mohr-Coulomb	135	10	40	0
<div></div>	Sand Bedding	Mohr-Coulomb	125	10	30	0

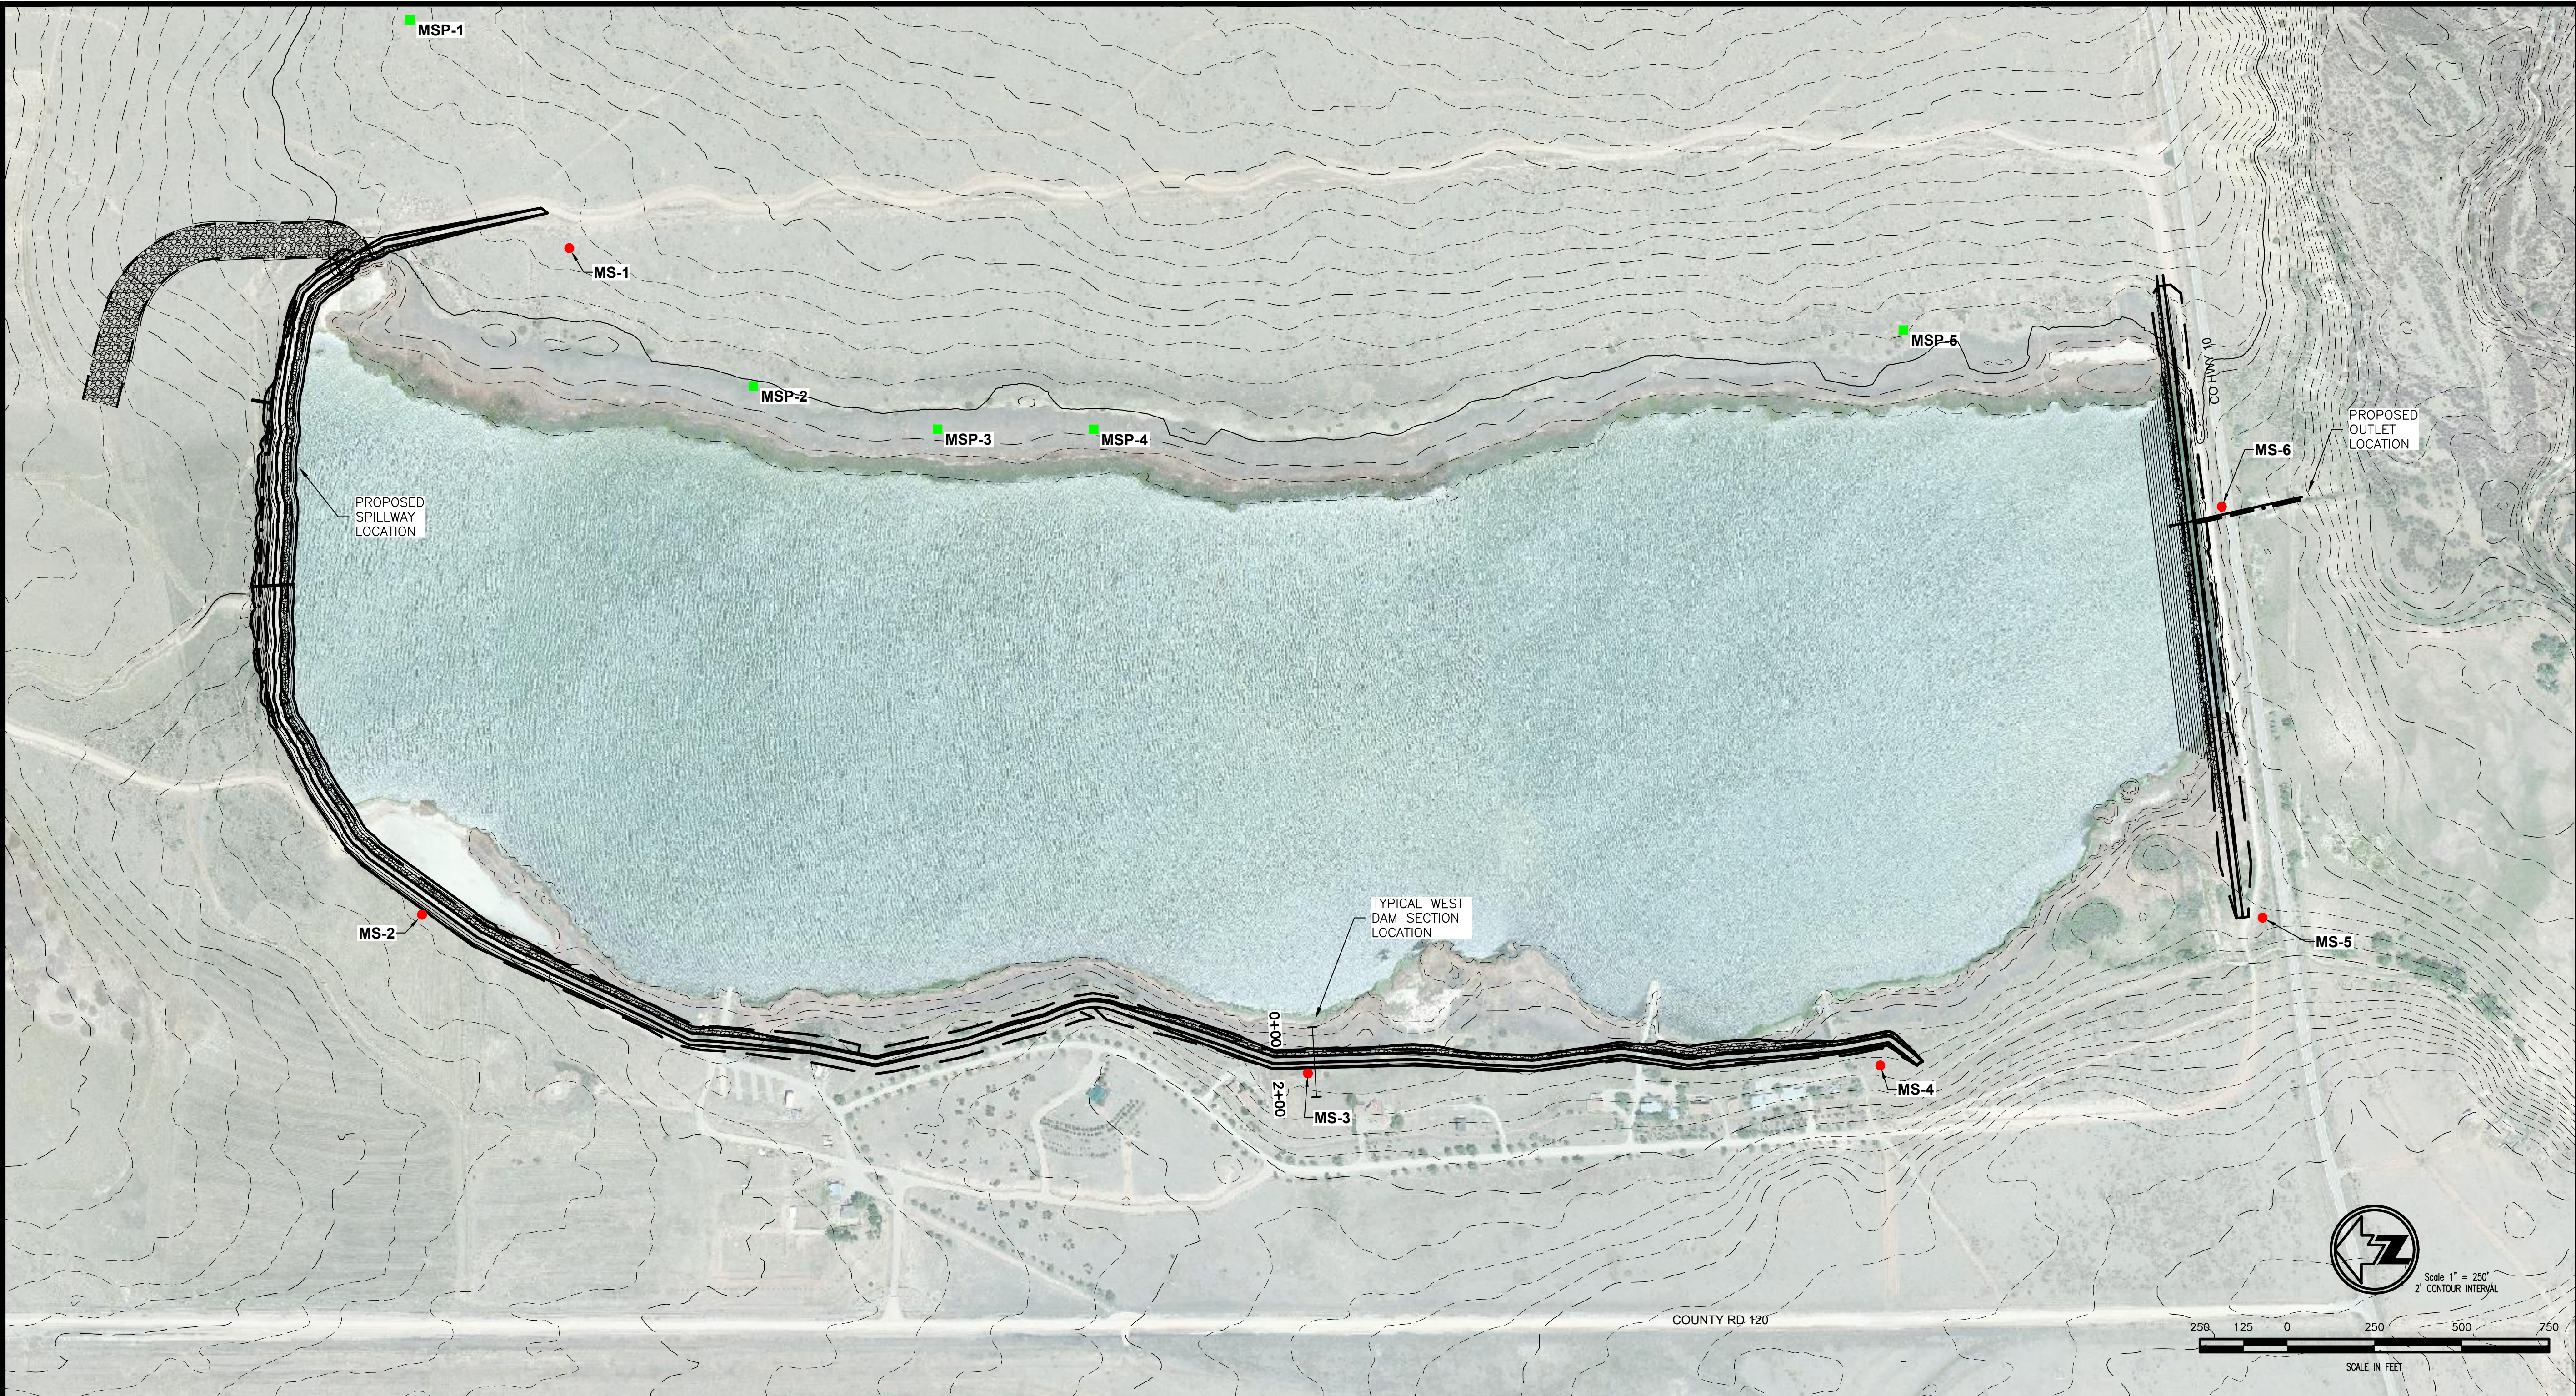
Stage (ft)	North Outlet Discharge (cfs)	South Outlet Discharge (cfs)	Combined Outlets Discharge (cfs)	Stage Storage Data		
				Stage (ft)	Area (ac)	Storage (ac-ft)
5921	9.82	63.01	72.83	5900	4	3
5920	9.28	58.57	67.85	5901	8	15
5919	8.71	53.23	61.94	5902	13	35
5918	8.10	47.30	55.40	5903	23	65
5917	7.44	40.50	47.94	5904	33	105
5916	6.72	32.31	39.03	5905	44	158
5915	5.92	14.29	20.21	5906	73	227
5914	4.79	4.55	9.34	5907	89	309
5913	2.09	0.00	2.09	5908	105	408
5912	0.00	0.00	0.00	5909	117	521
				5910	129	646
				5911	141	783
				5912	156	934
				5913	169	1099
				5914	180	1275
				5915	192	1463
				5916	204	1663
				5917	216	1875
				5918	228	2099
				5919*	231	2306
				5920*	233	2513
				5921*	236	2741
				5922*	239	2968
