# *South Baker Creek Dam*

## 30% Design Report

### Huerfano County Water Conservancy District

AG JOB No. 18-117

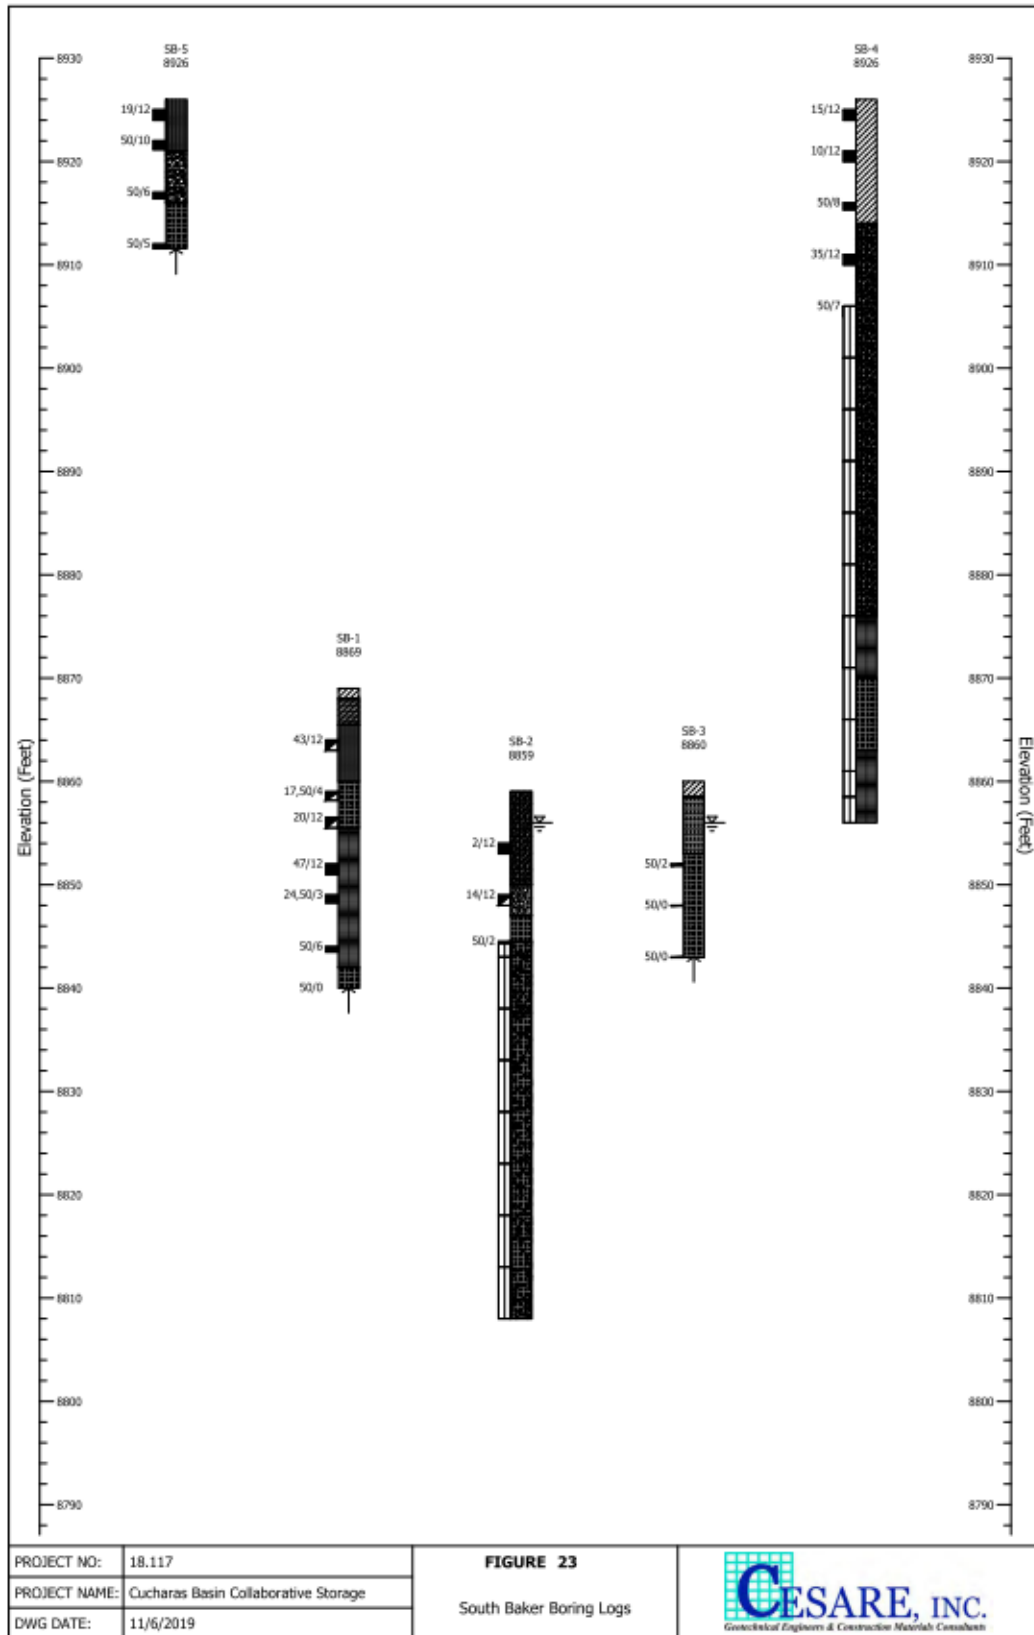
FIGURE 2. BORING LOGS

Soil and bedrock were sampled at designated intervals during drilling using a modified California sampler. Locations of sampling and results of penetration tests are shown on the boring log profiles included with Cesare's report. Figure 2 provides a lithologic summary for the five borings completed at the site. Note that the elevations shown are approximate and are based on the 5-meter DEM data used for design; field survey was not performed. Borings SB-1 through SB-3 indicated soils consisting of interbedded silty, clayey and relatively clean sands (with lesser amounts of sandy clay to depths between 7 and 22 feet below ground surface (bgs)), overlying predominantly sandstone bedrock with claystone observed between 13 and 27 feet bgs at SB-1. Depth to bedrock in borings SB-1 through SB-3 ranged from 7 to 12 feet bgs. At the north abutment, boring SB-5 encountered silty sand and clayey gravel to a depth of 10 feet overlying hard, weathered sandstone bedrock. At the south abutment, boring SB-4 encountered sandy clays with increasing gravel and cobble content was observed to a depth of 12 feet overlying a mix of sand, gravel and cobbles to approximately 50 feet. Interbedded claystone and sandstone was encountered between 50 and 70 feet bgs.

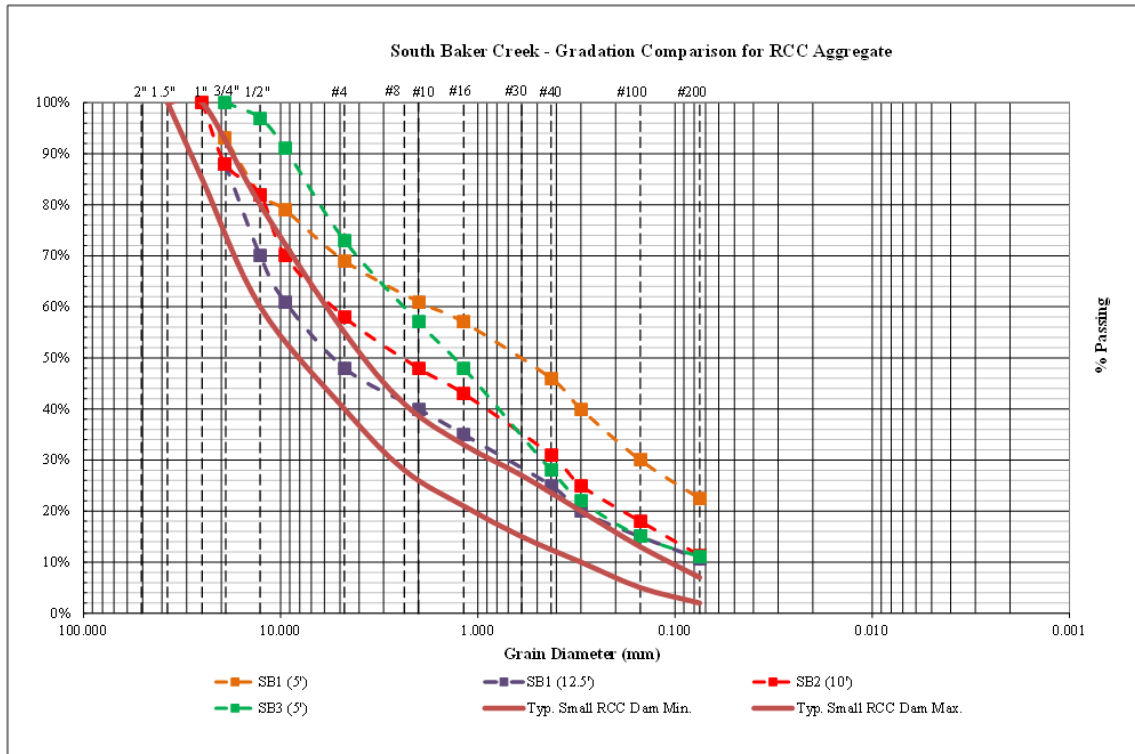
Figure 3. S. Baker Creek Gradation Comparison

One benefit of RCC dams is that it typically permits the use of lower quality aggregate as opposed to conventional concrete gravity dams. Applegate reviewed results of lab testing performed by Cesare on samples collected from borings and test pits to evaluate the suitability of native materials for RCC dam construction. Gradation plots for sampled materials were compared to a typical aggregate gradation band for small RCC dams<sup>1</sup>. Figure 3 compares gradation plots for soil samples collected from borings SB-1 through SB-3 to the typical gradation band referenced above. These samples were determined to be most compatible with the recommended gradation band. The comparison indicates that coarse aggregate would need to be imported (either purchased commercially or from another borrow site) to achieve a gradation within the typical band. It is possible that a 3:1 blend of native sands encountered in borings SB-1 through SB-3 and a coarse aggregate similar to AASHTO #467 stone would meet the recommended gradation band. Figure 4 shows the proposed 3:1 aggregate blend utilizing #467 stone. Estimated additional costs associated with importing aggregate for the RCC mix have been incorporated in the updated Opinion of Probable Cost. Note that additional geotechnical investigation should be completed to identify other potential borrow sources, confirm the suitability of native materials for use as RCC aggregate, and estimate required quantities.

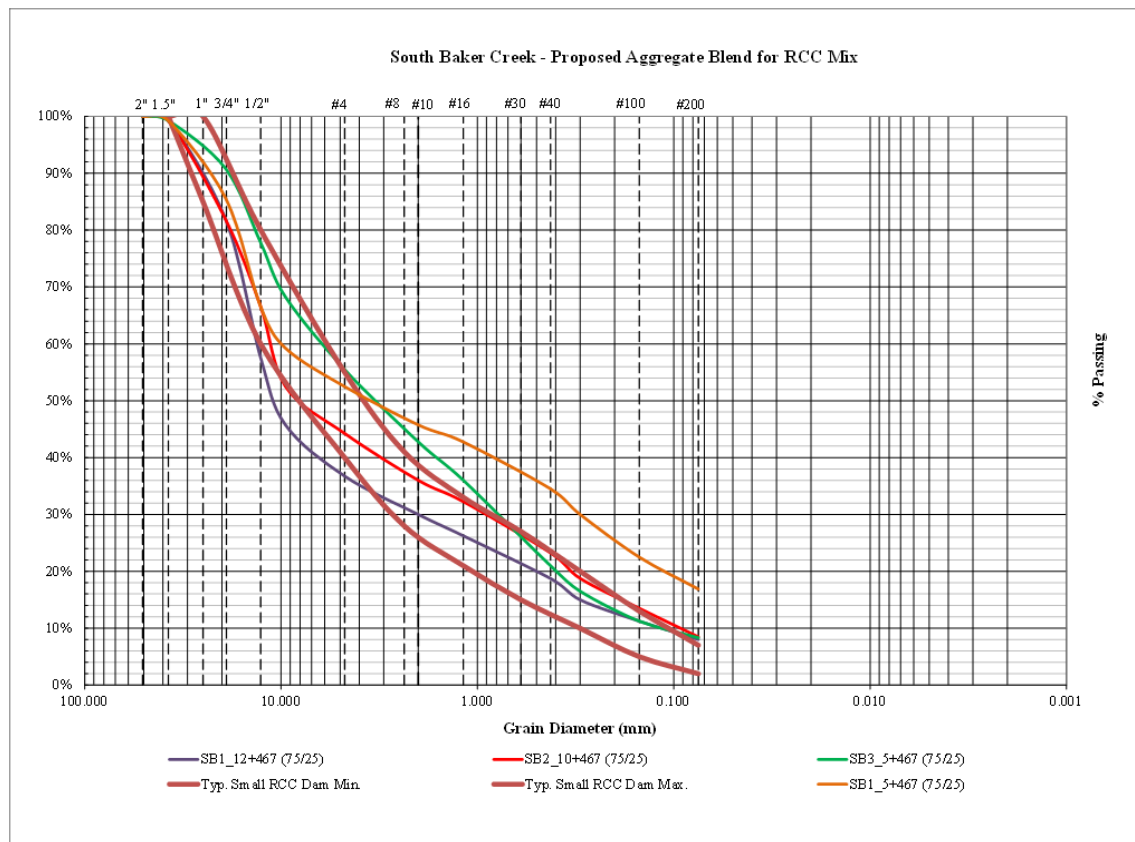
Figure 4. Proposed Aggregate Blend for RCC Mix

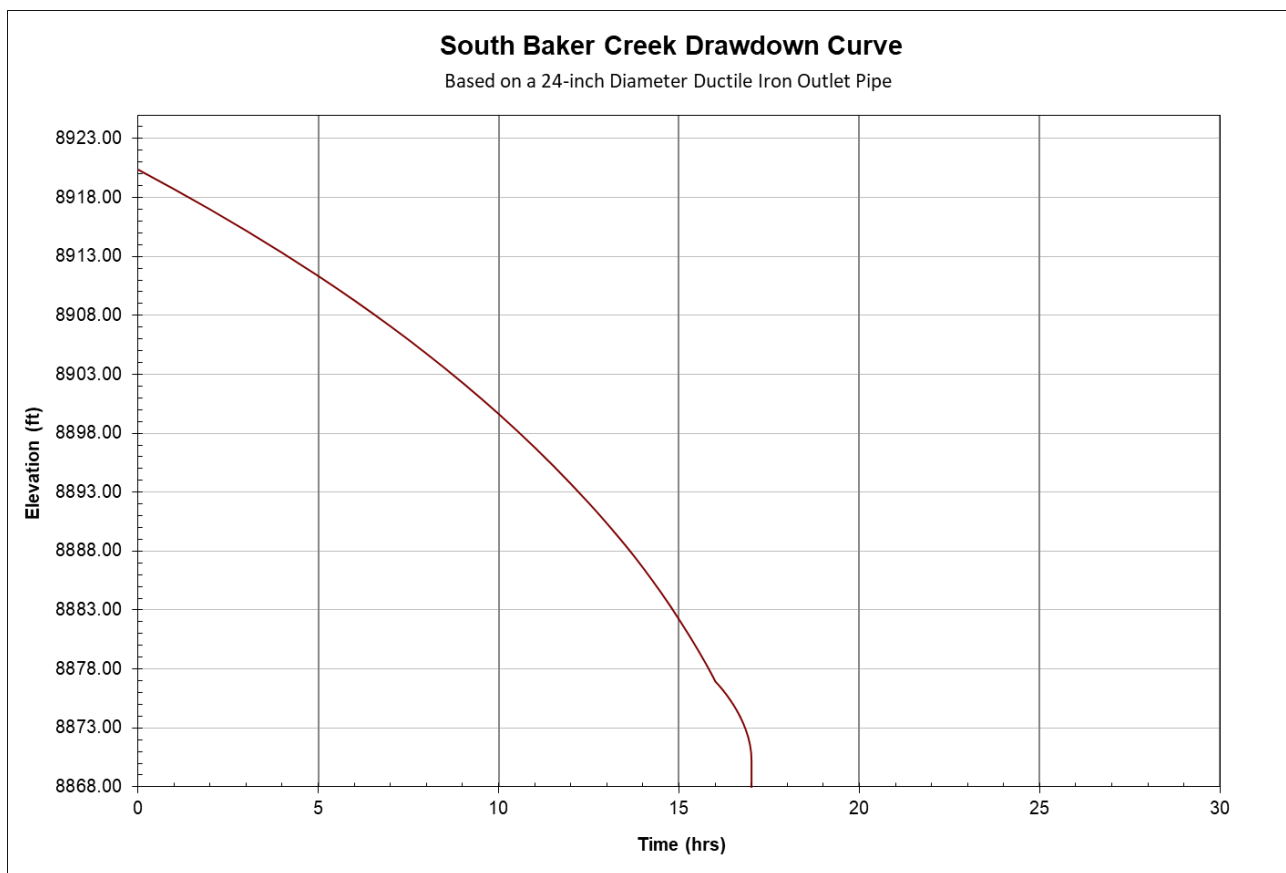
Figure 5. South Baker Creek Drawdown Curve

The outlet works will consist of a 24-inch ductile iron concrete encased outlet pipe. The outlet will regulate low-level releases through a 24-inch sluice gate which will be operated from the dam crest. The gate stem will be enclosed in a carrier pipe running along the upstream face of the dam and encased in concrete. Applegate completed stage-discharge calculations to confirm that the 24-inch outlet pipe is capable of drawing down the reservoir 5 feet in 5 days. Calculations indicate that the 24-inch pipe will be capable of drawing down the reservoir 5 feet in only 2 hours. Figure 5 shows the drawdown curve for the proposed outlet configuration. The maximum discharge is estimated to be approximately 90 cfs at full storage. Baffle blocks will be constructed in the stilling basin for energy dissipation during rapid drawdown of the reservoir. Construction details for concrete encasement of the outlet pipe and gate stem, as well as trash rack and stilling basin baffle blocks will be developed during later stages of design.

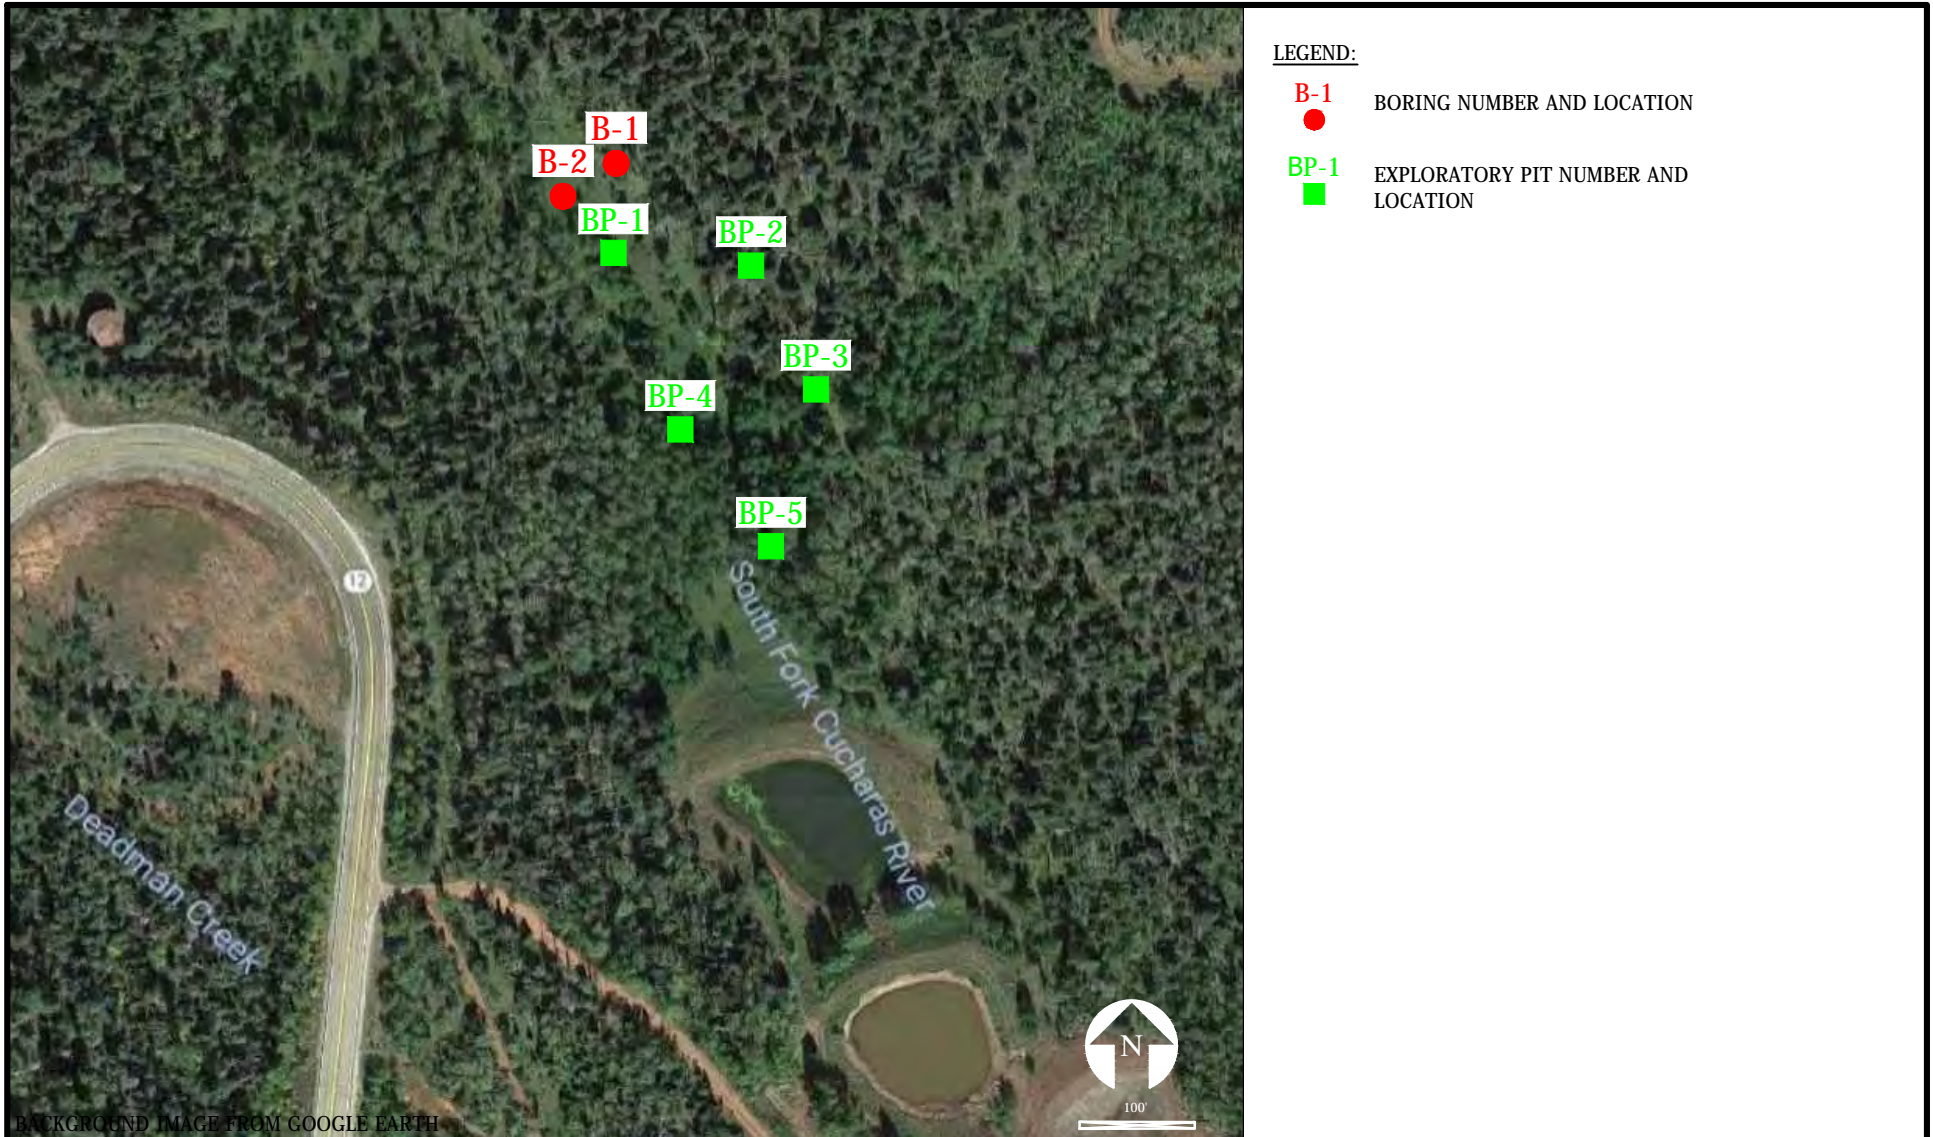
**FIGURE 11**  
Britton  
Locations of Borings and Exploratory Pits

Cesare explored subsurface conditions at each site by drilling borings at the locations indicated in Figures 11, 14, 17, 19, and 22. Table 1 presents the number of borings drilled at each site.

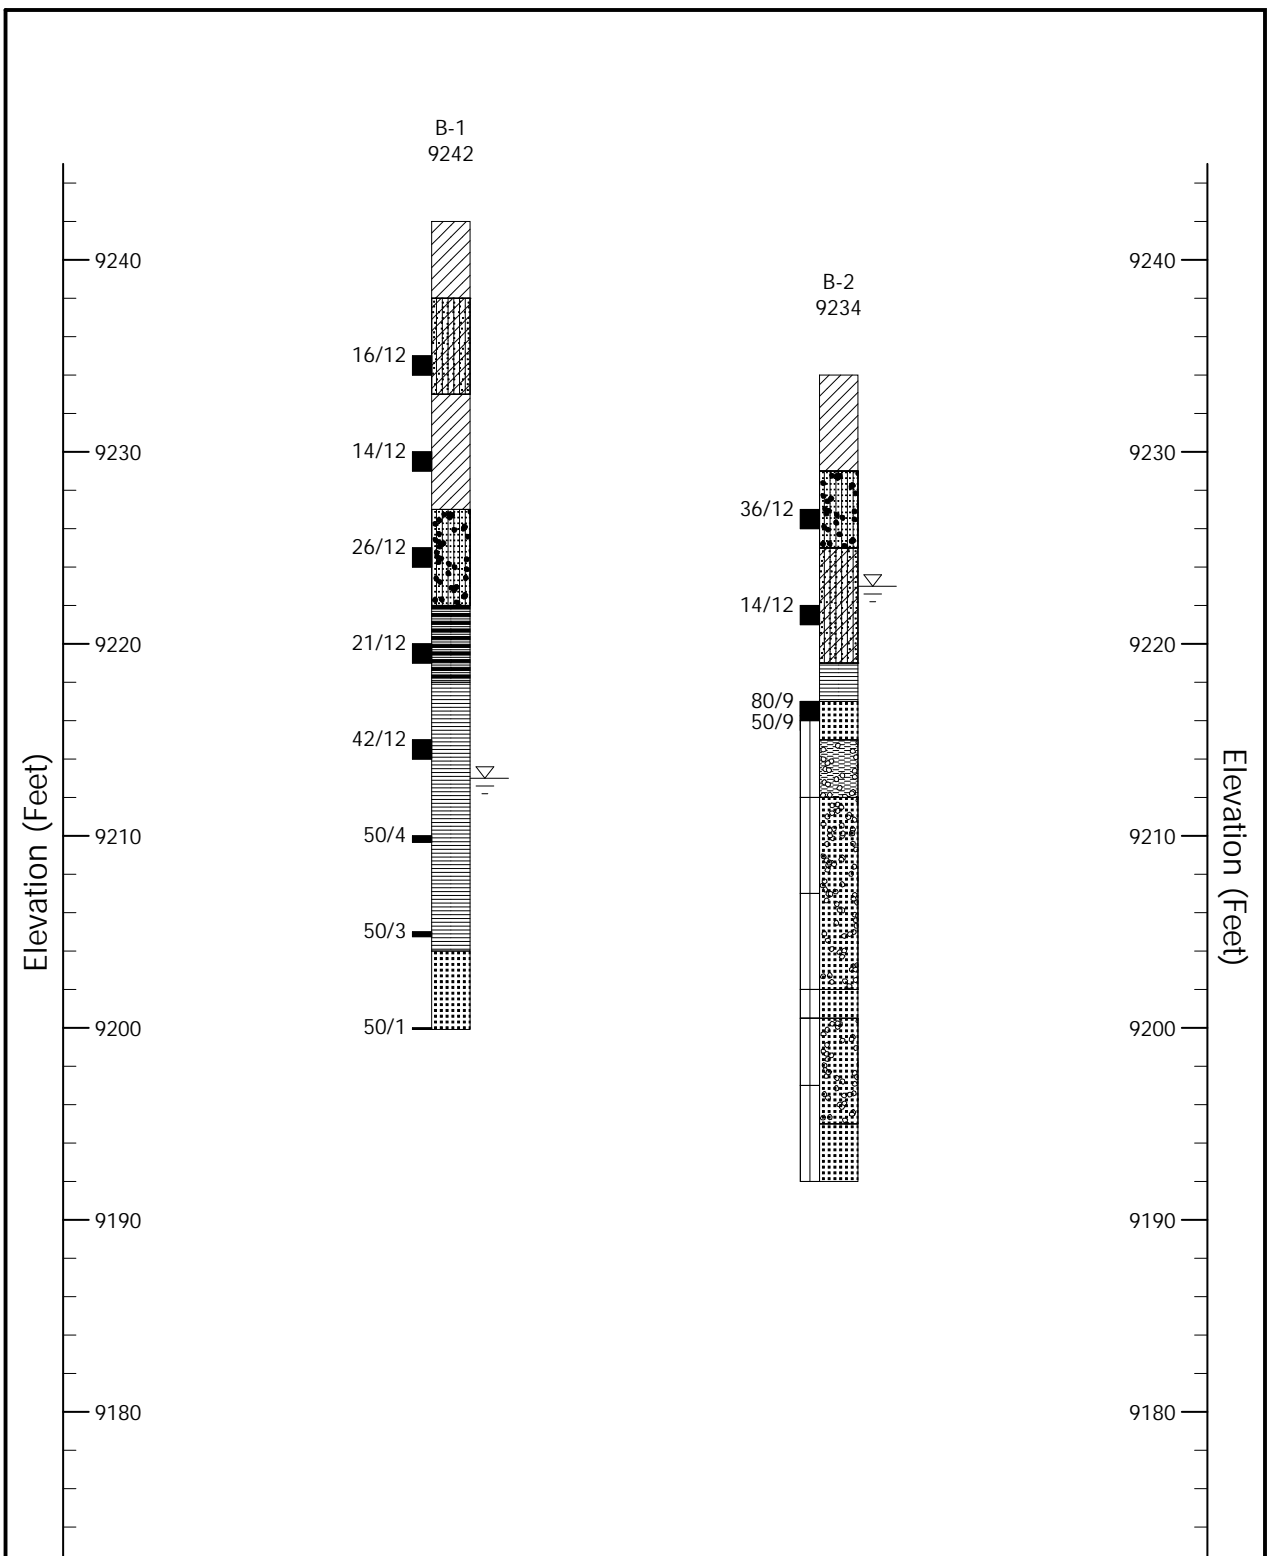
**FIGURE 12**  
Britton Boring Logs

Borings were advanced using a CME 550 track mounted drill rig equipped with 6 inch diameter, continuous flight, hollow stem auger and HQ and NX wireline coring equipment. ODEX casing driving was used at one location. Soil and bedrock were sampled to practical auger refusal at designated intervals using a modified California sampler which is driven into the soil by dropping a 140 pound hammer through a free fall of 30 inches. The modified California sampler is a 2.5 inch outside diameter by 2 inch inside diameter device lined with thin brass tubes to recover relatively undisturbed samples. A penetration test is the procedure to drive the modified California sampler into the soil and to record the number of blows required to do so. The number of blows required for the sampler to penetrate 12 inches gives an indication of the consistency or relative density of the soil encountered. Results of the penetration tests and locations of sampling are presented on the Boring Logs profiles, Figures 12, 15, 18, 20, and 23. Individual logs are presented in Appendix A.

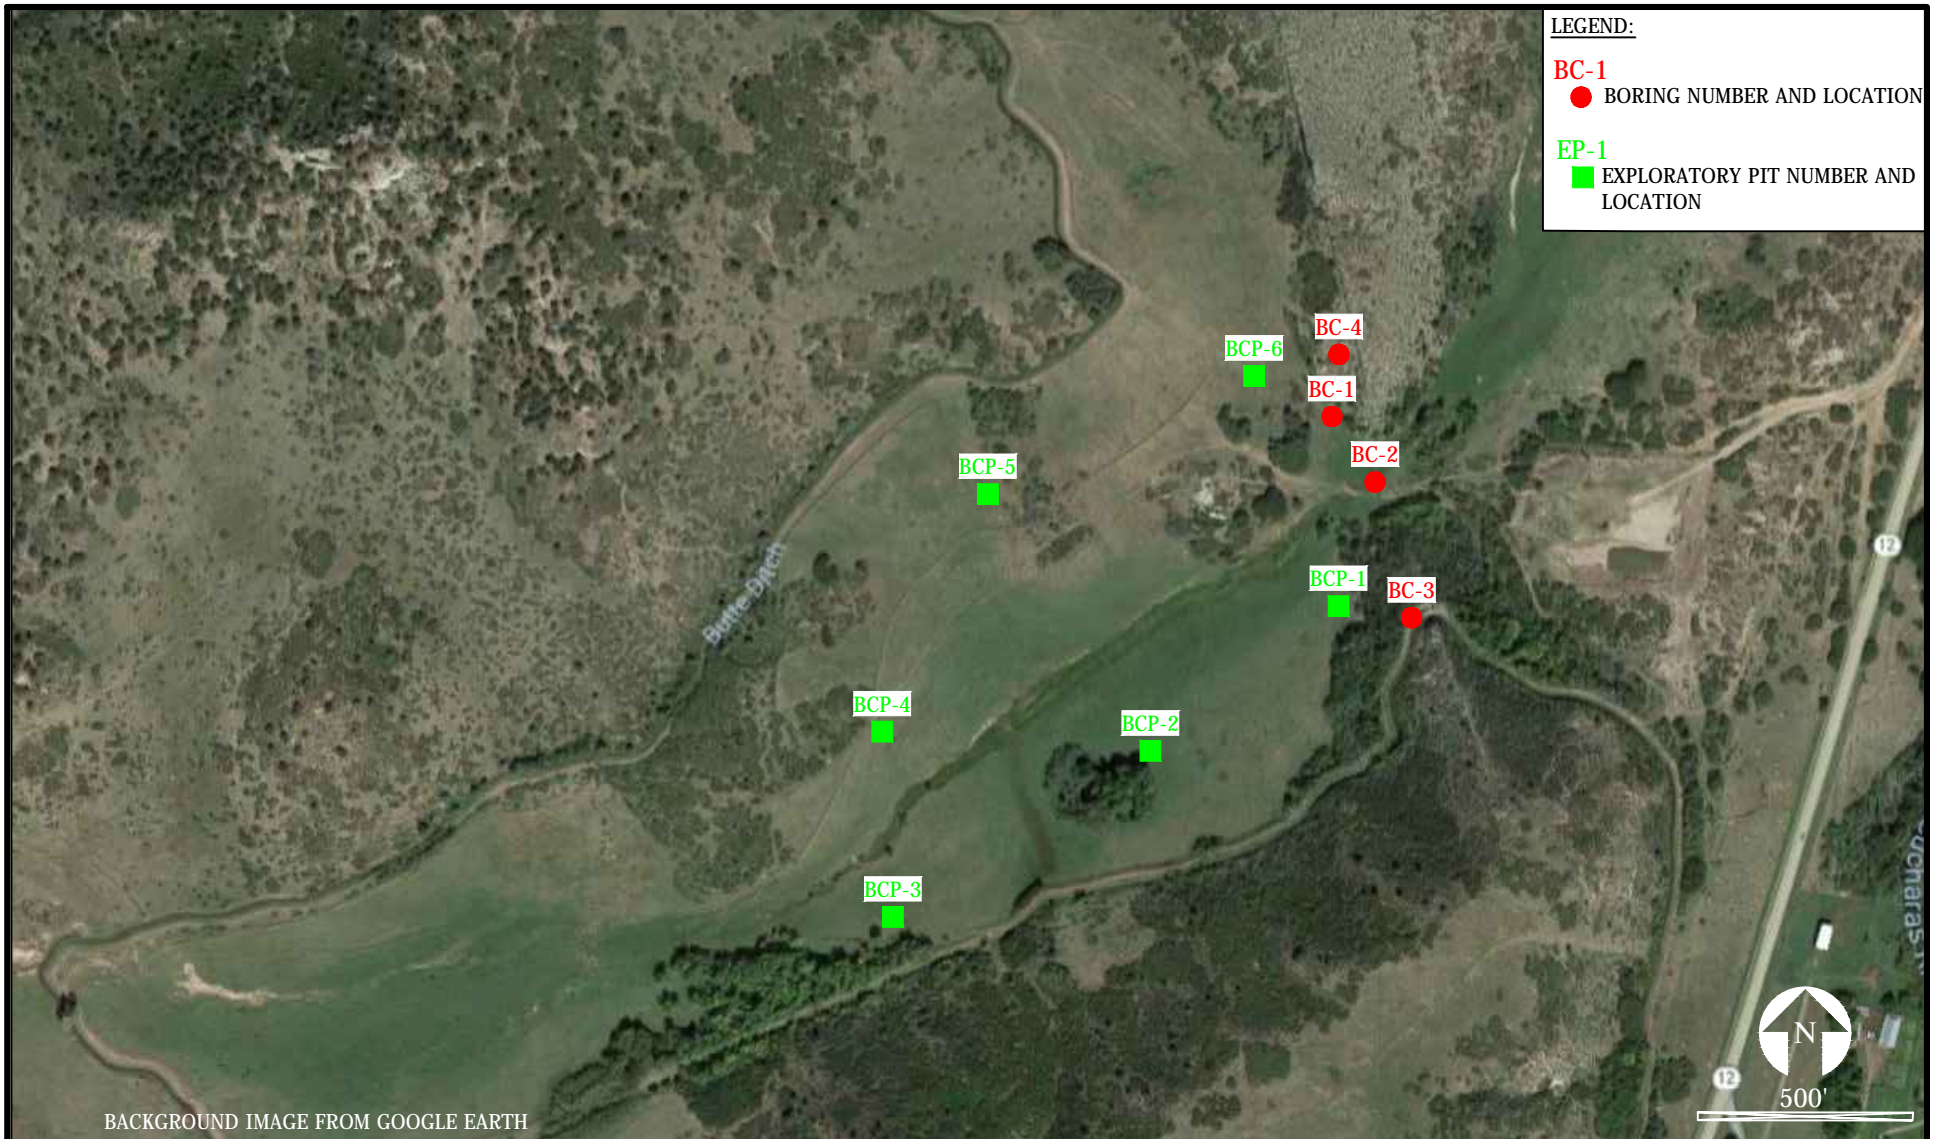
**FIGURE 14**  
Bruce Canyon Reservoir  
Locations of Borings and Exploratory Pits

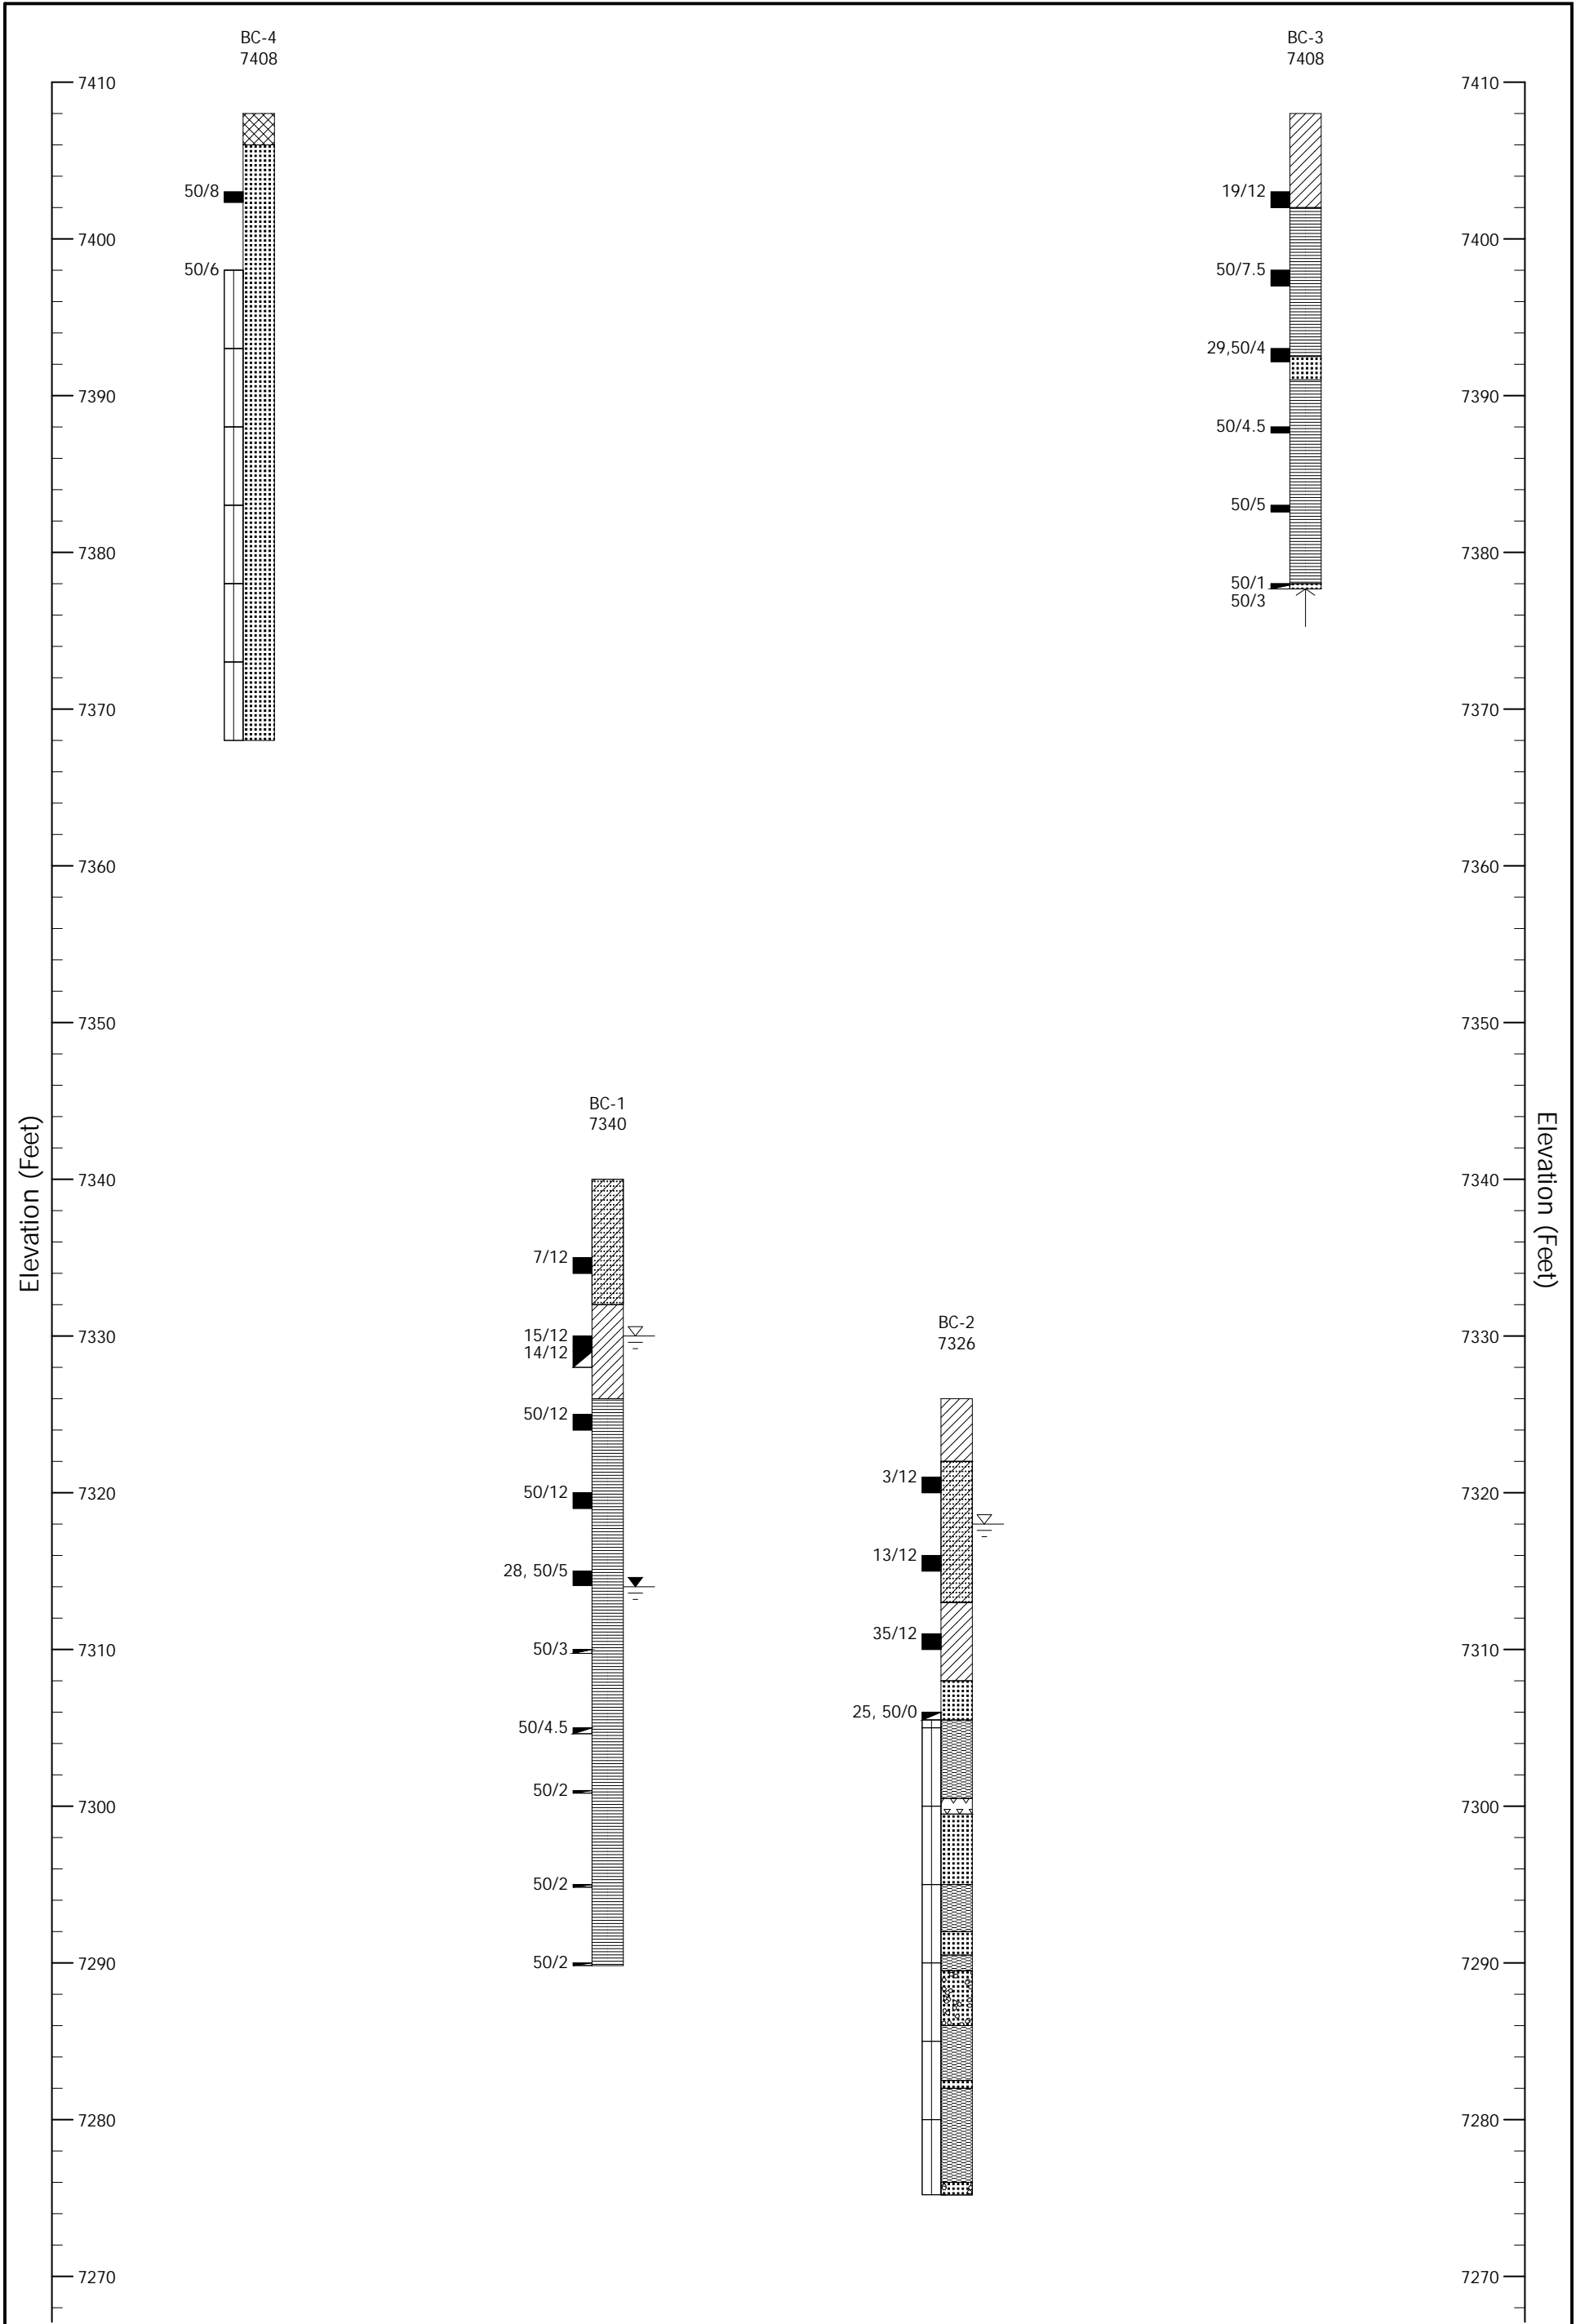
PROJECT NO:	18.117	<b>FIGURE 15</b>  Bruce Canyon Boring Logs

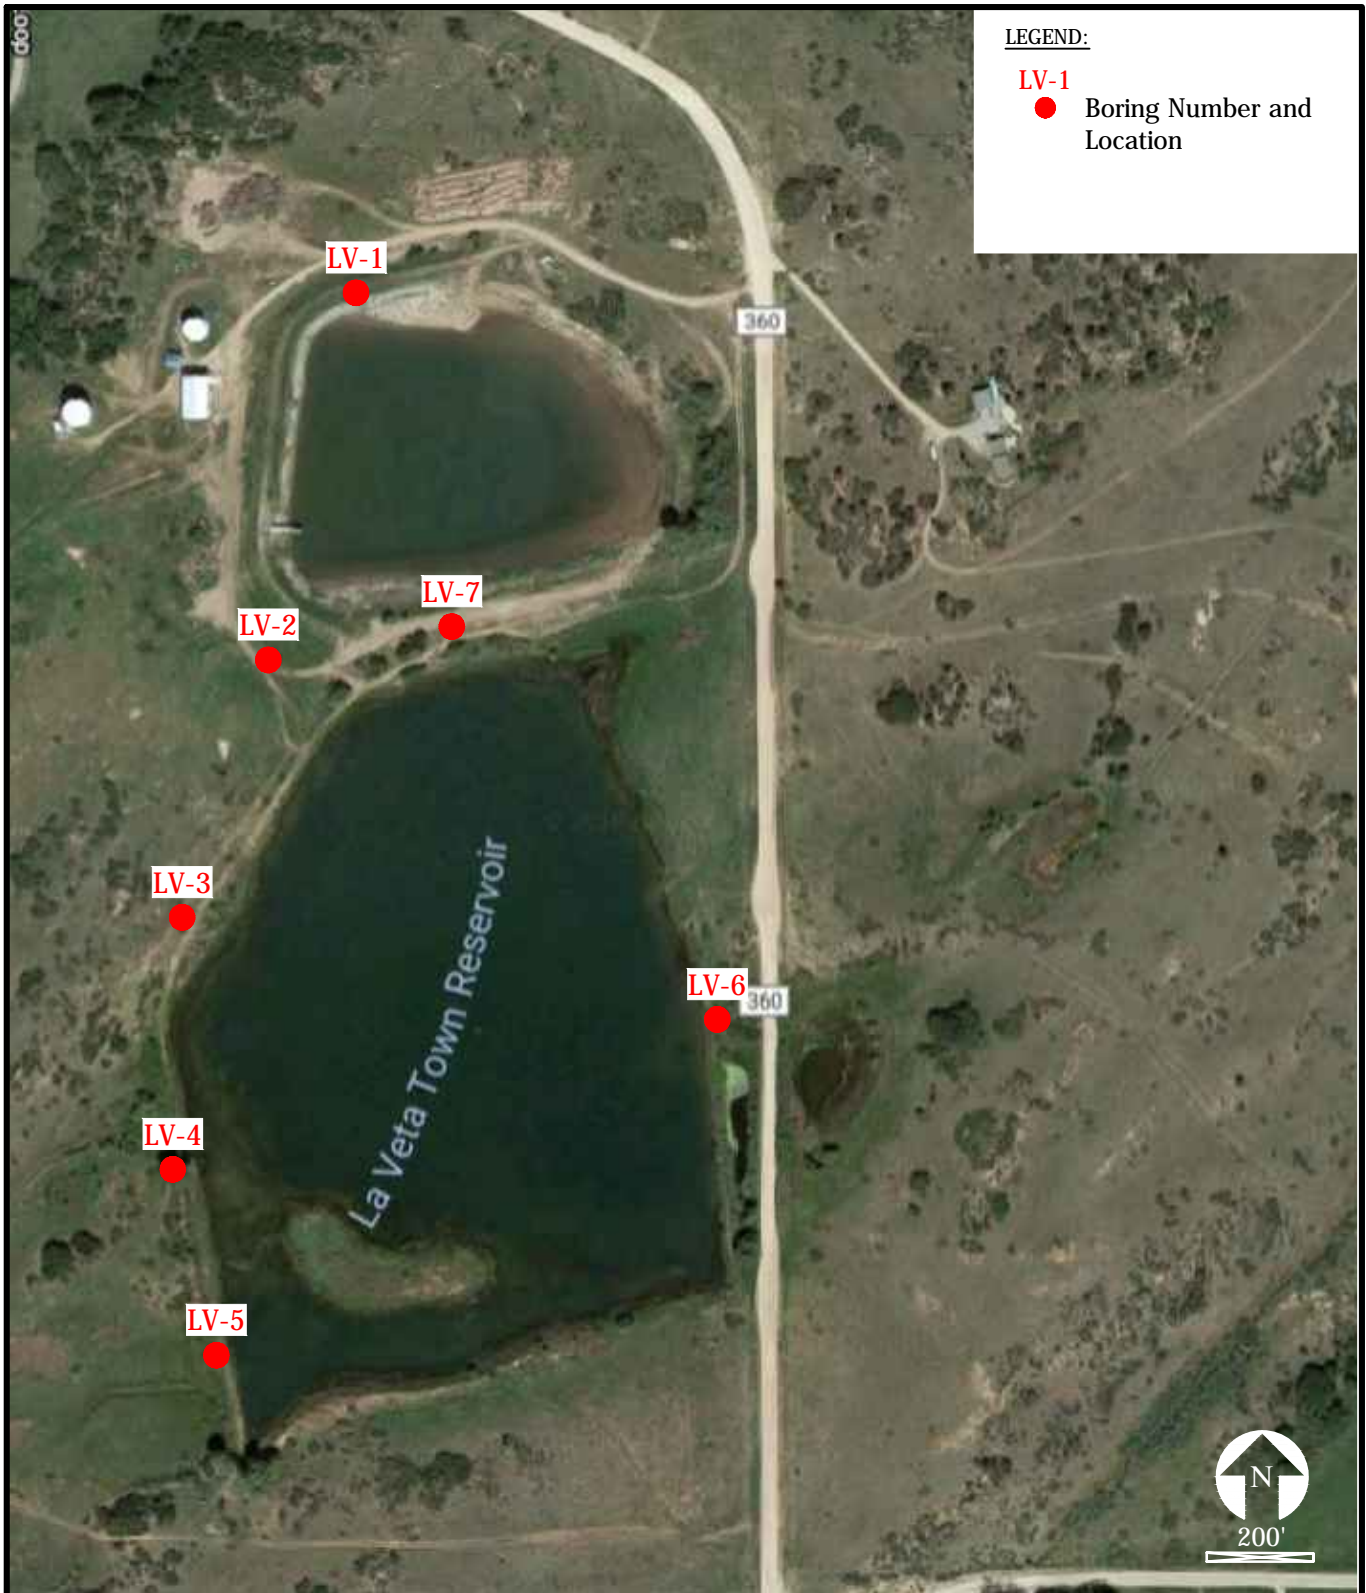
**FIGURE 17**  
 La Veta Lakes  
 Locations of Borings

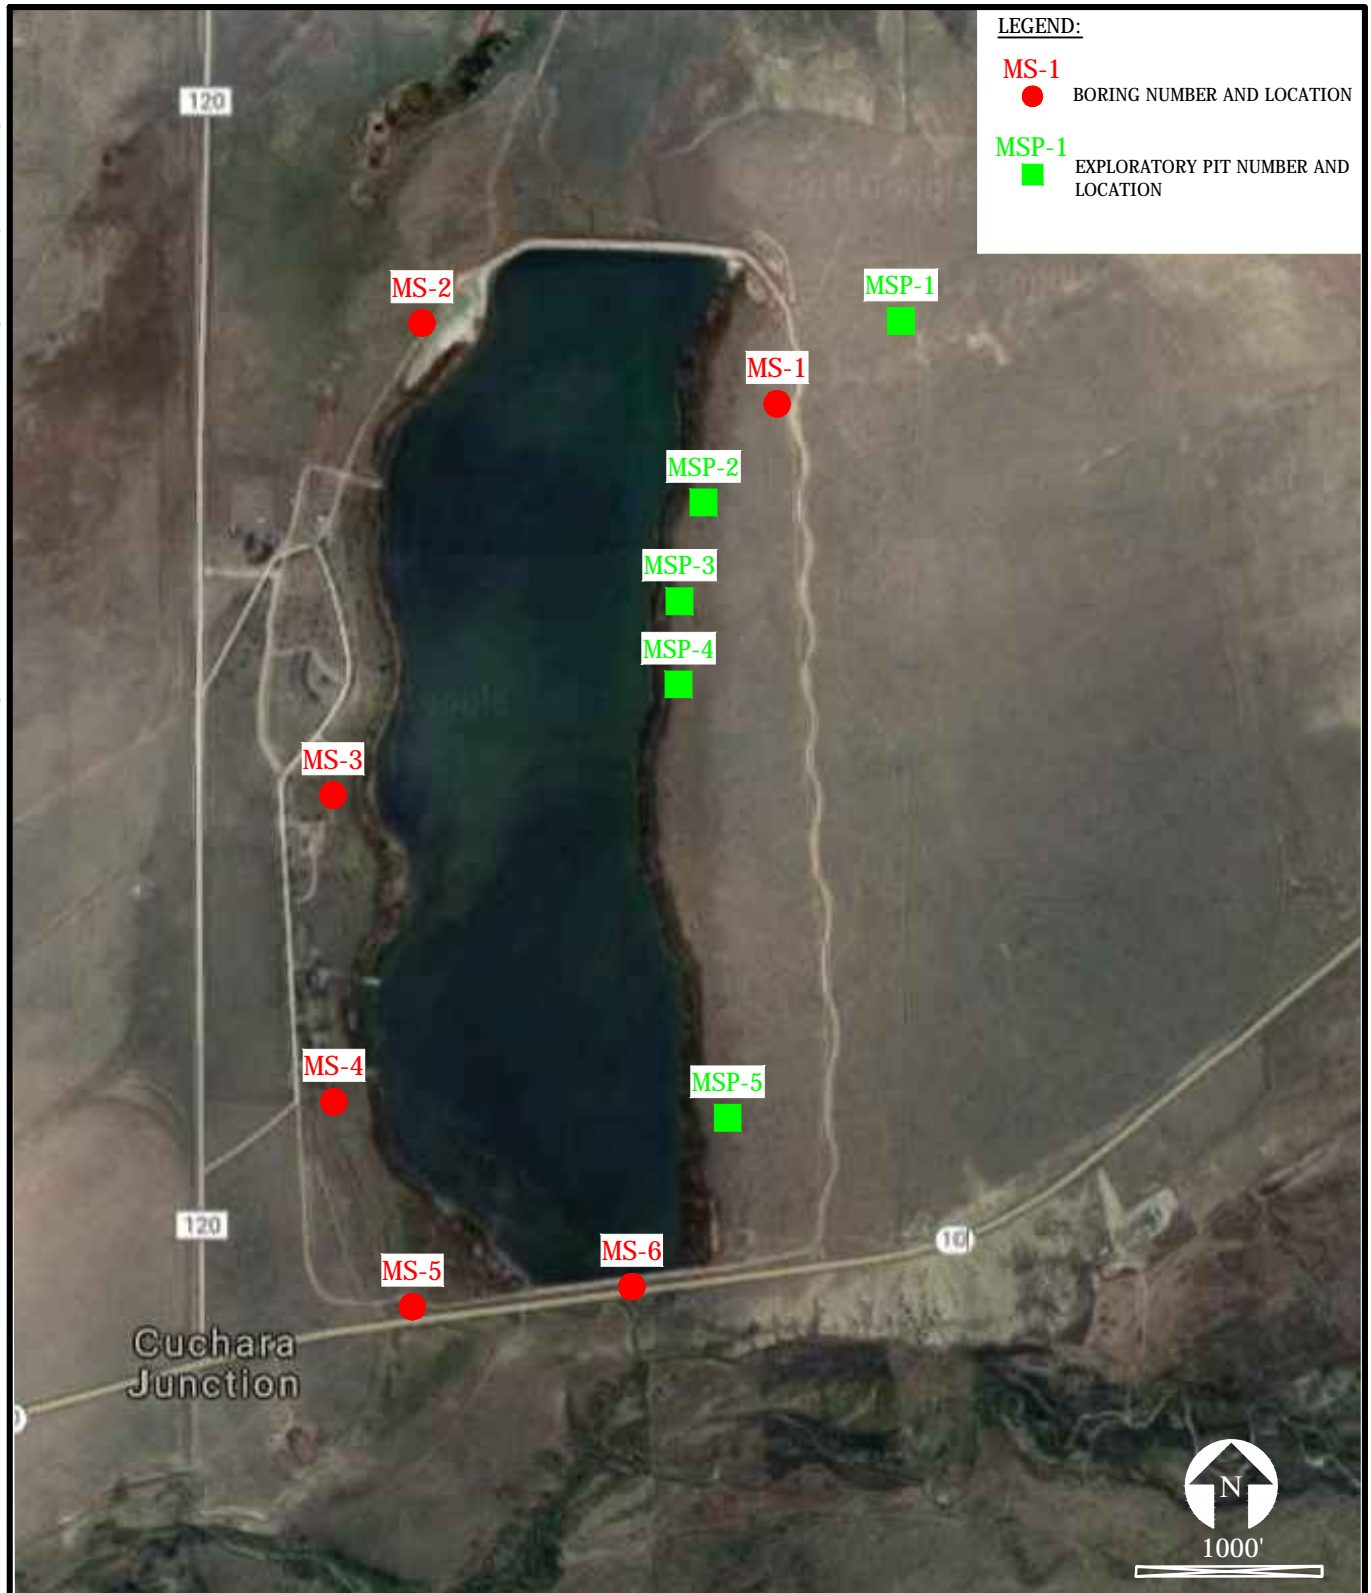
**FIGURE 19**  
**Maria Stevens**  
**Locations of Borings and Exploratory Pits**

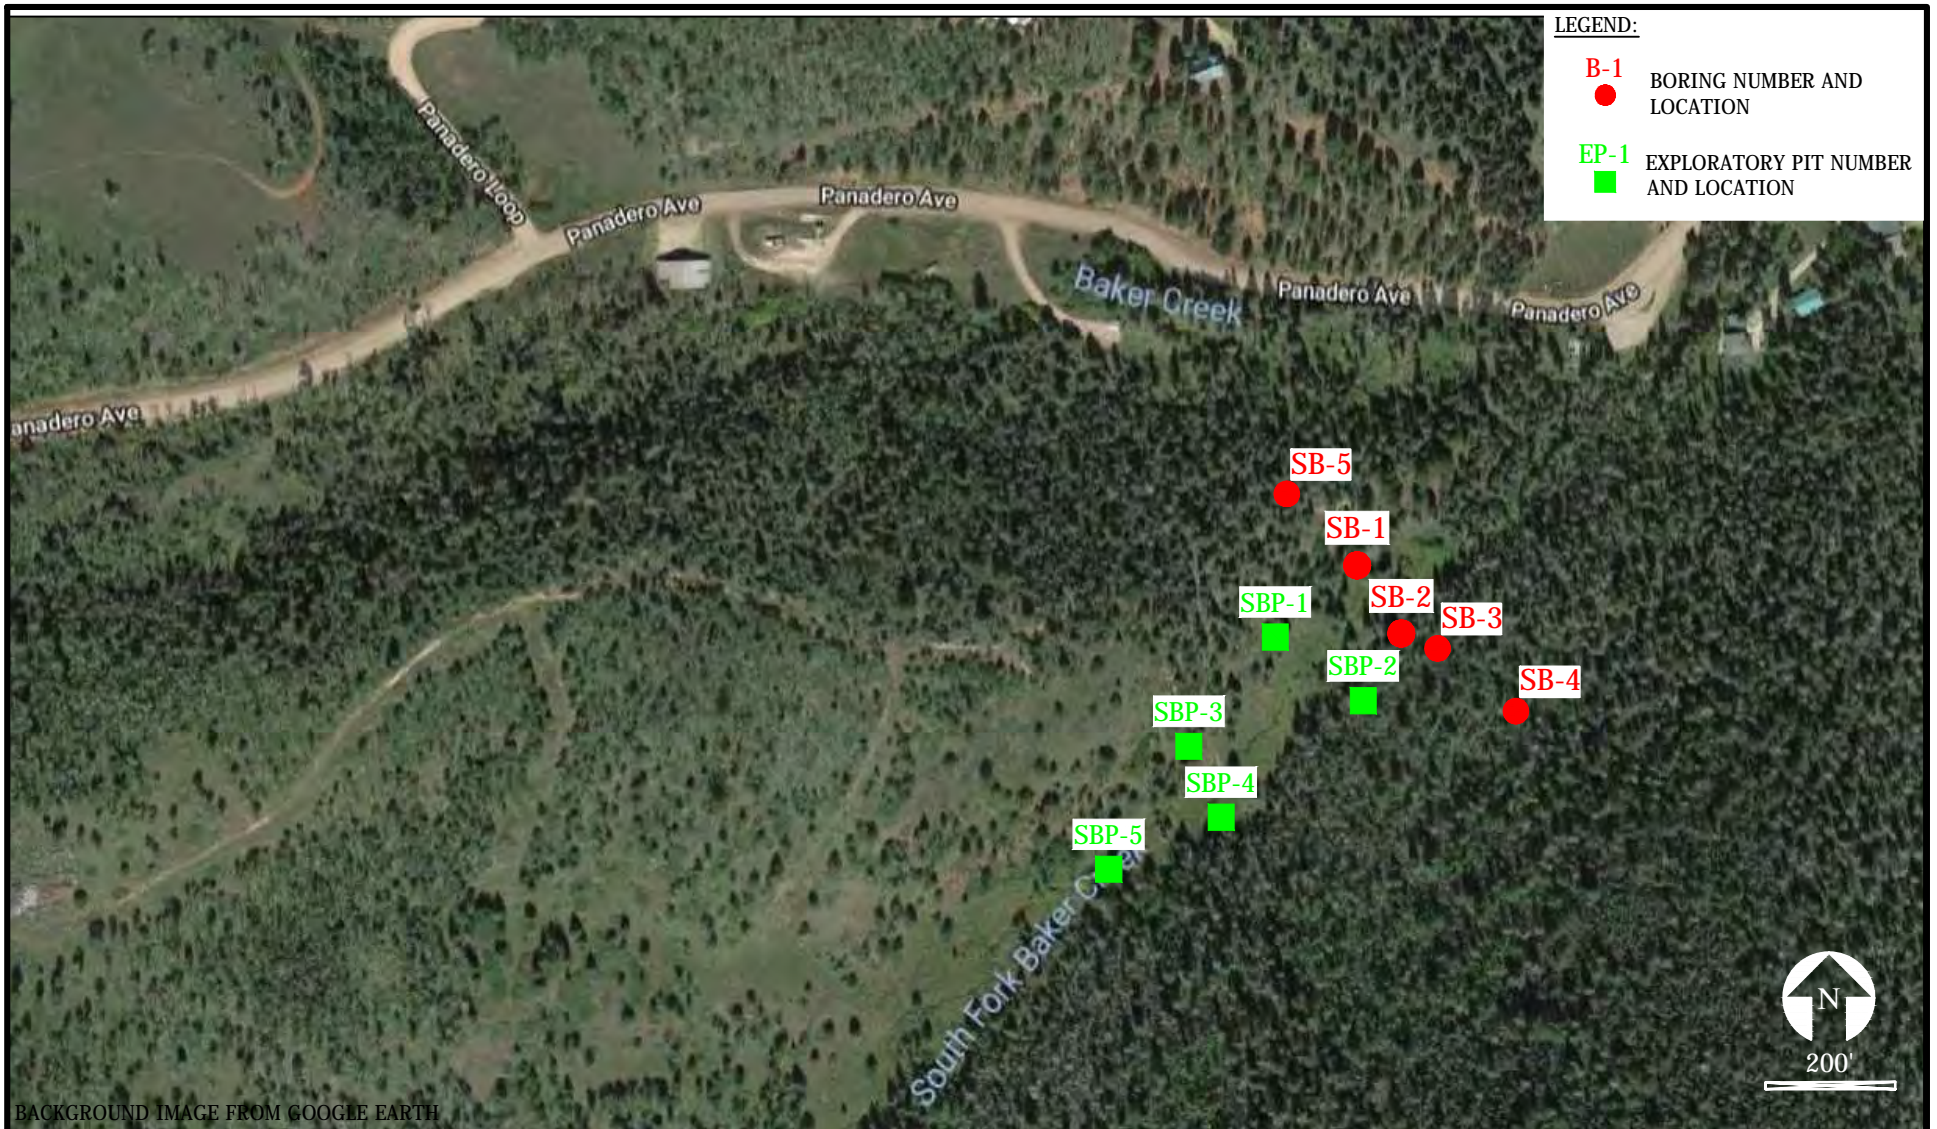
**FIGURE 22**  
South Baker  
Locations of Borings and Exploratory Pits
